Expertise

Protocol number: 46644227  
Order No. / Reference: 26450097  
Inspection date: 22 Jul 2026

| Manufacturer: Volvo | Model: XC90 T8 AWD Plug-in Hybrid Ultra Dark |

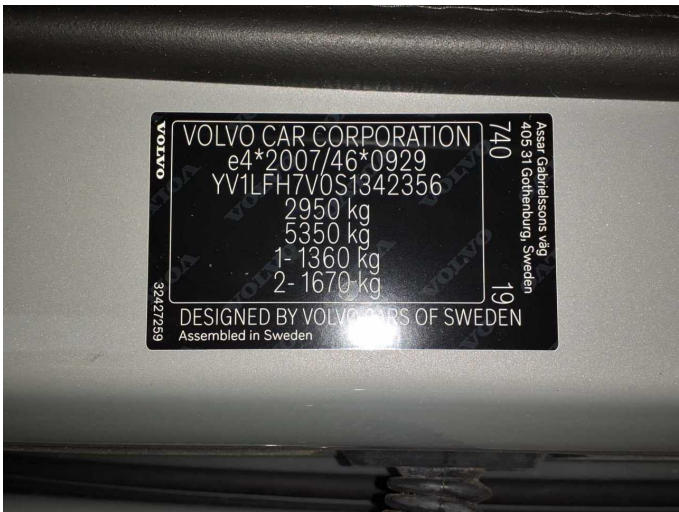
Figure 12: VIN

| VIN comparison | The vehicle identification number (VIN) was read from the vehicle and its conformity with the submitted documents was confirmed by the undersigned during the inspection. |

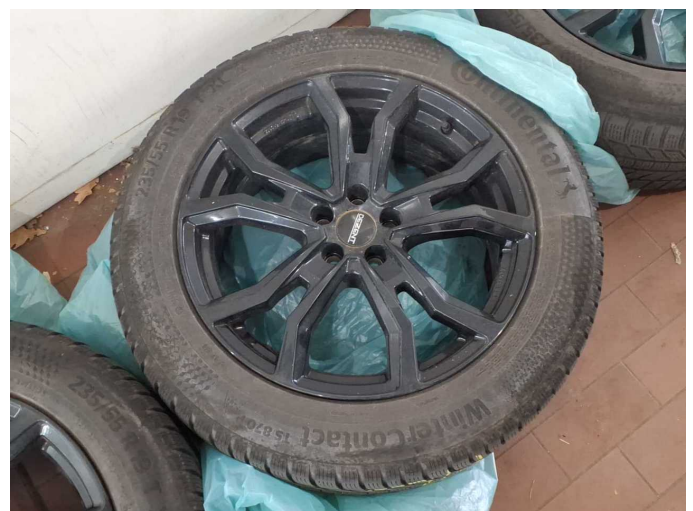
**Figure 18: Additional tyres**

| # | Tyre size | Type of tyre | Manufacturer | Tread depth |
|---|---|---|---|---|
| 1) | 235/55 R19 105T | Winter tyres on Light alloy | Continental | 4mm / 4mm |
| 2) | 235/55 R19 105T | Winter tyres on Light alloy | Continental | 5mm / 5mm |

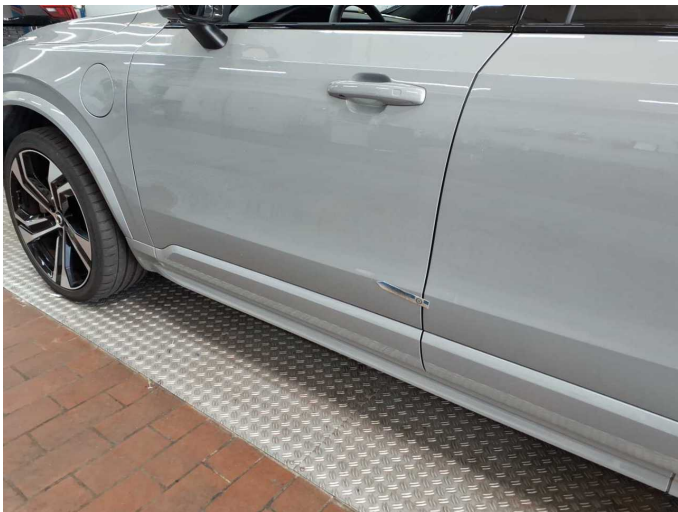
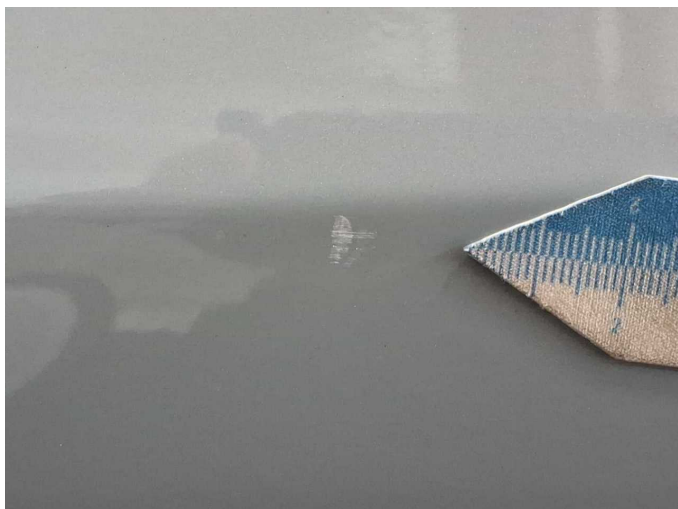
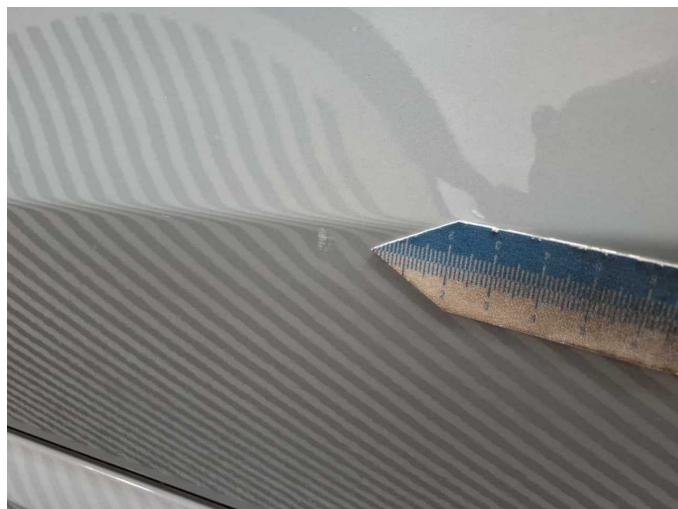
| No. | Component group | Description |
|---|---|---|
| 1 | Door - front left side | Door - Dent / paintcoat damage - Smart repair |

Damage 1: Door - front left side: Door - Dent / paintcoat damage - Smart repair

**Damage 1:** Door - front left side: Door - Dent / paintcoat damage - Smart repair

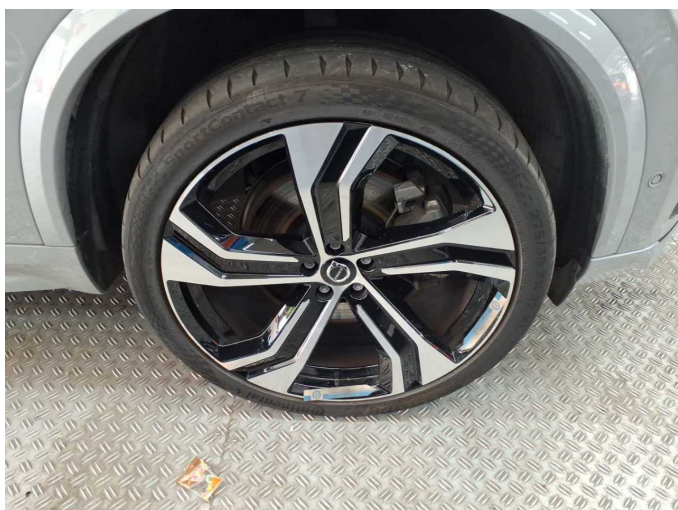
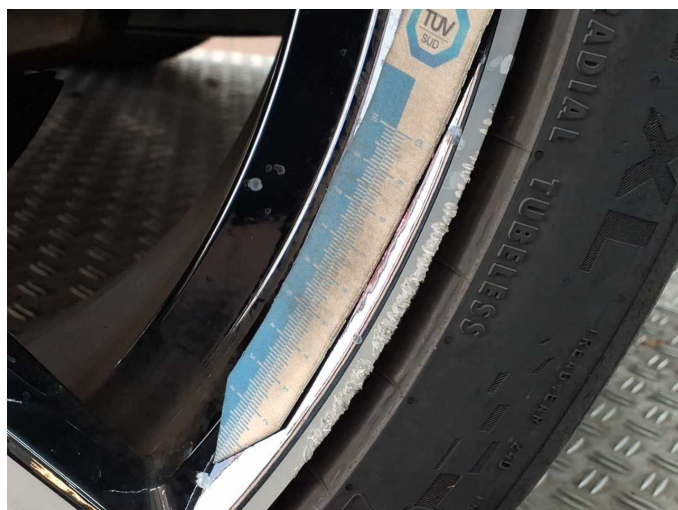
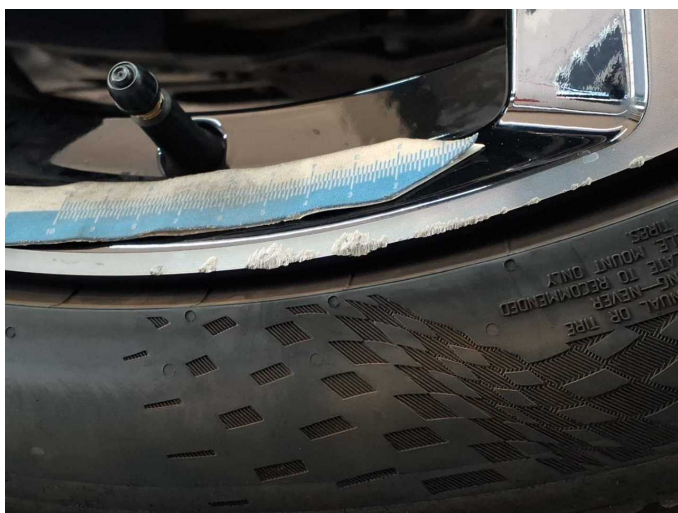
| No. | Component group | Description |
|---|---|---|
| 2 | Wheel / tyres | Alloy rim - front right side - Scratched - Replace |

**Damage 2:** Wheel / tyres: Alloy rim - front right side - Scratched - Replace

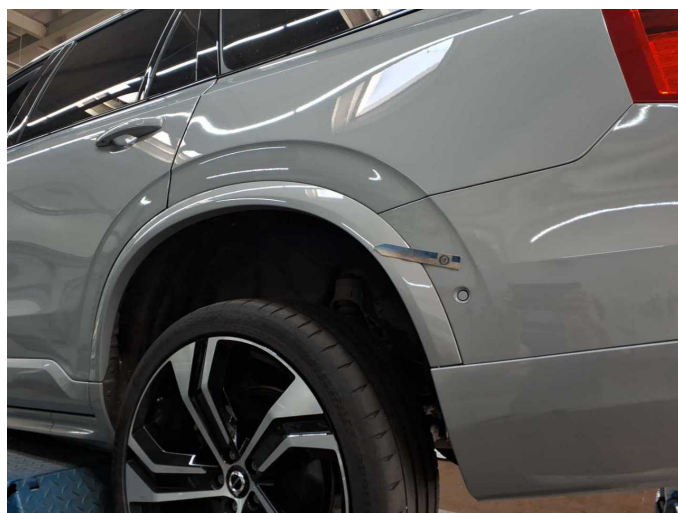
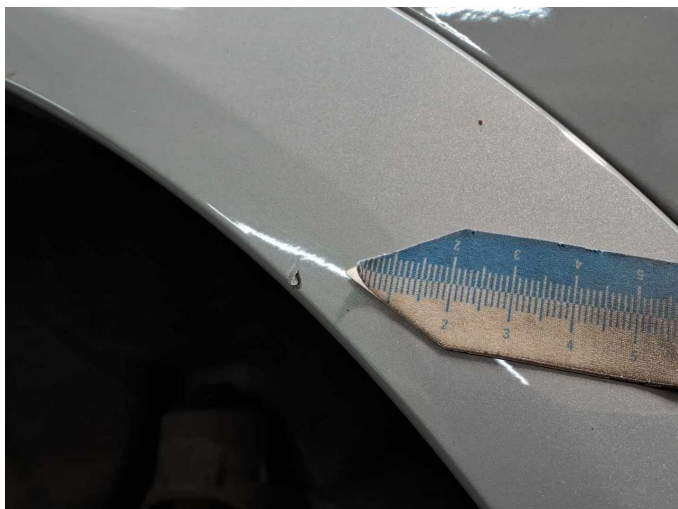
| No. | Component group | Description |
|---|---|---|
| 3 | Side panel - rear left side | Wheel well extension - Scratch(es) - No deduction |

**Wear and tear 3:** Side panel - rear left side: Wheel well extension - Scratch(es) - No deduction

**Wear and tear 3:** Side panel - rear left side: Wheel well extension -  
Scratch(es) - No deduction
