Expertise

Protocol number: 46199602  
Order No. / Reference: 26530158  
Inspection date: 29 Jun 2026

Manufacturer: Volkswagen

Model: Multivan 2,0 TDI SCR KÜ

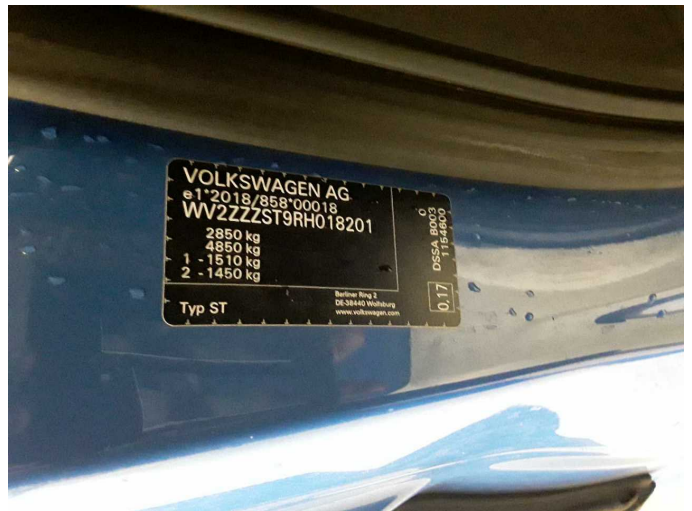
Figure 10: VIN

| VIN comparison | The vehicle identification number (VIN) was read from the vehicle and its conformity with the submitted documents was confirmed by the undersigned during the inspection. |

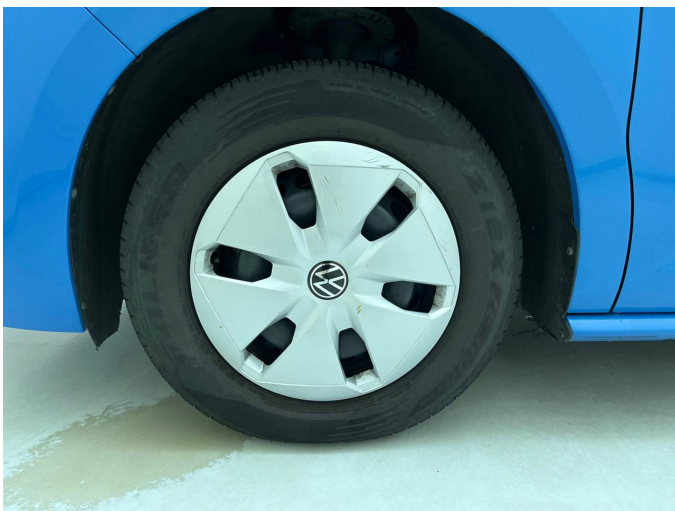
Figure 11: Mounted tyres

| # | Tyre size | Type of tyre | Manufacturer | Tread depth |
|---|---|---|---|---|
| 1) | 215/65 R16 102H | Summer tyres on Steel rim with wheel cover | Falken | 5mm / 5mm |
| 2) | 215/65 R16 102V | Summer tyres on Steel rim with wheel cover | Continental | 7mm / 6mm |

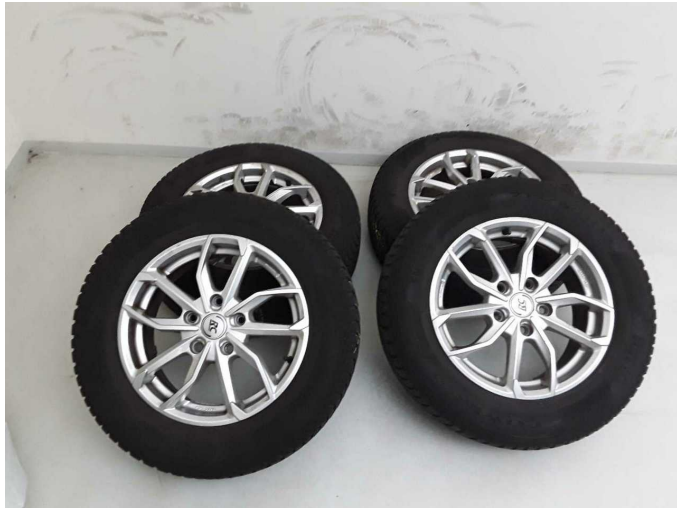
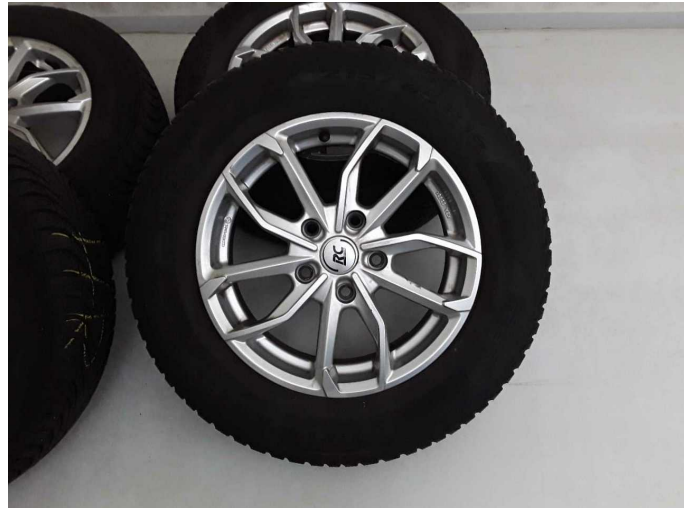
Figure 13: Additional tyres

| # | Tyre size | Type of tyre | Manufacturer | Tread depth |
|---|---|---|---|---|
| 1) | 215/65 R16 102H | Winter tyres on Light alloy | Pirelli | 5mm / 5mm |
| 2) | 215/65 R16 102H | Winter tyres on Light alloy | Pirelli | 7mm / 7mm |

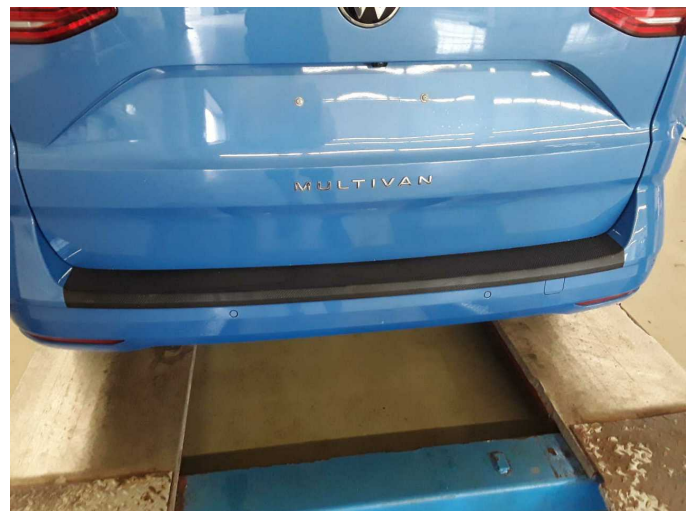
**Damage 2:** Rear bumper: Rear bumper (Zusatzkosten können entstehen) - Glued / labelled - De-glue / neutralise

| No. | Component group | Description |
|---|---|---|
| 2 | Rear bumper | Rear bumper (Zusatzkosten können entstehen) - Glued / labelled - De-glue / neutralise |

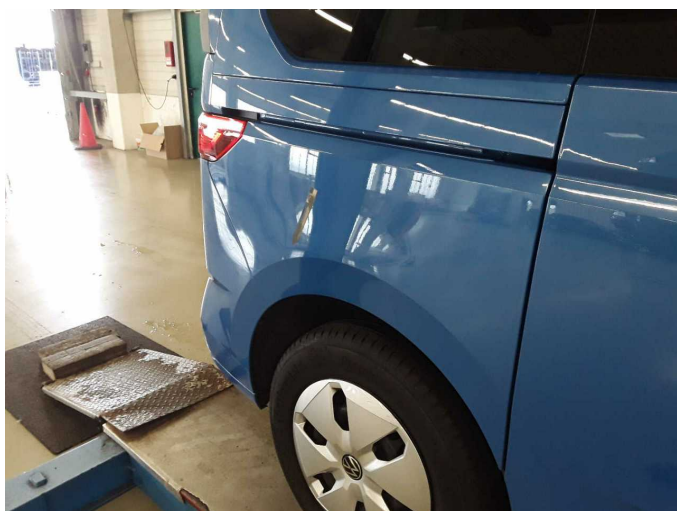
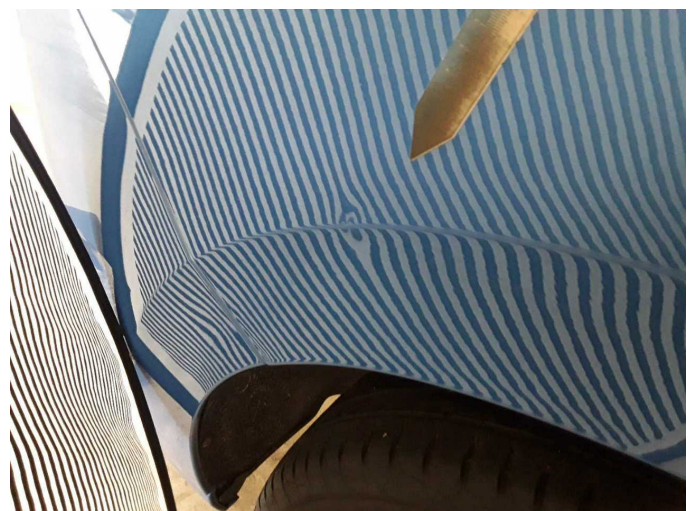
**Damage 3:** Side panel - rear right side: Side panel - dent(s) - Repair and paint

| No. | Component group | Description |
|---|---|---|
| 3 | Side panel - rear right side | Side panel - dent(s) - Repair and paint |

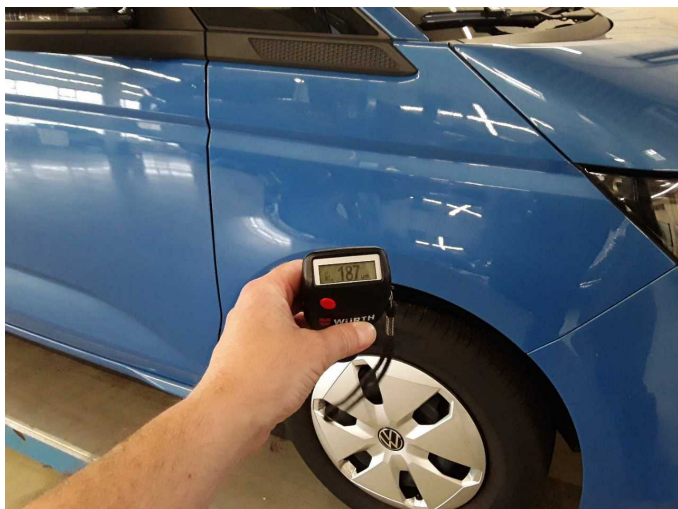
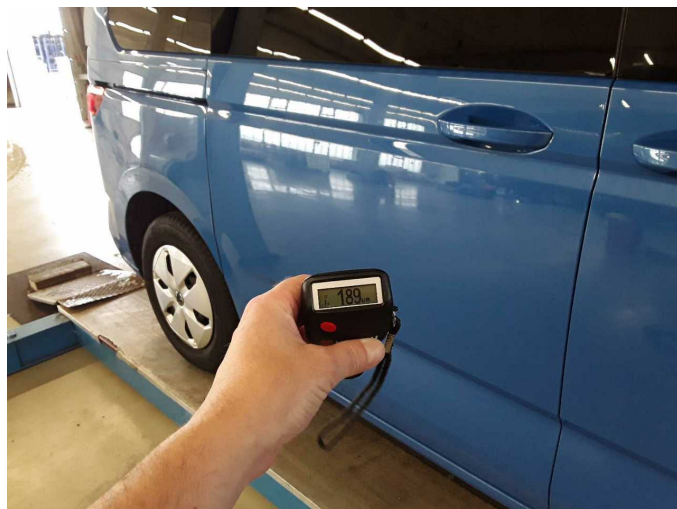
**Repainting 1:** Mudguard - right side, Door - rear right side

| No. | Repainting |
|---|---|
| 1 | Mudguard - right side, Door - rear right side, Professionally carried out |

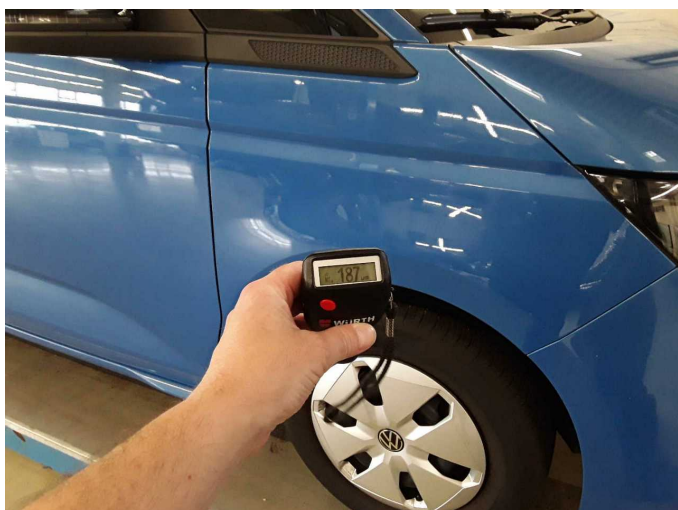
**Mudguard - right side:** 187  $\mu\text{m}$

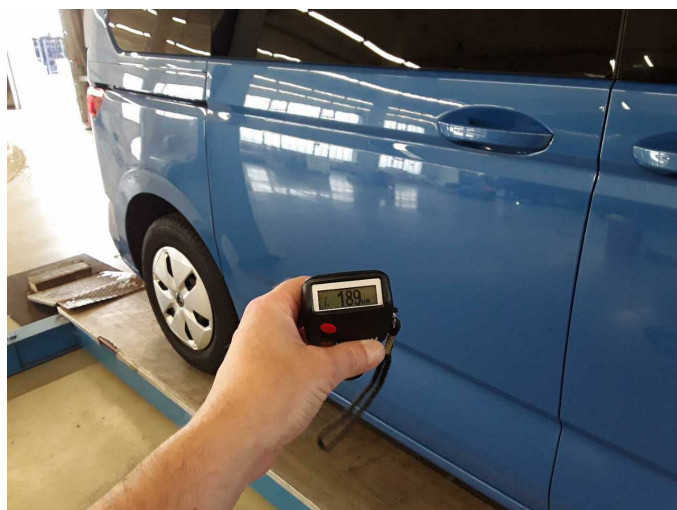
**Door - rear right side:** 189  $\mu\text{m}$
