Expertise

Protocol number: 46490204  
Order No. / Reference: 26605646  
Inspection date: 14 Jul 2026

Model: 508 SW BlueHDi 130 EAT8 GT

An order was placed to prepare a sales report for the described vehicle. This report includes the following:

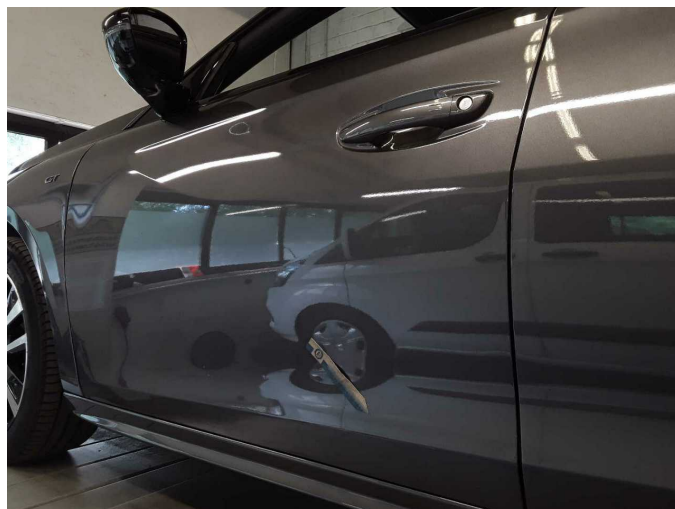
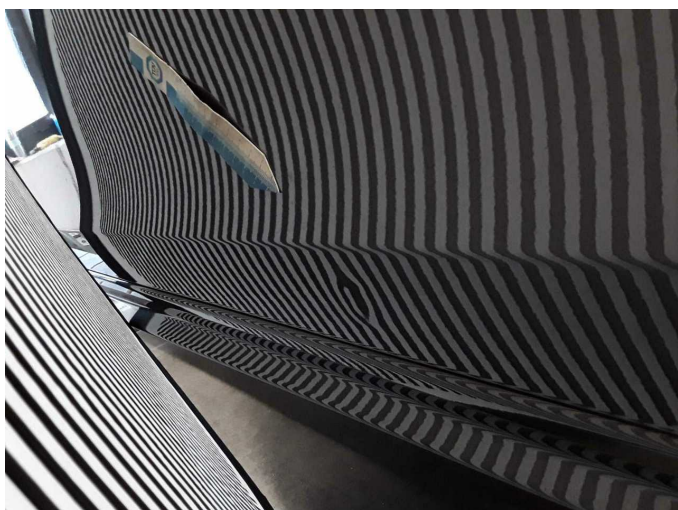
| No. | Component group | Description |
|---|---|---|
| 1 | Door - front left side | Door - dent(s) - Smooth repair work |

**Damage 1:** Door - front left side: Door - dent(s) - Smooth repair work

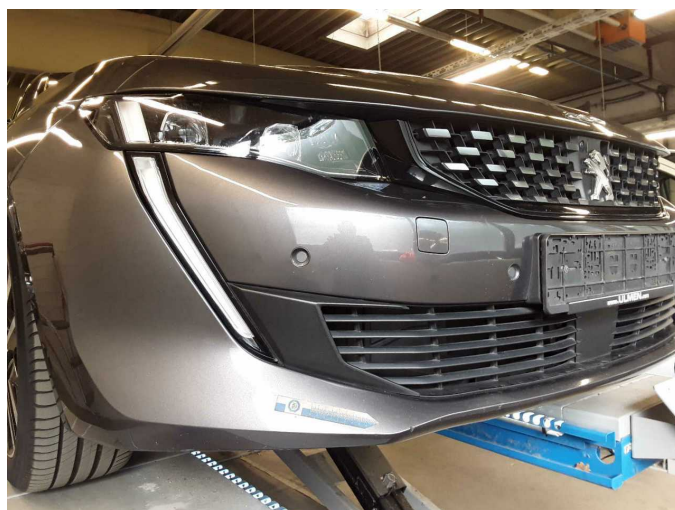
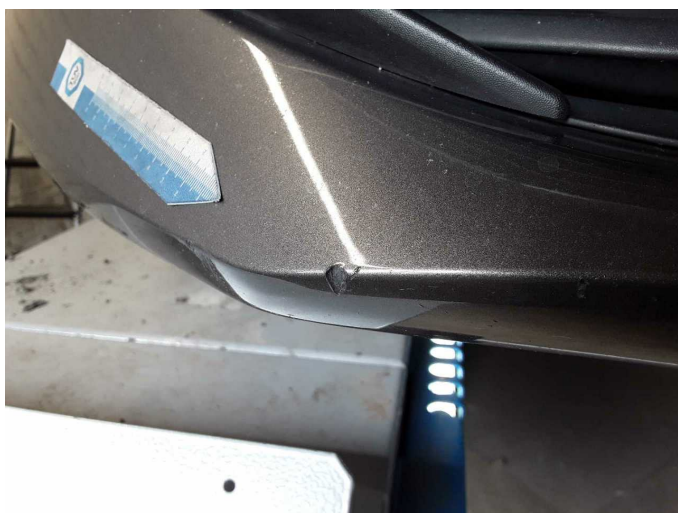
| No. | Component group | Description |
|---|---|---|
| 2 | Front bumper | Front bumper - Scratch(es) - Smart repair |

**Damage 2:** Front bumper: Front bumper - Scratch(es) - Smart repair

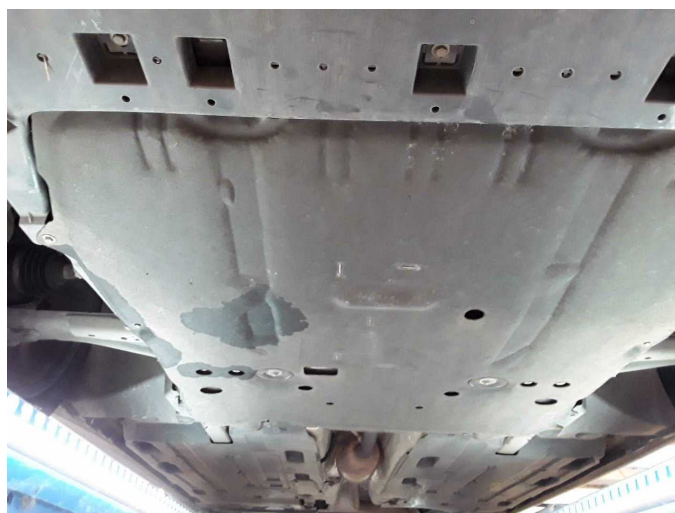
| No. | Component group | Description |
|---|---|---|
| 3 | Engine | Engine - Leaking - Diagnosed and repair if necessary |

**Damage 3:** Engine: Engine - Leaking - Diagnosed and repair if necessary

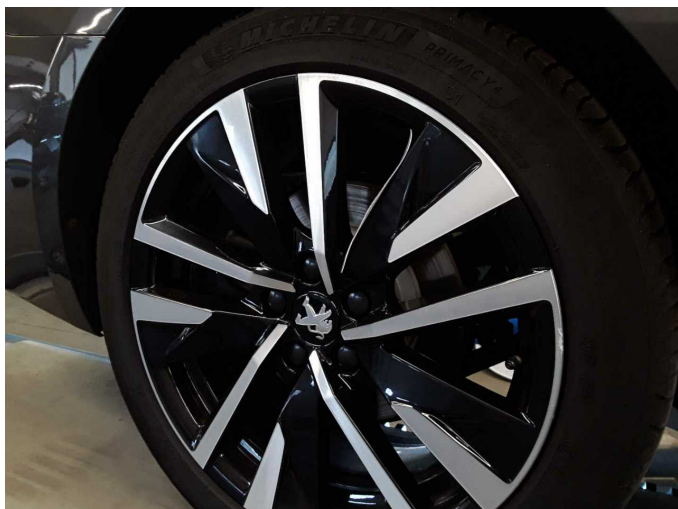
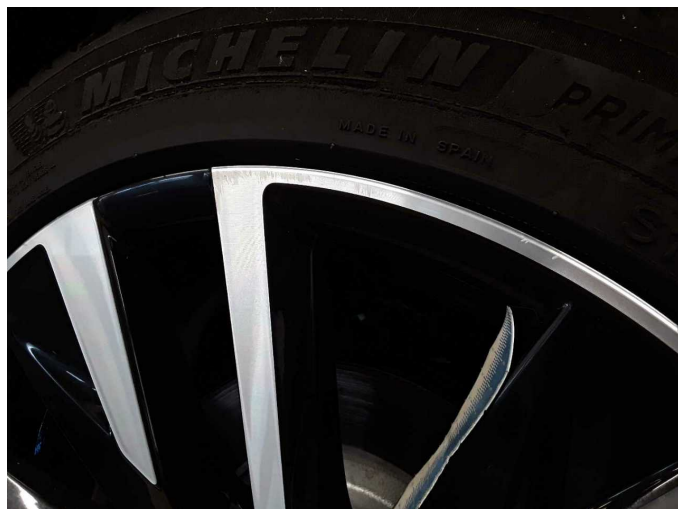
| No. | Component group | Description |
|---|---|---|
| 4 | Wheel / tyres | Alloy rim - rear right side - Scratch(es) - Loss in value |

**Damage 4:** Wheel / tyres: Alloy rim - rear right side - Scratch(es) - Loss in value

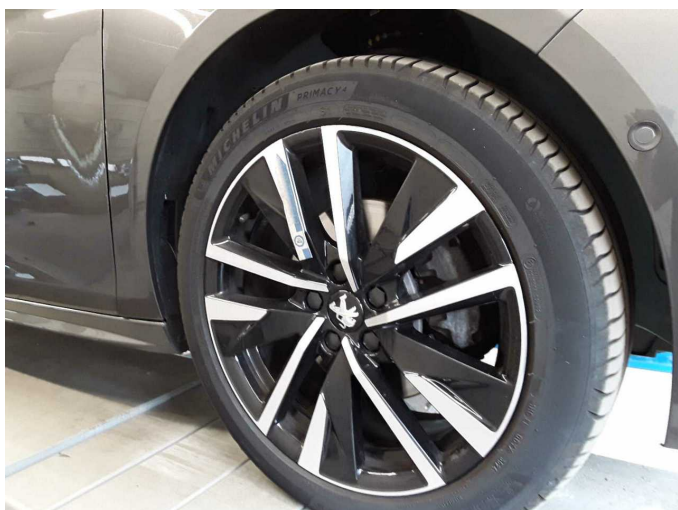
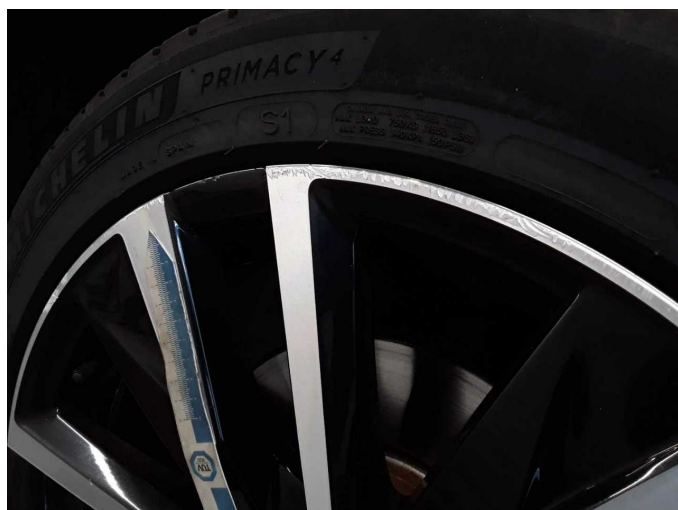
| No. | Component group | Description |
|---|---|---|
| 5 | Wheel / tyres | Alloy rim - front right side - Scratched - Replace |

**Damage 5:** Wheel / tyres: Alloy rim - front right side - Scratched - Replace
