Expertise

Protocol number: 46713493  
Order No. / Reference: 26640214  
Inspection date: 21 Jul 2026

Manufacturer: Mercedes-Benz

Model: GLE 350 de 4Matic 9G-TRONIC

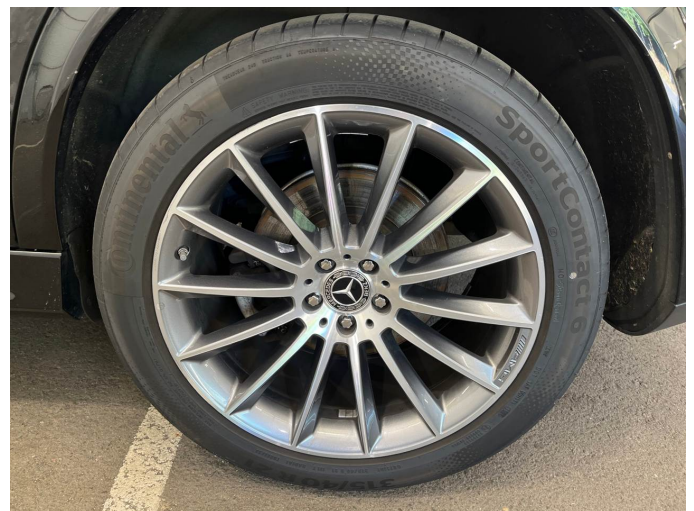
Figure 12: Mounted tyres

| # | Tyre size | Type of tyre | Manufacturer | Tread depth |
|---|---|---|---|---|
| 1) | 275/45 R21 107Y | Summer tyres on Light alloy | Continental | 5mm / 5mm |
| 2) | 315/40 R21 111Y | Summer tyres on Light alloy | Continental | 6mm / 6mm |

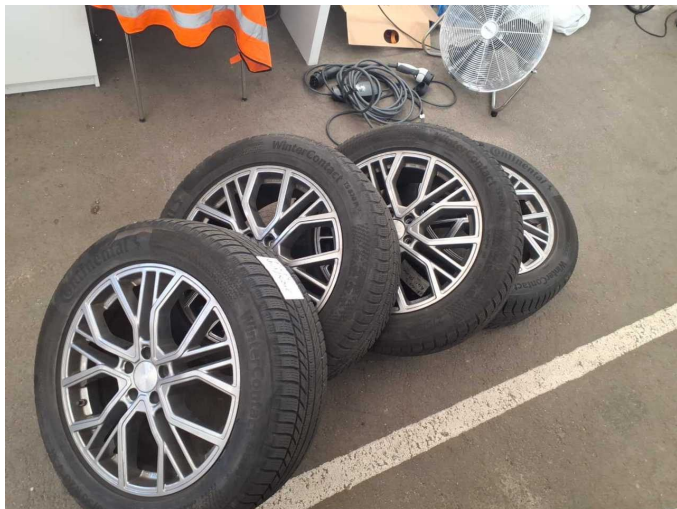
Figure 15: Additional tyres

| # | Tyre size | Type of tyre | Manufacturer | Tread depth |
|---|---|---|---|---|
| 1) | 275/50 R20 113V | Winter tyres on Light alloy | Continental | 6mm / 6mm |
| 2) | 275/50 R20 113V | Winter tyres on Light alloy | Continental | 6mm / 6mm |

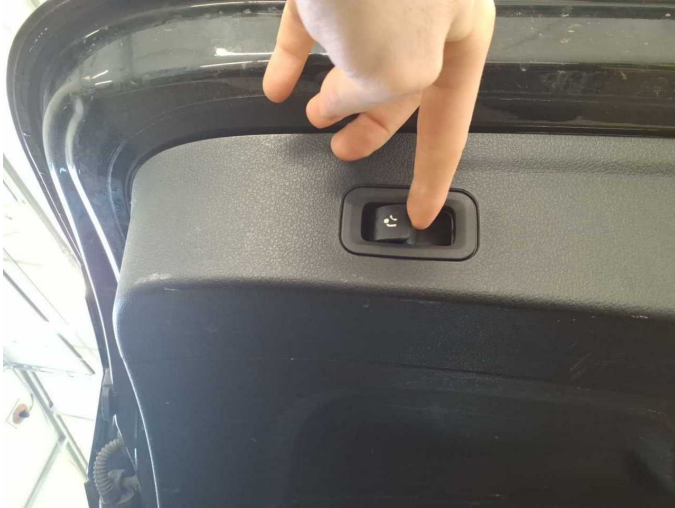
| No. | Component group | Description |
|---|---|---|
| 1 | Rear of vehicle | Trailer hitch (Anhängerkupplung fährt nicht aus, ohne Funktion) - Specify findings - Perform diagnosis |

**Damage 1:** Rear of vehicle: Trailer hitch (Anhängerkupplung fährt nicht aus, ohne Funktion) - Specify findings - Perform diagnosis

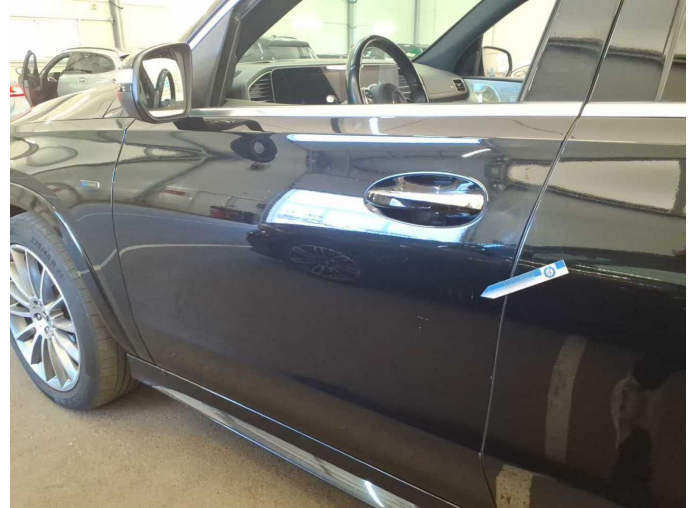
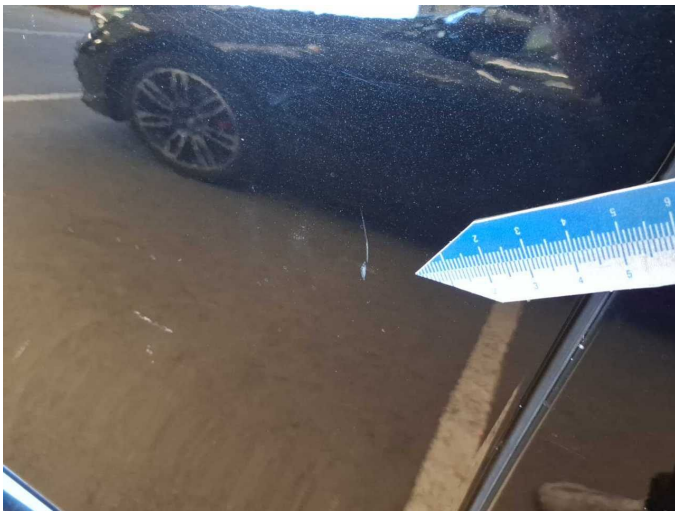
| No. | Component group | Description |
|---|---|---|
| 2 | Door - front left side | Door - Scratch(es) - Smart repair |

**Damage 2:** Door - front left side: Door - Scratch(es) - Smart repair

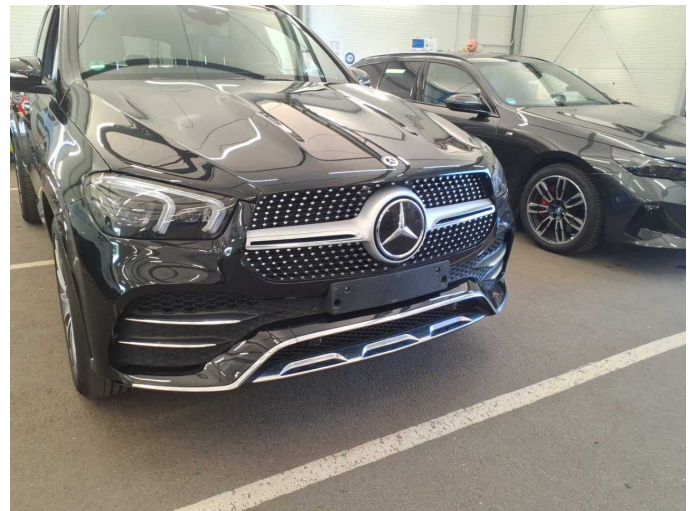
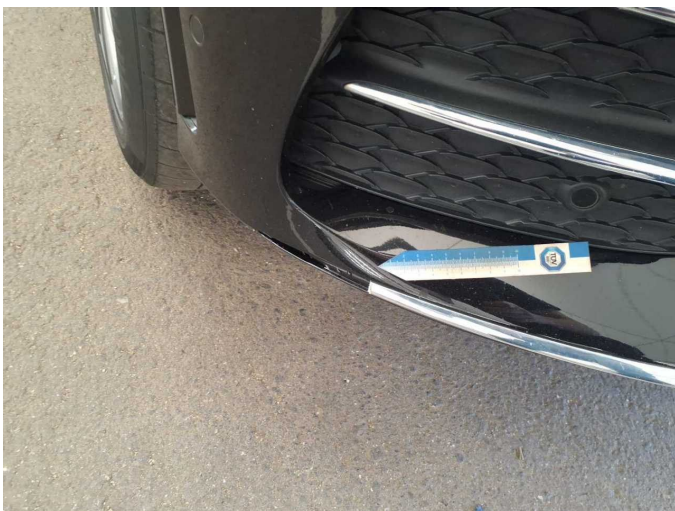
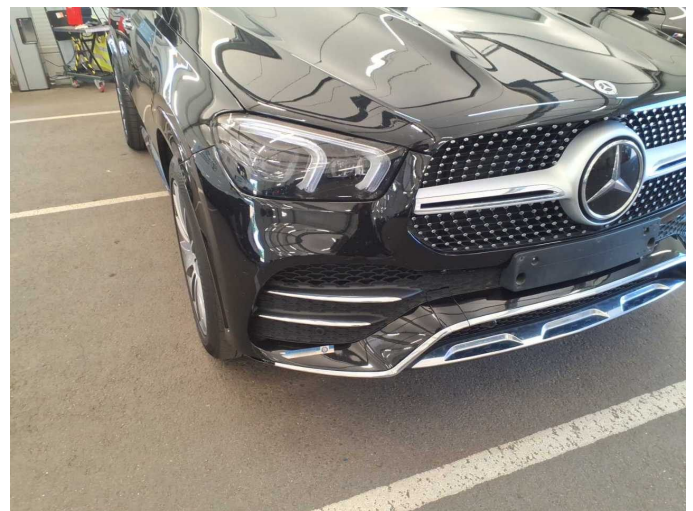
| No. | Component group | Description |
|---|---|---|
| 3 | Front bumper | Spoiler (Zierleiste rechts) - Damaged - Replace |

**Damage 3:** Front bumper: Spoiler (Zierleiste rechts) - Damaged - Replace

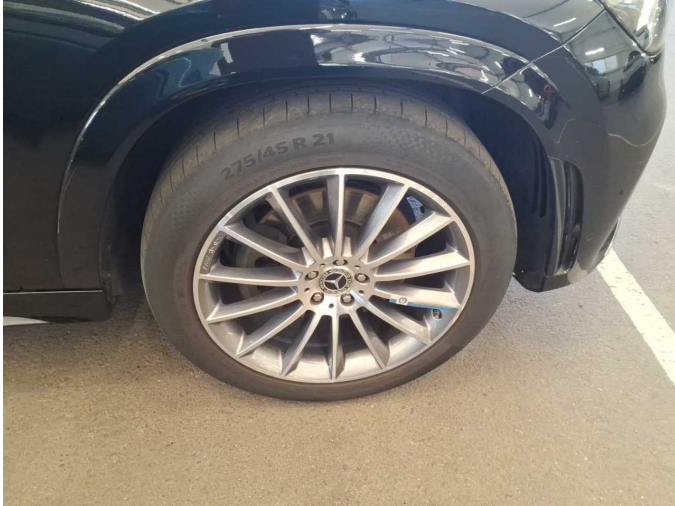
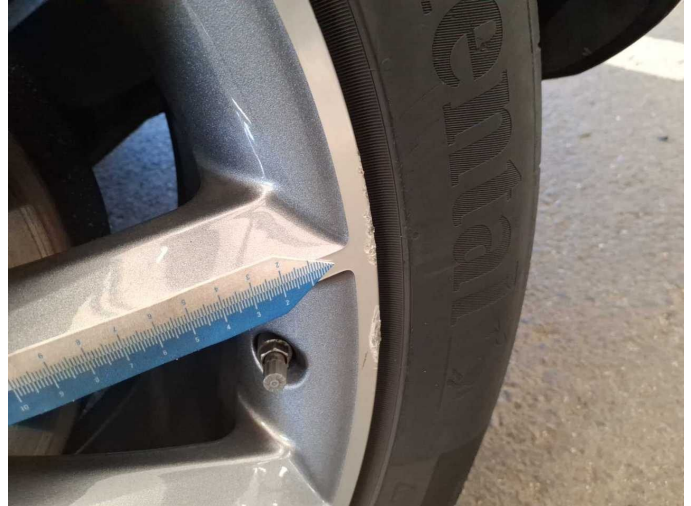
| No. | Component group | Description |
|---|---|---|
| 4 | Wheel / tyres | Alloy rim - front right side - Scratch(es) - Loss in value |

**Damage 4:** Wheel / tyres: Alloy rim - front right side - Scratch(es) - Loss in value

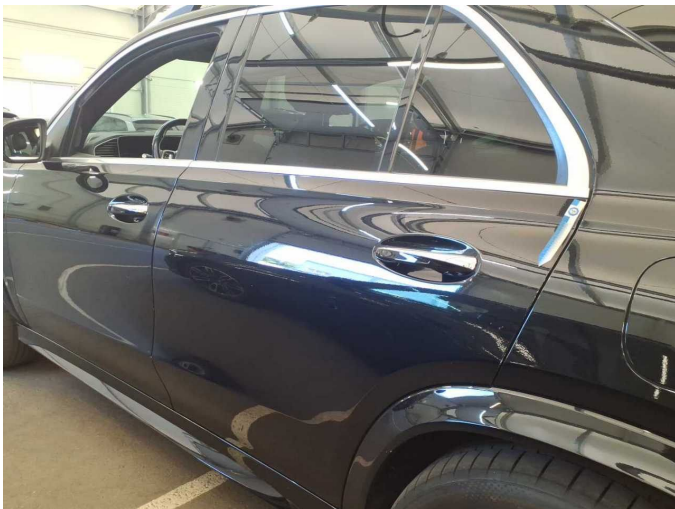
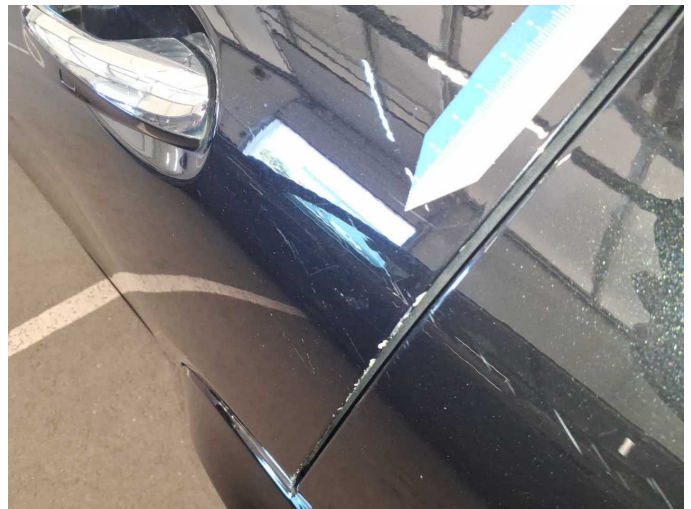
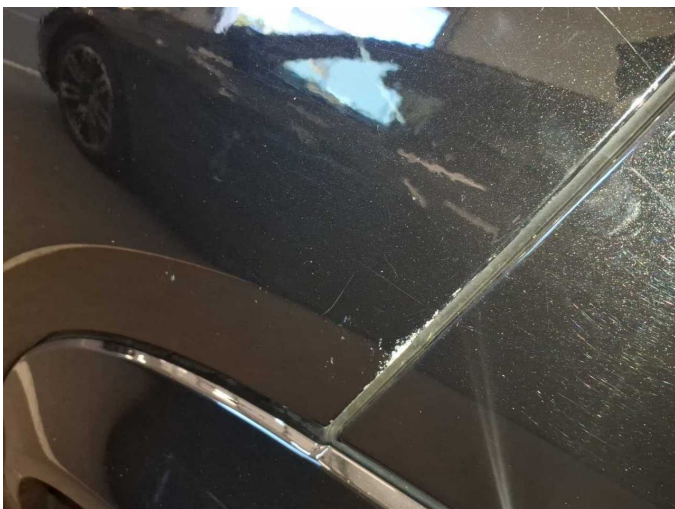
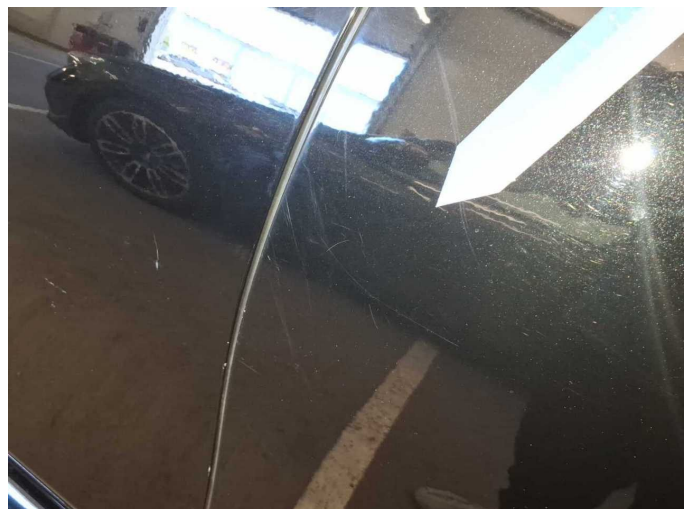
| No. | Component group | Description |
|---|---|---|
| 5 | Door - rear left side | Door - Scratch(es) - Paint |

**Damage 5:** Door - rear left side: Door - Scratch(es) - Paint

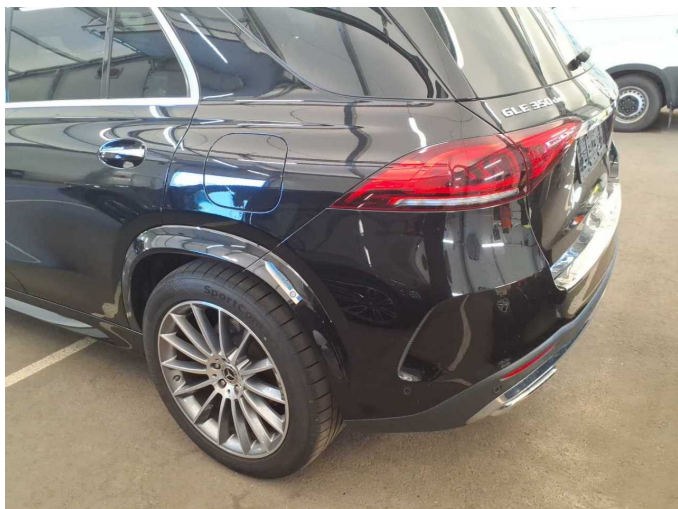
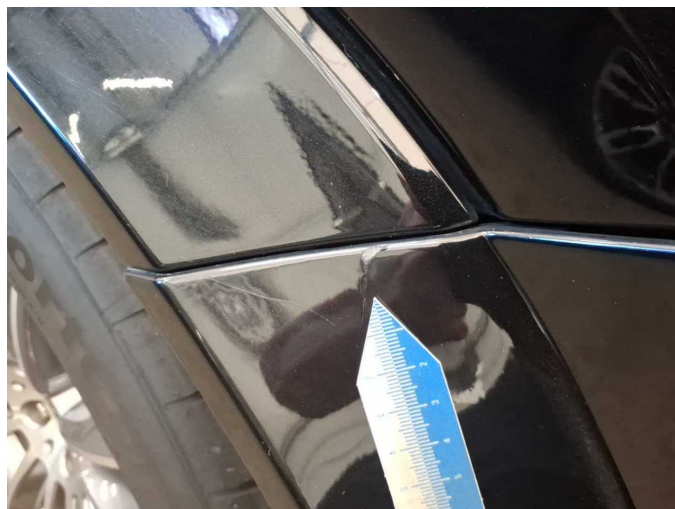
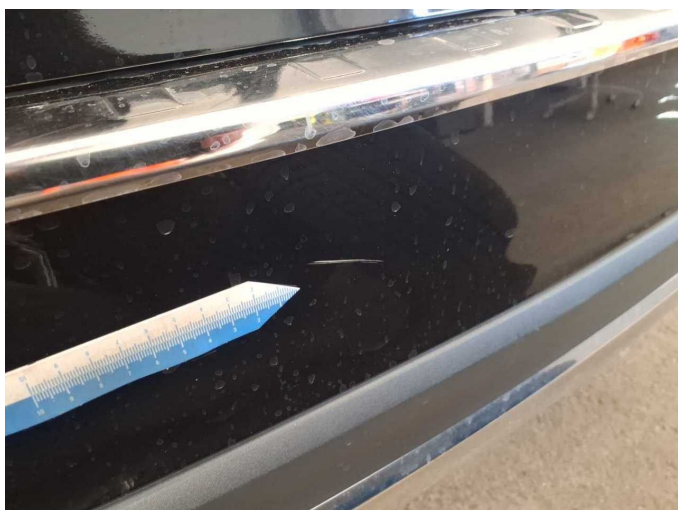
| No. | Component group | Description |
|---|---|---|
| 6 | Rear bumper | Rear bumper - Scratched - Paint |

**Damage 6:** Rear bumper: Rear bumper - Scratched - Paint

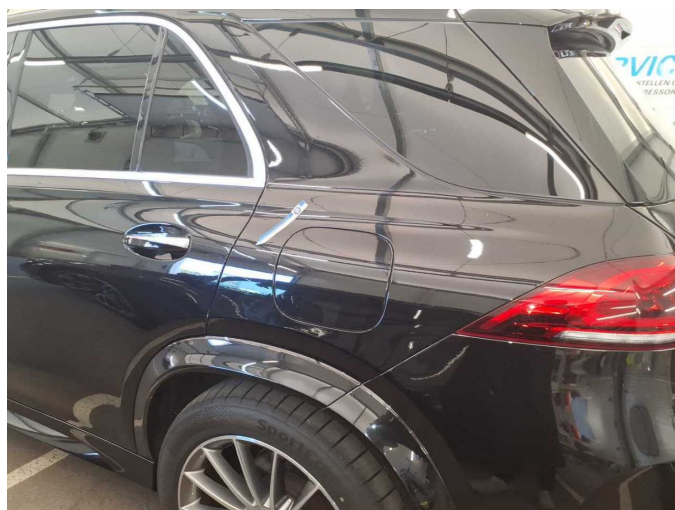
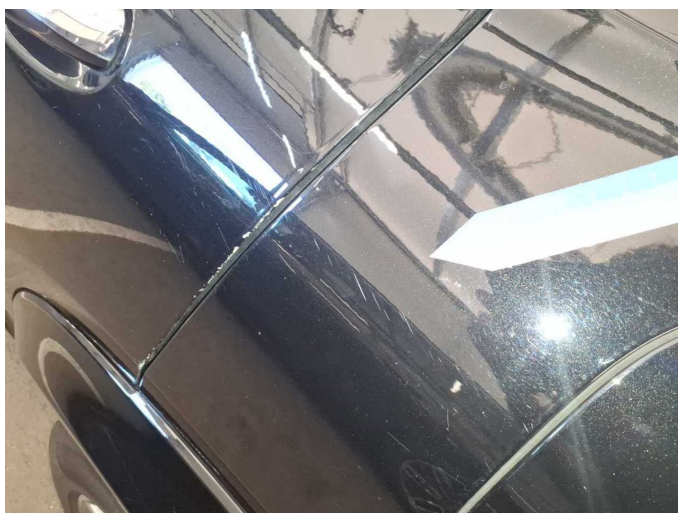
| No. | Component group | Description |
|---|---|---|
| 7 | Side panel - rear left side | Side panel - Scratch(es) - Paint |

**Damage 7:** Side panel - rear left side: Side panel - Scratch(es) - Paint

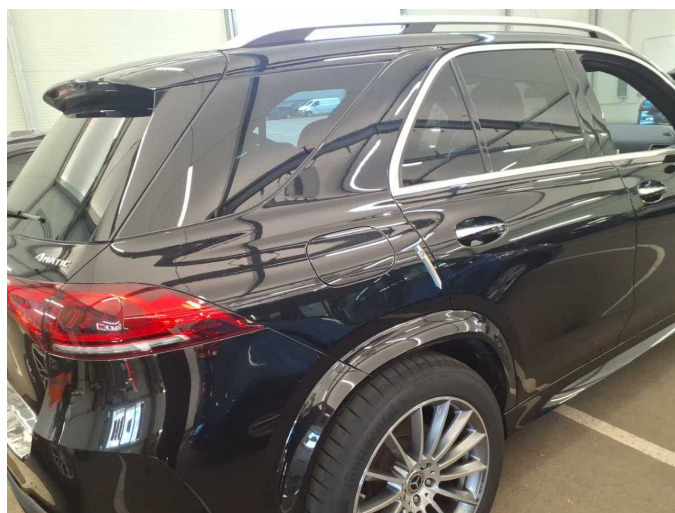
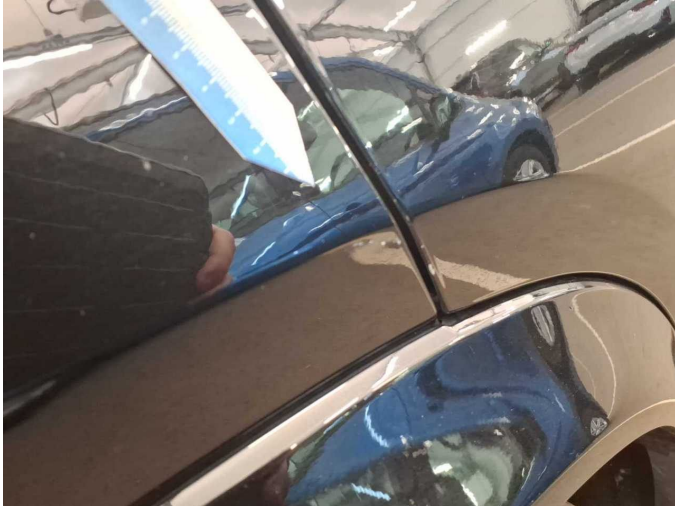
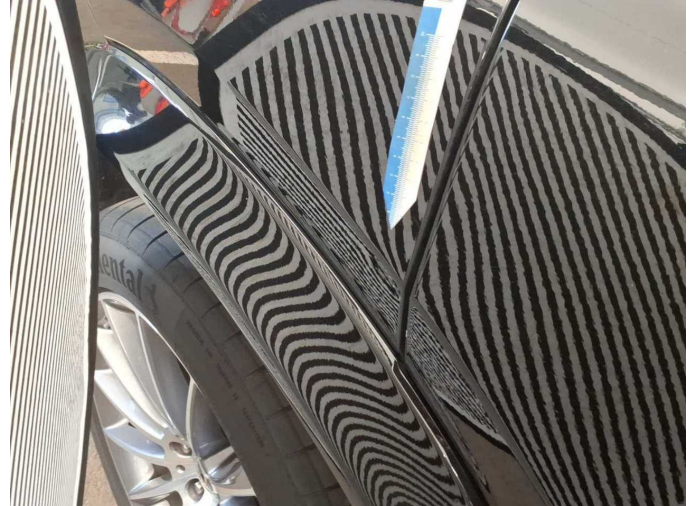
| No. | Component group | Description |
|---|---|---|
| 8 | Side panel - rear right side | Side panel - Dent / paintcoat damage - Repair and paint |

**Damage 8:** Side panel - rear right side: Side panel - Dent / paintcoat damage - Repair and paint

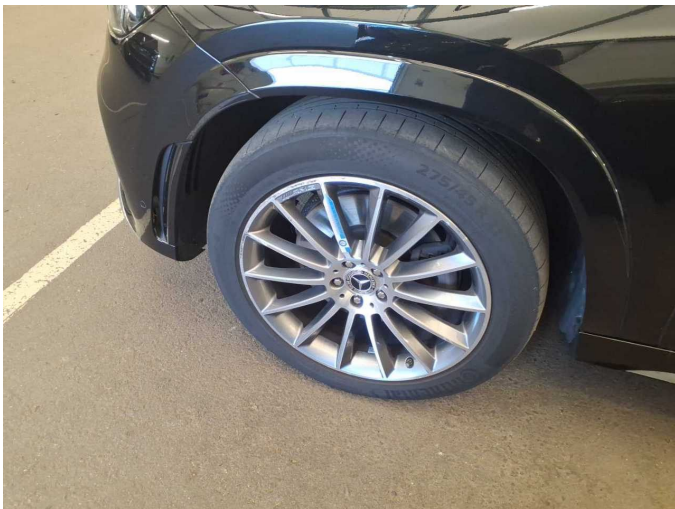
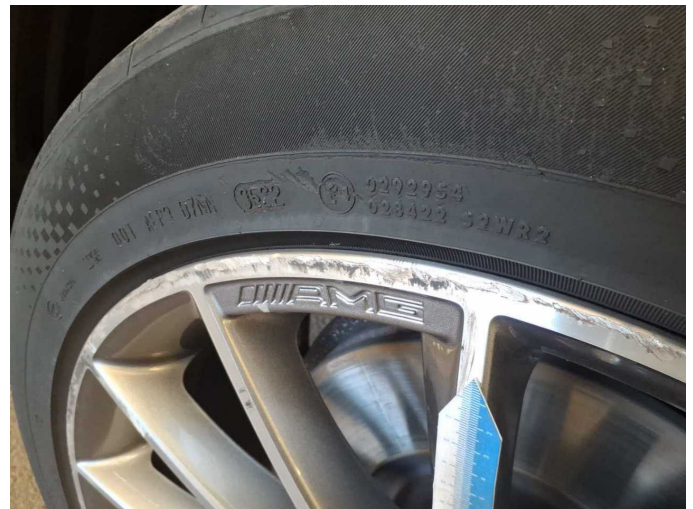
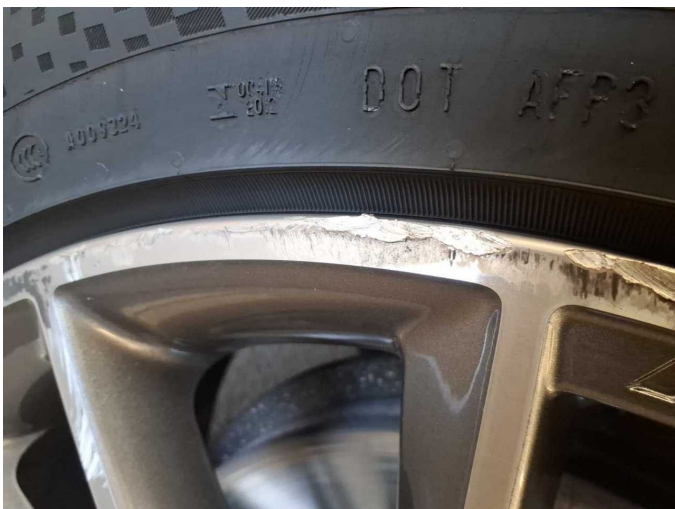
| No. | Component group | Description |
|---|---|---|
| 9 | Wheel / tyres | Alloy rim - front left side (Mit Materialabtrag) - Scratch(es) - Replace |

**Damage 9:** Wheel / tyres: Alloy rim - front left side (Mit Materialabtrag) - Scratch(es) - Replace

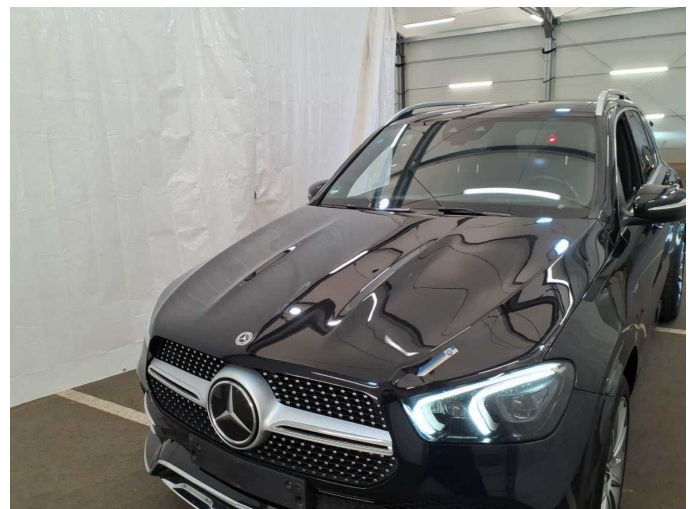
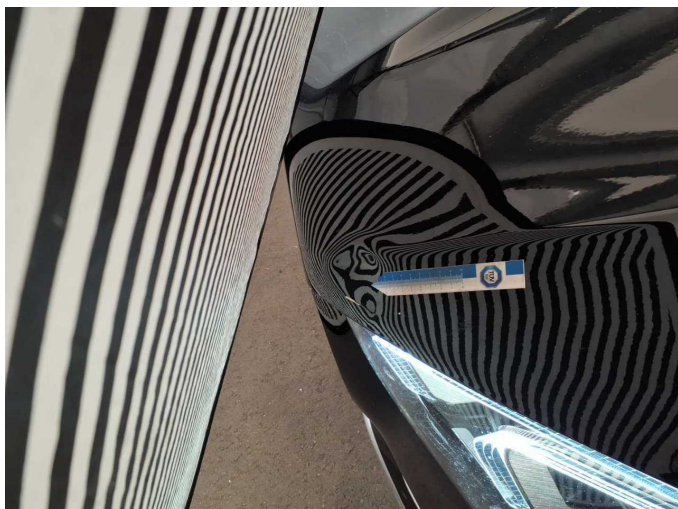
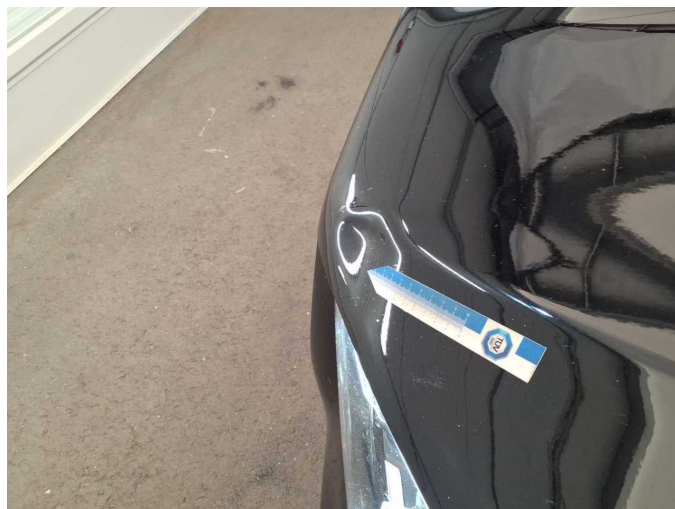
| No. | Component group | Description |
|---|---|---|
| 10 | Bonnet | Bonnet - Deformed - Repair and paint |

**Damage 10:** Bonnet: Bonnet - Deformed - Repair and paint
