Expertise

Protocol number: 46428374  
Order No. / Reference: 26605940  
Inspection date: 9 Jul 2026

Manufacturer: Audi

Model: A4 Avant 30 TDI S tronic advanced

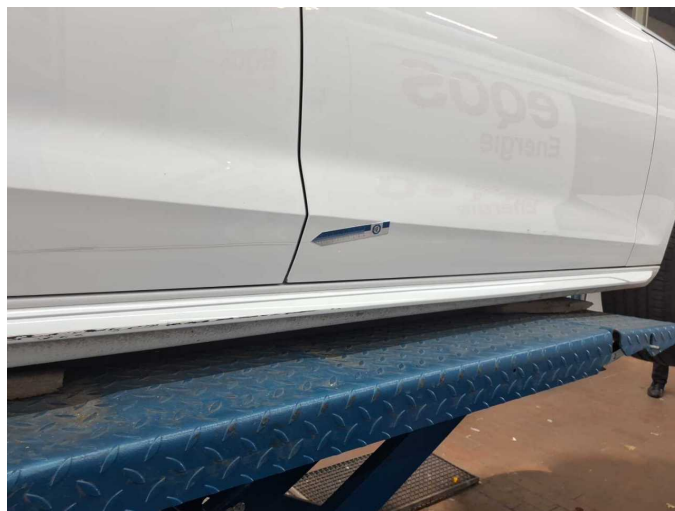
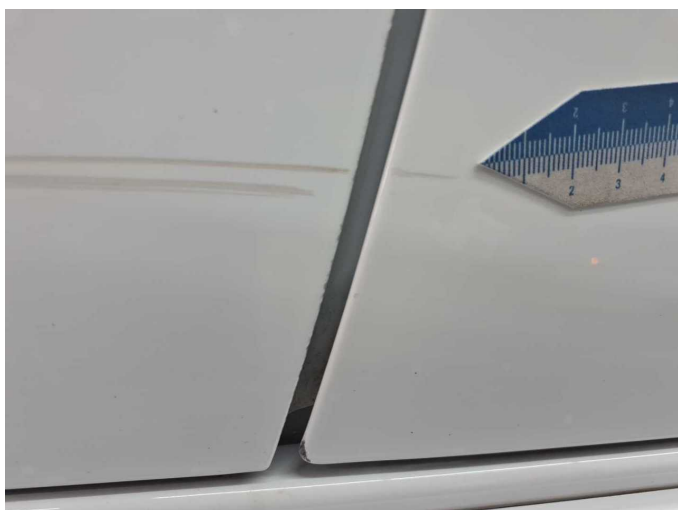
| No. | Component group | Description |
|---|---|---|
| 1 | Door - front right side | Door (Mehrkosten möglich) - Scratch(es) - Conditioning |

**Damage 1:** Door - front right side: Door (Mehrkosten möglich) - Scratch(es) - Conditioning

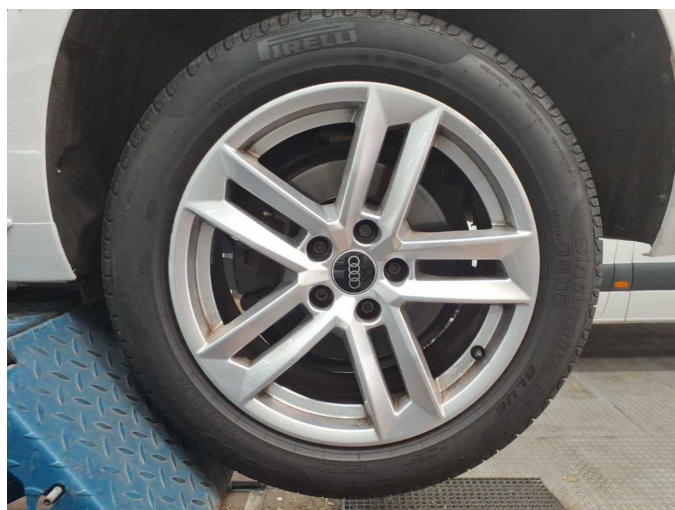
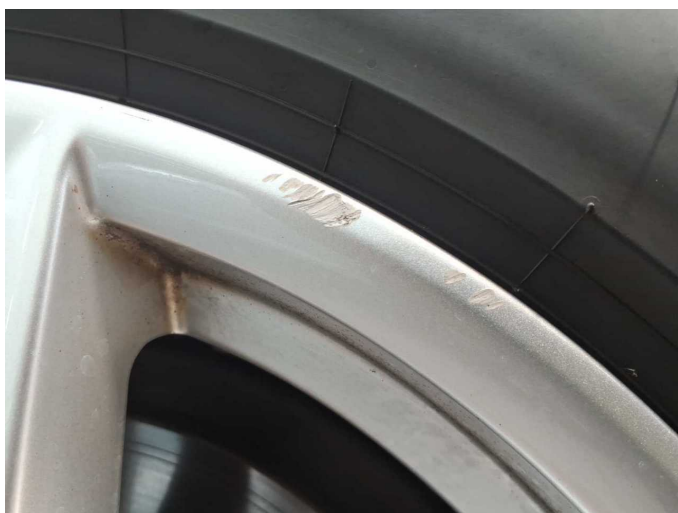
| No. | Component group | Description |
|---|---|---|
| 2 | Wheel / tyres | Alloy rim - rear left side - Scratched - Loss in value |

**Damage 2:** Wheel / tyres: Alloy rim - rear left side - Scratched - Loss in value

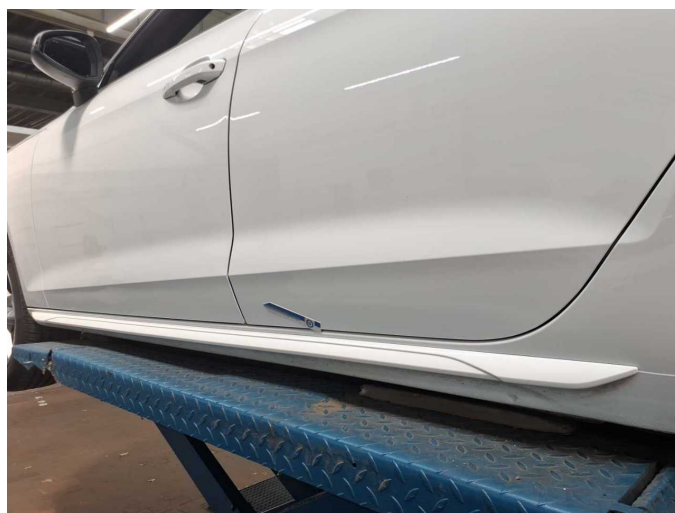
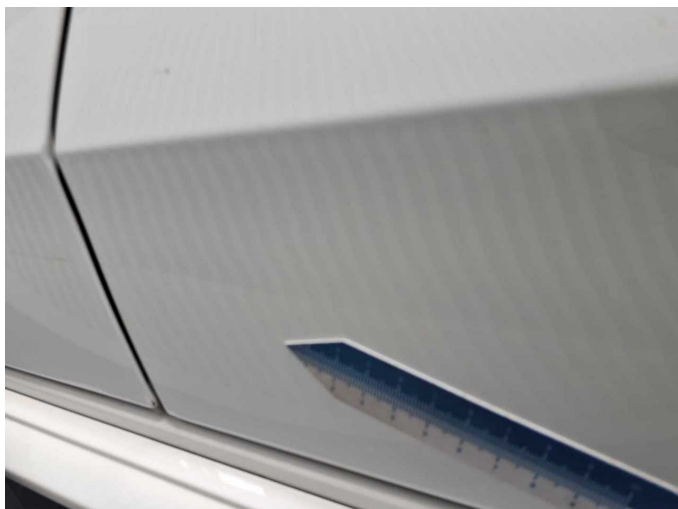
| No. | Component group | Description |
|---|---|---|
| 3 | Door - rear left side | Door - dent(s) - Smart repair |

**Damage 3:** Door - rear left side: Door - dent(s) - Smart repair

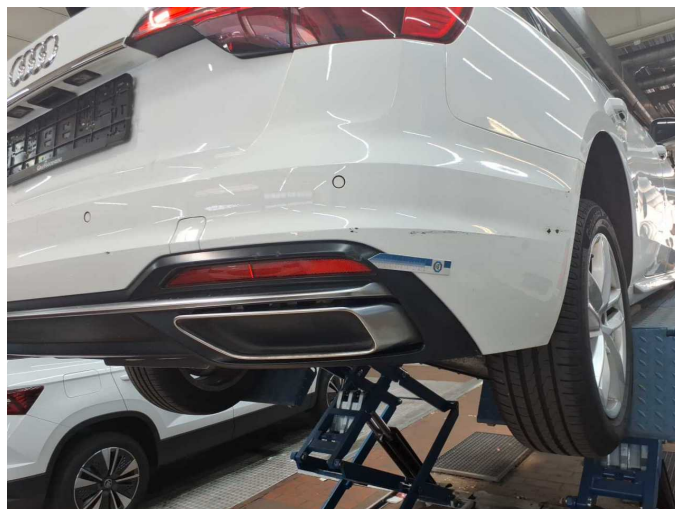
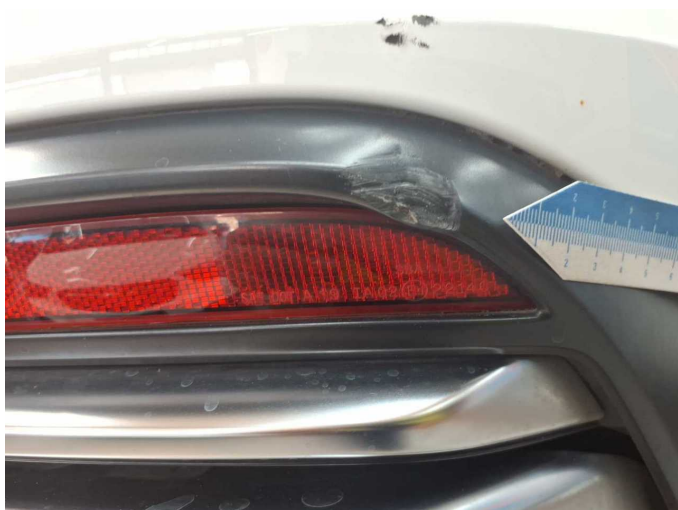
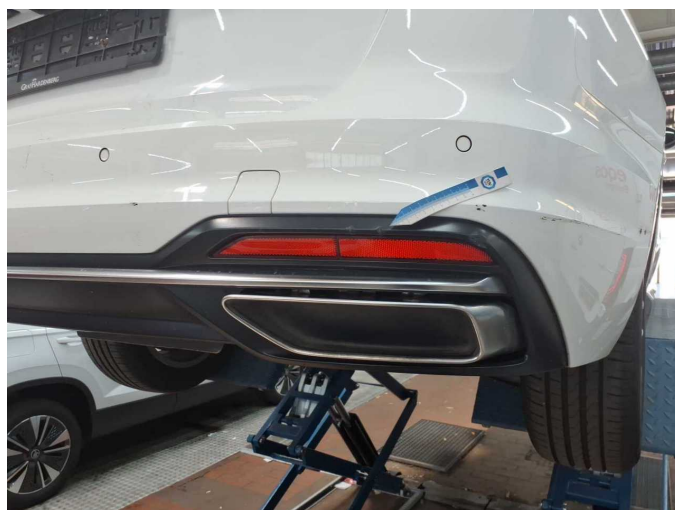
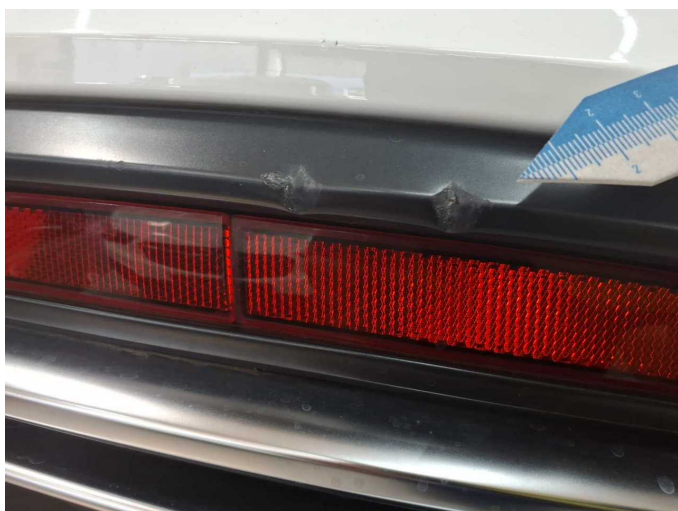
| No. | Component group | Description |
|---|---|---|
| 4 | Rear bumper | Spoiler - Scratched - Loss in value |

**Damage 4:** Rear bumper: Spoiler - Scratched - Loss in value

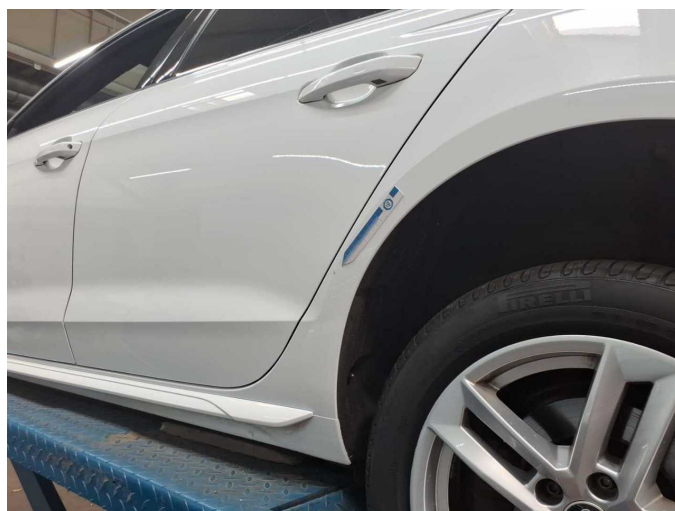
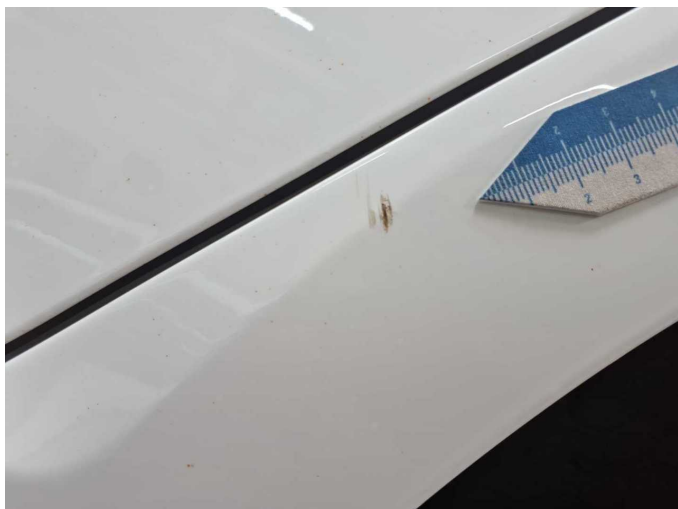
| No. | Component group | Description |
|---|---|---|
| 5 | Side panel - rear left side | Elbow - Scratch(es) - Paint |

**Damage 5:** Side panel - rear left side: Elbow - Scratch(es) - Paint

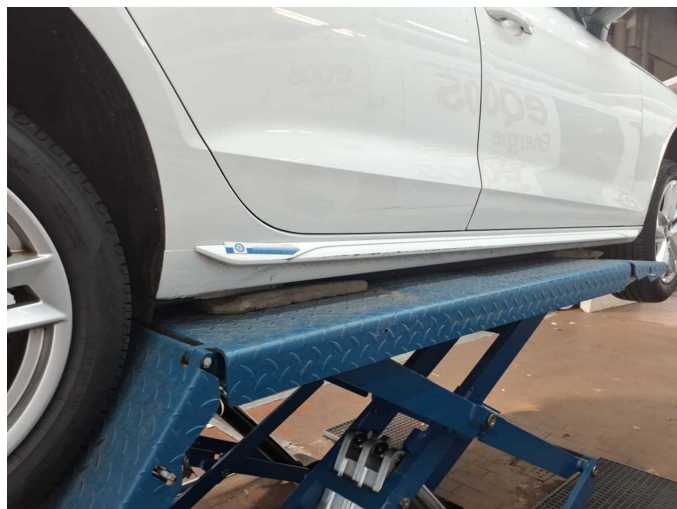
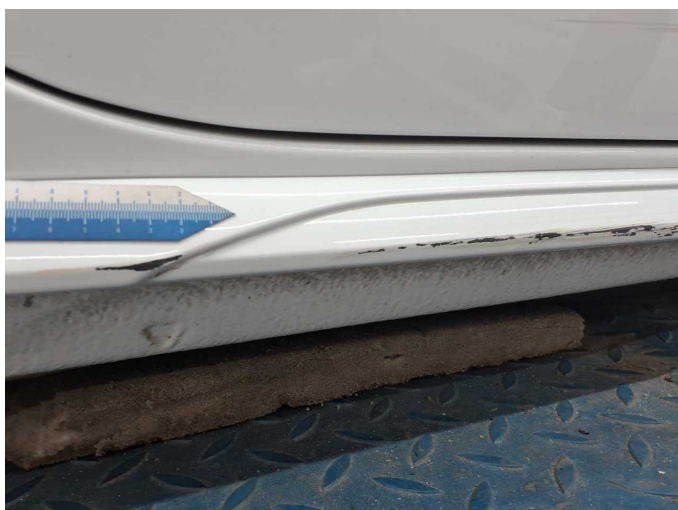
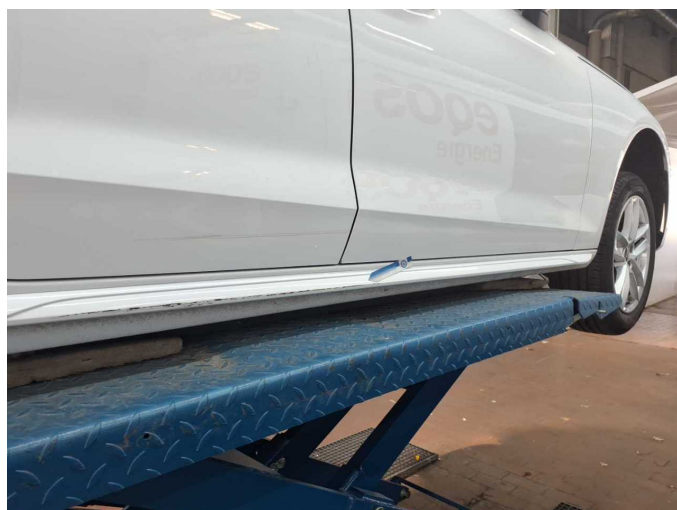
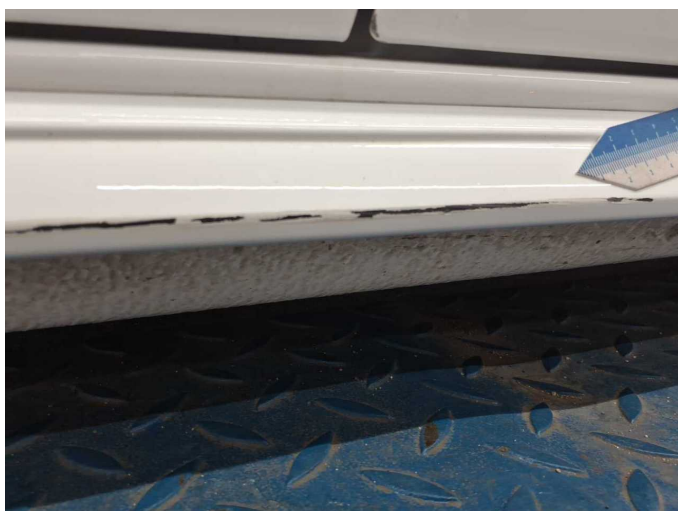
| No. | Component group | Description |
|---|---|---|
| 6 | Sill - right side | Sill (Zierleiste) - Scratched - Paint |

**Damage 6:** Sill - right side: Sill (Zierleiste) - Scratched - Paint

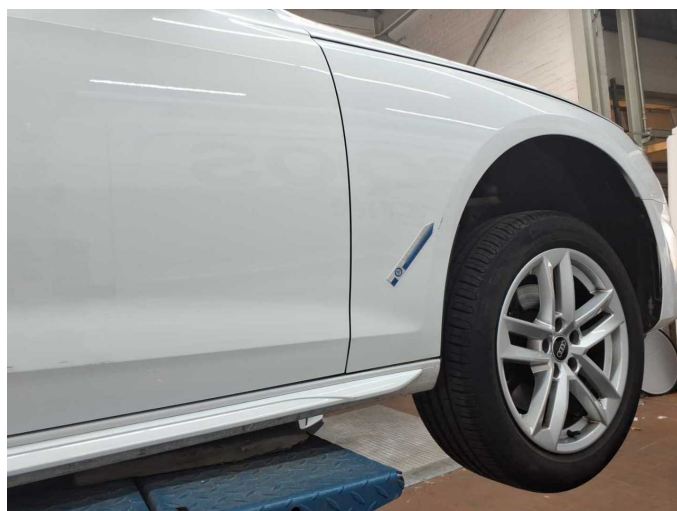
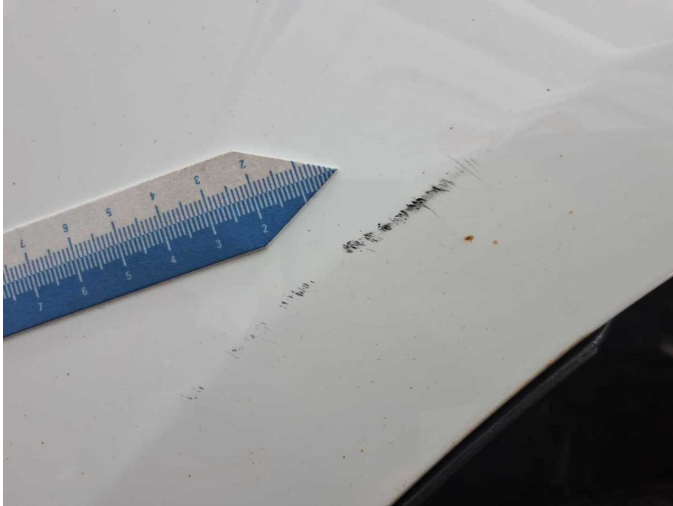
| No. | Component group | Description |
|---|---|---|
| 7 | Mudguard - right side | Mudguard - right side - Scratch(es) - Paint |

**Damage 7:** Mudguard - right side: Mudguard - right side - Scratch(es) - Paint

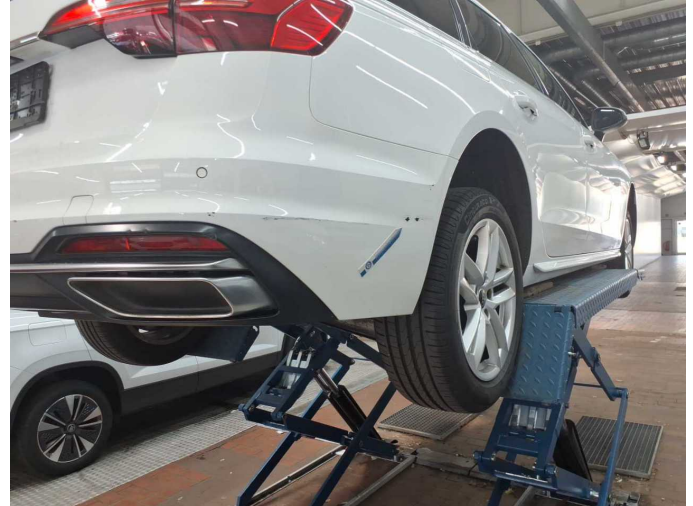
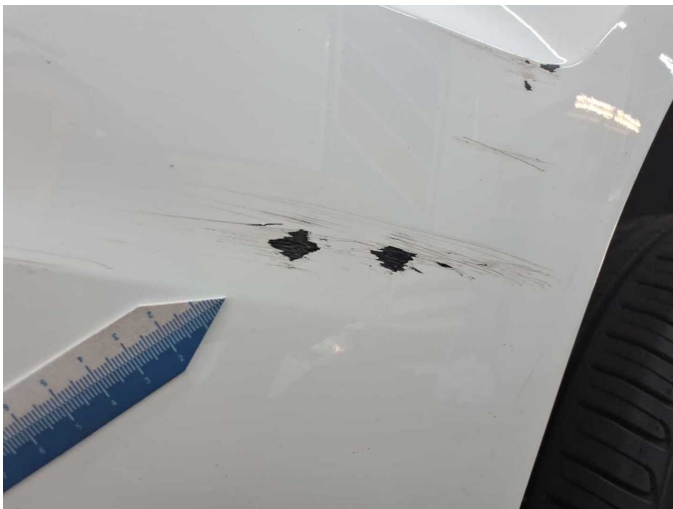
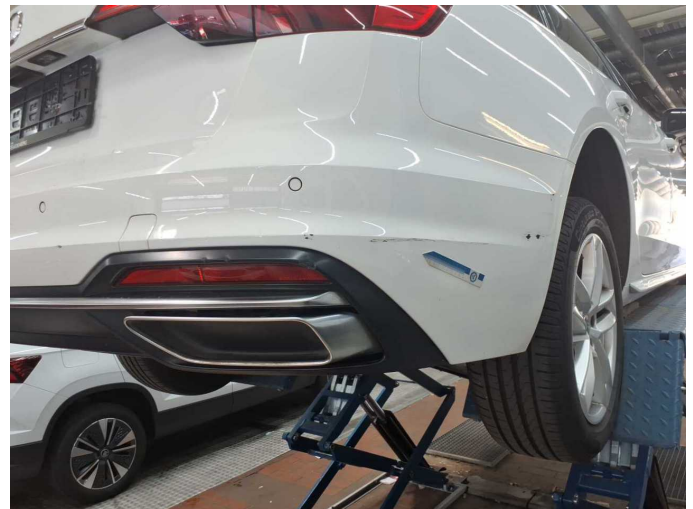
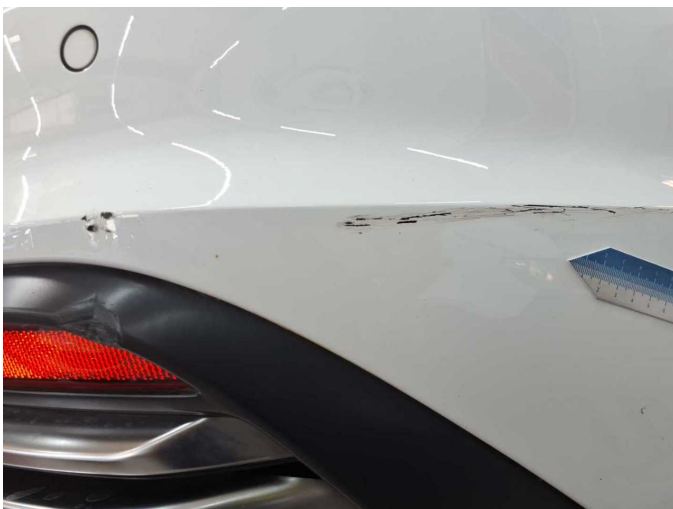
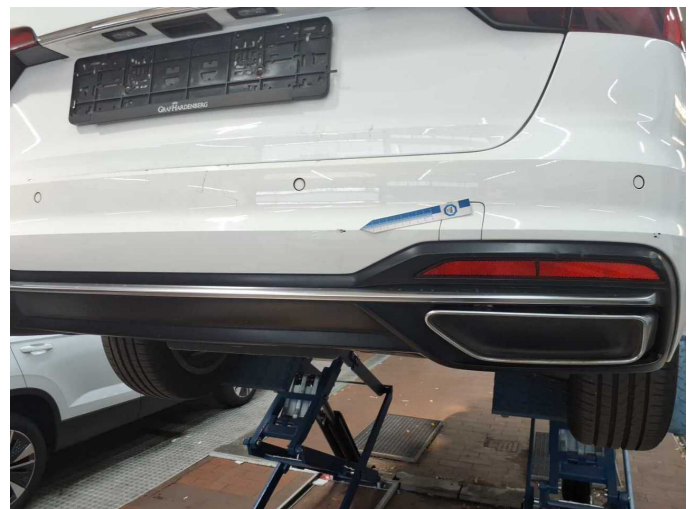
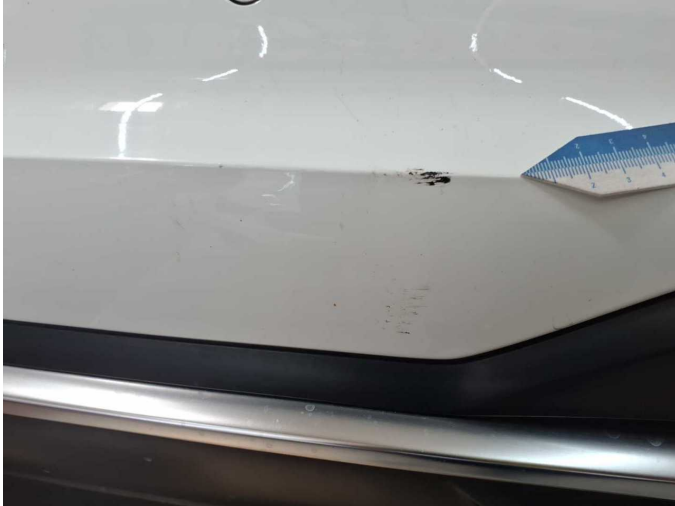
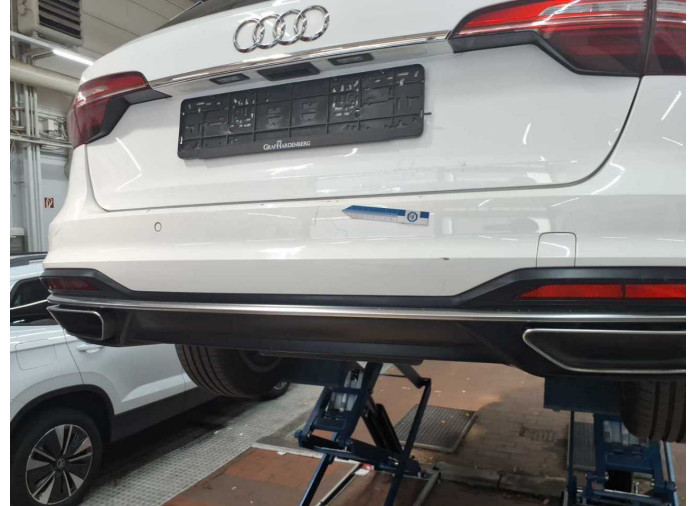
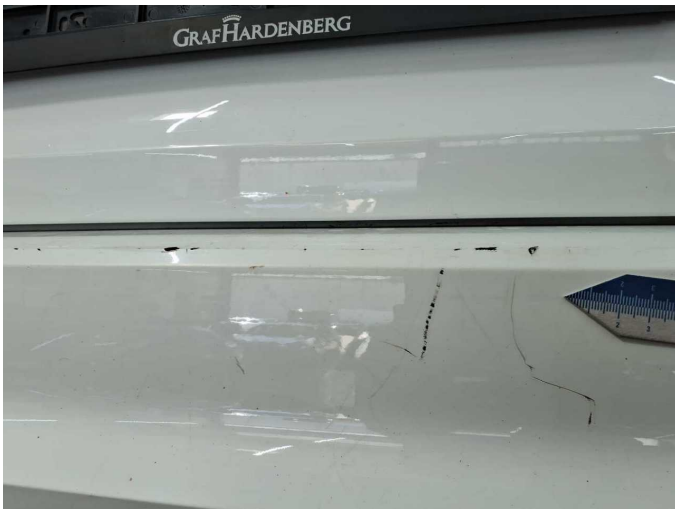
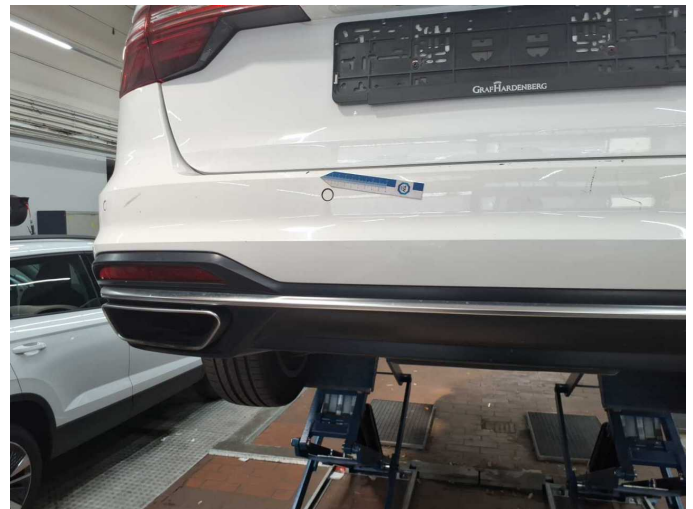
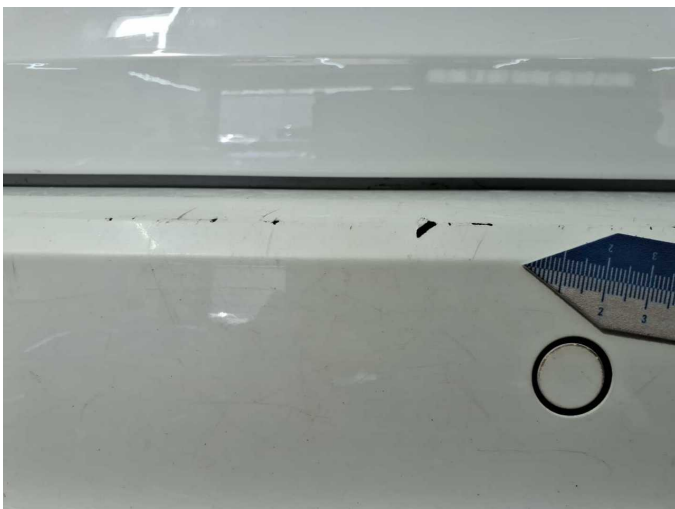
| No. | Component group | Description |
|---|---|---|
| 8 | Rear bumper | Rear bumper - Scratched - Paint |

**Damage 8:** Rear bumper: Rear bumper - Scratched - Paint

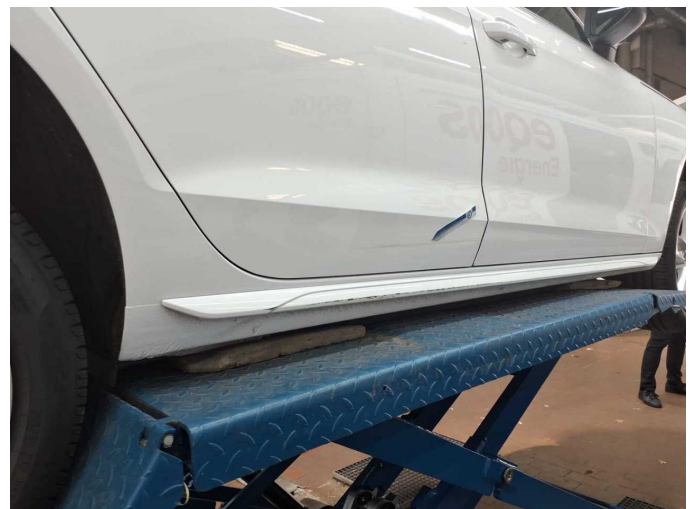
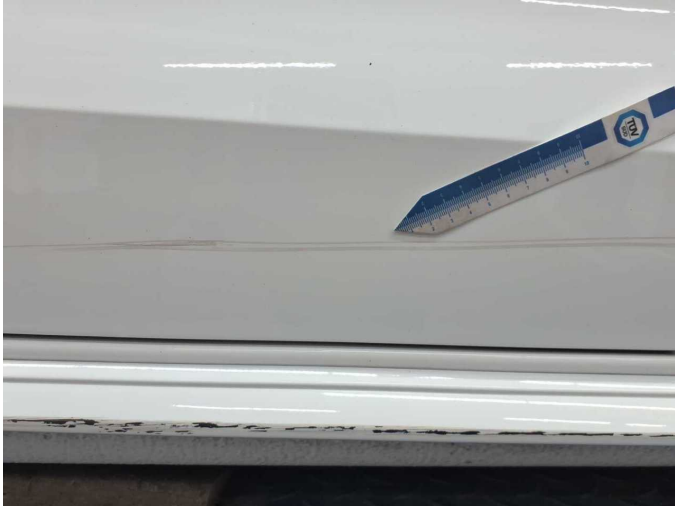
| No. | Component group | Description |
|---|---|---|
| 9 | Door - rear right side | Door - Scratched - Paint |

**Damage 9:** Door - rear right side: Door - Scratched - Paint

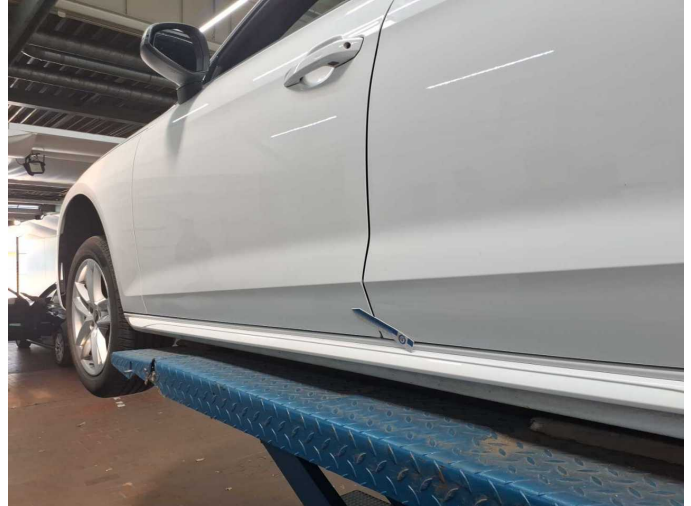
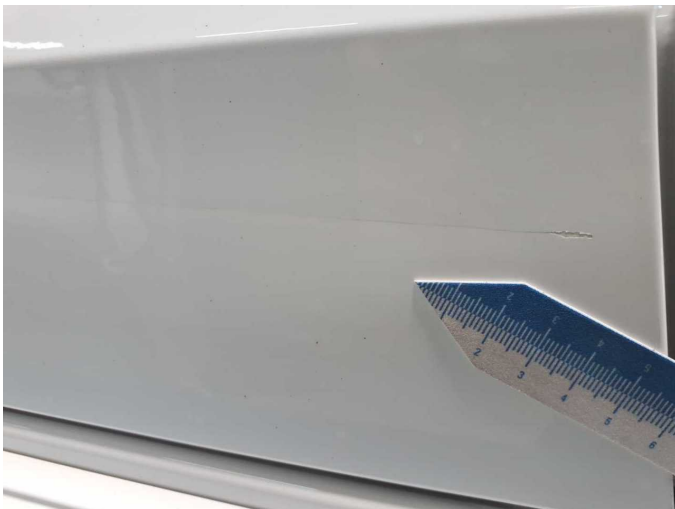
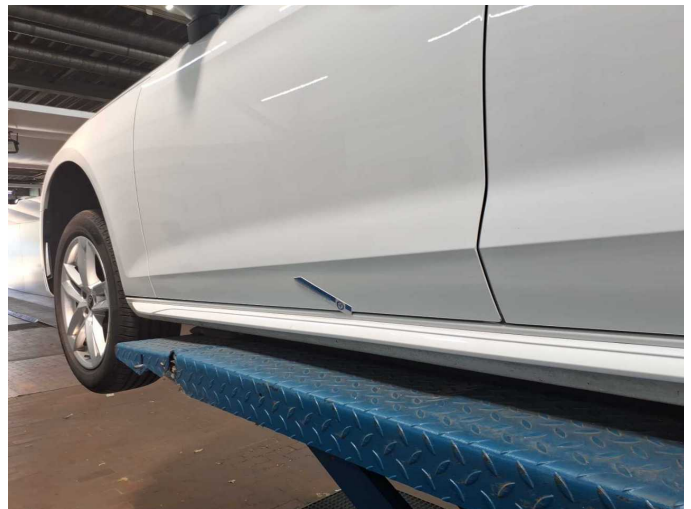
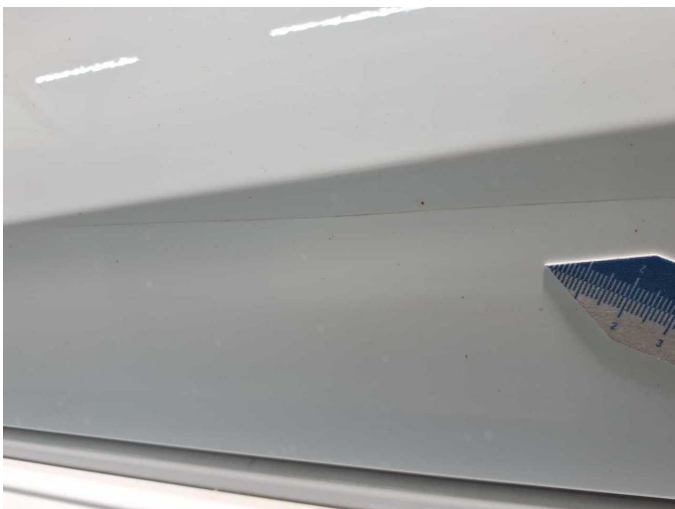
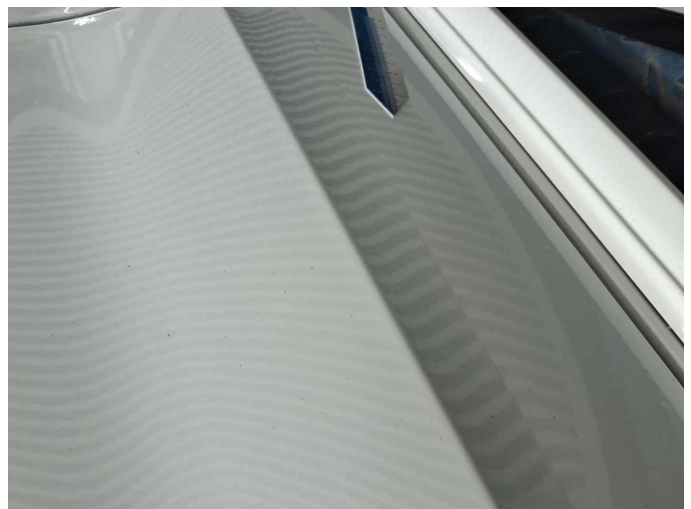
| No. | Component group | Description |
|---|---|---|
| 10 | Door - front left side | Door - Dent / paintcoat damage - Paint |

**Damage 10:** Door - front left side: Door - Dent / paintcoat damage - Paint

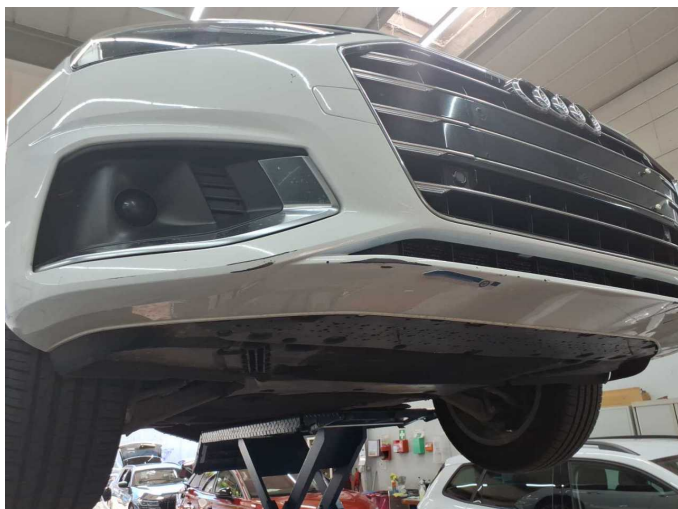
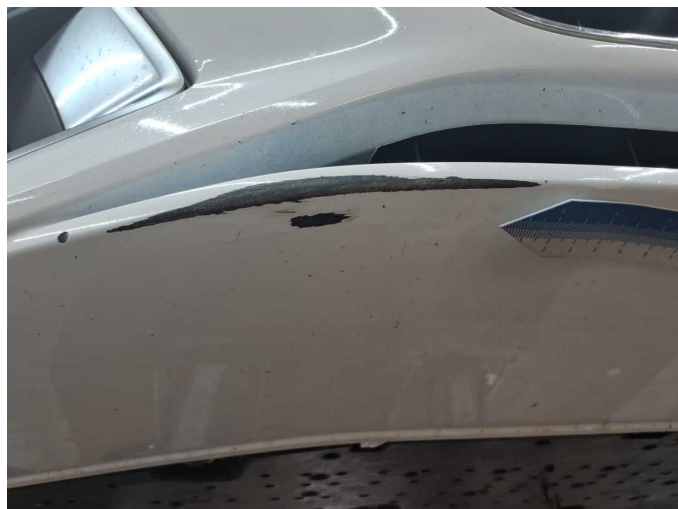
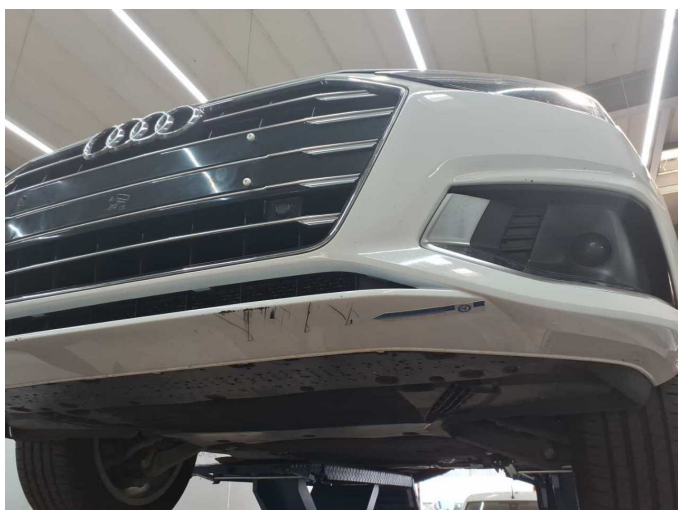
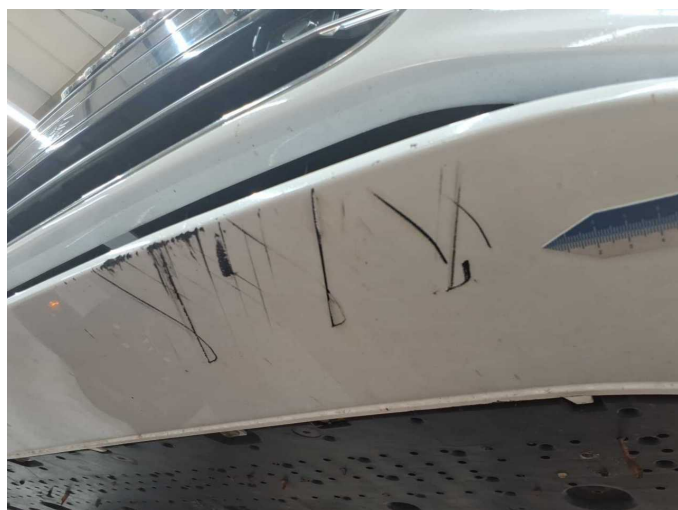
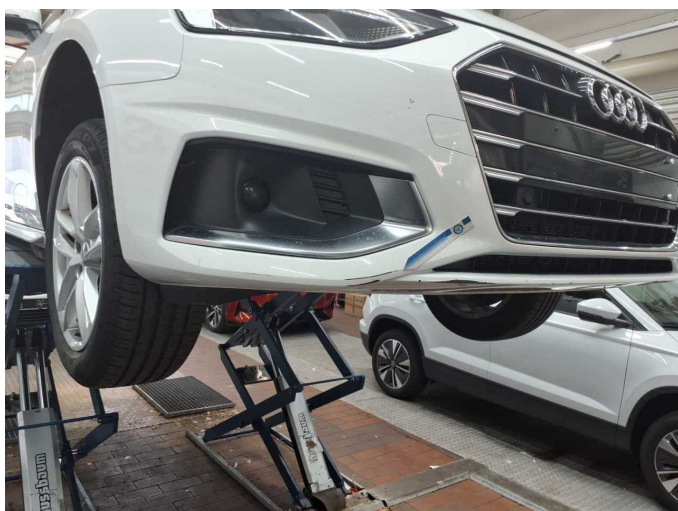
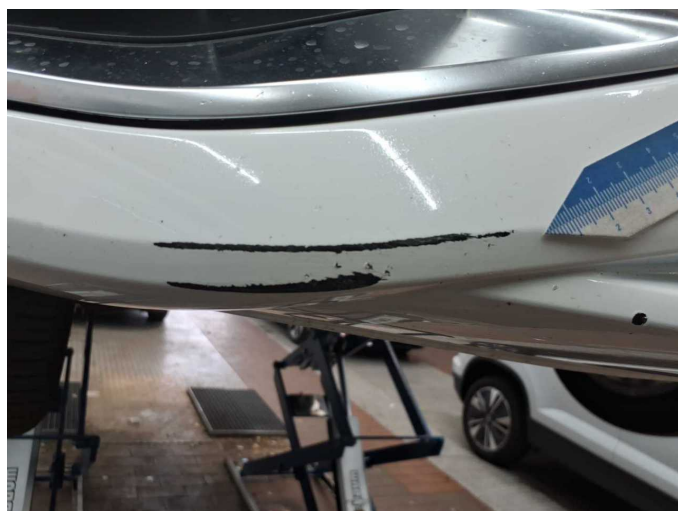
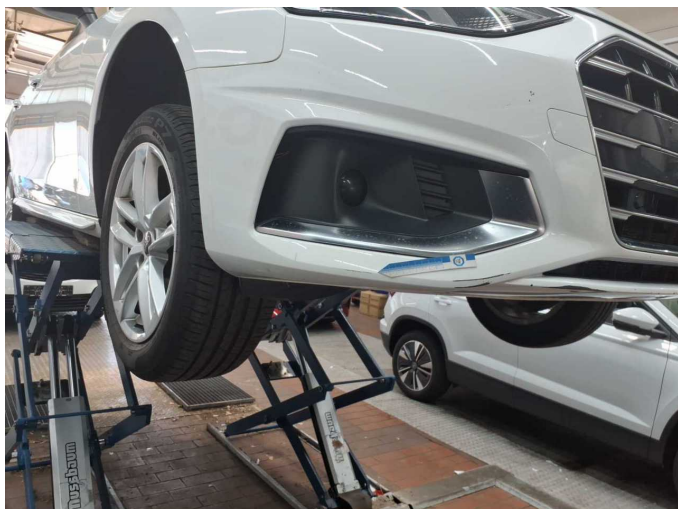
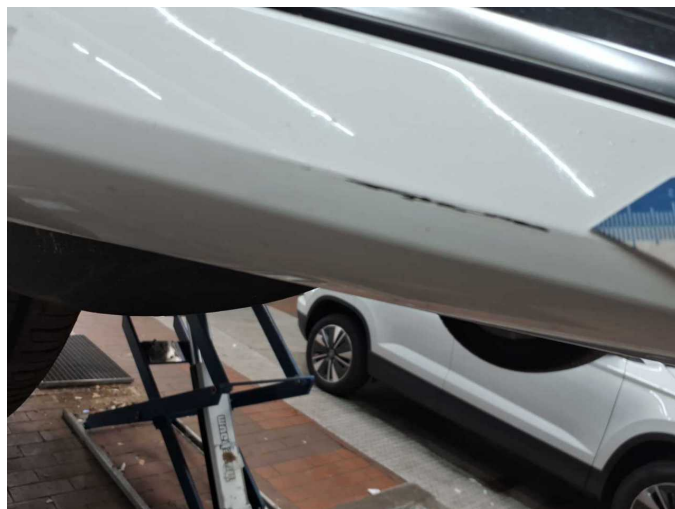
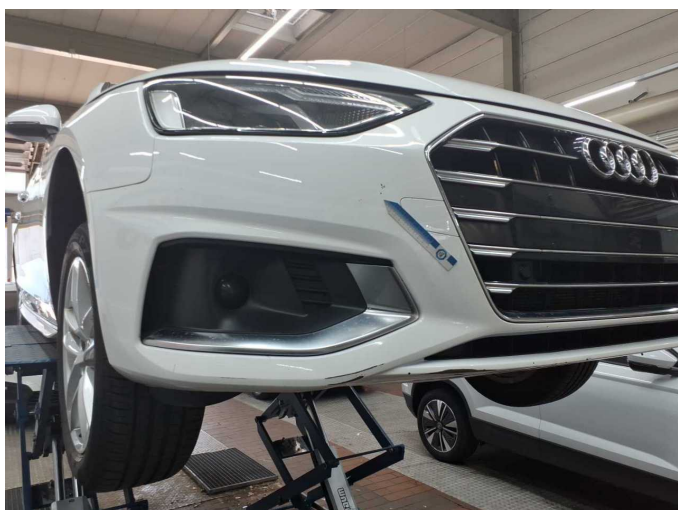
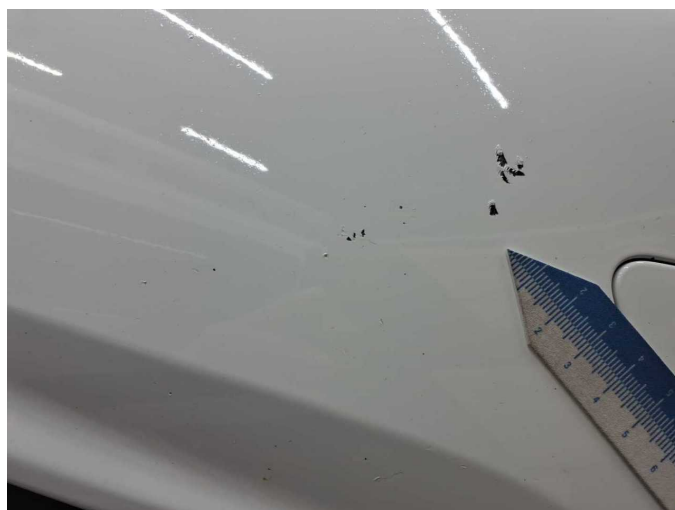
| No. | Component group | Description |
|---|---|---|
| 11 | Front bumper | Front bumper - Scratched - Paint |

**Damage 11:** Front bumper: Front bumper - Scratched - Paint

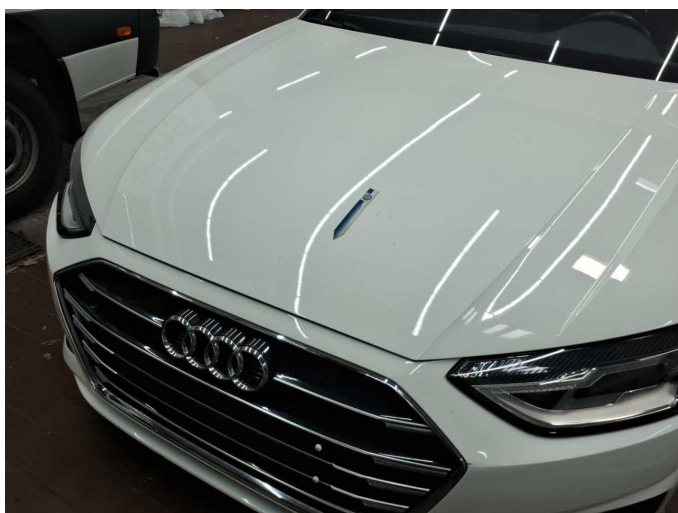
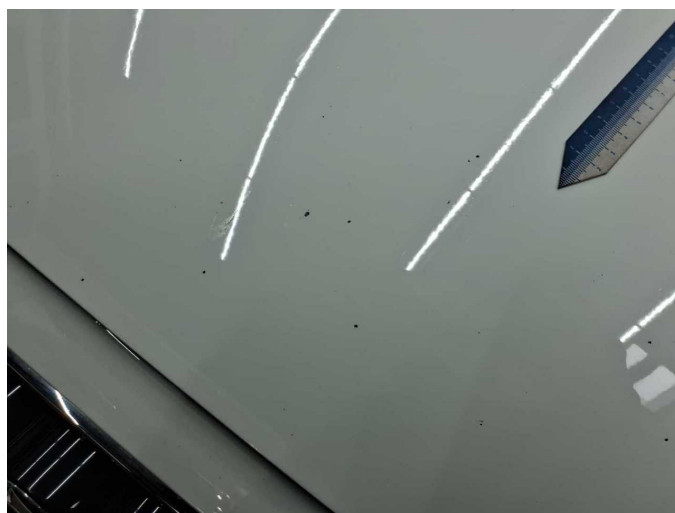
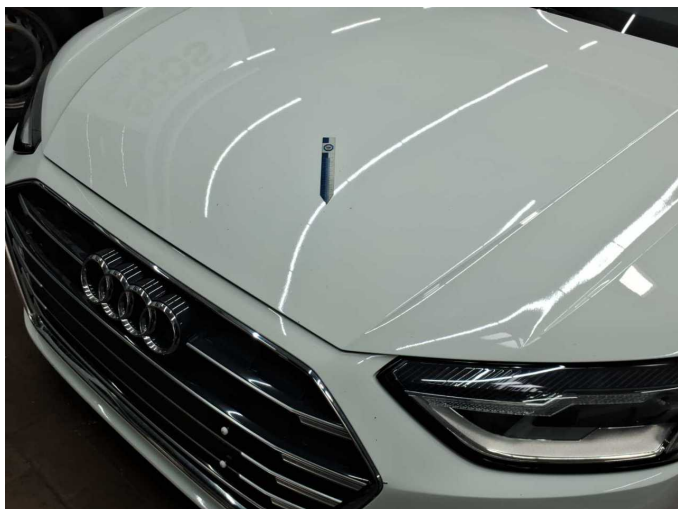
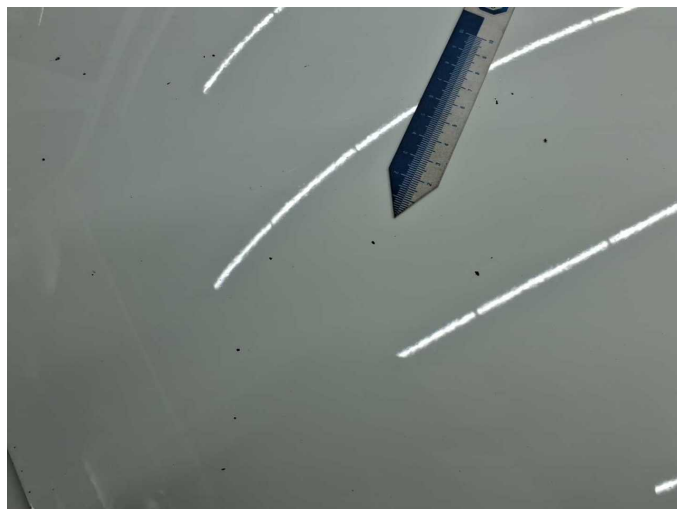
| No. | Component group | Description |
|---|---|---|
| 12 | Bonnet | Bonnet - Stone chips - Paint |

**Damage 12:** Bonnet: Bonnet - Stone chips - Paint

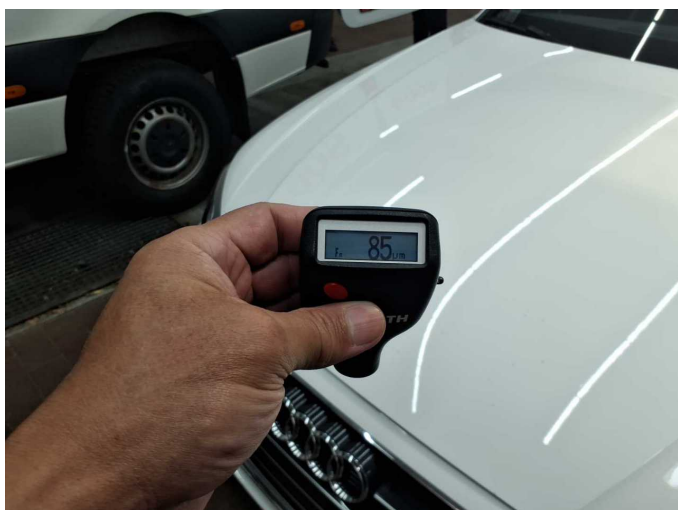
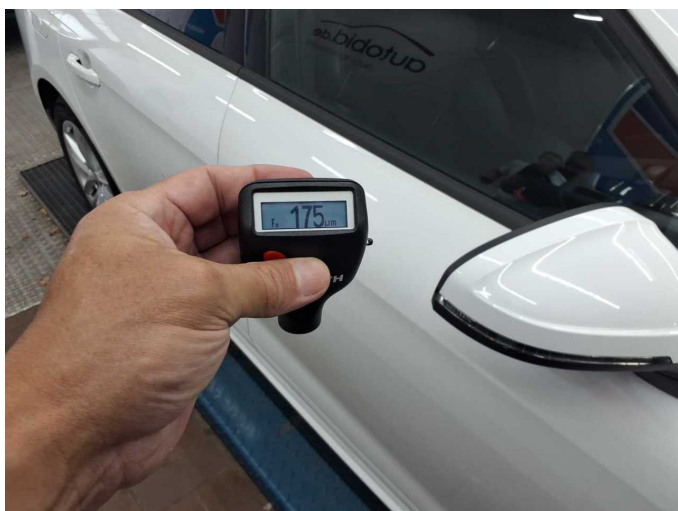
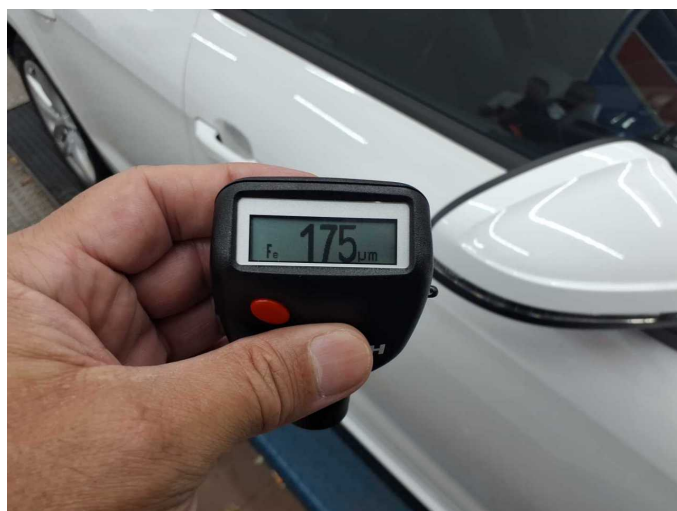
| No. | Repainting |
|---|---|
| 1 | Bonnet, Door - front right side, Professionally carried out |

| Bonnet | 85 µm | Door - front right side | 175 µm |

**Repainting 1:** Bonnet, Door - front right side
