Expertise

Protocol number: 46423848  
Order No. / Reference: 26578289  
Inspection date: 9 Jul 2026

Manufacturer: Volkswagen

Model: ID.4 Performance Upgrade Pro

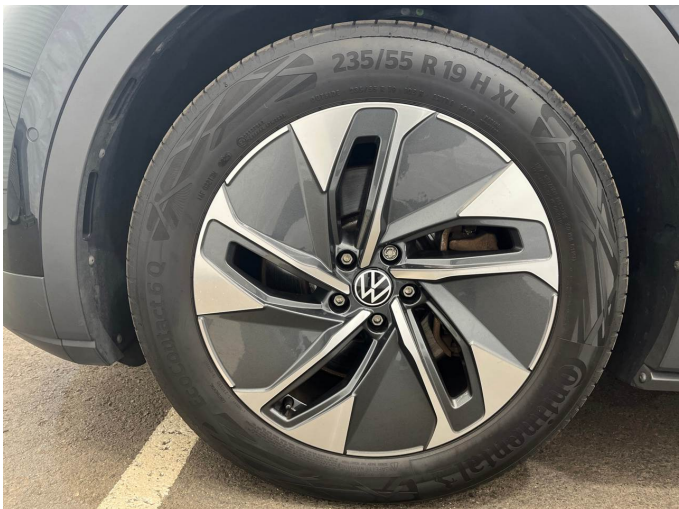
Figure 12: Mounted tyres

| # | Tyre size | Type of tyre | Manufacturer | Tread depth |
|---|---|---|---|---|
| 1) | 235/55 R19 105H | Summer tyres on Light alloy | Continental | 6mm / 6mm |
| 2) | 225/50 R19 107H | Summer tyres on Light alloy | Continental | 5mm / 5mm |

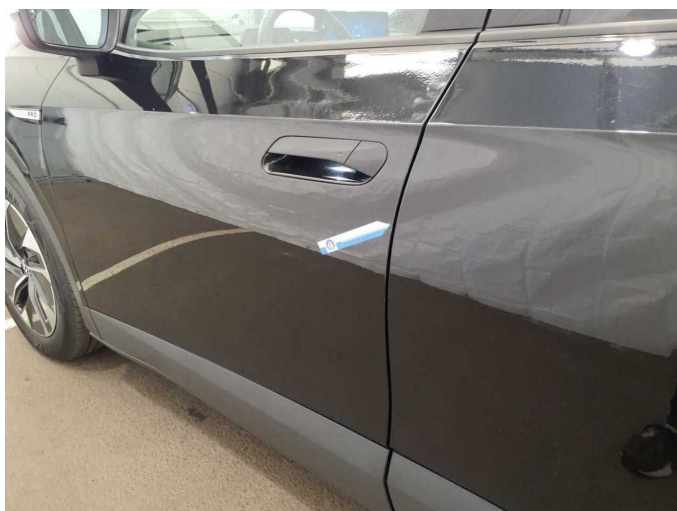
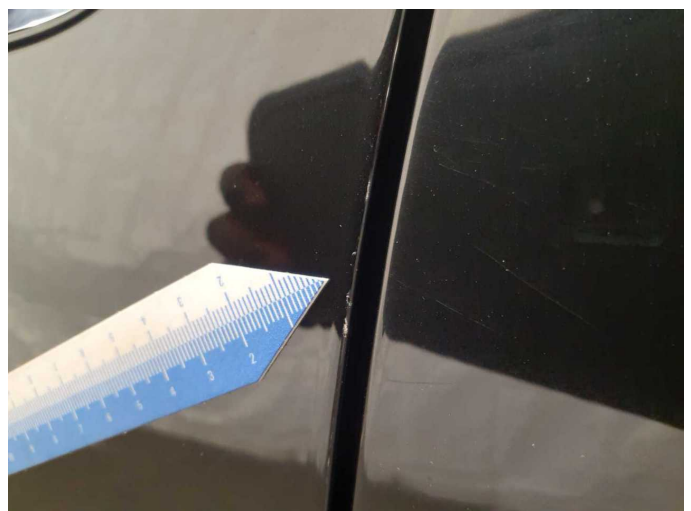
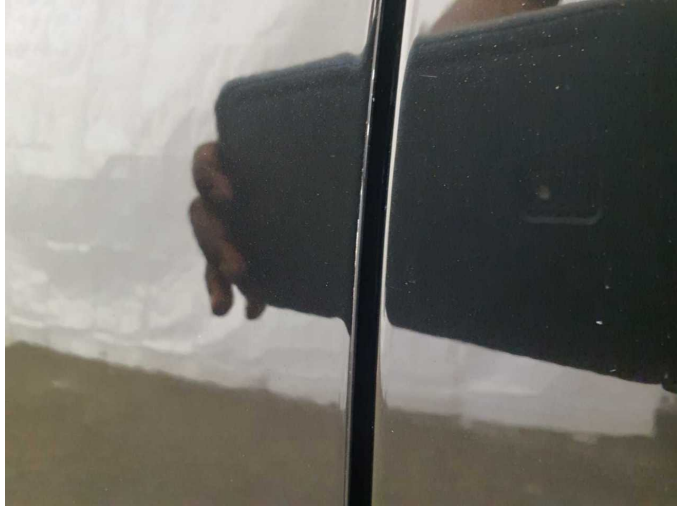
Damage 1: Door - front left side: Door edge - Scratch(es) - Smart repair

**Damage 1:** Door - front left side: Door edge - Scratch(es) - Smart repair

| No. | Component group | Description |
|---|---|---|
| 1 | Door - front left side | Door edge - Scratch(es) - Smart repair |

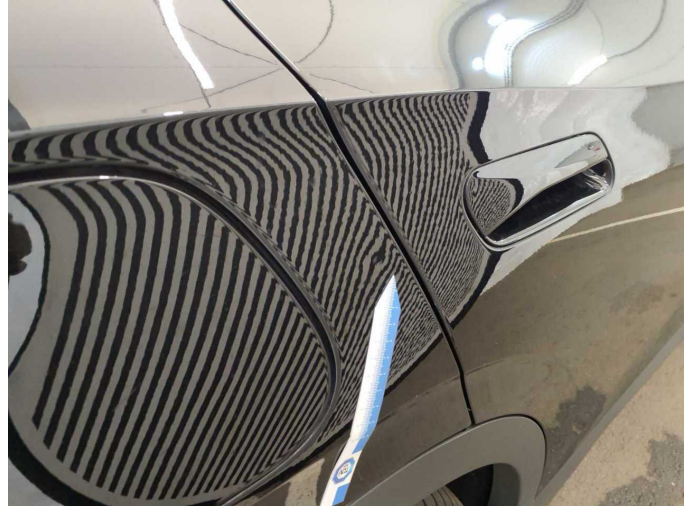
**Damage 2:** Side panel - rear right side: Side panel - dent(s) - Smart repair

| No. | Component group | Description |
|---|---|---|
| 2 | Side panel - rear right side | Side panel - dent(s) - Smart repair |

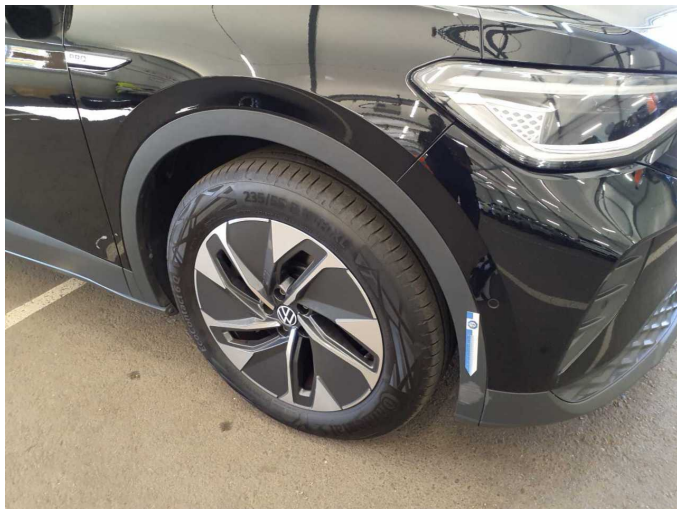
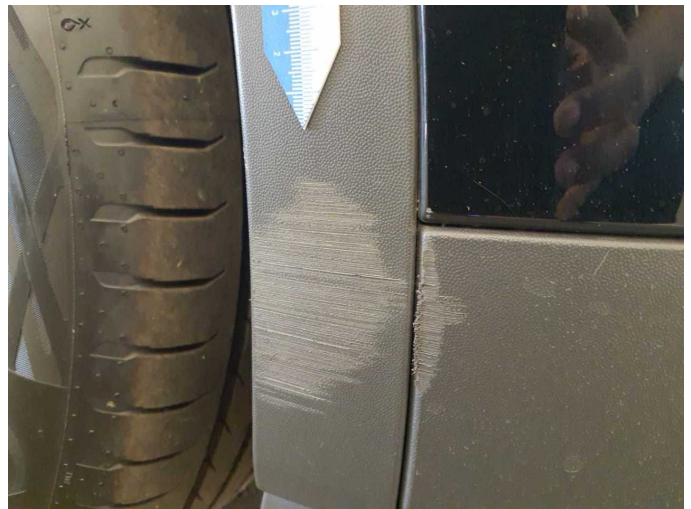
**Damage 3:** Mudguard - right side: Wheel well extension - Scratch(es) - Replace

| No. | Component group | Description |
|---|---|---|
| 3 | Mudguard - right side | Wheel well extension - Scratch(es) - Replace |

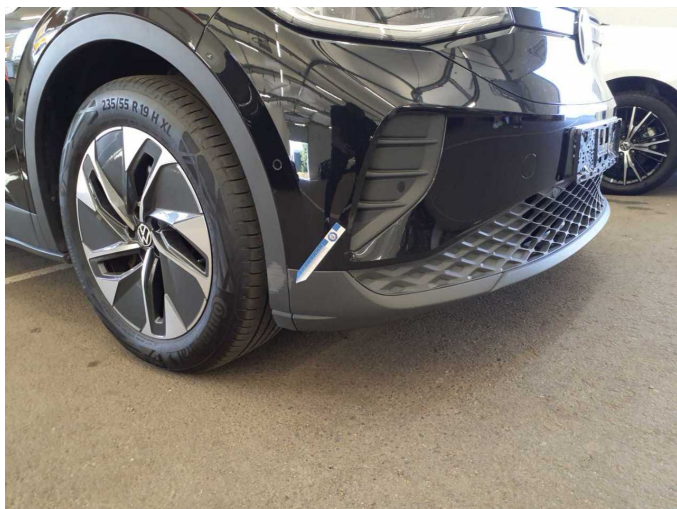
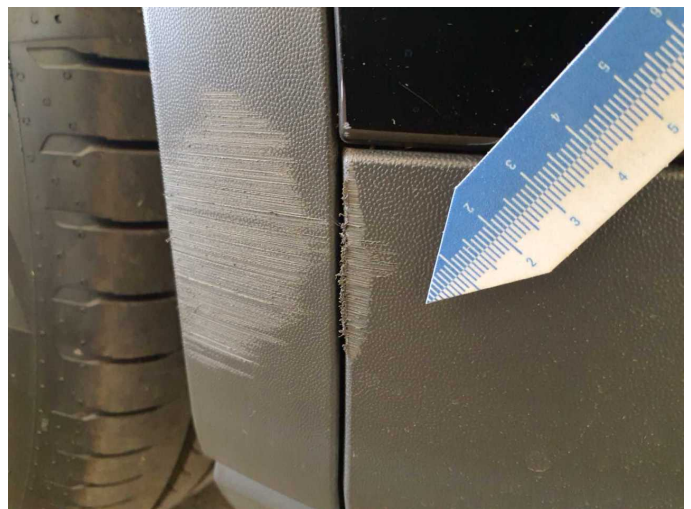
**Damage 4:** Front bumper: Spoiler - Scratch(es) - Replace

| No. | Component group | Description |
|---|---|---|
| 4 | Front bumper | Spoiler - Scratch(es) - Replace |
