Expertise

Protocol number: 46328207  
Order No. / Reference: 26644375  
Inspection date: 2 Jul 2026

Manufacturer: Opel

Model: Insignia Sports Tourer 2.0 Diesel Aut. Business Edition

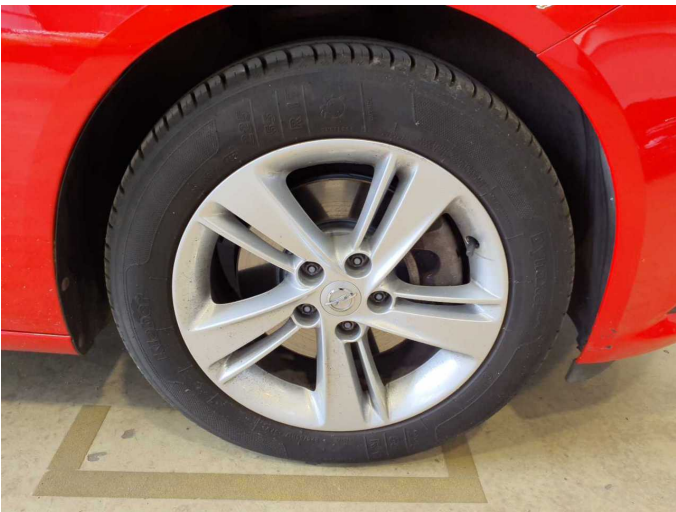
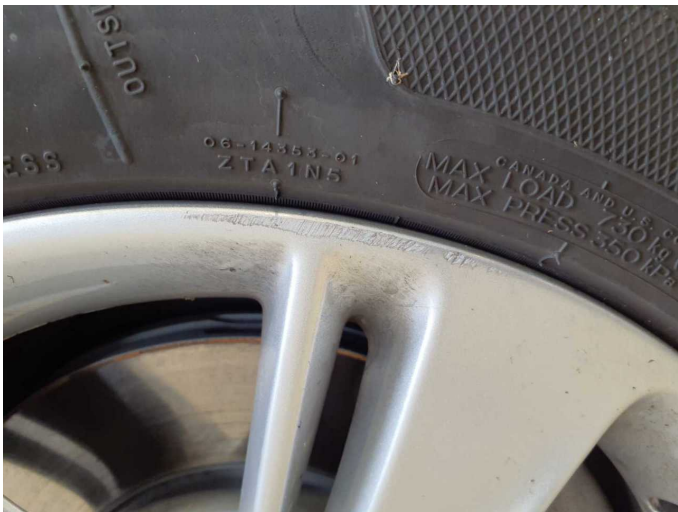
| No. | Component group | Description |
|---|---|---|
| 1 | Wheel / tyres | Alloy rim - front right side - Scratch(es) - Loss in value |

Damage 1: Wheel / tyres: Alloy rim - front right side - Scratch(es) - Loss in value

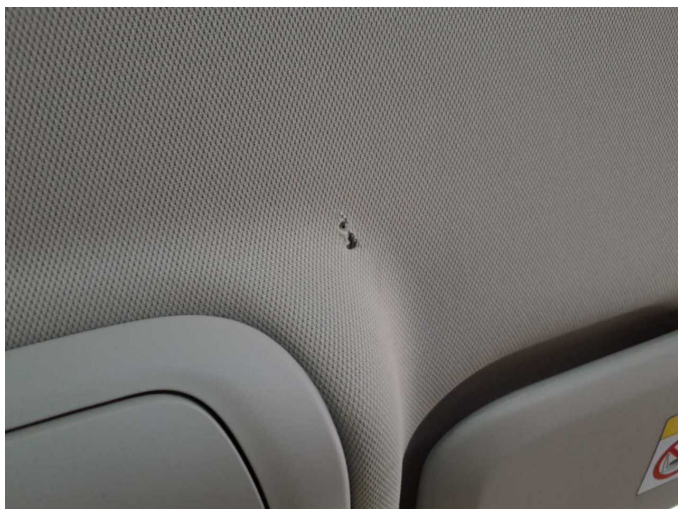
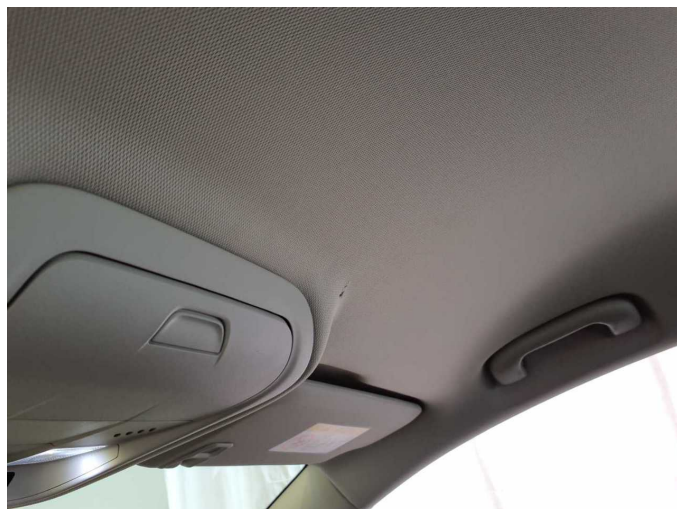
| No. | Component group | Description |
|---|---|---|
| 2 | Roof | Roof - Holes - Loss in value |

**Damage 2:** Roof: Roof - Holes - Loss in value

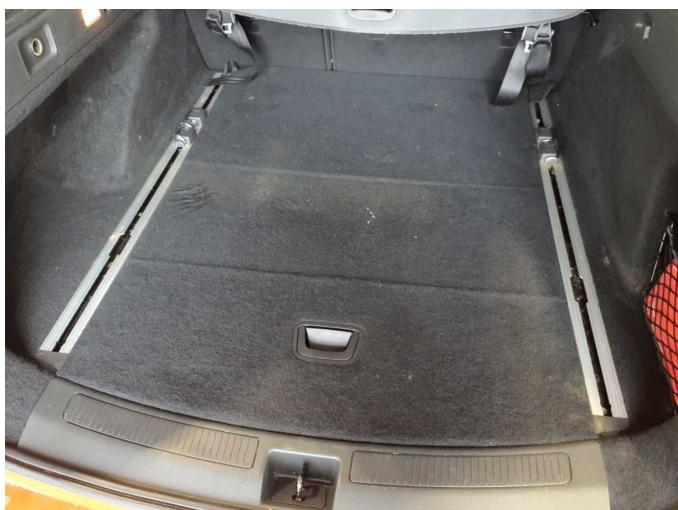
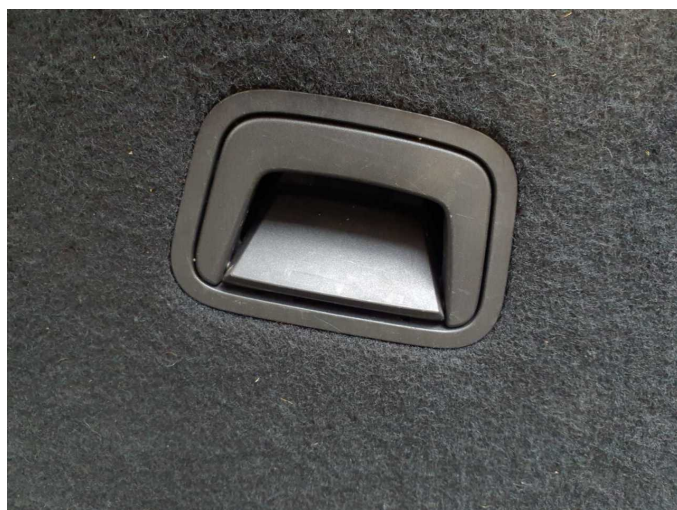
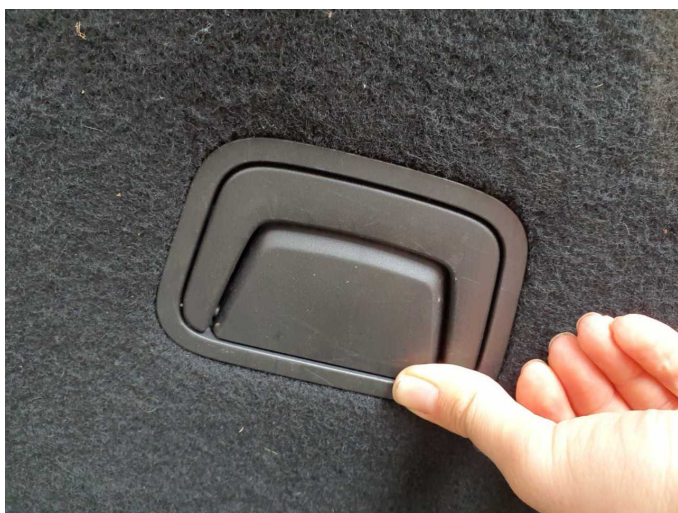
| No. | Component group | Description |
|---|---|---|
| 3 | Interior | Cargo area floor (Griff) - Broken / torn - Replace |

**Damage 3:** Interior: Cargo area floor (Griff) - Broken / torn - Replace

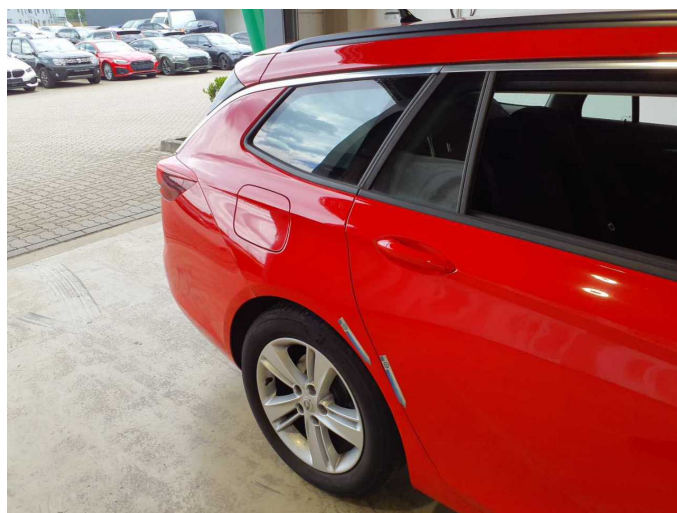
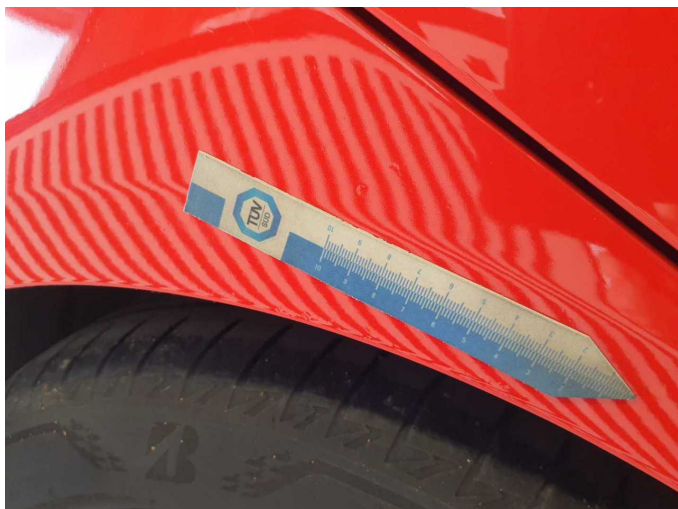
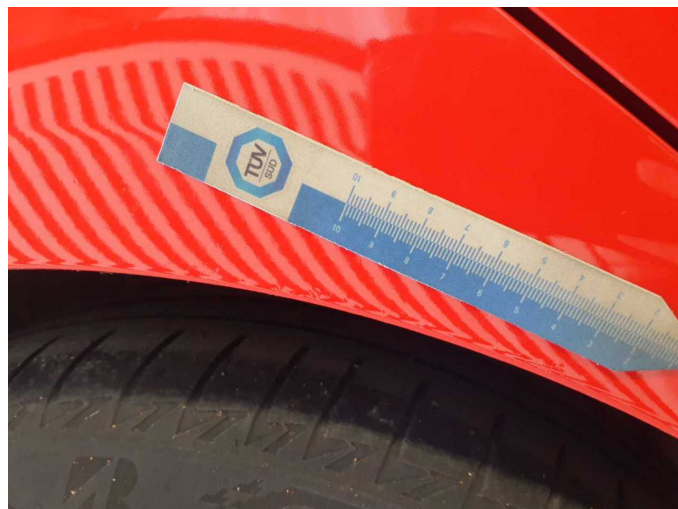
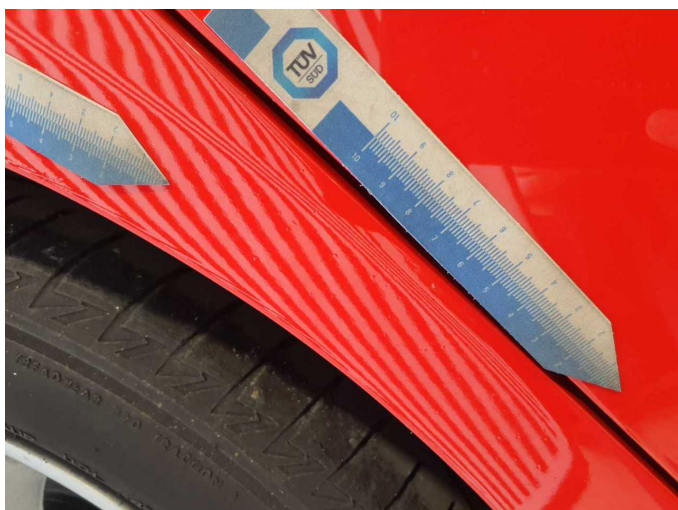
| No. | Component group | Description |
|---|---|---|
| 4 | Side panel - rear right side | Side panel (Spachtelmasse eingefallen) - Unprofessionally repaired - Repair and paint |

**Damage 4:** Side panel - rear right side: Side panel (Spachtelmasse eingefallen) - Unprofessionally repaired - Repair and paint

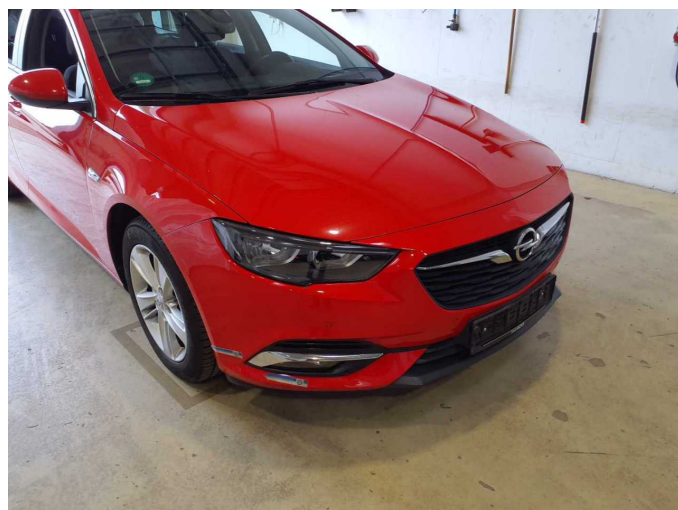
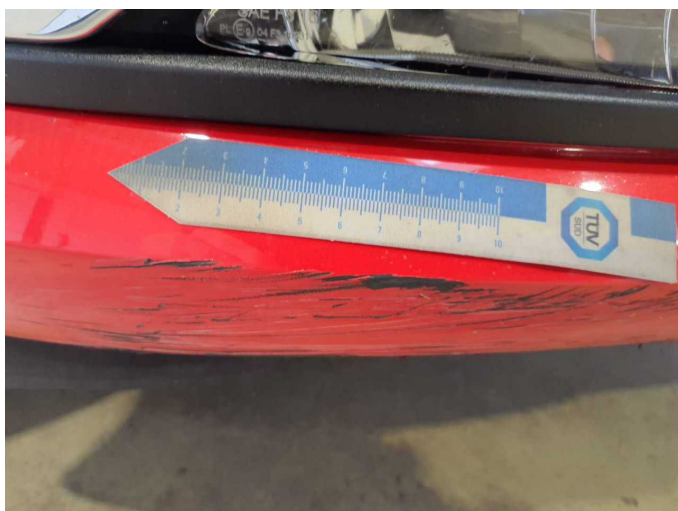
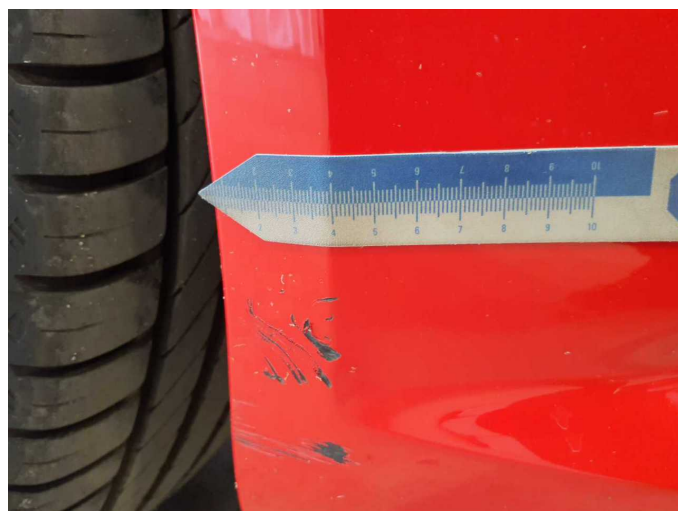
| No. | Component group | Description |
|---|---|---|
| 5 | Front bumper | Front bumper - Scratch(es) - Paint |

**Damage 5:** Front bumper: Front bumper - Scratch(es) - Paint

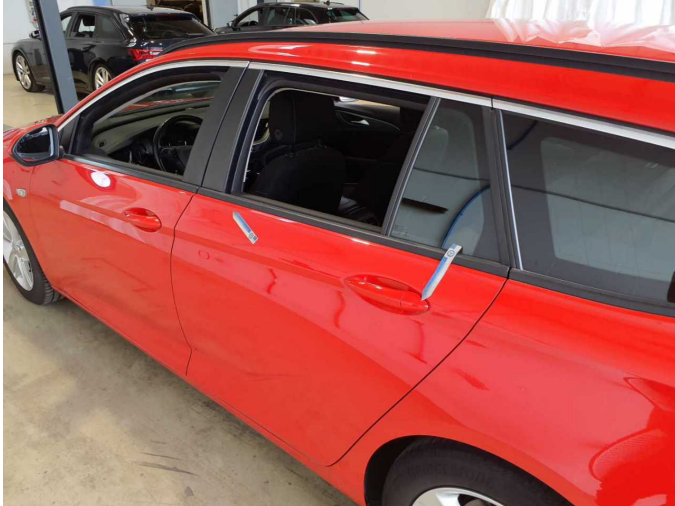
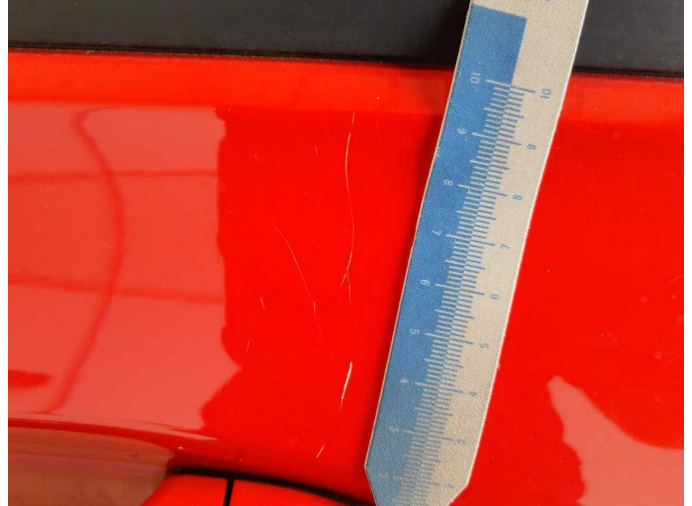
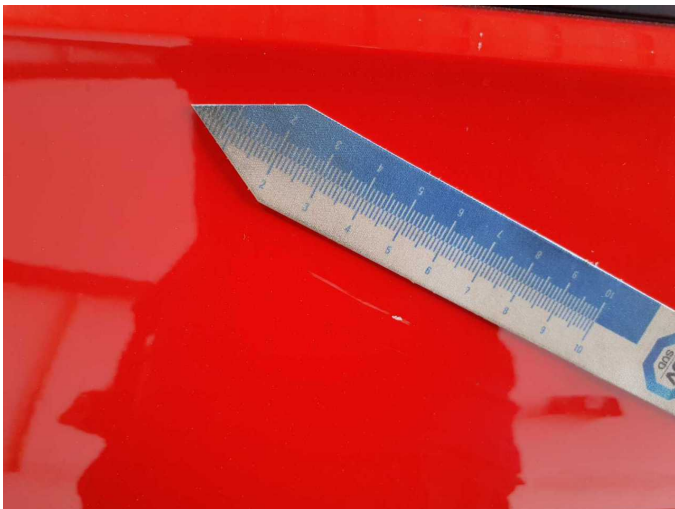
| No. | Component group | Description |
|---|---|---|
| 6 | Door - rear left side | Door - Scratch(es) - Paint |

**Damage 6:** Door - rear left side: Door - Scratch(es) - Paint

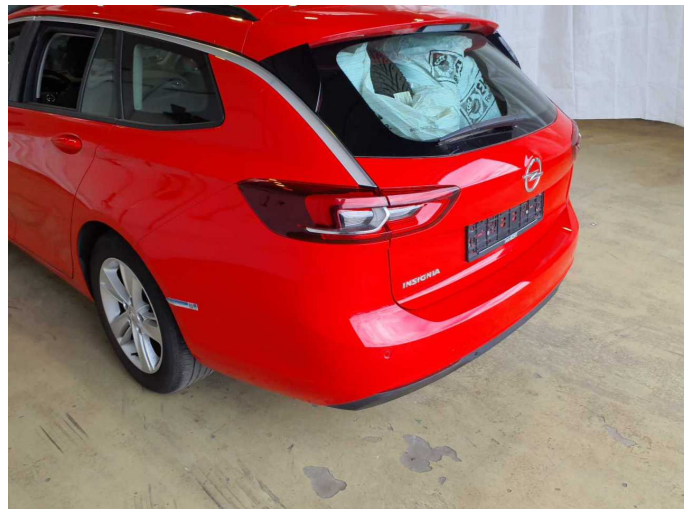
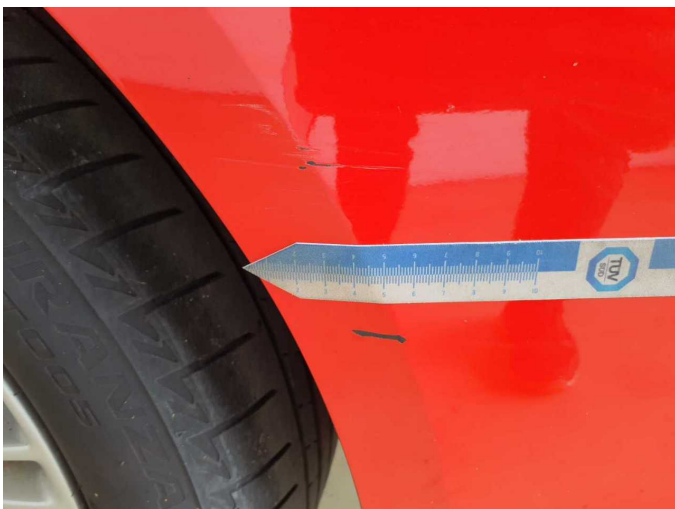
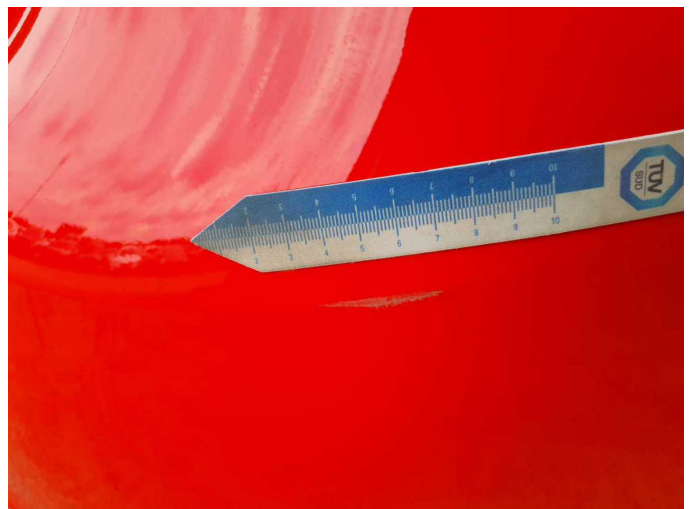
| No. | Component group | Description |
|---|---|---|
| 7 | Rear bumper | Rear bumper - Scratch(es) - Paint |

**Damage 7:** Rear bumper: Rear bumper - Scratch(es) - Paint

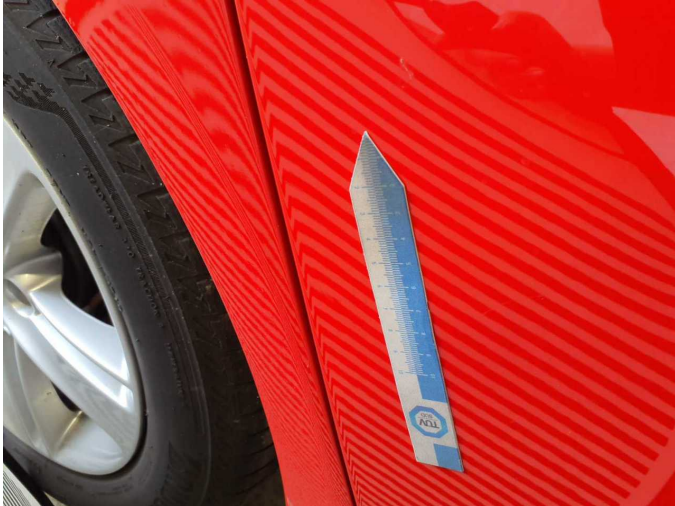
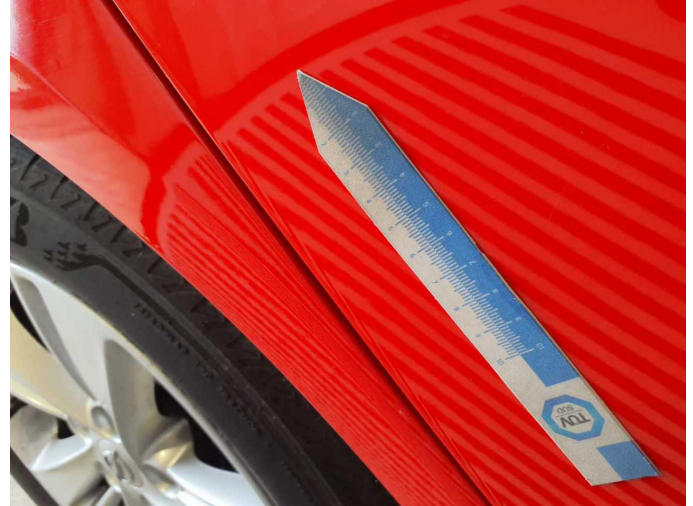
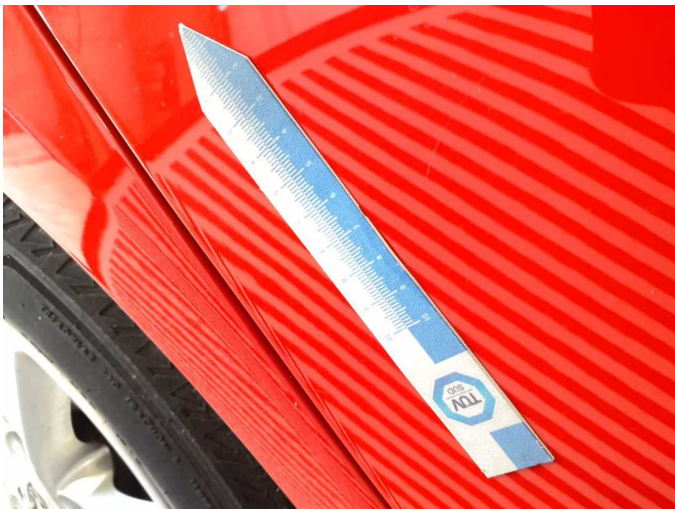
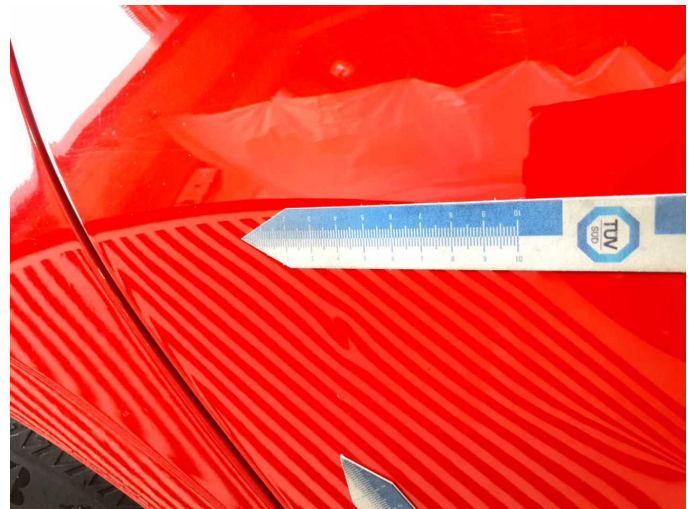
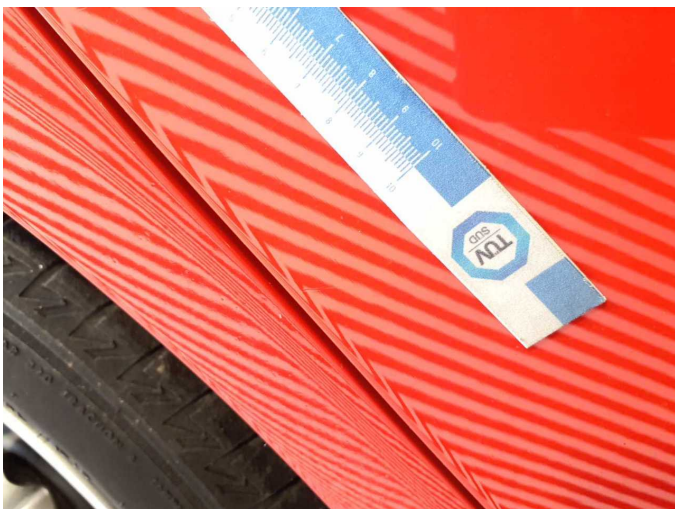
| No. | Component group | Description |
|---|---|---|
| 8 | Door - rear right side | Door (Schleifspuren und Spachtel eingefallen) - Unprofessionally repaired - Repair and paint |

**Damage 8:** Door - rear right side: Door (Schleifspuren und Spachtel eingefallen) - Unprofessionally repaired - Repair and paint

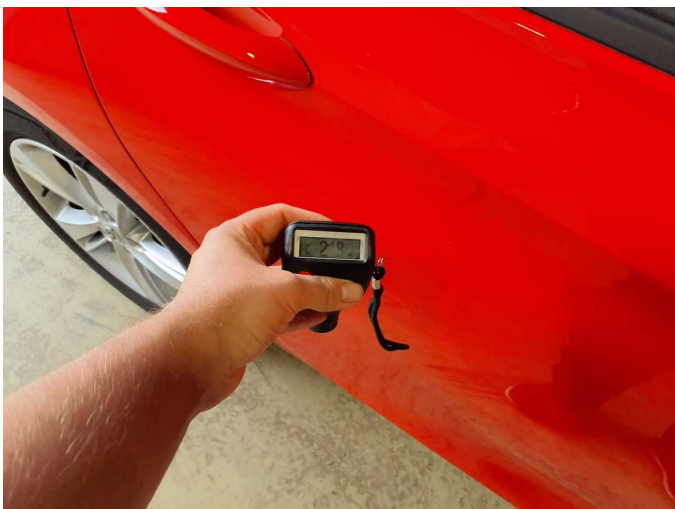
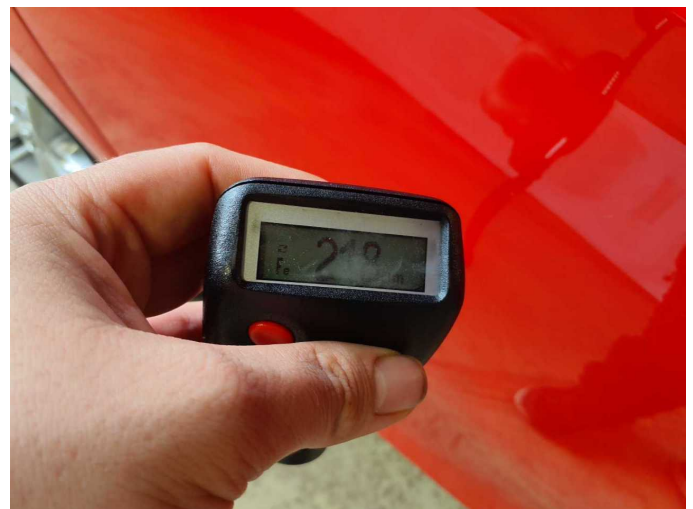
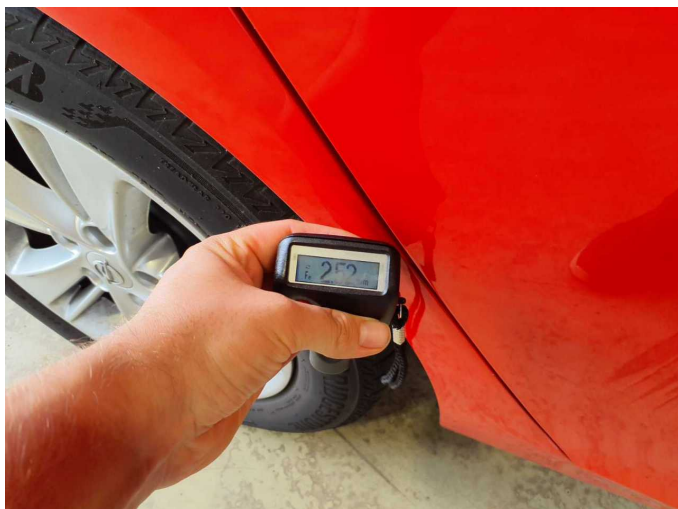
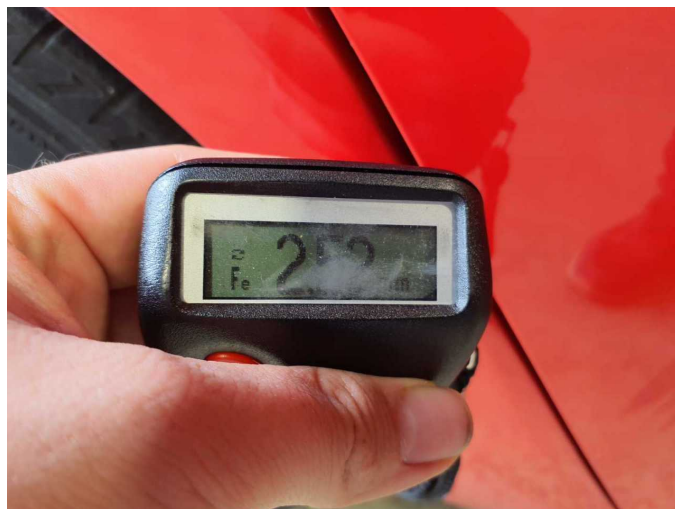
| No. | Repainting |
|---|---|
| 1 | Side panel - rear right side, Door - rear right side, Unprofessionally carried out |

| Side panel - rear right side | 2,520<br>µm | Door - rear right side | 218 µm |

**Repainting 1:** Side panel - rear right side, Door - rear right side
