## Expertise

Protocol number: 45975606  
Order No. / Reference: 26372781  
Inspection date: 16 Jun 2026

Model: EX30 Single M. Extended Range RWD Ultra

VIN: YV12ZEL93RS051932

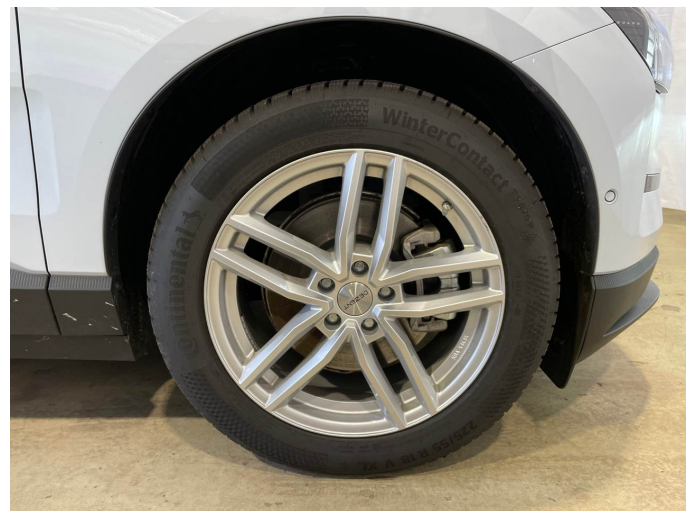
Figure 12: Mounted tyres

#	Tyre size	Type of tyre	Manufacturer	Tread depth
1)	225/55 R18 102V	Winter tyres on Light alloy	Continental	9mm / 9mm
2)	225/55 R18 102V	Winter tyres on Light alloy	Continental	8mm / 8mm

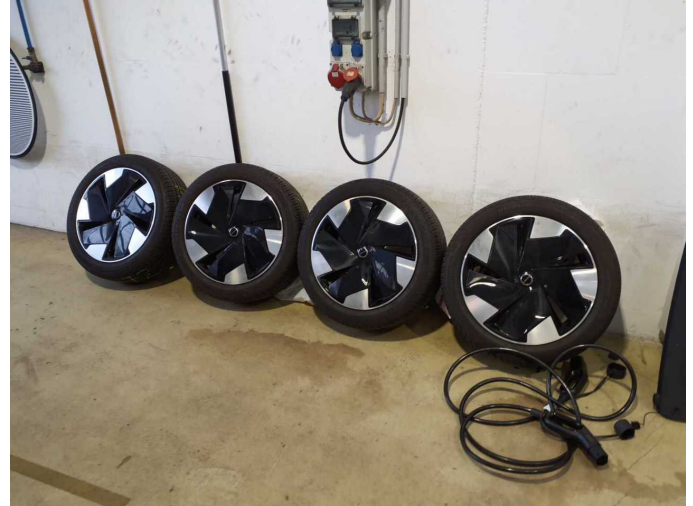
Figure 14: Additional tyres

#	Tyre size	Type of tyre	Manufacturer	Tread depth
1)	245/45 R19 102V	Summer tyres on Light alloy	Goodyear	6mm / 6mm
2)	245/45 R19 102V	Summer tyres on Light alloy	Goodyear	6mm / 6mm

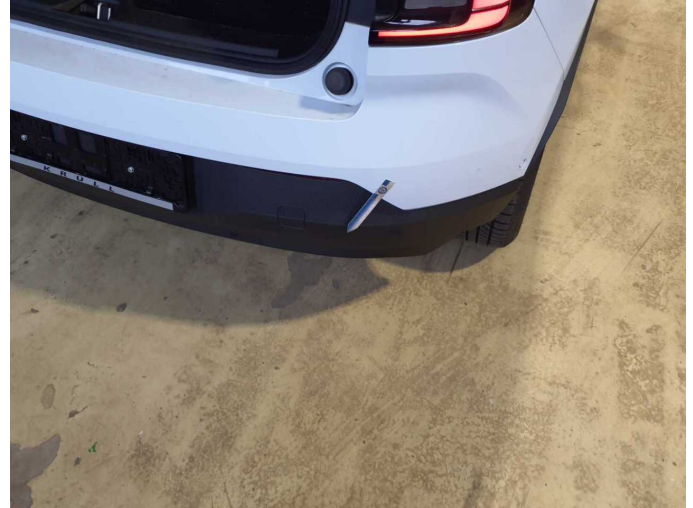
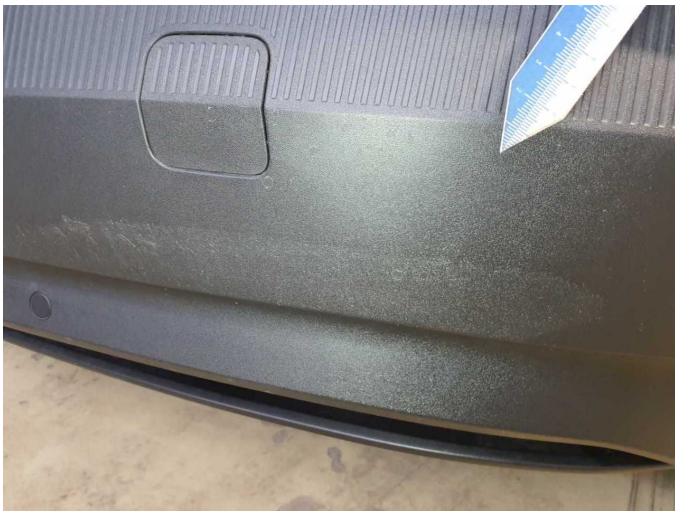
**Damage 1:** Rear bumper: Spoiler - Scratch(es) - Loss in value

No.	Component group	Description
1	Rear bumper	Spoiler - Scratch(es) - Loss in value
2	Vehicle glazing	Windscreen with lane departure assistant - Stone chips - Replace

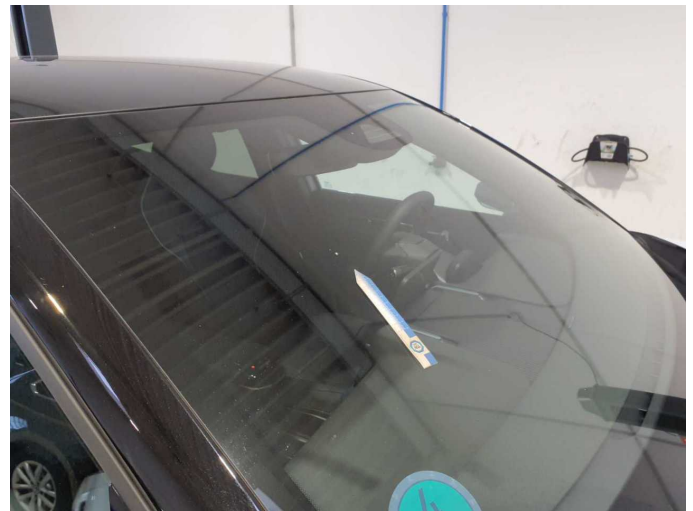
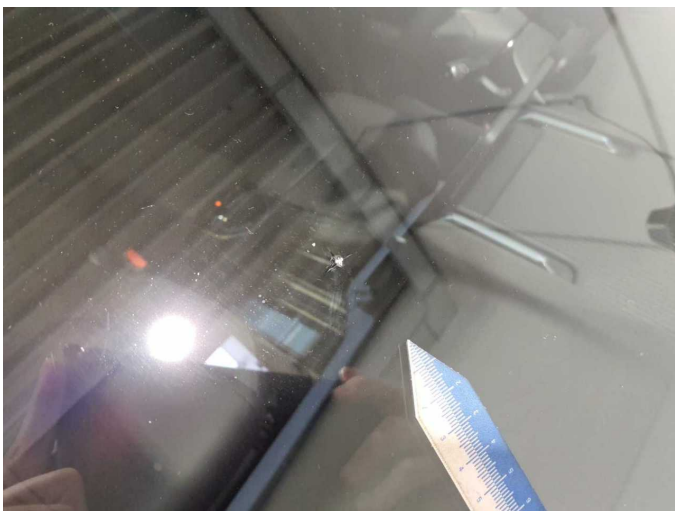
**Damage 2:** Vehicle glazing: Windscreen with lane departure assistant - Stone chips - Replace
