Expertise

Protocol number: 46566928  
Order No. / Reference: 26652502  
Inspection date: 17 Jul 2026

Manufacturer: Volvo

Model: XC90 B5 D AWD Geartronic Inscription

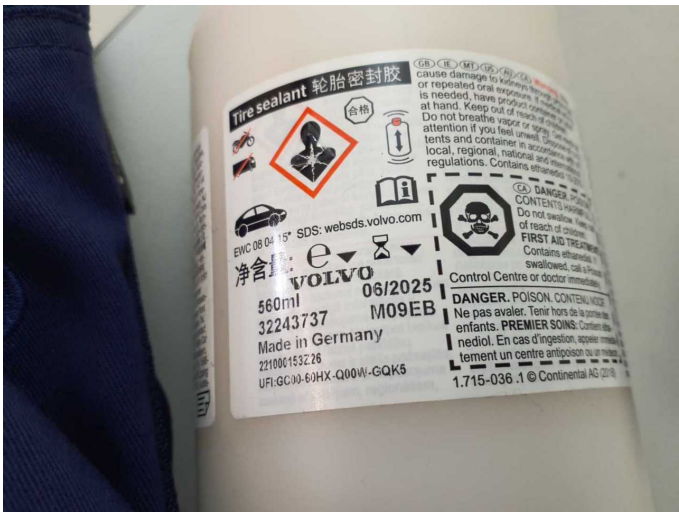
Damage 1: Equipment: Tirefit filler - Expired - Replace

| No. | Component group | Description |
|---|---|---|
| 1 | Equipment | Tirefit filler - Expired - Replace |

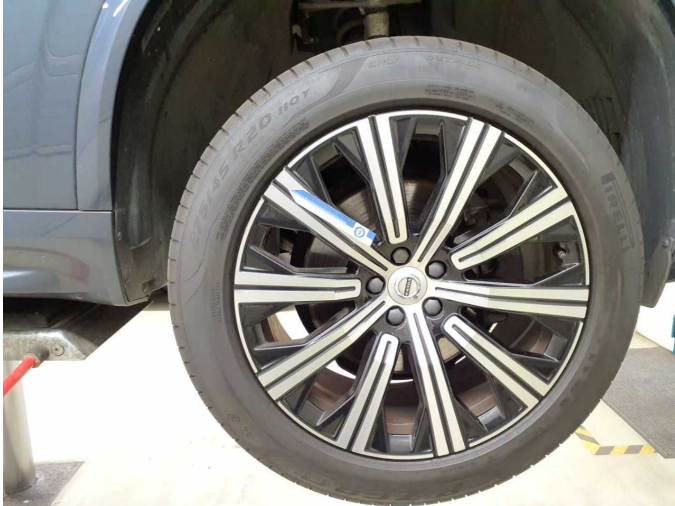
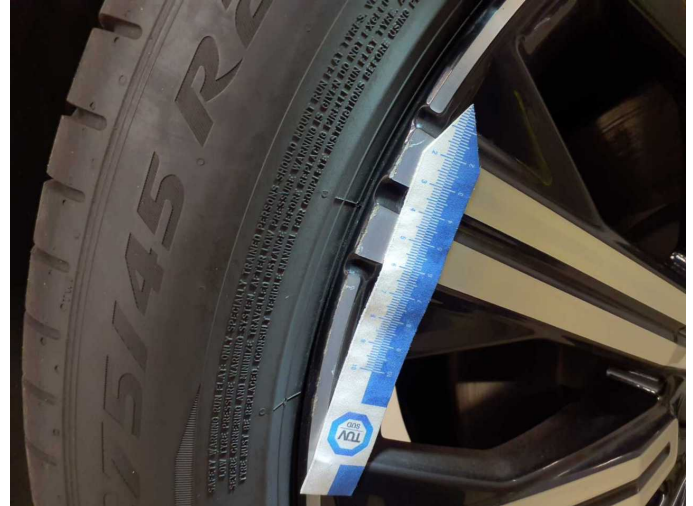
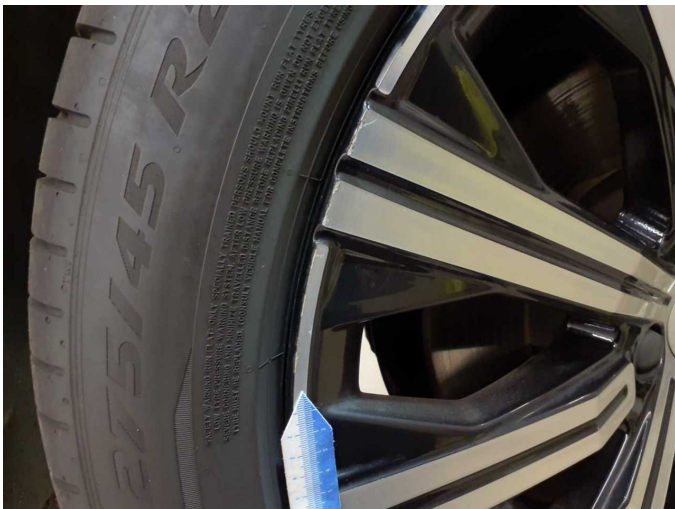
**Damage 2:** Wheel / tyres: Alloy rim - front right side - Scratched - Loss in value

| No. | Component group | Description |
|---|---|---|
| 2 | Wheel / tyres | Alloy rim - front right side - Scratched - Loss in value |

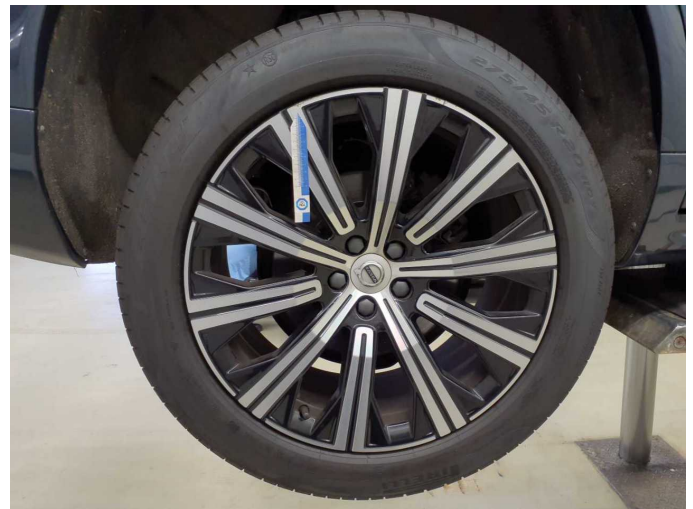
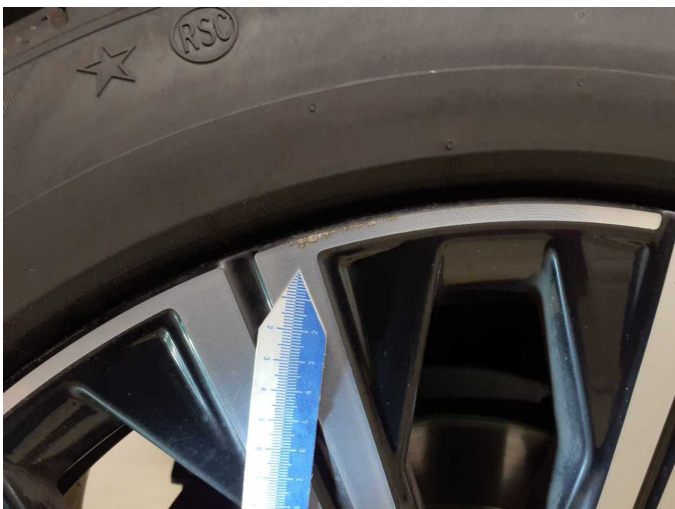
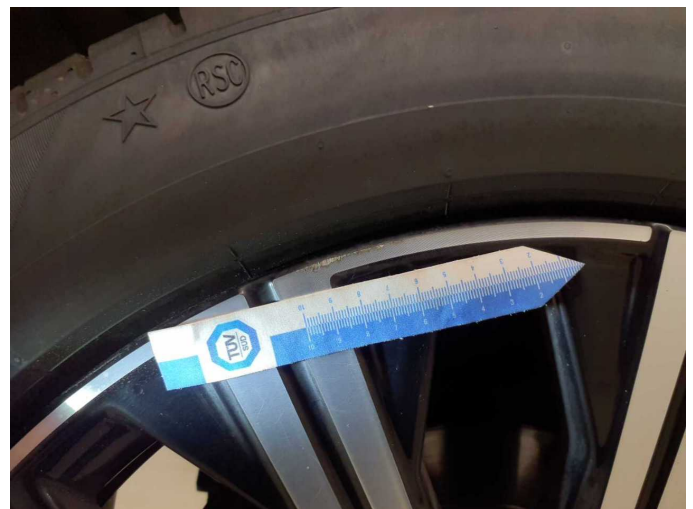
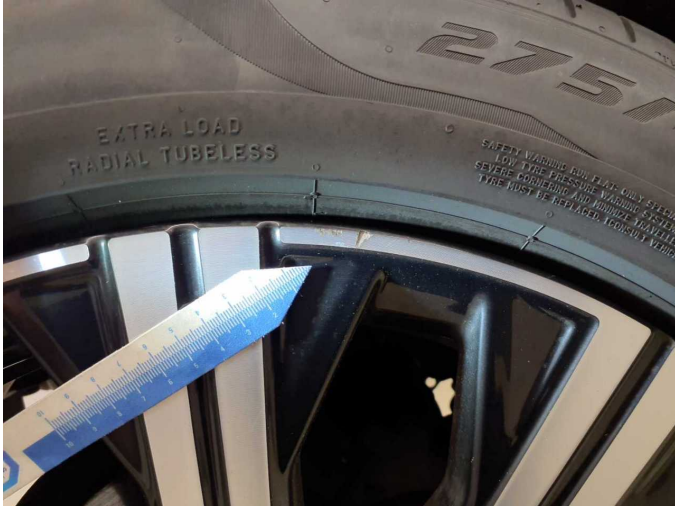
**Damage 3:** Wheel / tyres: Alloy rim - rear right side - Scratched - Loss in value

| No. | Component group | Description |
|---|---|---|
| 3 | Wheel / tyres | Alloy rim - rear right side - Scratched - Loss in value |

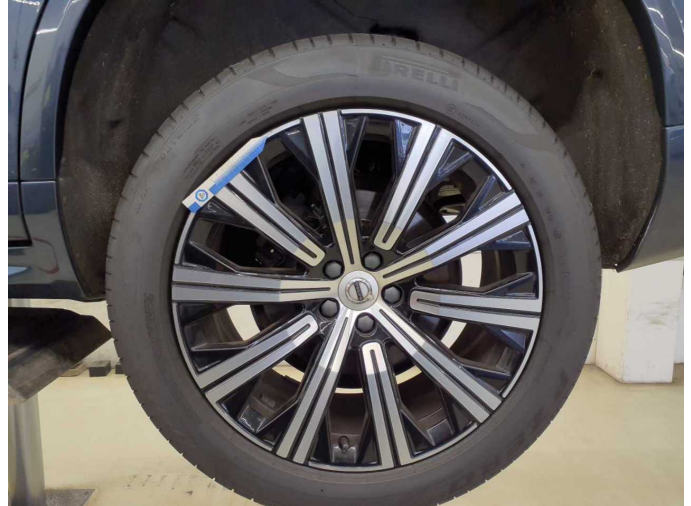
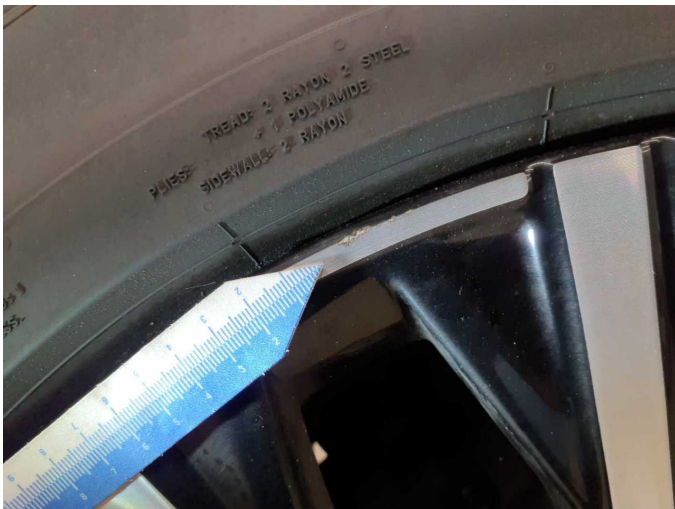
**Damage 4:** Wheel / tyres: Alloy rim - rear left side - Scratched - Loss in value

| No. | Component group | Description |
|---|---|---|
| 4 | Wheel / tyres | Alloy rim - rear left side - Scratched - Loss in value |

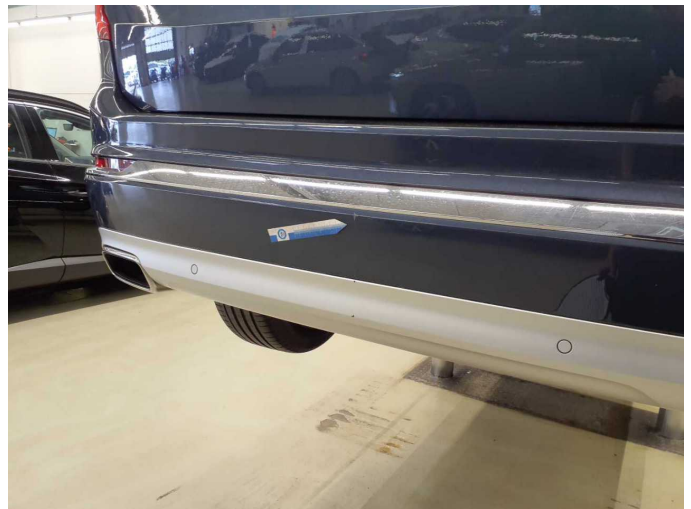
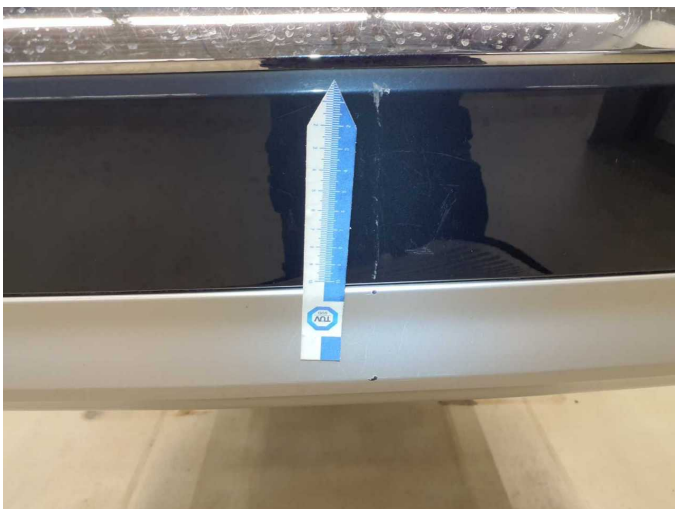
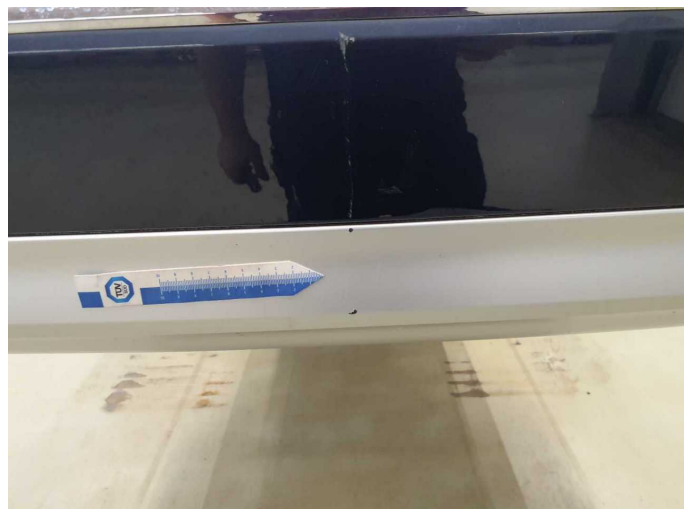
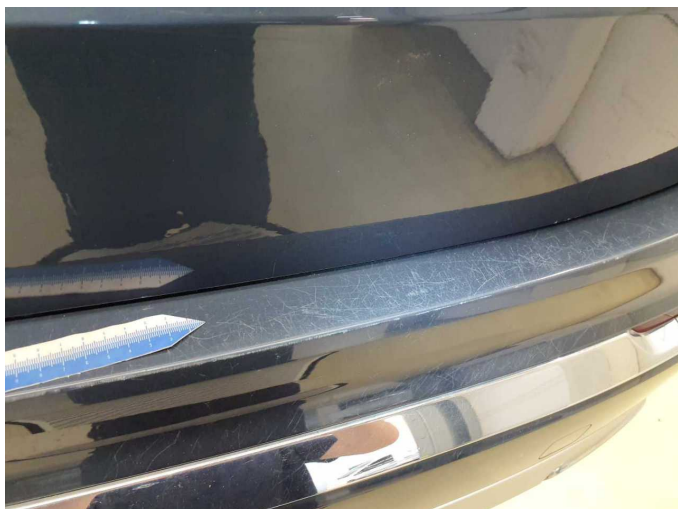
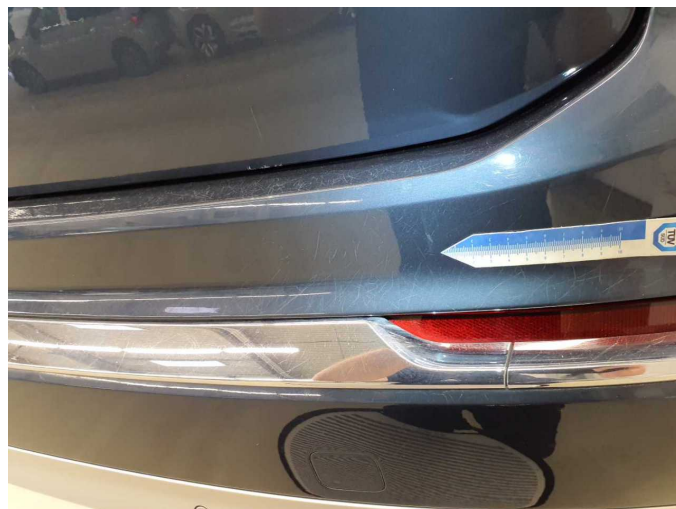
**Damage 5:** Rear bumper: Bumper with Parktronic - Scratched - Smart repair

| No. | Component group | Description |
|---|---|---|
| 5 | Rear bumper | Bumper with Parktronic - Scratched - Smart repair |

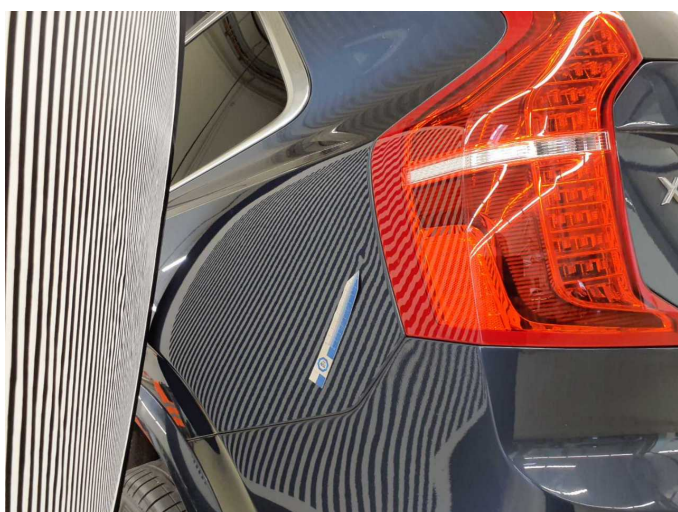
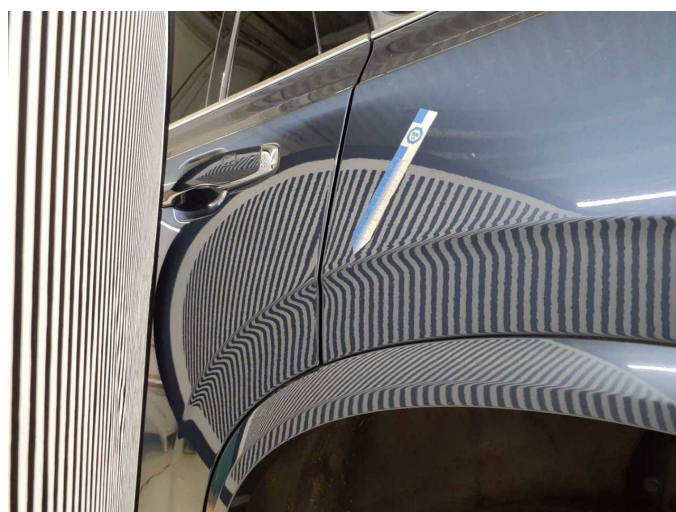
**Damage 6:** Side panel - rear left side: Side panel - dent(s) - Smart repair

| No. | Component group | Description |
|---|---|---|
| 6 | Side panel - rear left side | Side panel - dent(s) - Smart repair |

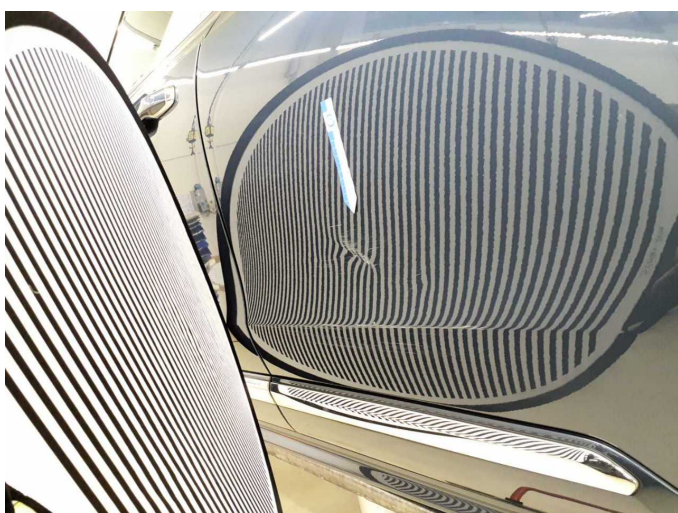
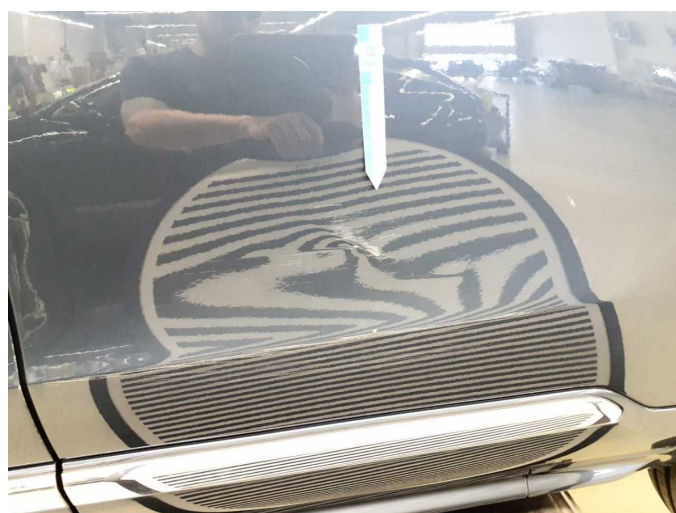
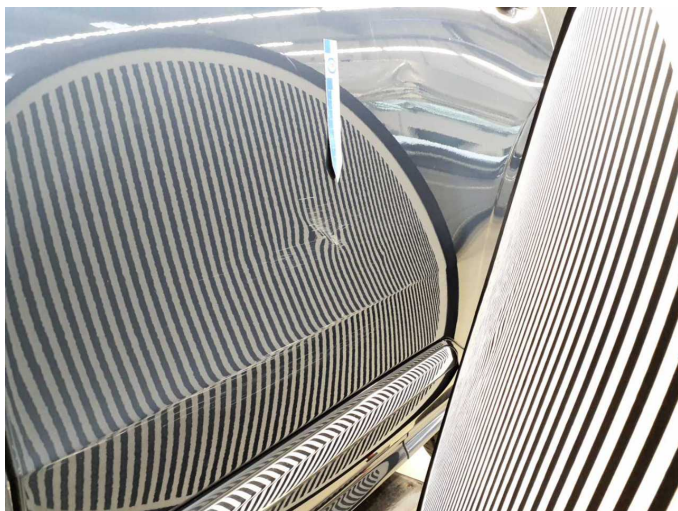
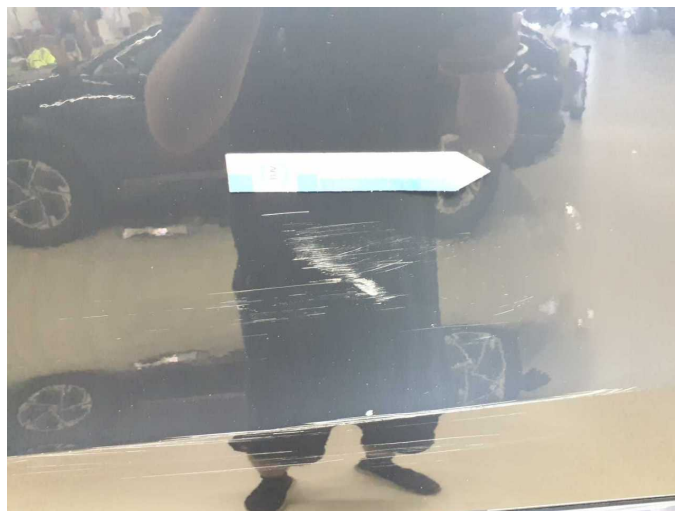
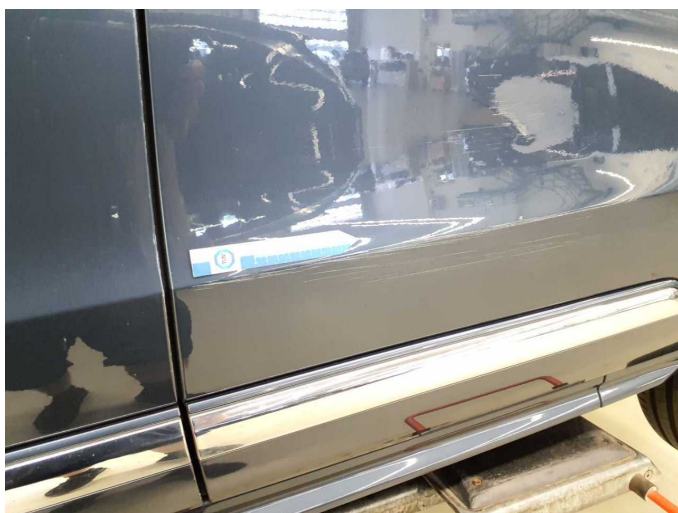
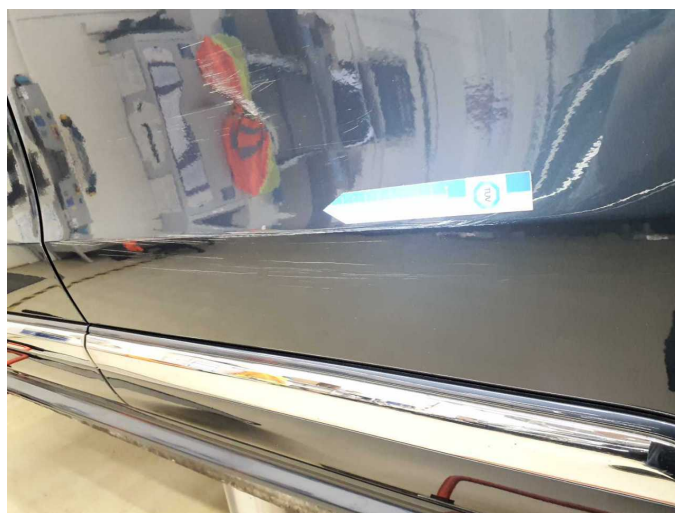
**Damage 7:** Door - rear left side: Door - Deformed - Repair and paint

| No. | Component group | Description |
|---|---|---|
| 7 | Door - rear left side | Door - Deformed - Repair and paint |

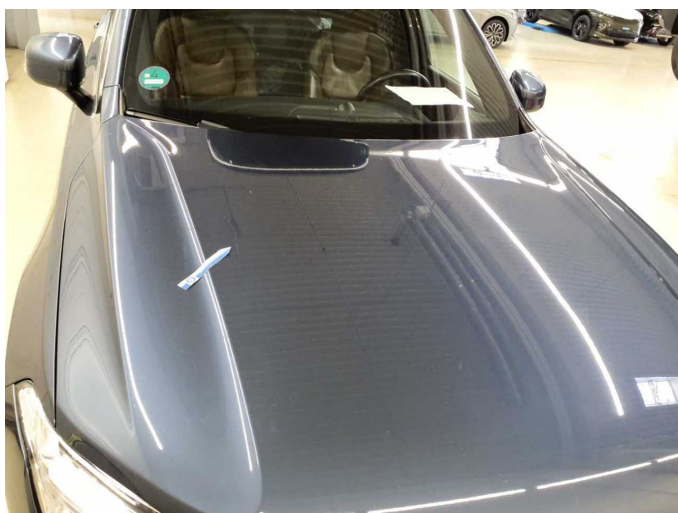
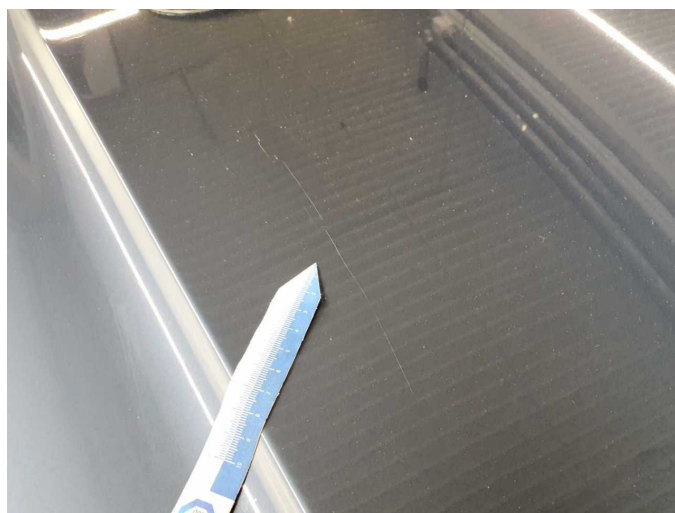
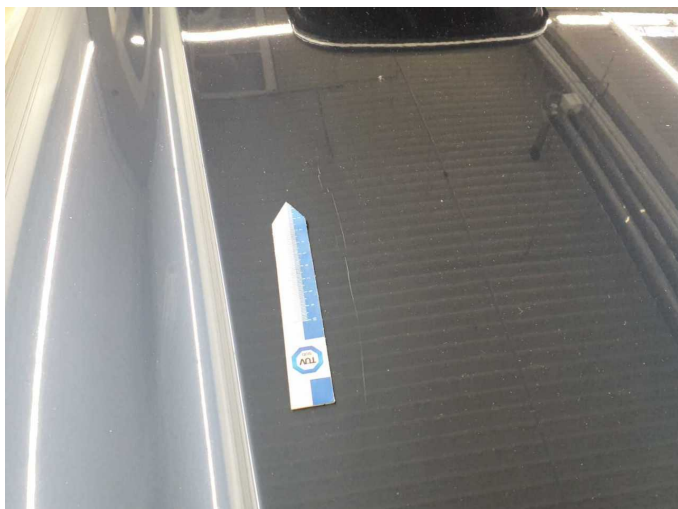
**Damage 8:** Bonnet: Bonnet - Scratch(es) - Paint

| No. | Component group | Description |
|---|---|---|
| 8 | Bonnet | Bonnet - Scratch(es) - Paint |

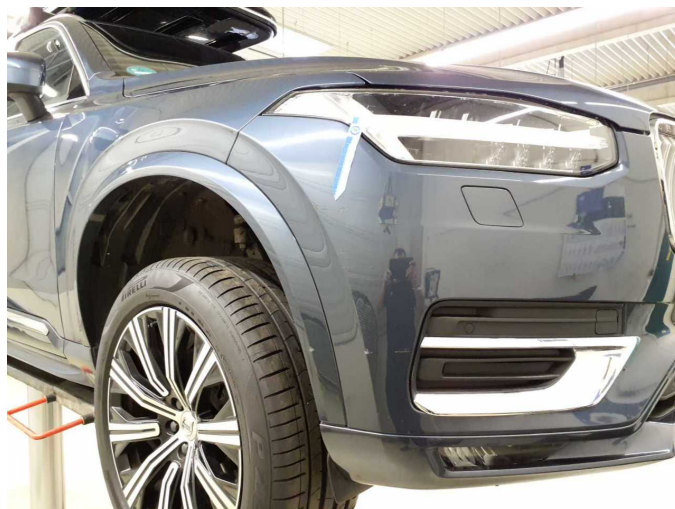
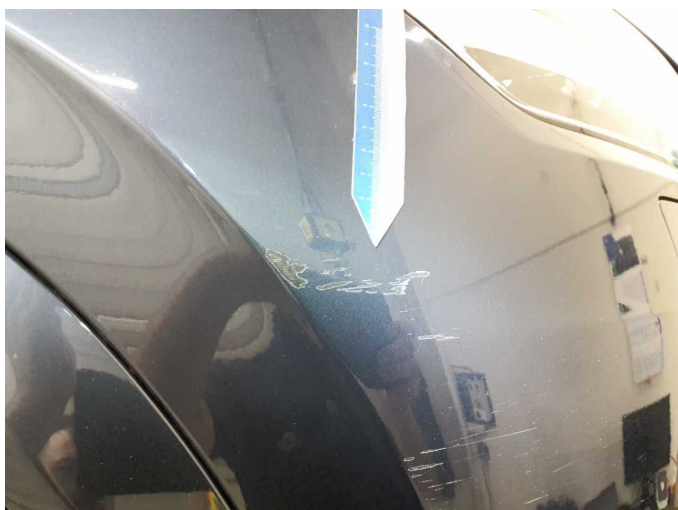
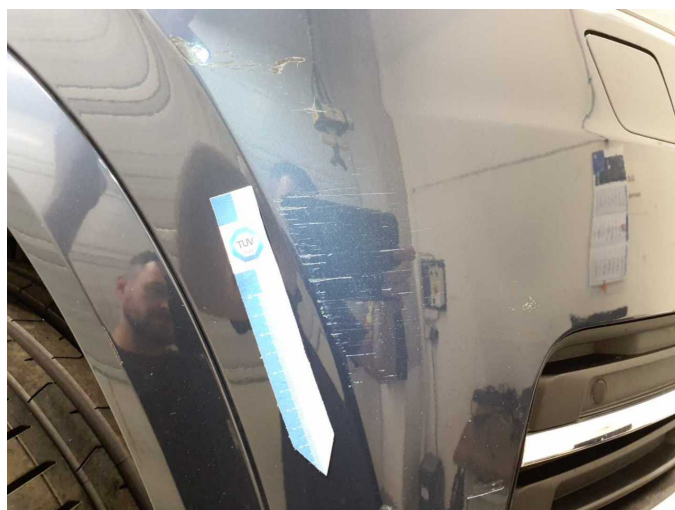
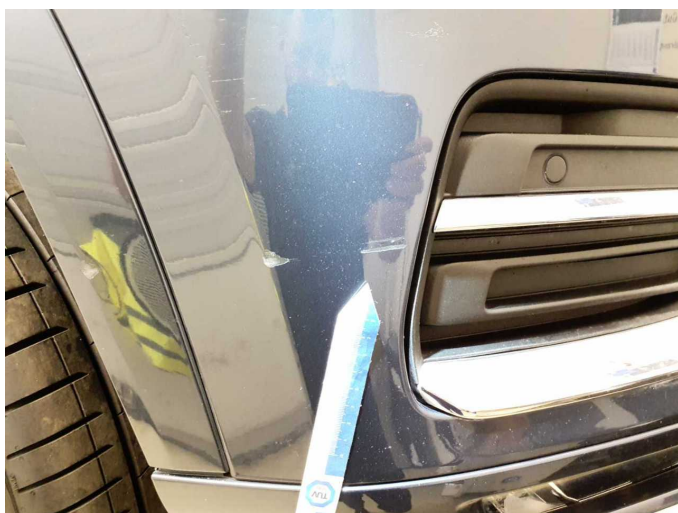
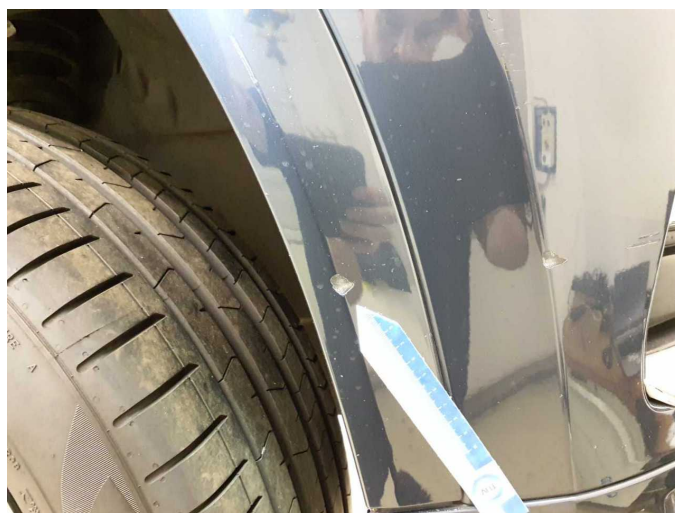
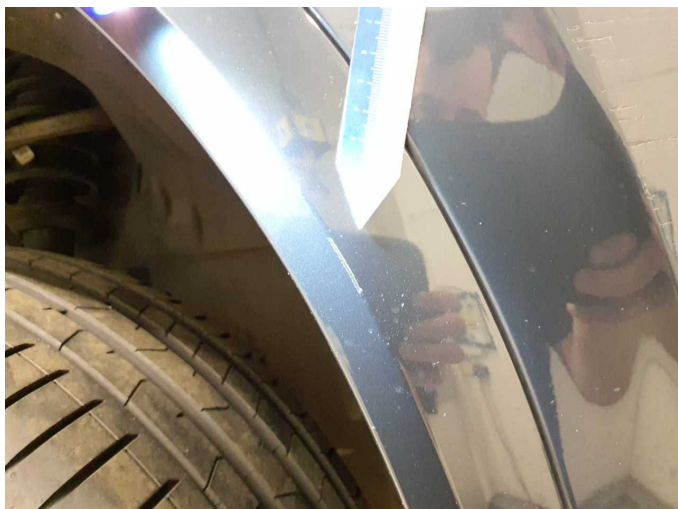
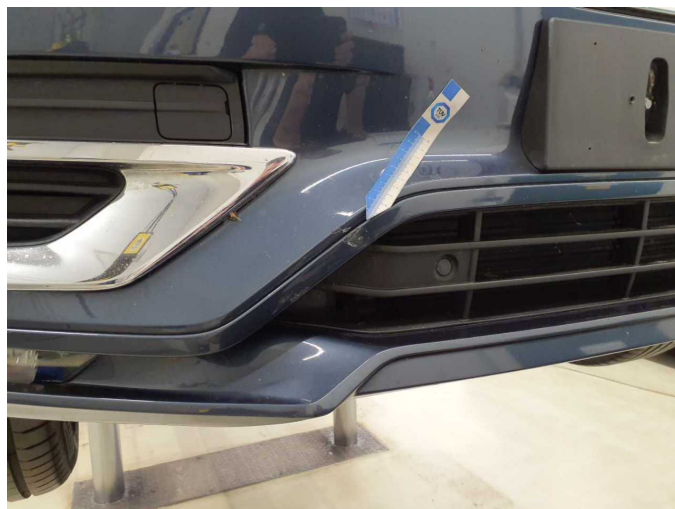
**Damage 9:** Front bumper: Bumper with Parktronic (Inkl. Kotflügelverkleidung VR) - Scratched - Paint

| No. | Component group | Description |
|---|---|---|
| 9 | Front bumper | Bumper with Parktronic (Inkl. Kotflügelverkleidung VR) - Scratched - Paint |

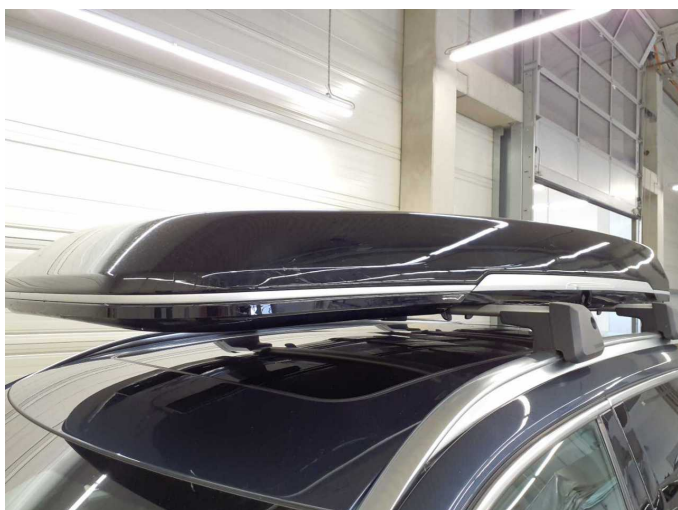
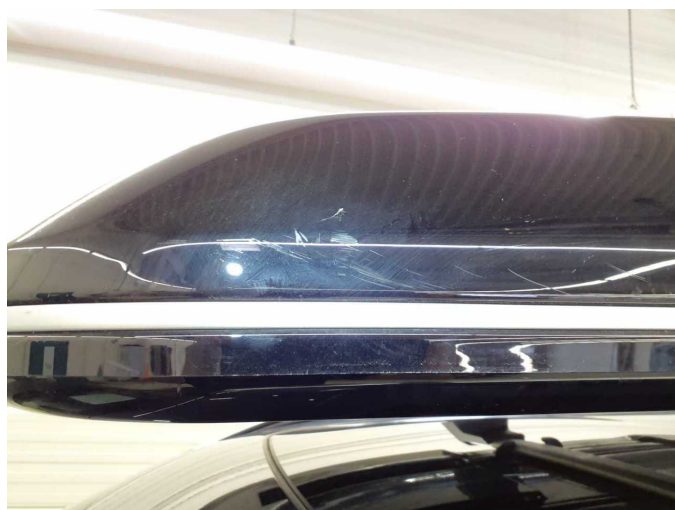
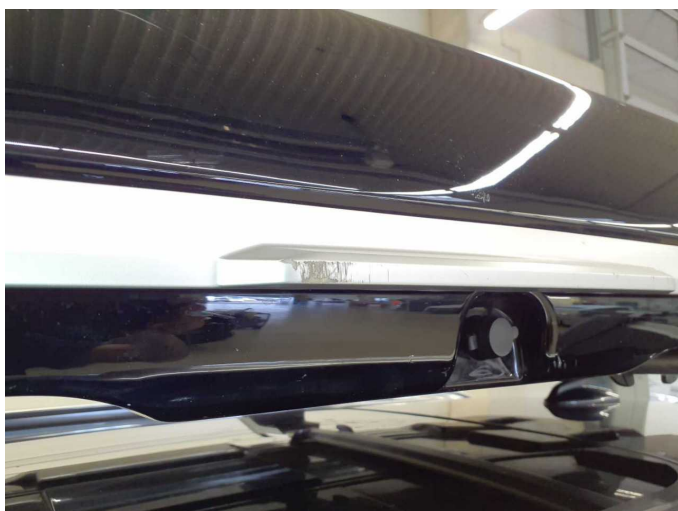
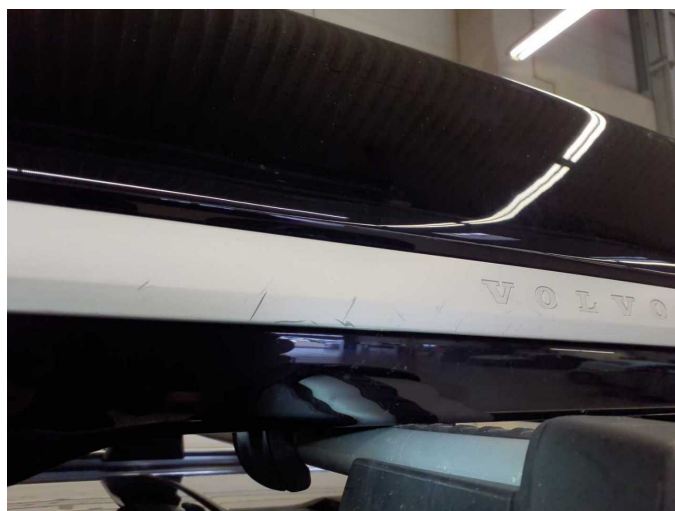
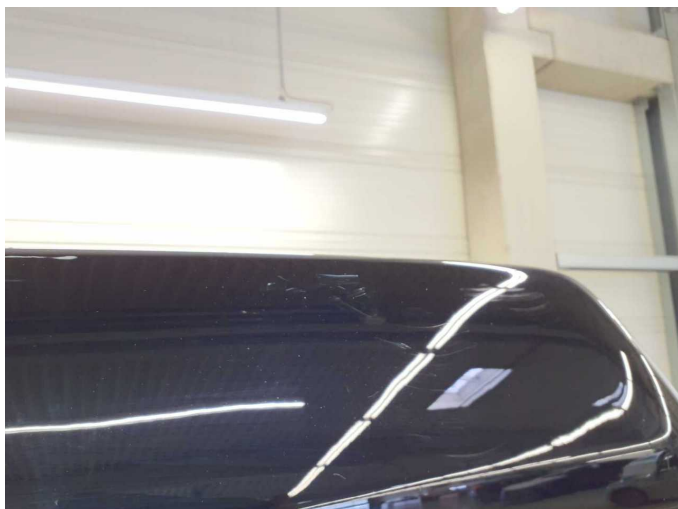
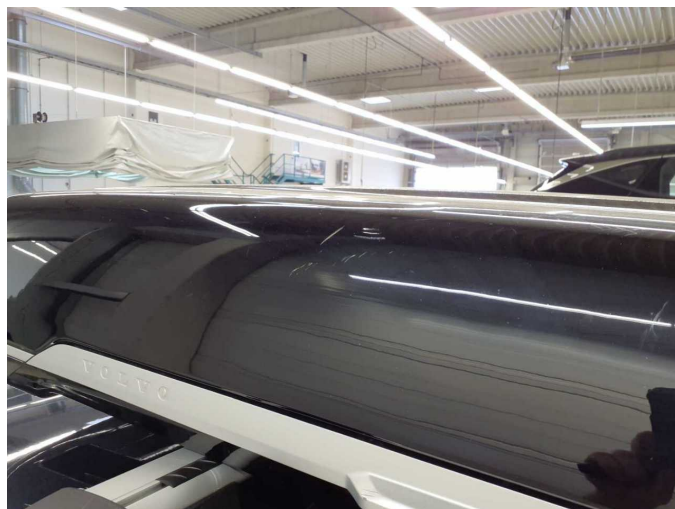
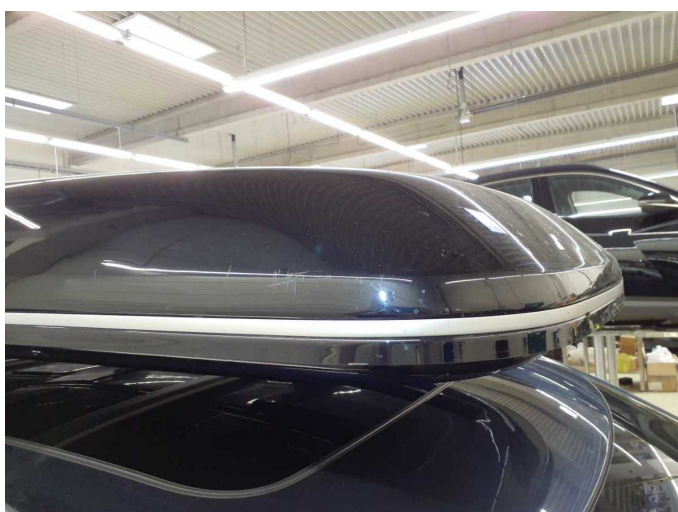
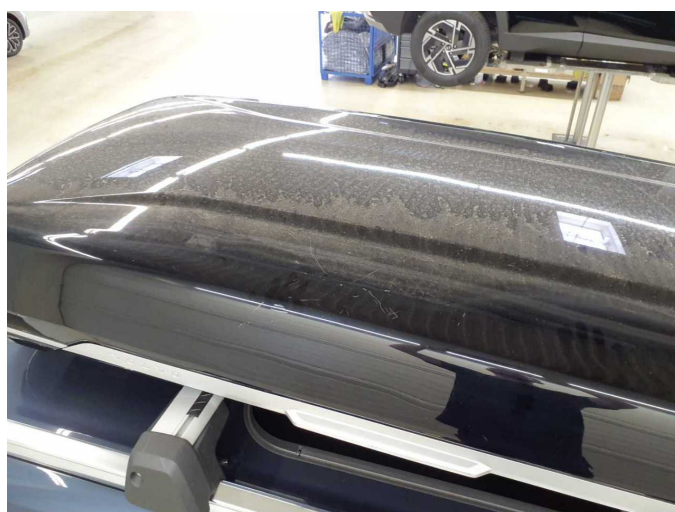
**Wear and tear 1:** Misc.: Misc. (Dachbox) - Scratched - No deduction

| No. | Component group | Description |
|---|---|---|
| 1 | Misc. | Misc. (Dachbox) - Scratched - No deduction |

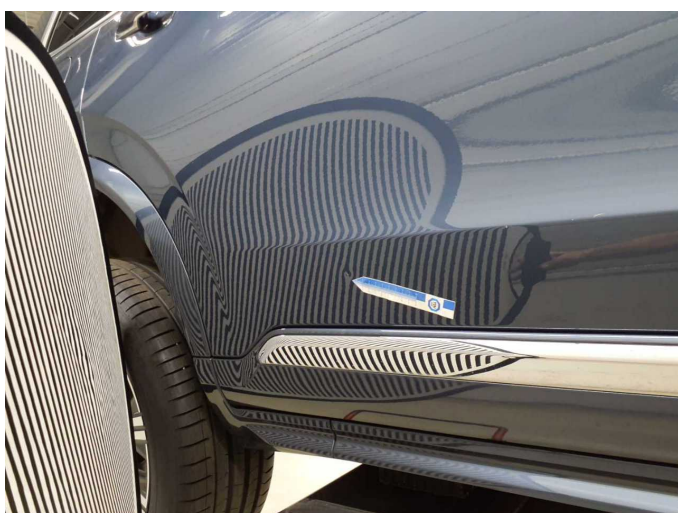
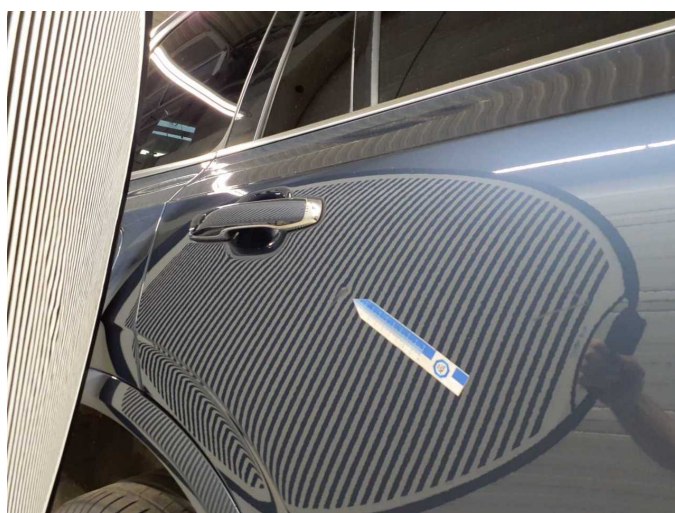
**Wear and tear 2:** Door - rear right side: Door - dent(s) - Smooth repair work

| No. | Component group | Description |
|---|---|---|
| 2 | Door - rear right side | Door - dent(s) - Smooth repair work |
