Expertise

Protocol number: 46913658  
Order No. / Reference: 26761397  
Inspection date: 6 Aug 2026

Manufacturer: Volkswagen

Model: Touran 2.0 TDI SCR DSG Highline

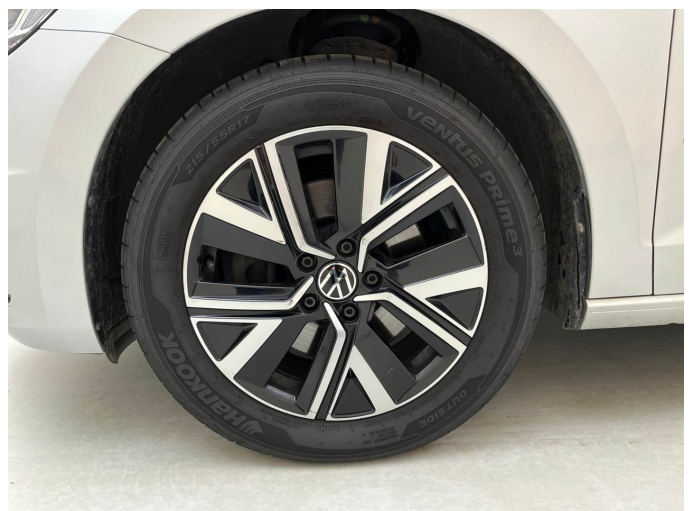
| # | Tyre size | Type of tyre | Manufacturer | Tread depth |
|---|---|---|---|---|
| 1) | 215/55 R17 94V | Summer tyres on Light alloy | Hankook | 6mm / 6mm |
| 2) | 215/55 R17 94V | Summer tyres on Light alloy | Hankook | 4mm / 4mm |

Figure 12: Mounted tyres

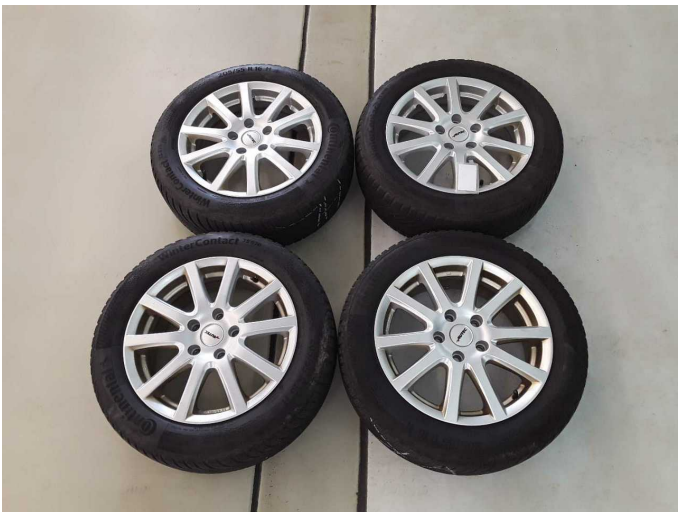
| # | Tyre size | Type of tyre | Manufacturer | Tread depth |
|---|---|---|---|---|
| 1) | 205/55 R16 91H | Winter tyres on Light alloy | Continental | 3mm / 4mm |
| 2) | 205/55 R16 91H | Winter tyres on Light alloy | Continental | 5mm / 5mm |

Figure 18: Additional tyres

| No. | Component group | Description |
|---|---|---|
| 3 | 2nd wheel set | 2 tyres - Worn - No deduction |

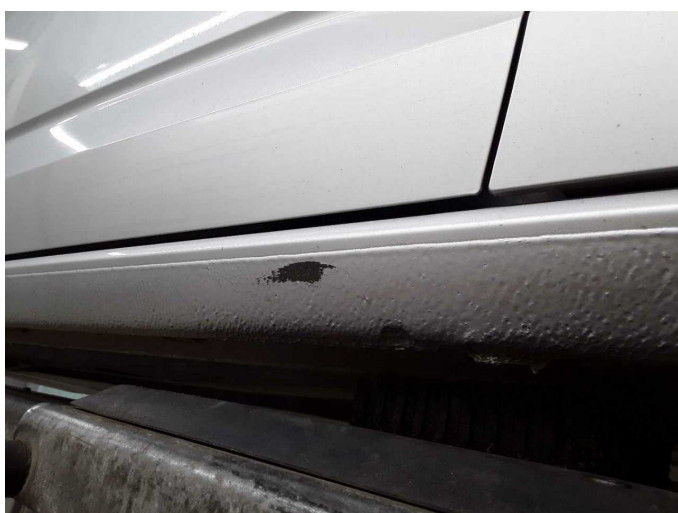
Figure 29: Verschmutzung

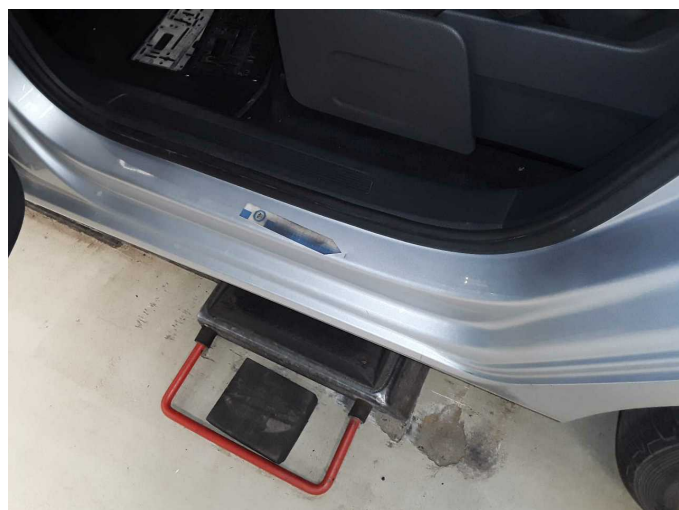
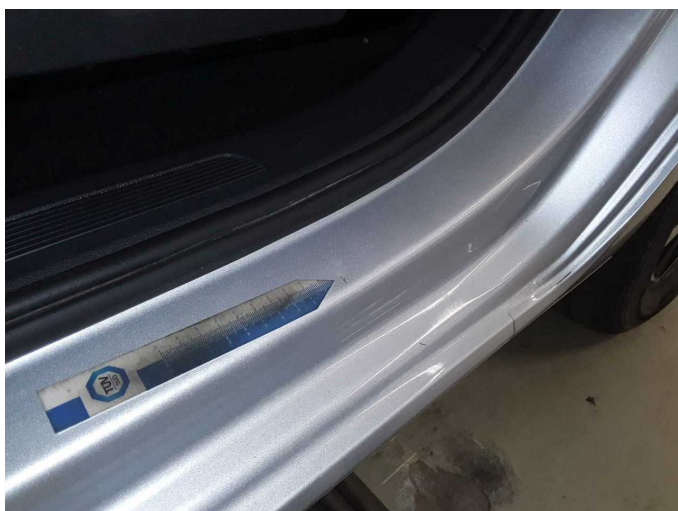
**Damage 1:** Side panel - rear left side: Sill - Dent / paintcoat damage - Smart repair

| No. | Component group | Description |
|---|---|---|
| 1 | Side panel - rear left side | Sill - Dent / paintcoat damage - Smart repair |

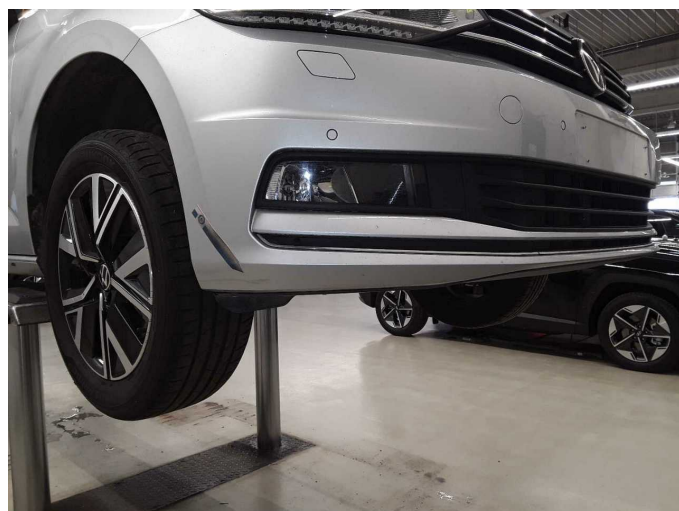
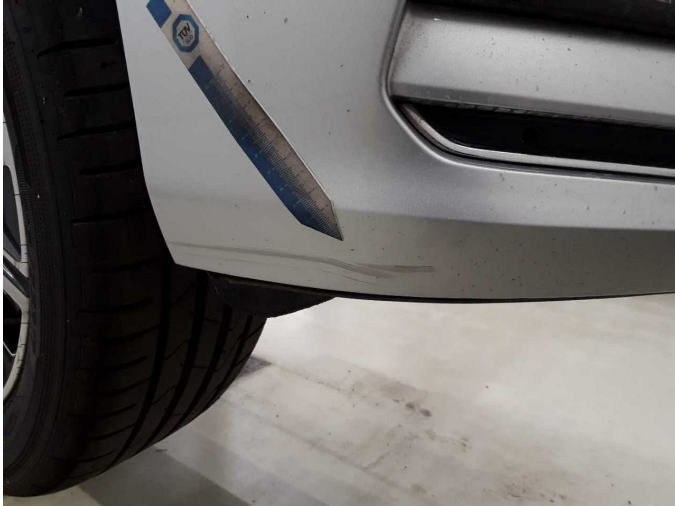
**Damage 2:** Front bumper: Front bumper - Scratch(es) - Smart repair

| No. | Component group | Description |
|---|---|---|
| 2 | Front bumper | Front bumper - Scratch(es) - Smart repair |

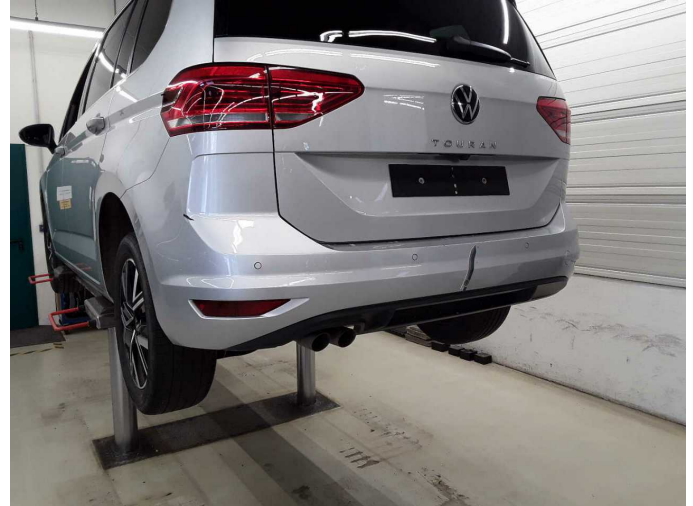
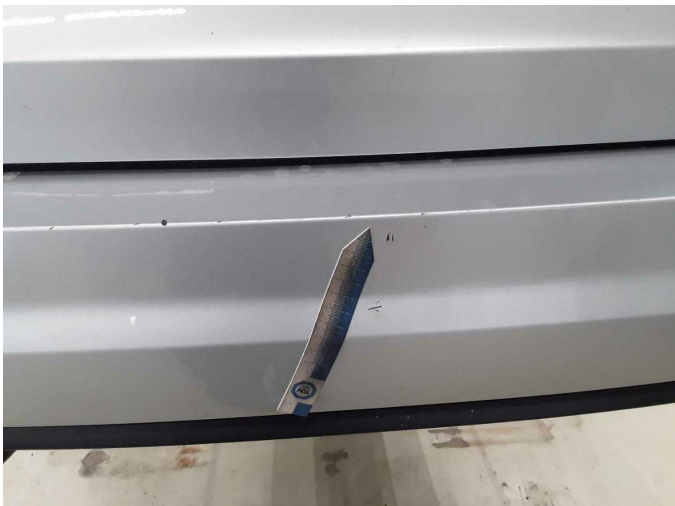
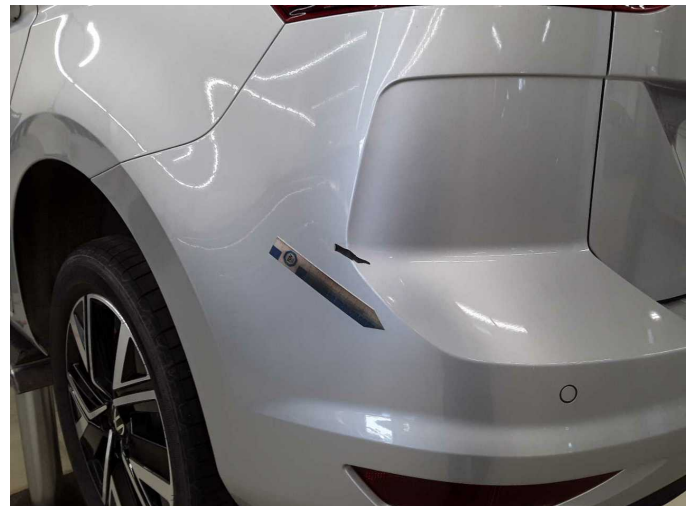
**Damage 3:** Rear bumper: Rear bumper - Scratched - Repair and paint

| No. | Component group | Description |
|---|---|---|
| 3 | Rear bumper | Rear bumper - Scratched - Repair and paint |

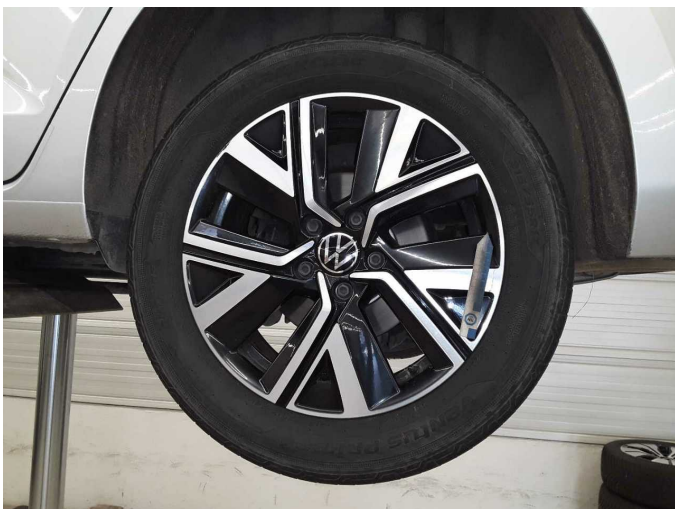
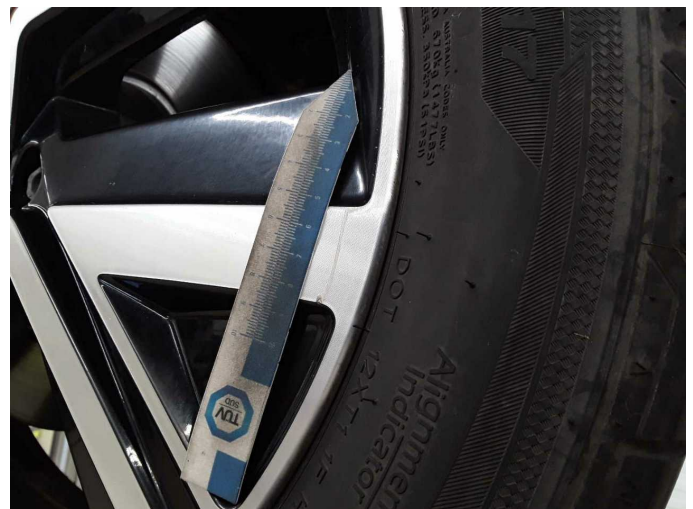
**Wear and tear 1:** Wheel / tyres: Alloy rim - rear left side - Scratch(es) - No deduction

| No. | Component group | Description |
|---|---|---|
| 1 | Wheel / tyres | Alloy rim - rear left side - Scratch(es) - No deduction |

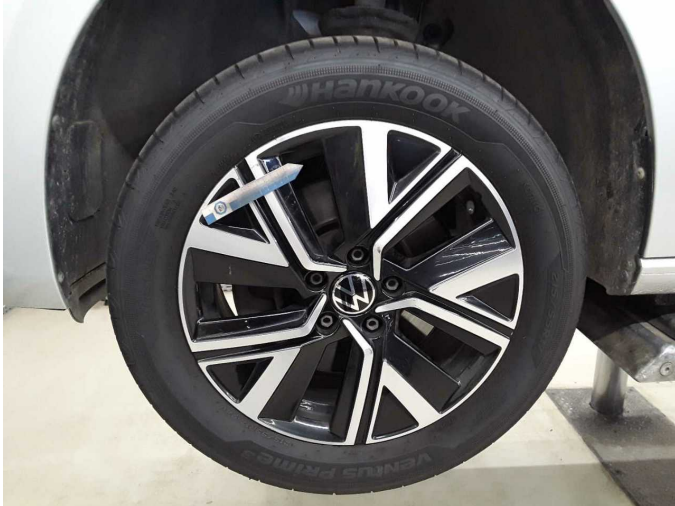
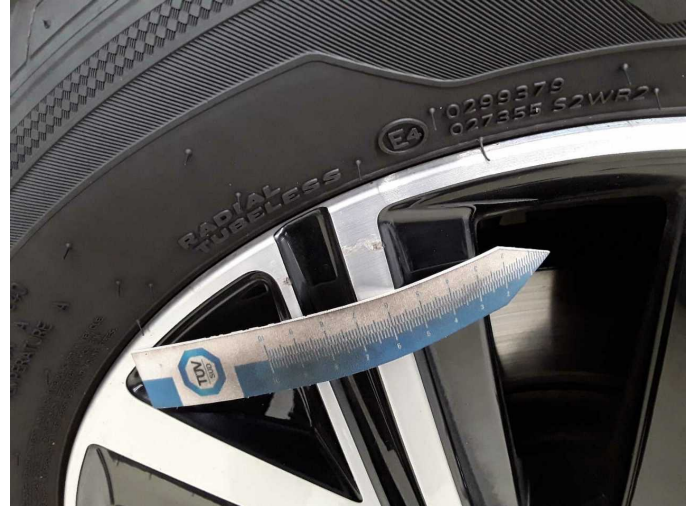
**Wear and tear 2:** Wheel / tyres: Alloy rim - front left side - Scratch(es) - No deduction

| No. | Component group | Description |
|---|---|---|
| 2 | Wheel / tyres | Alloy rim - front left side - Scratch(es) - No deduction |
