Expertise

Protocol number: 46048414  
Order No. / Reference: 26461307  
Inspection date: 19 Jun 2026

Manufacturer: Volkswagen

Model: Passat Variant 2.0 TDI SCR DSG Business

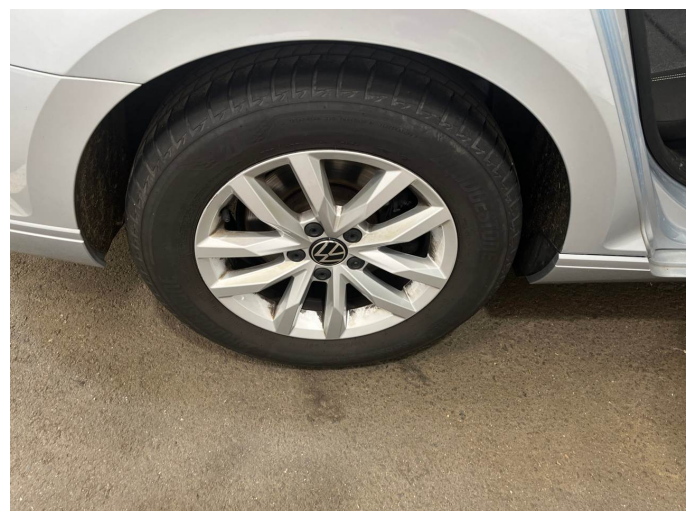
Figure 12: Mounted tyres

| # | Tyre size | Type of tyre | Manufacturer | Tread depth |
|---|---|---|---|---|
| 1) | 215/60 R16 95V | Summer tyres on Light alloy | Bridgestone | 5mm / 5mm |
| 2) | 215/60 R16 95V | Summer tyres on Light alloy | Bridgestone | 5mm / 5mm |

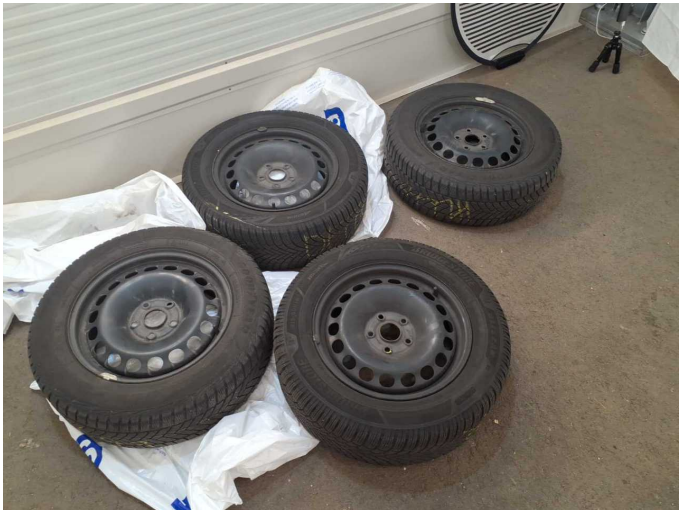
Figure 18: Additional tyres

| # | Tyre size | Type of tyre | Manufacturer | Tread depth |
|---|---|---|---|---|
| 1) | 215/60 R16 99H | Winter tyres on Steel | Bridgestone | 6mm / 6mm |
| 2) | 215/60 R16 99H | Winter tyres on Steel | Goodyear | 6mm / 6mm |

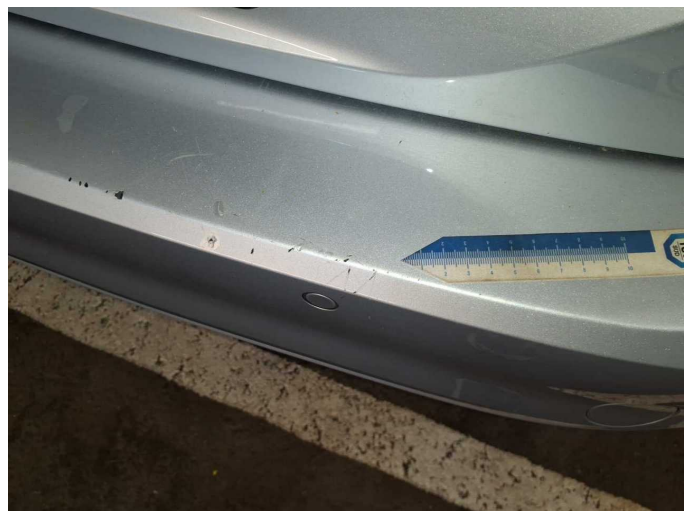
Damage 1: Rear bumper: Rear bumper - Scratched - Repair and paint

| No. | Component group | Description |
|---|---|---|
| 1 | Rear bumper | Rear bumper - Scratched - Repair and paint |

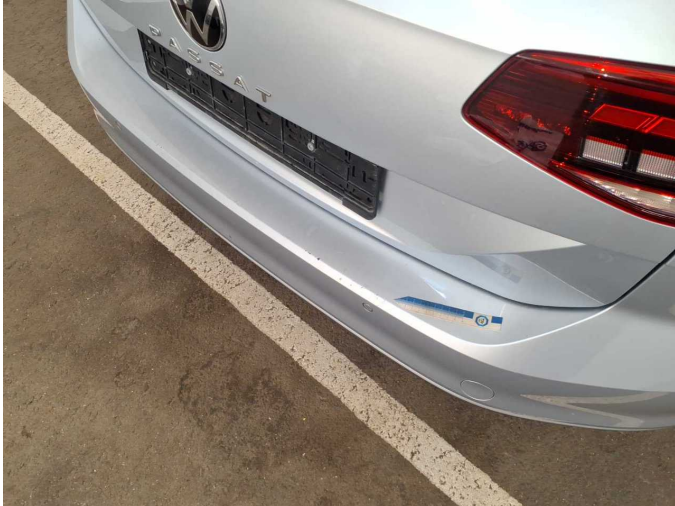
**Damage 1:** Rear bumper: Rear bumper - Scratched - Repair and paint

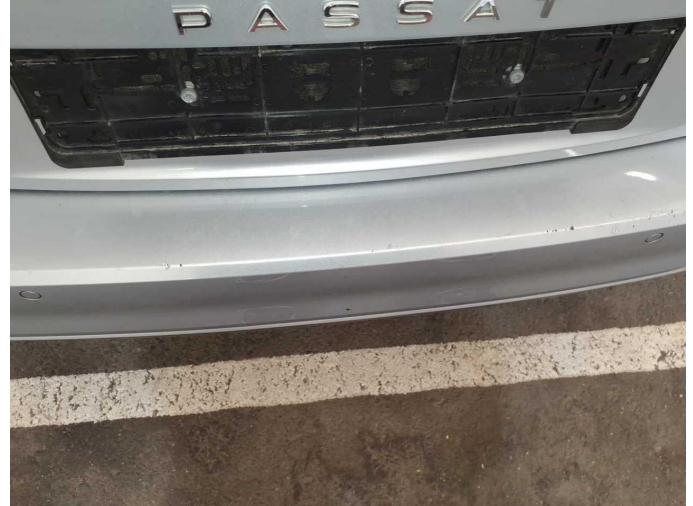
**Damage 1:** Rear bumper: Rear bumper - Scratched - Repair and paint

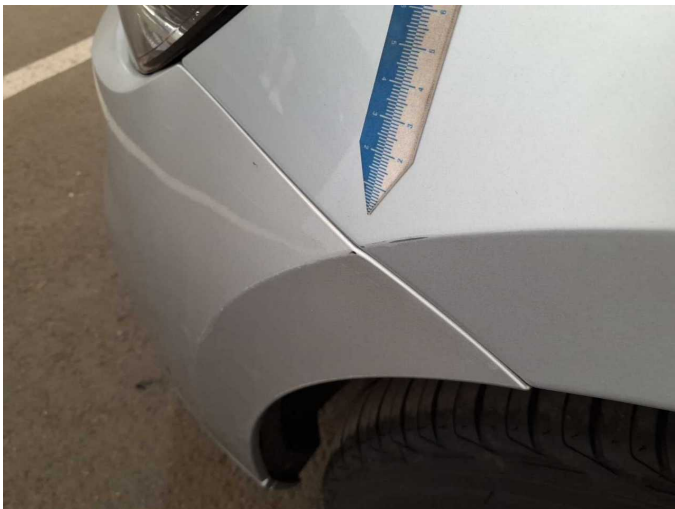
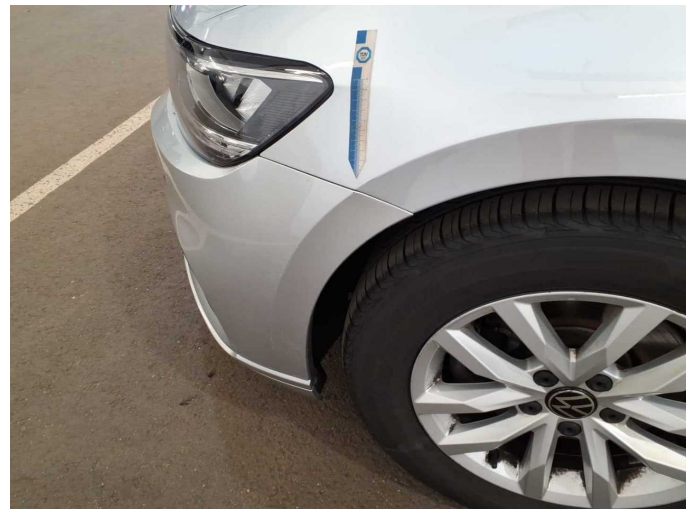
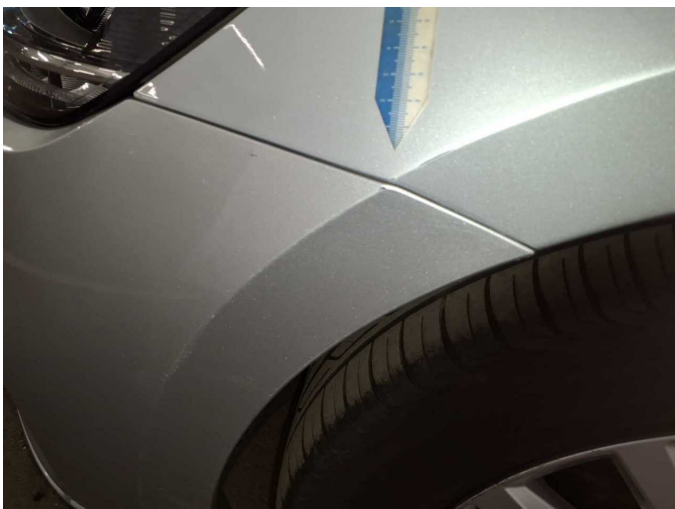
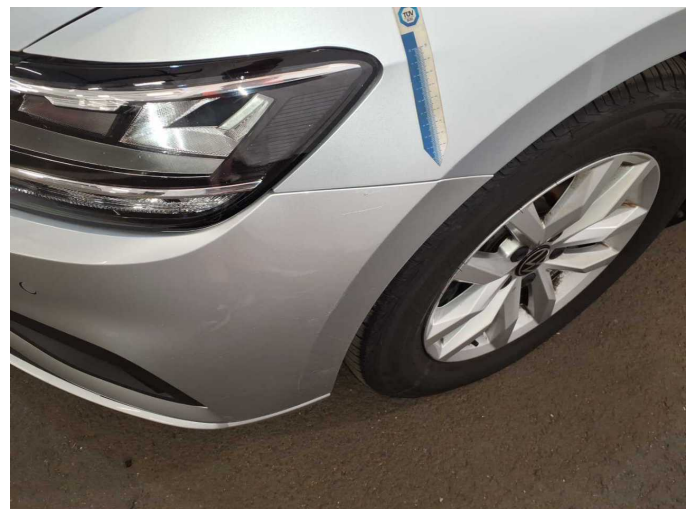
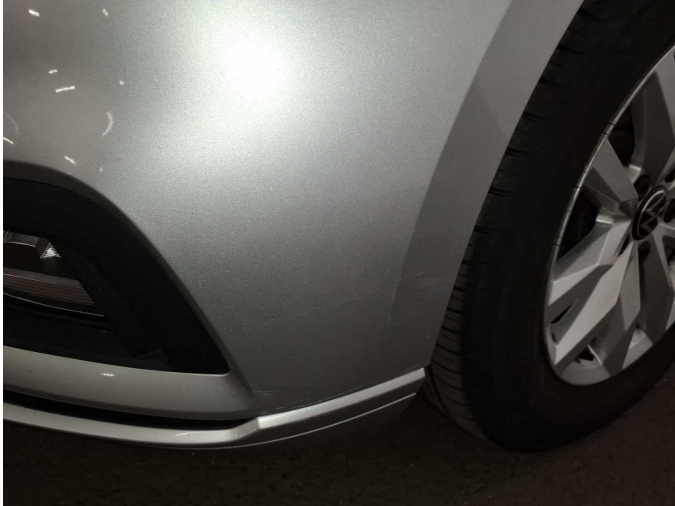
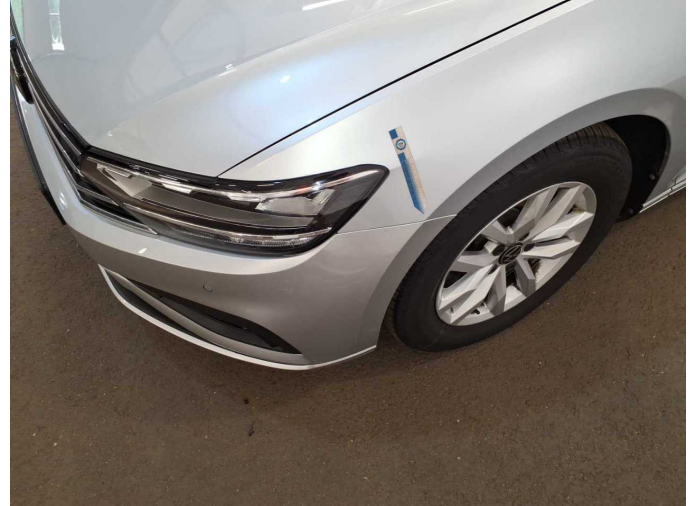
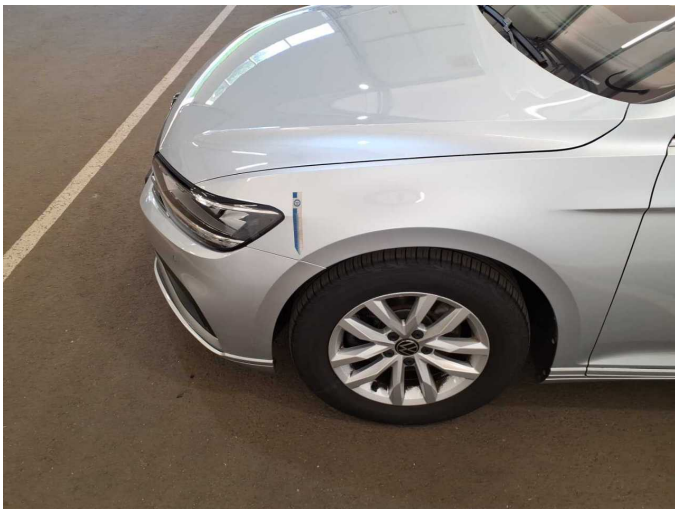
| No. | Previous damage | Extent of damage (Net) |
|---|---|---|
| 3 | Front, Side - left, Provided by user / customer, from 7 Dec 2024 | 2.065,16 € |

- 1 Front, Side - left

**Accident 1:** Front, Side - left

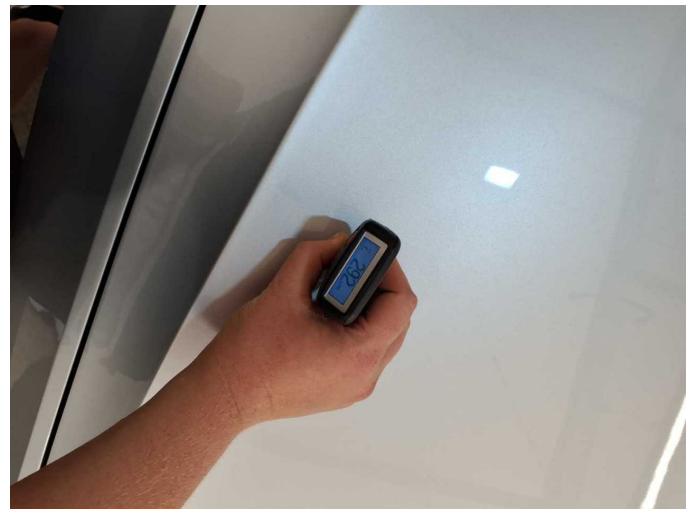
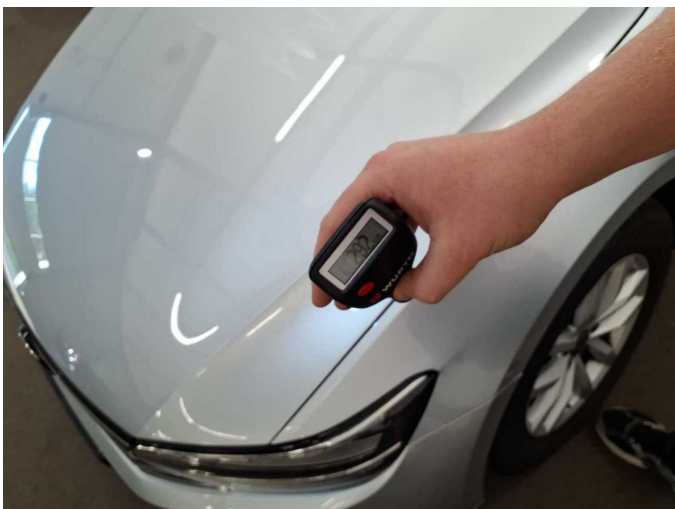
| Bonnet | 292 µm | Door - front left side | 241 µm |

**Repainting 1:** Bonnet

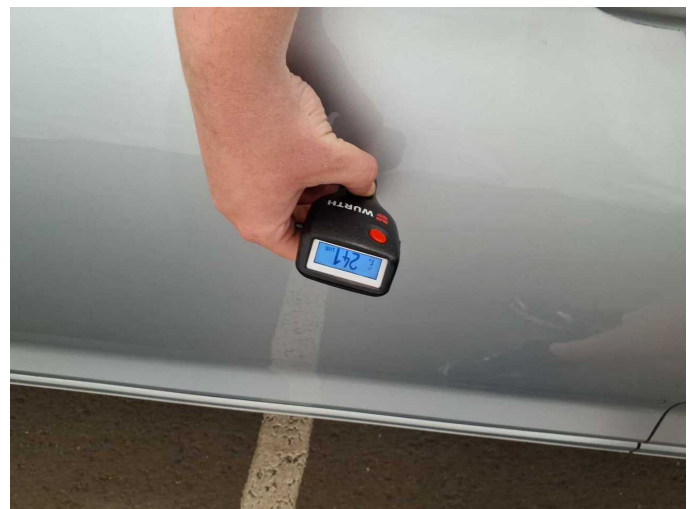
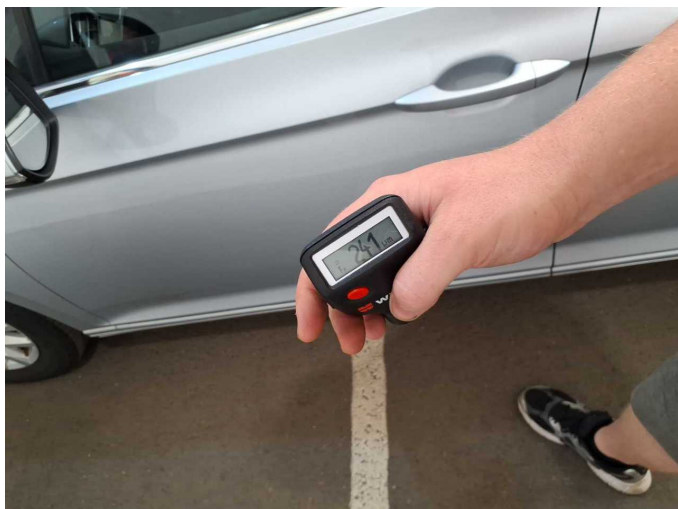
**Repainting 2:** Door - front left side
