Expertise

Protocol number: 46541169  
Order No. / Reference: 26503862  
Inspection date: 14 Jul 2026

Manufacturer: Skoda  
VIN: TMBJH7NP7N7046175

Model: Superb Combi 2.0 TDI DSG Style

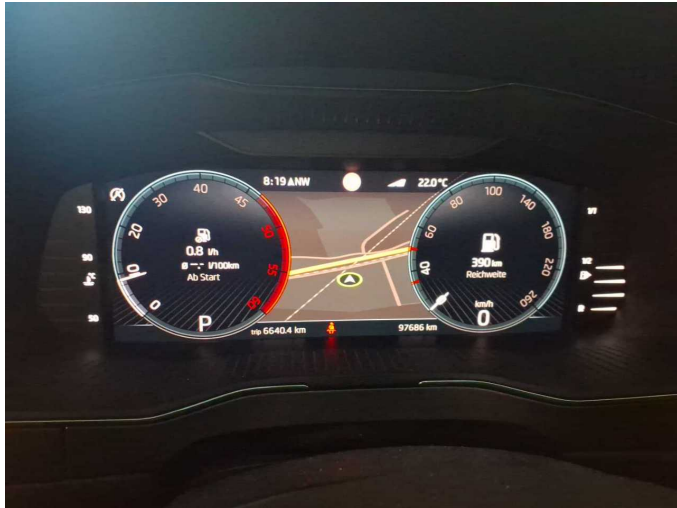
| Vehicle details | |
|---|---|
| Mileage (Read) | 97,686 km |

Figure 7: Instrument cluster

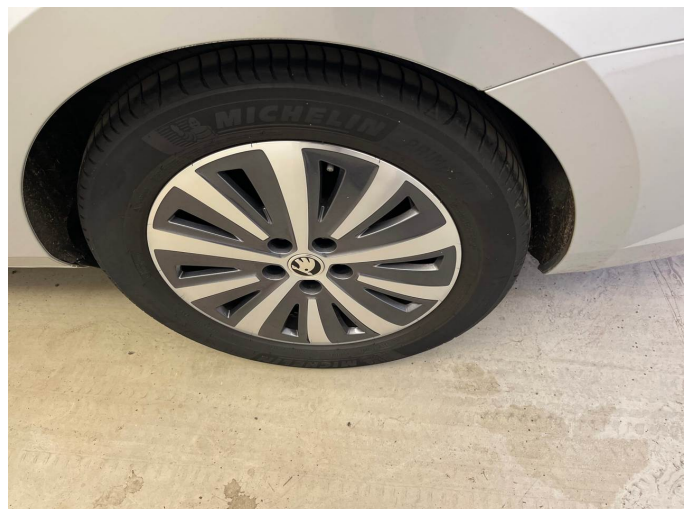
| # | Tyre size | Type of tyre | Manufacturer | Tread depth |
|---|---|---|---|---|
| 1) | 215/55 R17 94V | Summer tyres on Light alloy | Michelin | 4mm / 4mm |
| 2) | 215/55 R17 94V | Summer tyres on Light alloy | Michelin | 6mm / 6mm |

Figure 12: Mounted tyres

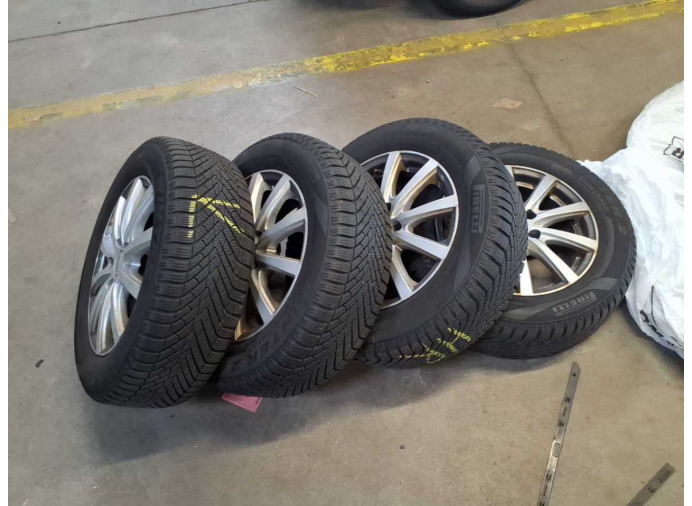
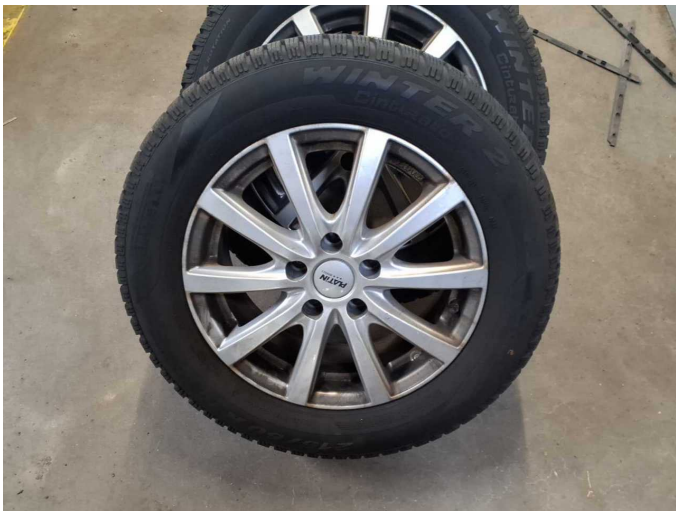
| # | Tyre size | Type of tyre | Manufacturer | Tread depth |
|---|---|---|---|---|
| 1) | 215/60 R16 99H | Winter tyres on Light alloy | Pirelli | 6mm / 6mm |
| 2) | 215/60 R16 99H | Winter tyres on Light alloy | Pirelli | 7mm / 7mm |

Figure 14: Additional tyres

Figure 15: Additional tyres

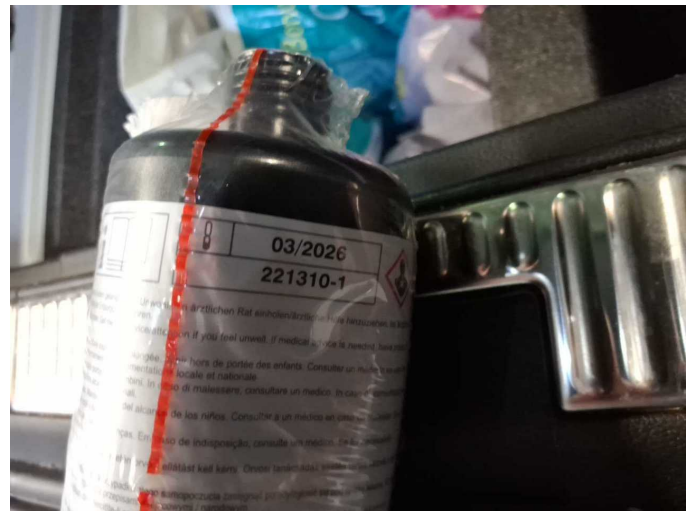
| No. | Component group | Description |
|---|---|---|
| 1 | Equipment | Tirefit filler - Expired - Replace |

Damage 1: Equipment: Tirefit filler - Expired - Replace

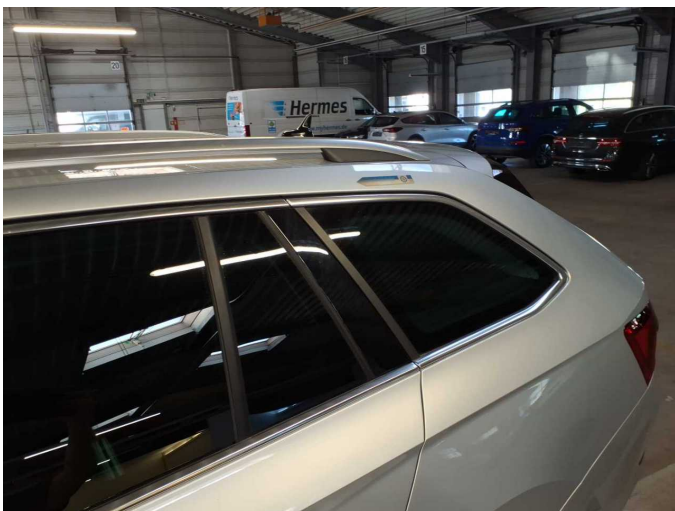
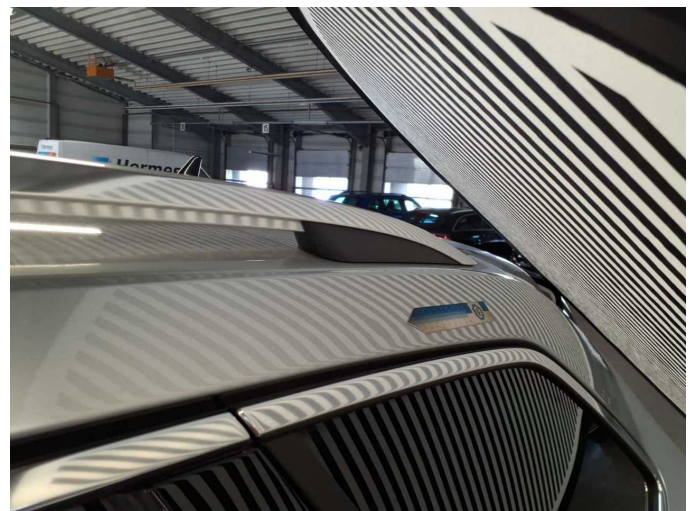
| No. | Component group | Description |
|---|---|---|
| 2 | Roof | Roof rail - left side - dent(s) - Smooth repair work |

Damage 2: Roof: Roof rail - left side - dent(s) - Smooth repair work

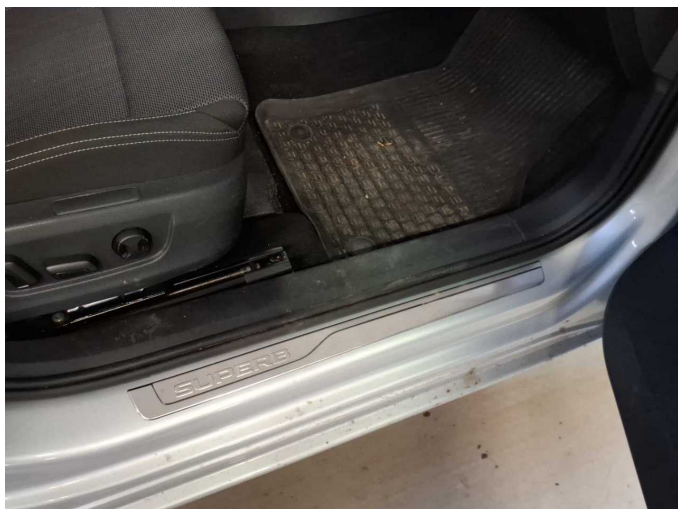
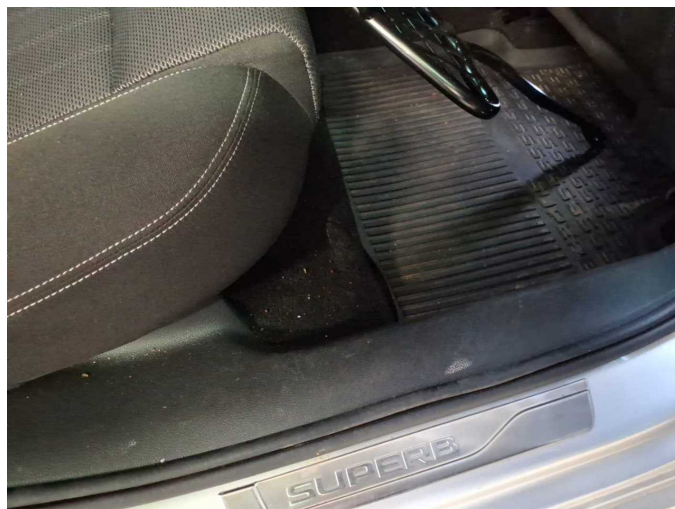
| No. | Component group | Description |
|---|---|---|
| 3 | Interior | Interior - Soiled - Clean |

**Damage 3:** Interior: Interior - Soiled - Clean

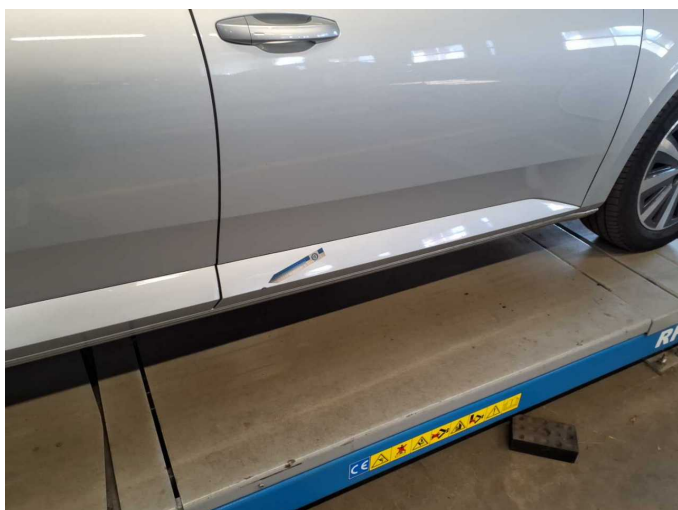
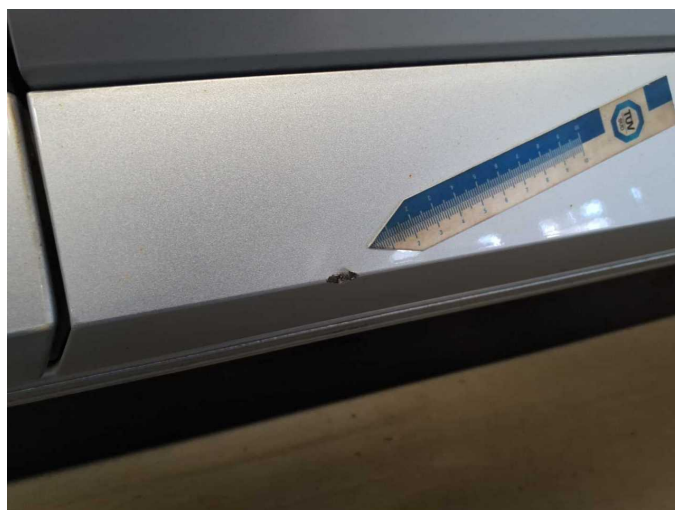
| No. | Component group | Description |
|---|---|---|
| 4 | Door - front right side | Door (Blende unten) - Damaged - Smart repair |

**Damage 4:** Door - front right side: Door (Blende unten) - Damaged - Smart repair

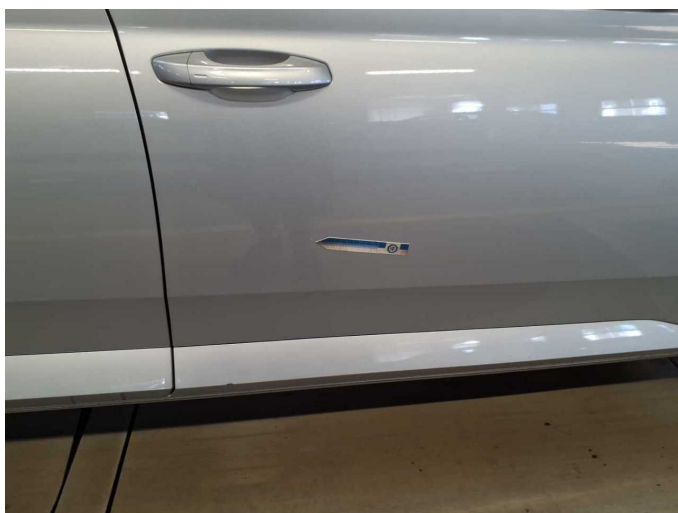
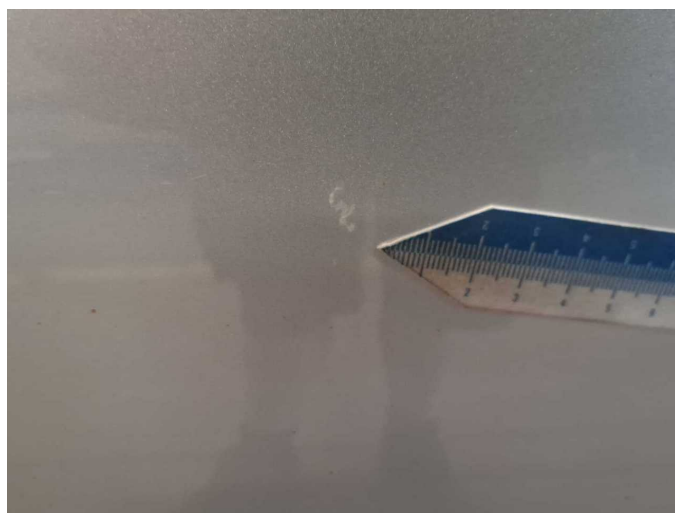
| No. | Component group | Description |
|---|---|---|
| 5 | Door - front right side | Door - Scratched - Smart repair |

**Damage 5:** Door - front right side: Door - Scratched - Smart repair

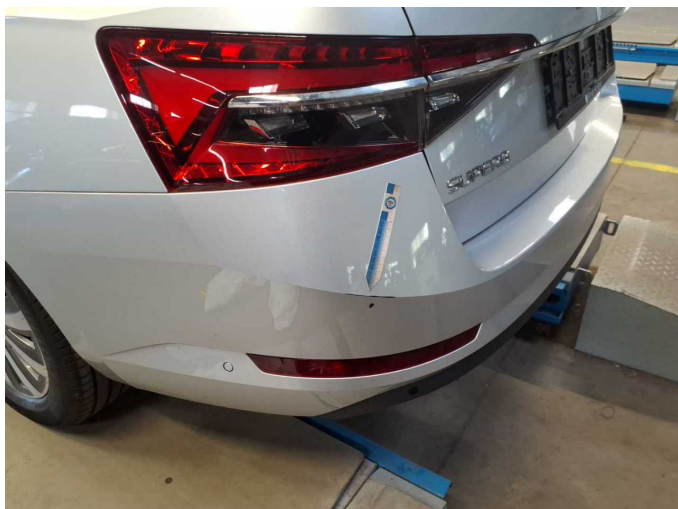
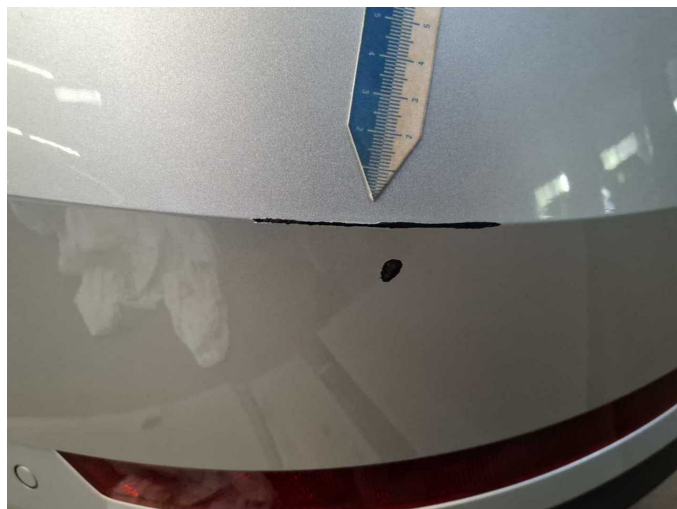
| No. | Component group | Description |
|---|---|---|
| 6 | Rear bumper | Rear bumper - Scratched - Paint |

**Damage 6:** Rear bumper: Rear bumper - Scratched - Paint

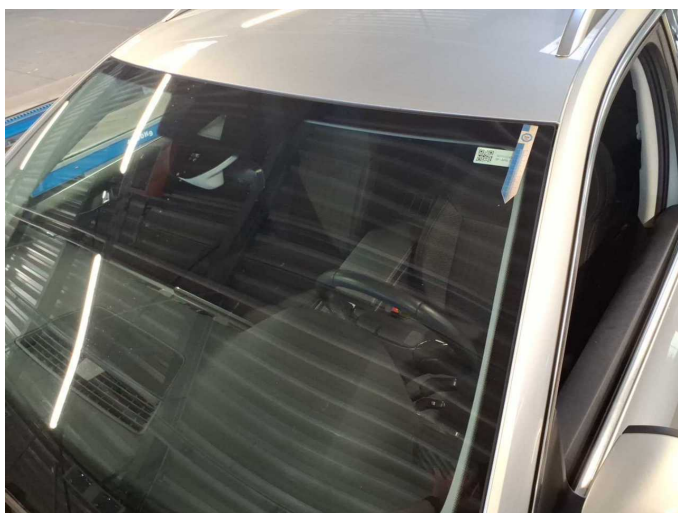
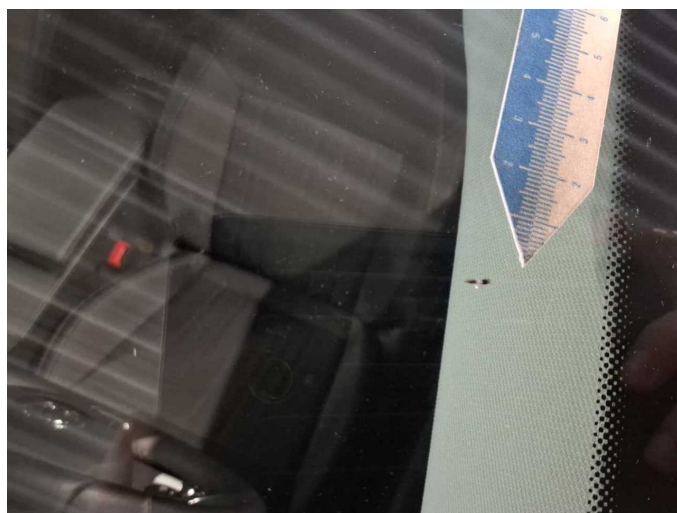
| No. | Component group | Description |
|---|---|---|
| 7 | Vehicle glazing | Windscreen (im Randbereich) - Broken / torn - Replace |

**Damage 7:** Vehicle glazing: Windscreen (im Randbereich) - Broken / torn  
- Replace

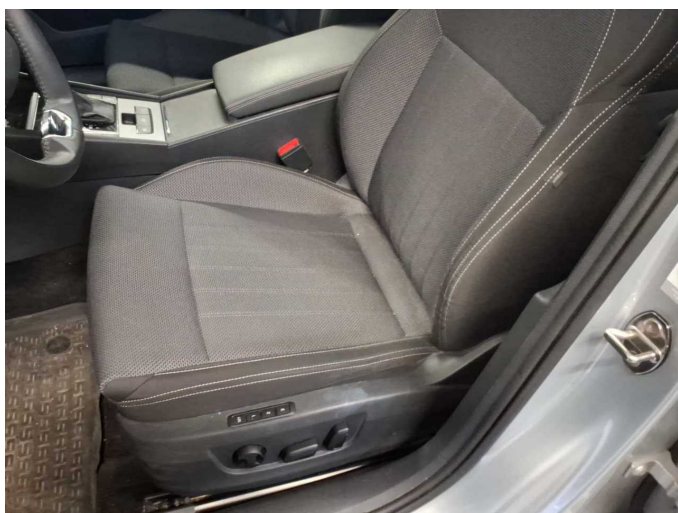
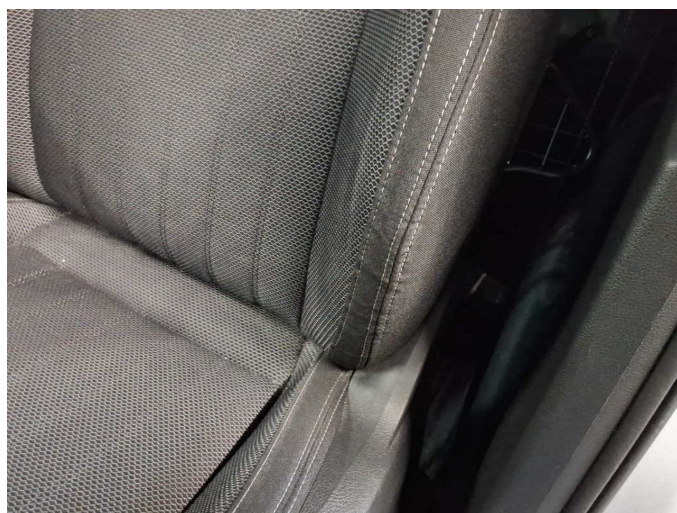
| No. | Component group | Description |
|---|---|---|
| 1 | Seat - front | Seat cover - left side - Abrasion - No deduction |

**Wear and tear 1:** Seat - front: Seat cover - left side - Abrasion - No deduction

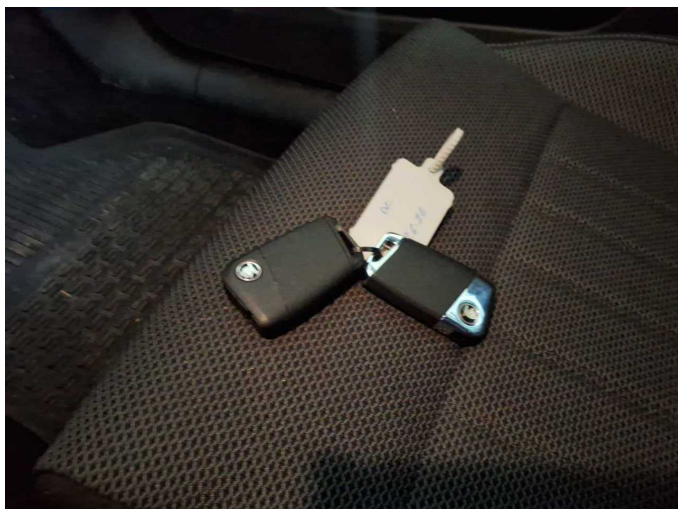
Documents - Log book

**Missing part 1:** Documents: Log book - Missing - Replace

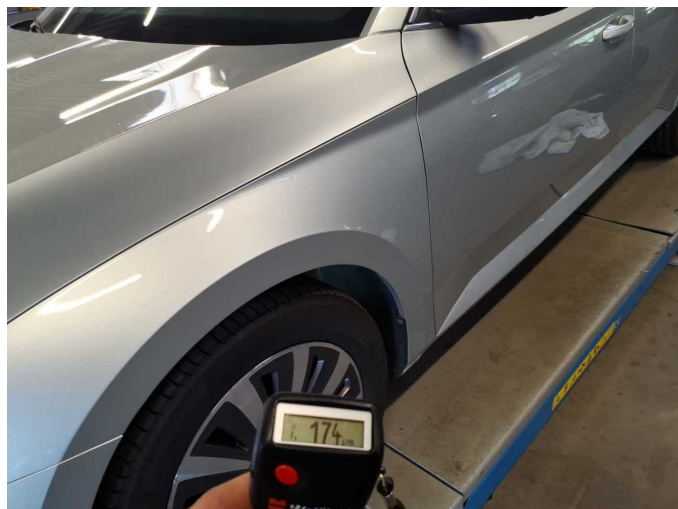
1 Mudguard - left side

Mudguard - left side

174 µm

**Repainting 1:** Mudguard - left side
