Expertise

Protocol number: 46267797
Order No. / Reference: 26637802
Inspection date: 30 Jun 2026

Model: Kodiaq 2.0 TDI 4x4 DSG Clever

VIN: TMBLN9NS3N8016750

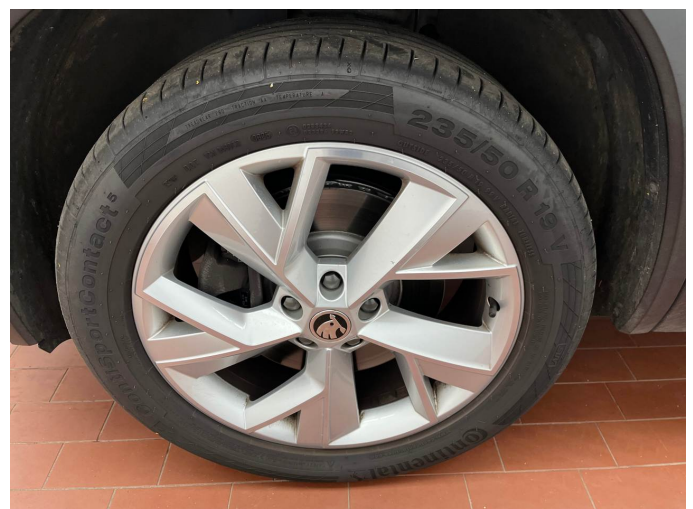
Figure 12: Mounted tyres

| Mounted tyres | | | | |
|---|---|---|---|---|
| 1) | 235/50 R19 99V | Summer tyres on Light alloy | Continental | 5mm / 5mm |
| 2) | 235/50 R19 99V | Summer tyres on Light alloy | Continental | 5mm / 5mm |

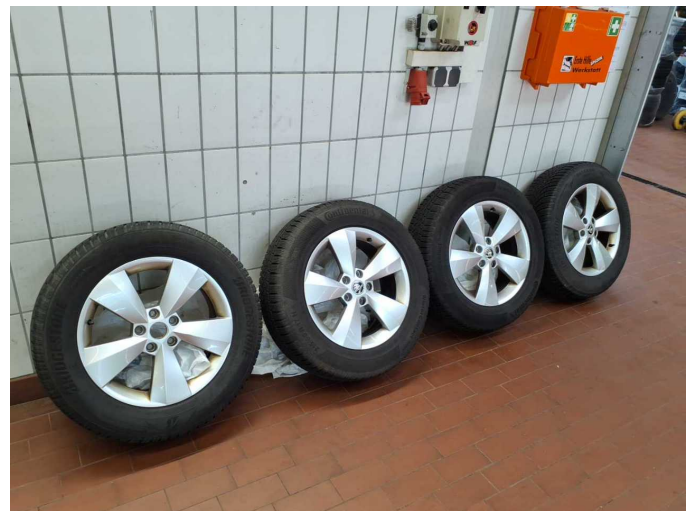
Figure 16: Additional tyres

| Mounted tyres | | | | |
|---|---|---|---|---|
| 1) | 215/65 R17 99H | Winter tyres on Light alloy | Continental | 5mm / 5mm |
| 2) | 215/65 R17 99H | Winter tyres on Light alloy | Continental | 6mm / 6mm |

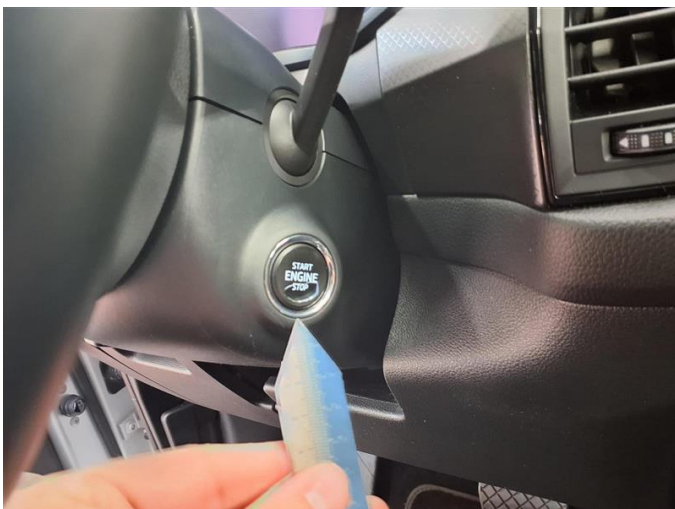
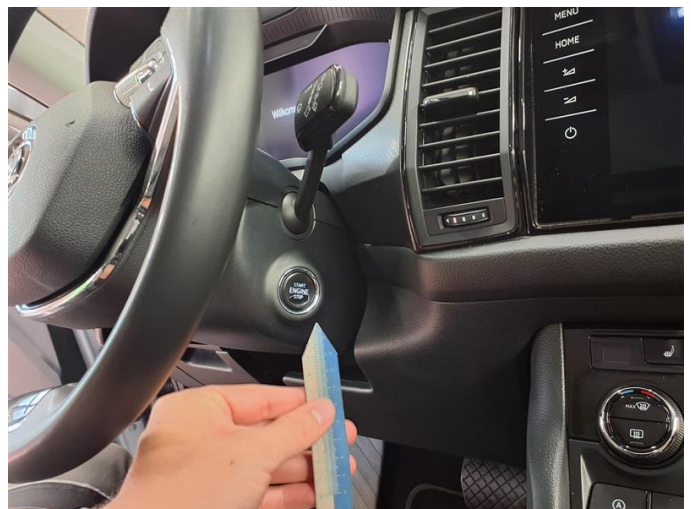
Damage 1: Instrument panel: Cover (Startknopf) - Broken / torn - Replace

| No. | Component group | Description |
|---|---|---|
| 1 | Instrument panel | Cover (Startknopf) - Broken / torn - Replace |

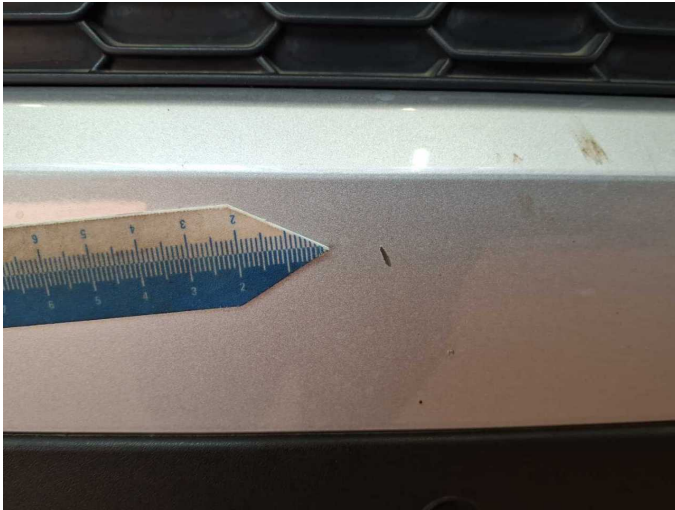
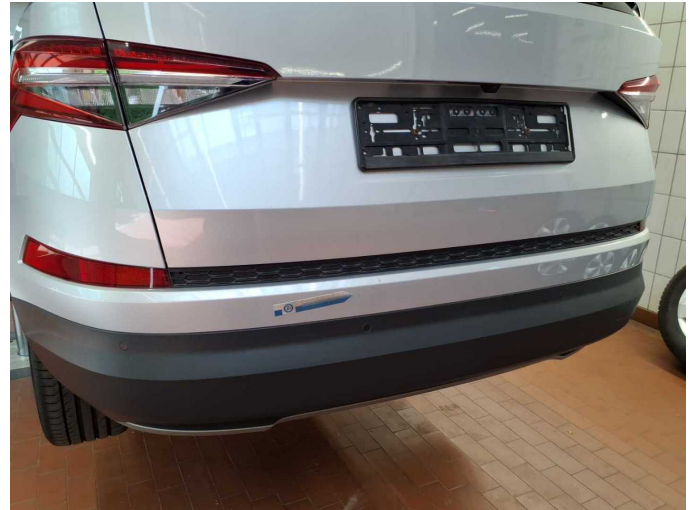
Damage 2: Rear bumper: Rear bumper - Scratch(es) - Smart repair

| No. | Component group | Description |
|---|---|---|
| 2 | Rear bumper | Rear bumper - Scratch(es) - Smart repair |

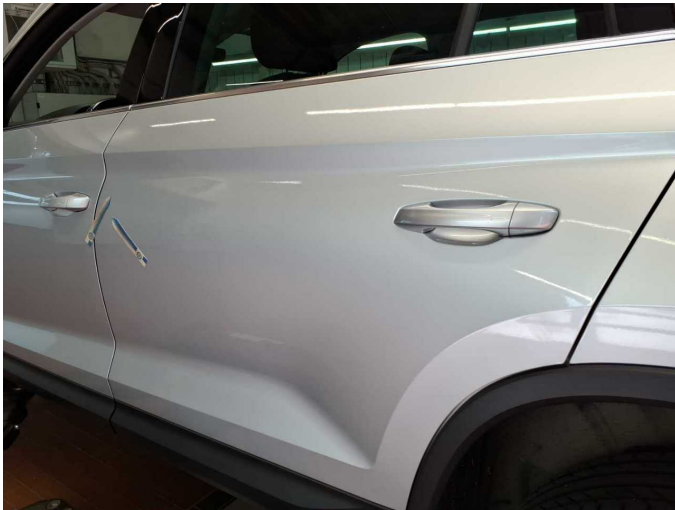
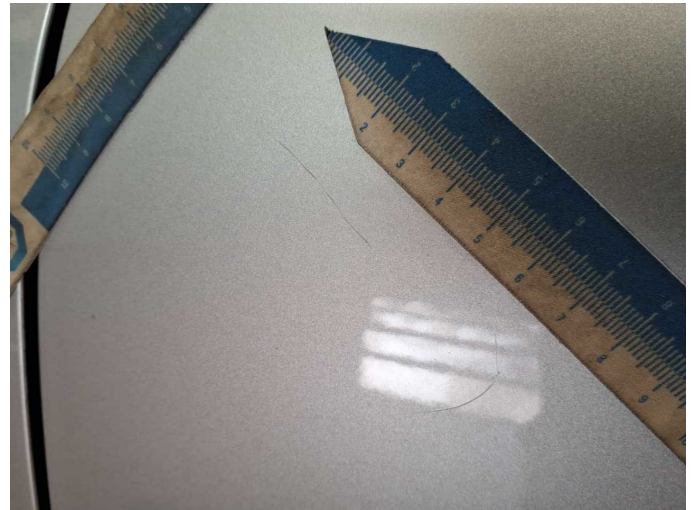
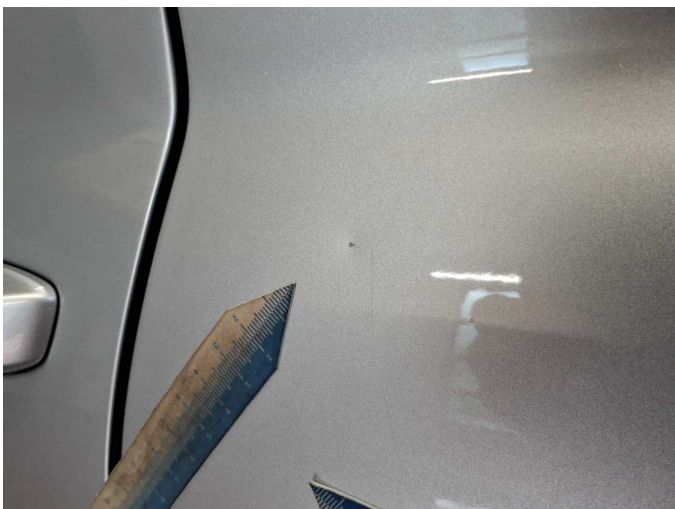
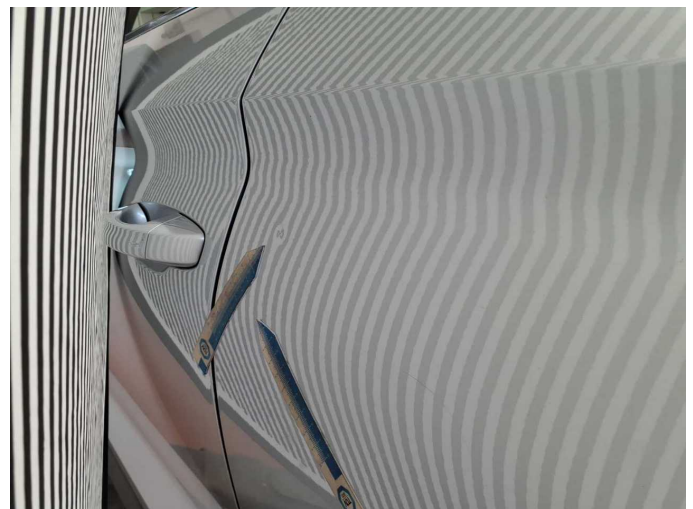
Damage 3: Door - rear left side: Door - Dent / paintcoat damage - Smart repair

| No. | Component group | Description |
|---|---|---|
| 3 | Door - rear left side | Door - Dent / paintcoat damage - Smart repair |

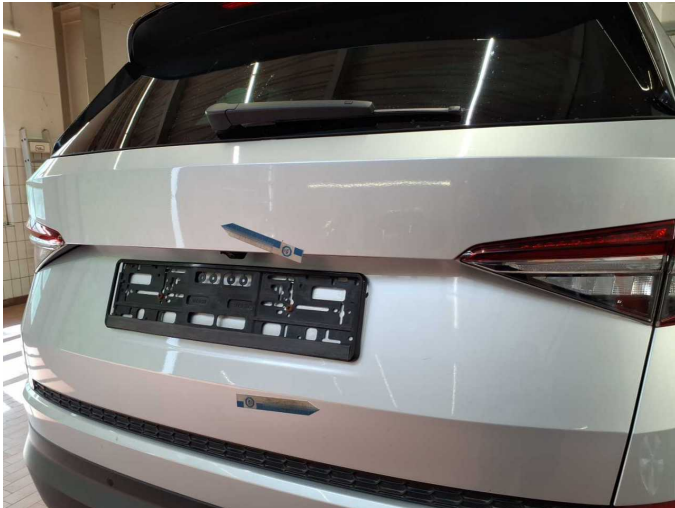
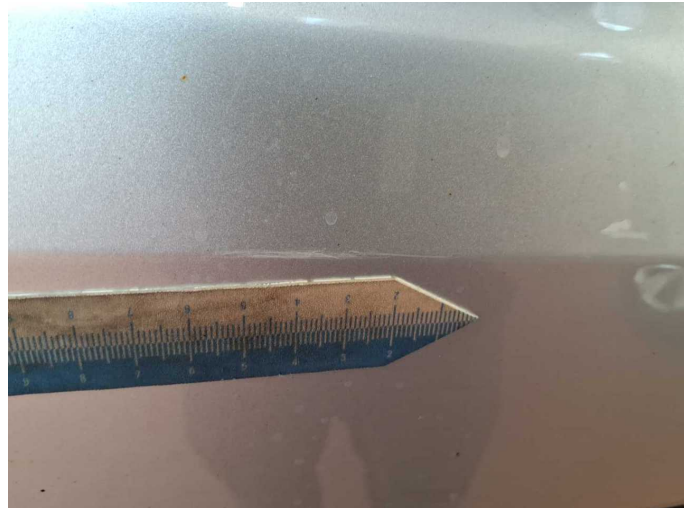
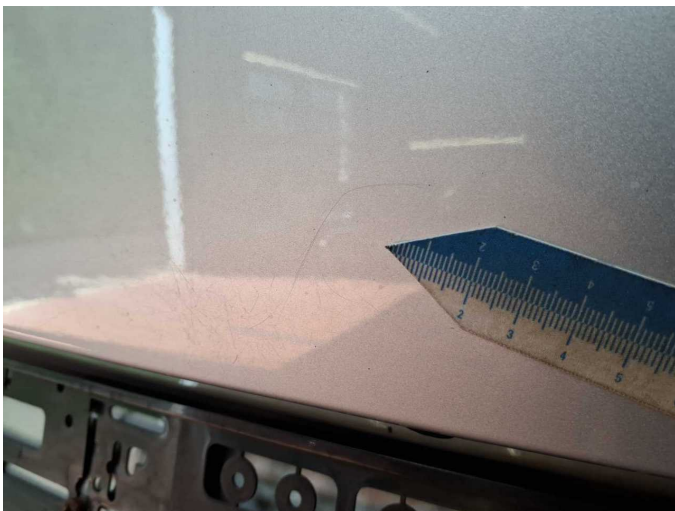
Damage 4: Boot lid / rear door: Boot lid - Scratch(es) - Paint

| No. | Component group | Description |
|---|---|---|
| 4 | Boot lid / rear door | Boot lid - Scratch(es) - Paint |

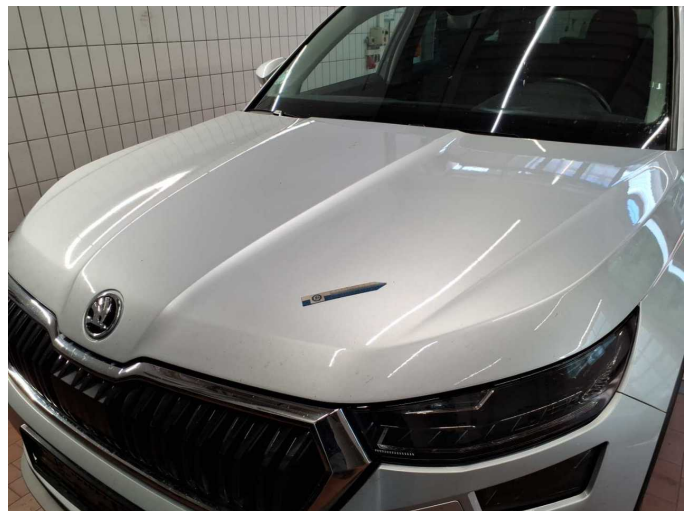
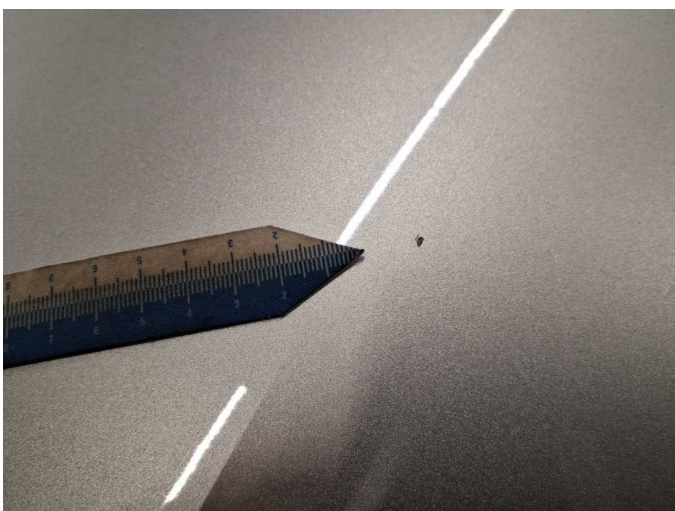
Wear and tear 4: Bonnet: Bonnet - Stone chips - No deduction

| No. | Component group | Description |
|---|---|---|
| 4 | Bonnet | Bonnet - Stone chips - No deduction |

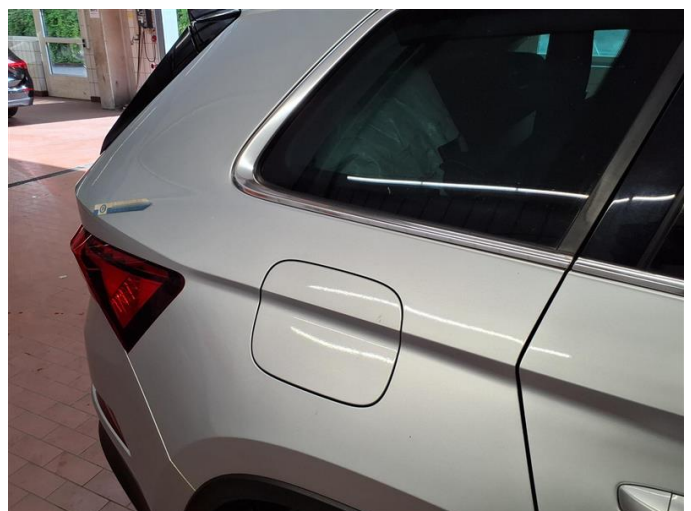
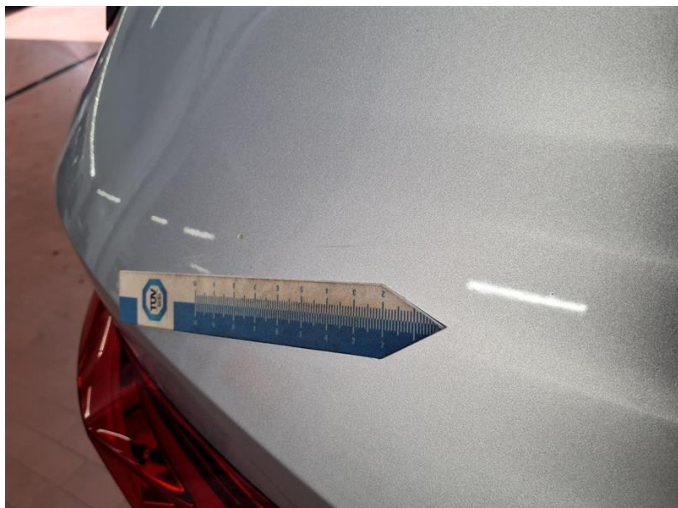
Wear and tear 5: Side panel - rear right side: Side panel - Scratch(es) - Conditioning

| No. | Component group | Description |
|---|---|---|
| 5 | Side panel - rear right side | Side panel - Scratch(es) - Conditioning |

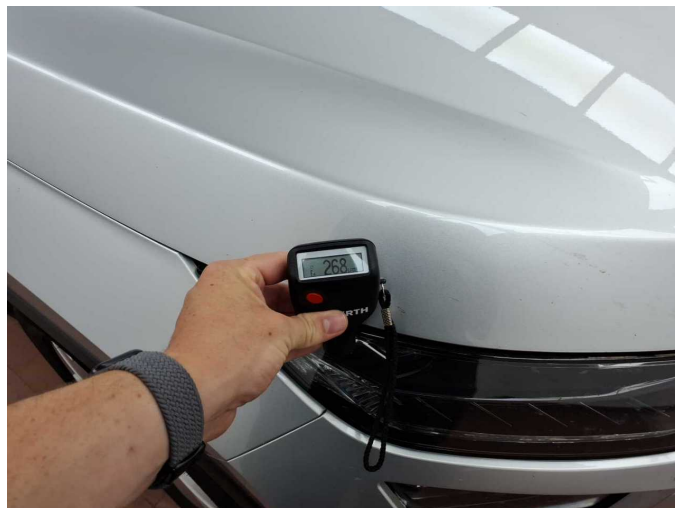
Repainting 1: Bonnet

| No. | Repainting |
|---|---|
| 1 | Bonnet, Professionally carried out, Invoice of repair done Non-existent |

Bonnet

268 µm
