Expertise

Protocol number: 46826774  
Order No. / Reference: 26578211  
Inspection date: 30 Jul 2026

Manufacturer: Skoda  
VIN: TMBLN9NS8N8054037

Model: Kodiahq 2.0 TDI 4x4 DSG Tour

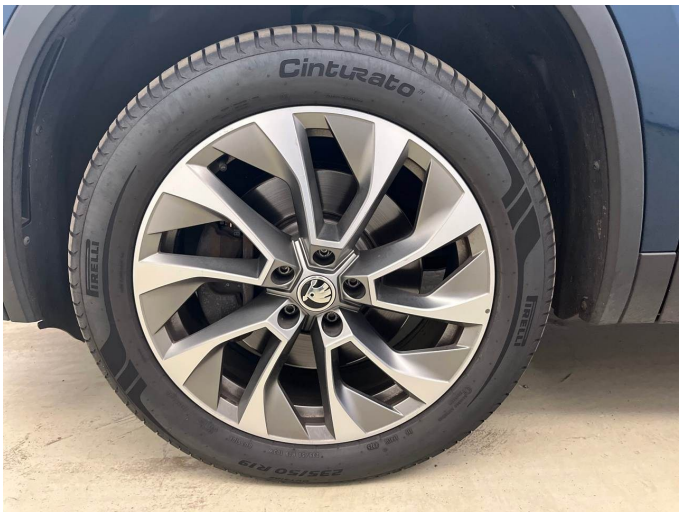
Figure 12: Mounted tyres

| # | Tyre size | Type of tyre | Manufacturer | Tread depth |
|---|---|---|---|---|
| 1) | 235/50 R19 103W | Summer tyres on Light alloy | Pirelli | 6mm / 6mm |
| 2) | 235/50 R19 103W | Summer tyres on Light alloy | Pirelli | 7mm / 7mm |

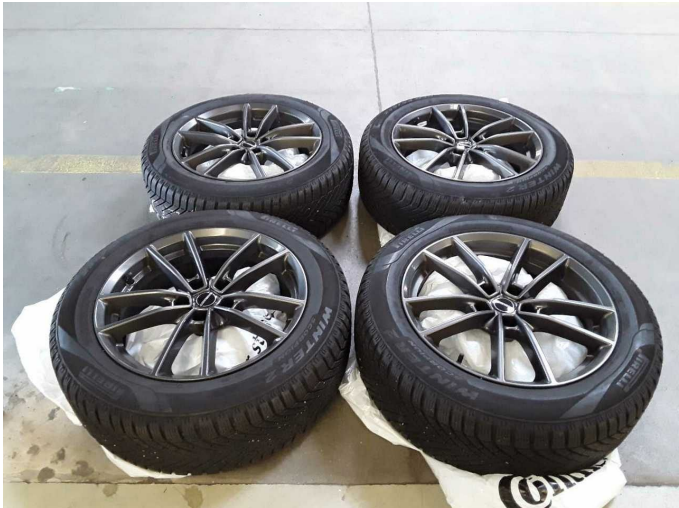
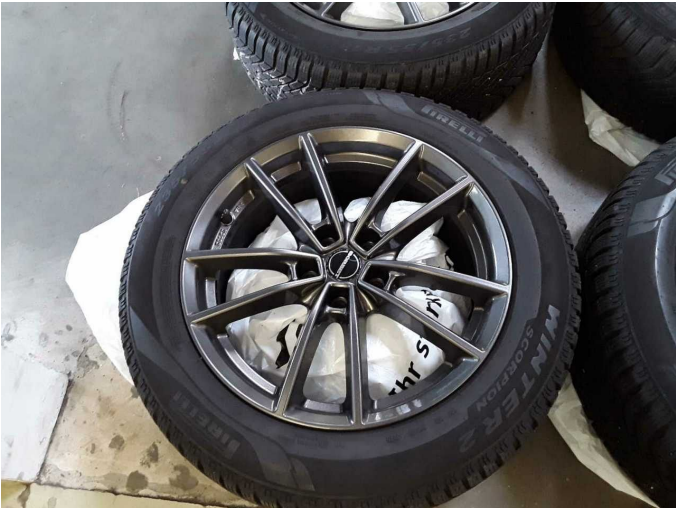
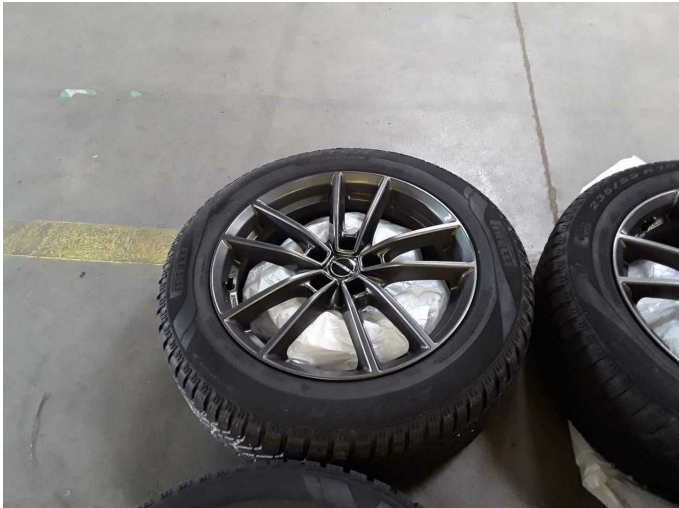
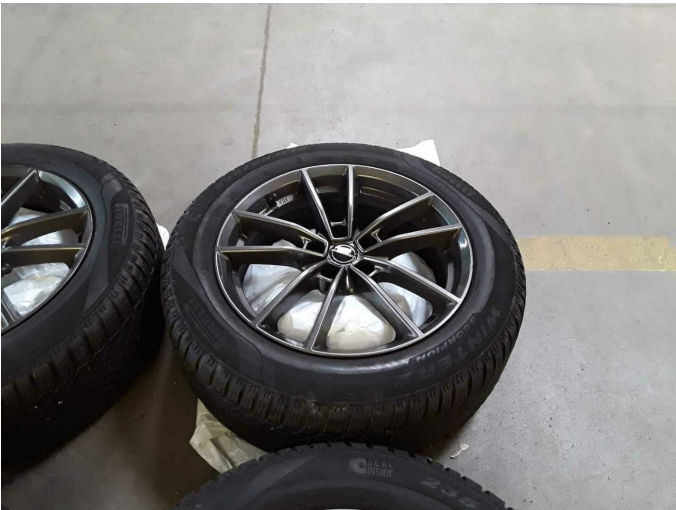
| # | Tyre size | Type of tyre | Manufacturer | Tread depth |
|---|---|---|---|---|
| 1) | 235/55 R18 104H | Winter tyres on Light alloy | Pirelli | 5mm / 5mm |
| 2) | 235/55 R18 104H | Winter tyres on Light alloy | Pirelli | 5mm / 5mm |

Figure 14: Additional tyres

Figure 15: Additional tyres

Figure 16: Additional tyres

Figure 17: Additional tyres

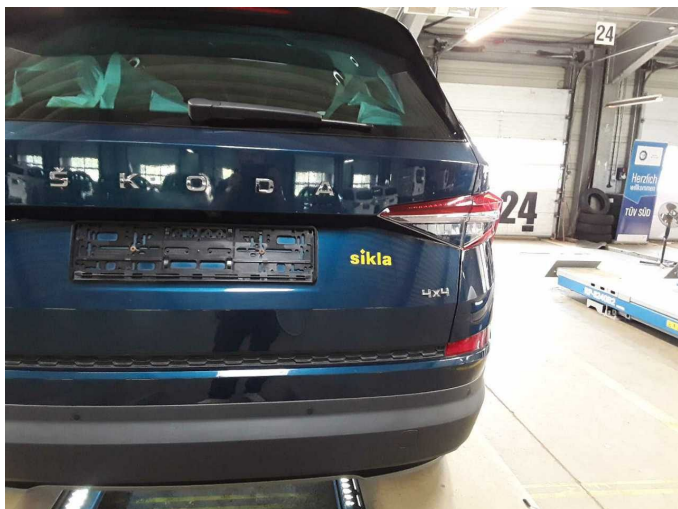
| No. | Component group | Description |
|---|---|---|
| 2 | Boot lid / rear door | Boot lid - Glued / labelled - Remove |

**Damage 2:** Boot lid / rear door: Boot lid - Glued / labelled - Remove

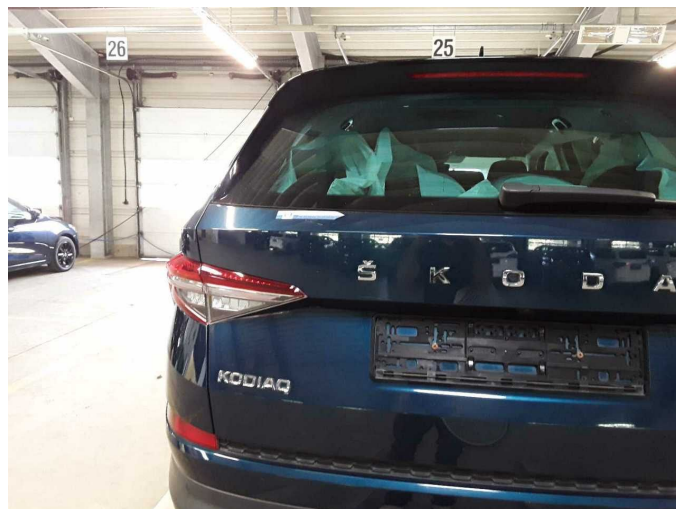
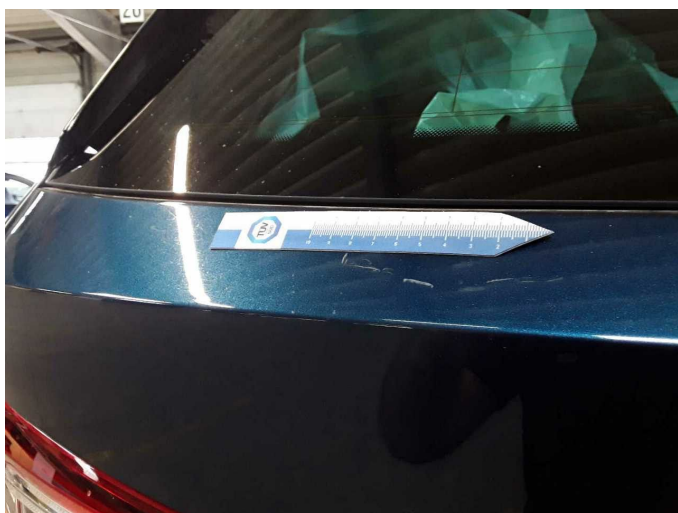
| No. | Component group | Description |
|---|---|---|
| 3 | Boot lid / rear door | Boot lid - Scratch(es) - Smart repair |

**Damage 3:** Boot lid / rear door: Boot lid - Scratch(es) - Smart repair

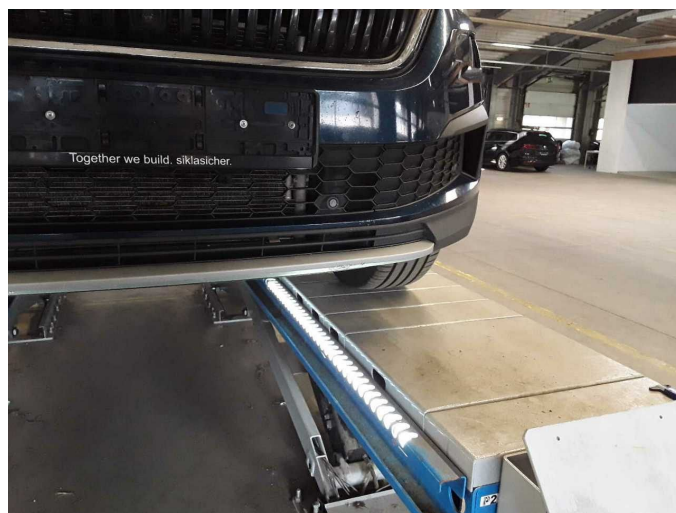
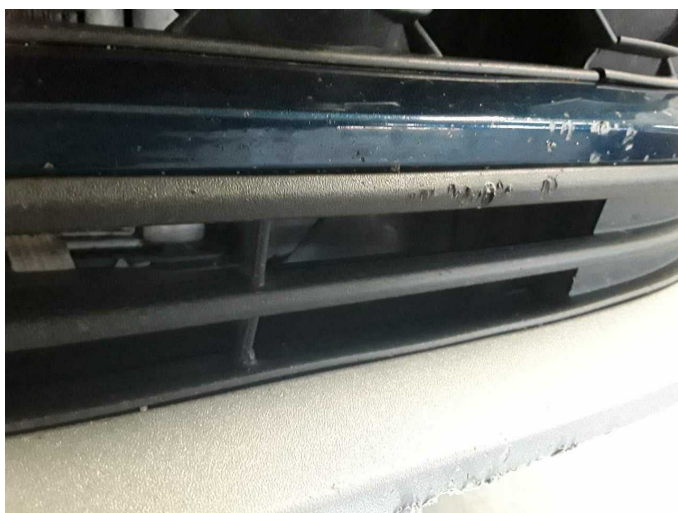
| No. | Component group | Description |
|---|---|---|
| 4 | Front bumper | Cover bumper - front - Scratch(es) - Smart repair |

**Damage 4:** Front bumper: Cover bumper - front - Scratch(es) - Smart repair

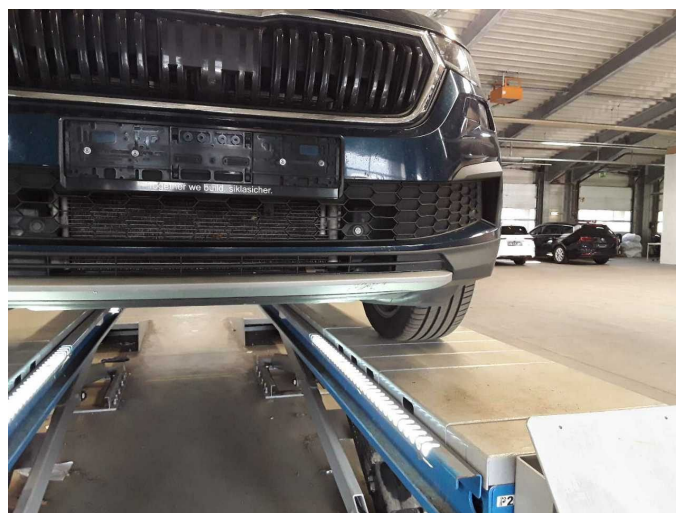
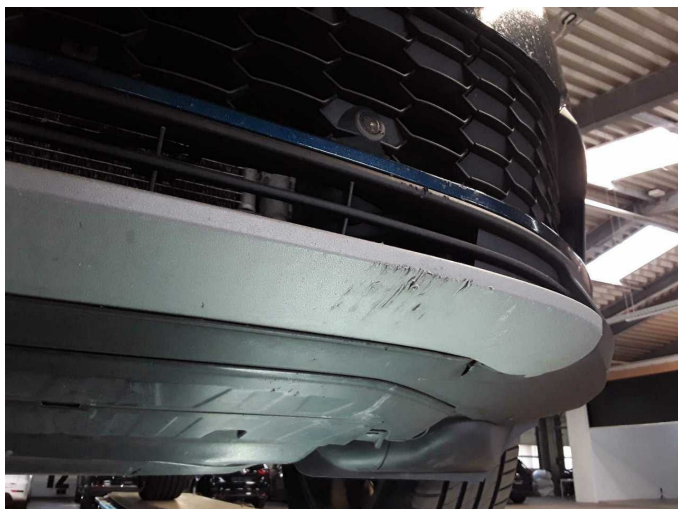
| No. | Component group | Description |
|---|---|---|
| 5 | Front bumper | Spoiler - Scratch(es) - Smart repair |

**Damage 5:** Front bumper: Spoiler - Scratch(es) - Smart repair

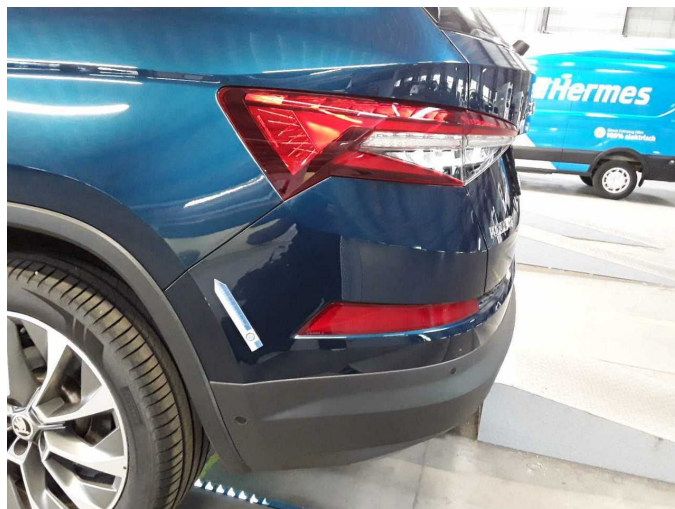
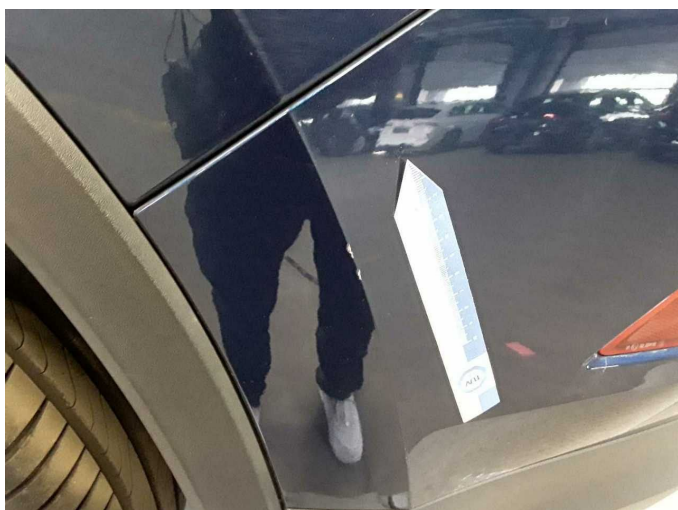
| No. | Component group | Description |
|---|---|---|
| 6 | Rear bumper | Rear bumper - Scratch(es) - Smart repair |

**Damage 6:** Rear bumper: Rear bumper - Scratch(es) - Smart repair

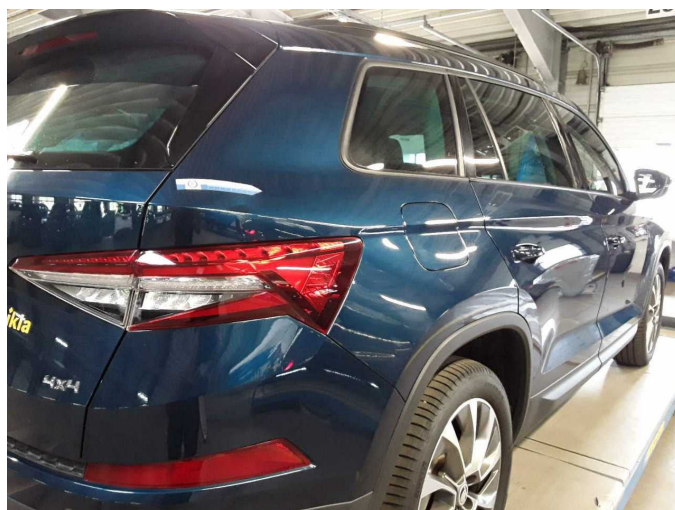
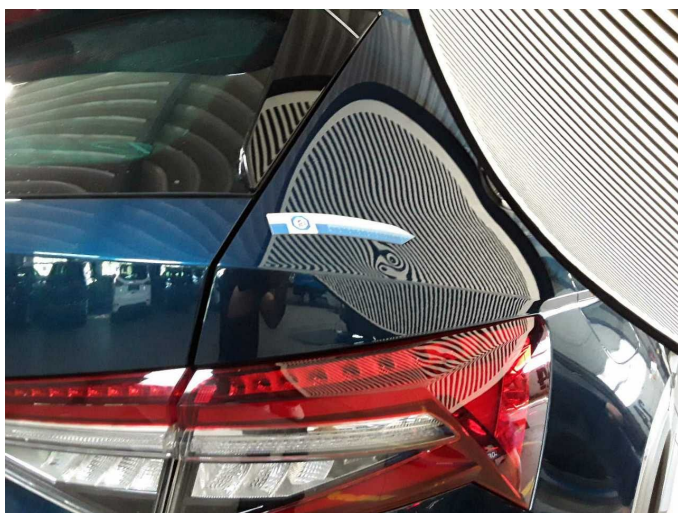
| No. | Component group | Description |
|---|---|---|
| 7 | Side panel - rear right side | Side panel - dent(s) - Smooth repair work |

**Damage 7:** Side panel - rear right side: Side panel - dent(s) - Smooth repair work

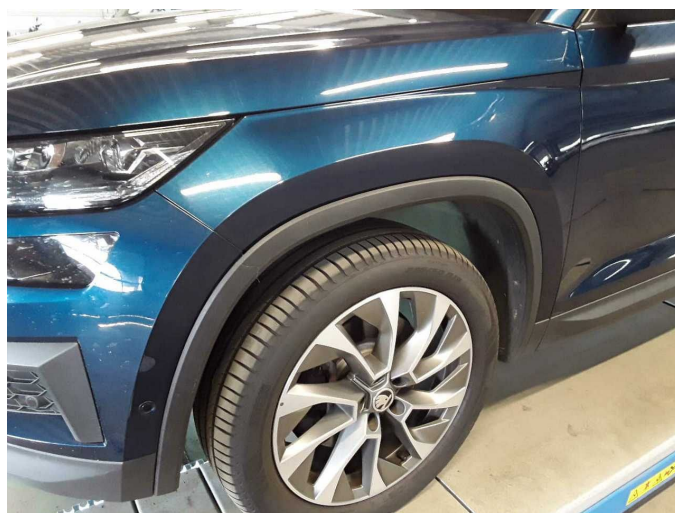
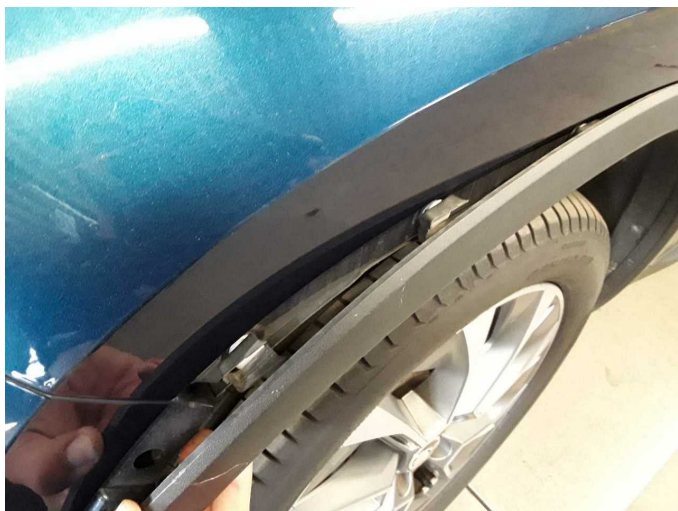
| No. | Component group | Description |
|---|---|---|
| 8 | Mudguard - left side | Wheel arch - Broken / torn - Replace |

**Damage 8:** Mudguard - left side: Wheel arch - Broken / torn - Replace

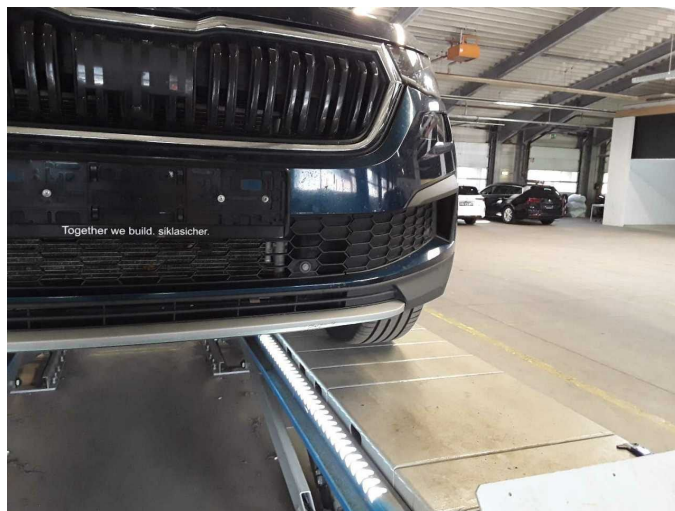
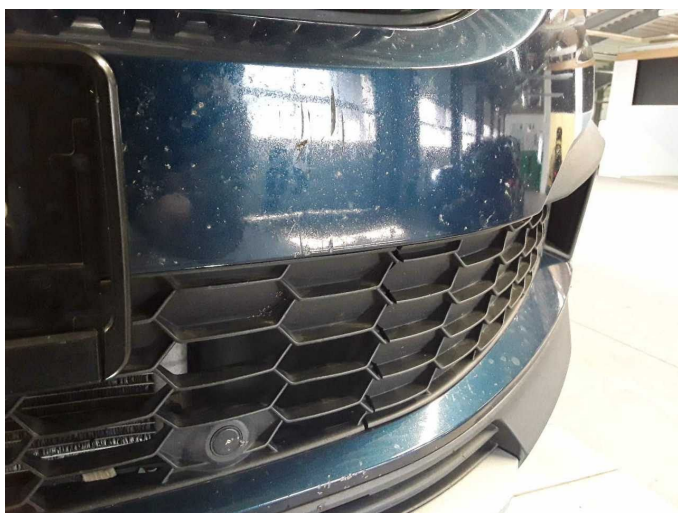
| No. | Component group | Description |
|---|---|---|
| 9 | Front bumper | Front bumper - Scratch(es) - Repair and paint |

**Damage 9:** Front bumper: Front bumper - Scratch(es) - Repair and paint

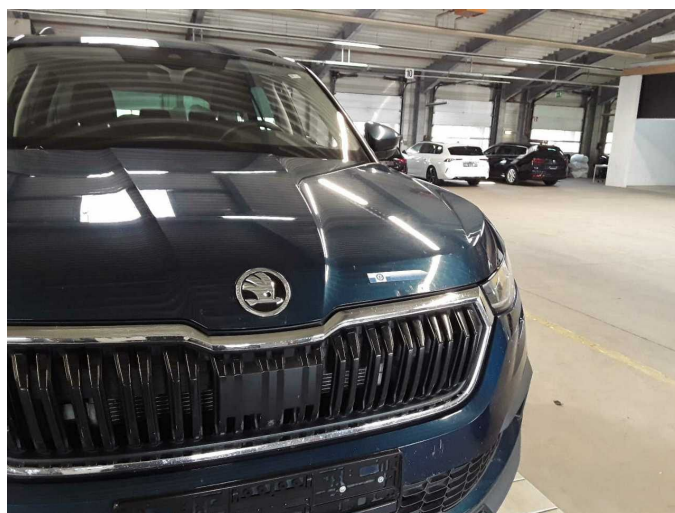
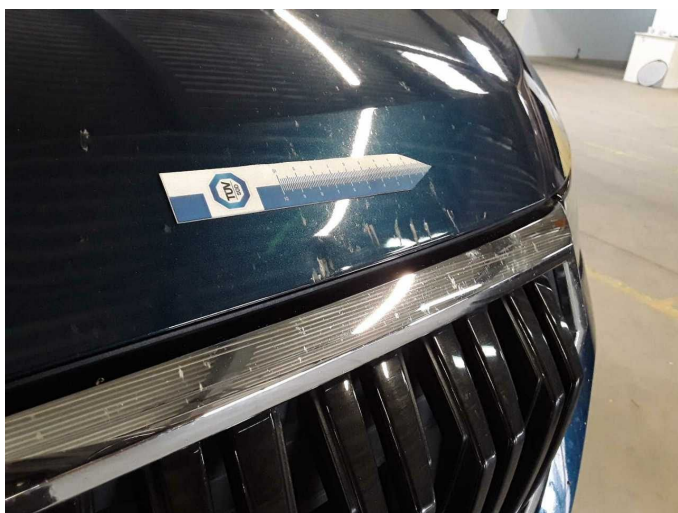
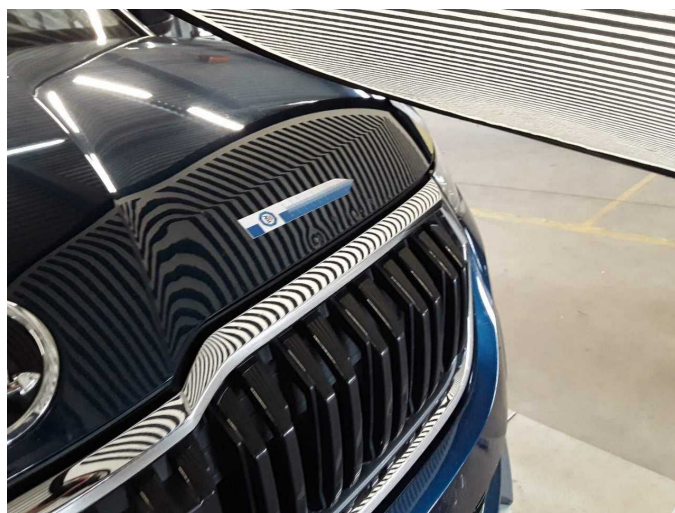
| No. | Component group | Description |
|---|---|---|
| 10 | Bonnet | Bonnet - Dent / paintcoat damage - Repair and paint |

**Damage 10:** Bonnet: Bonnet - Dent / paintcoat damage - Repair and paint

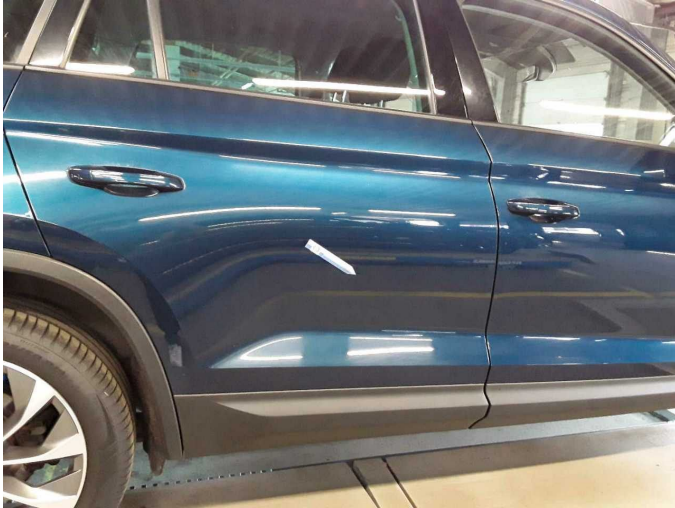
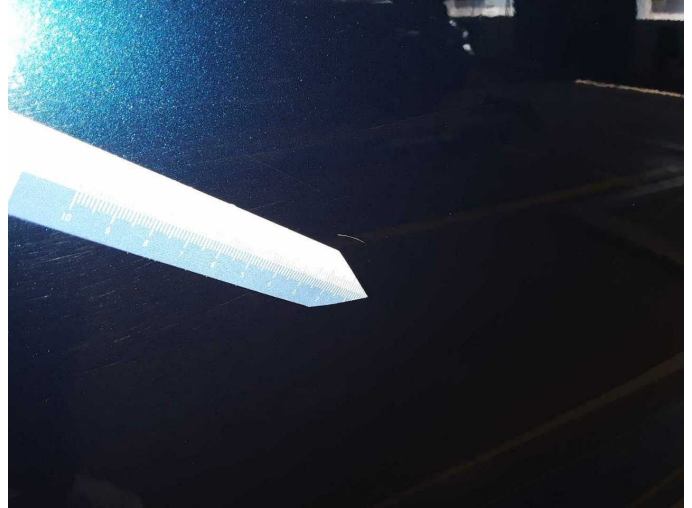
| No. | Component group | Description |
|---|---|---|
| 1 | Door - rear right side | Door - Scratch(es) - No deduction |

**Wear and tear 1:** Door - rear right side: Door - Scratch(es) - No deduction

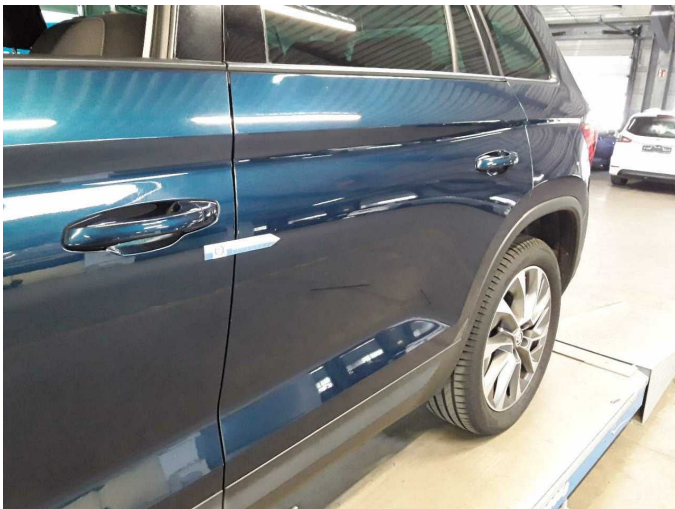
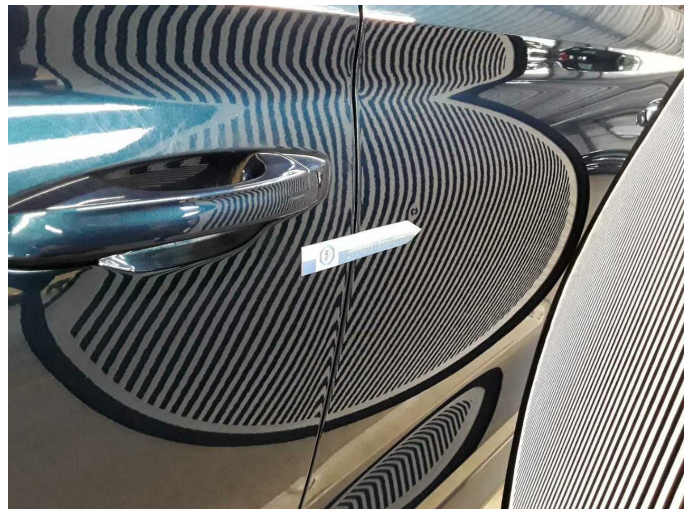
| No. | Component group | Description |
|---|---|---|
| 7 | Door - rear left side | Door - dent(s) - Smooth repair work |

**Wear and tear 7:** Door - rear left side: Door - dent(s) - Smooth repair work

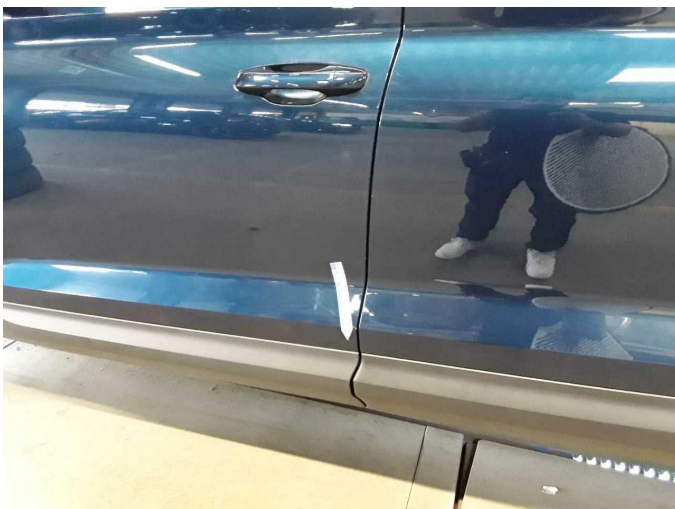
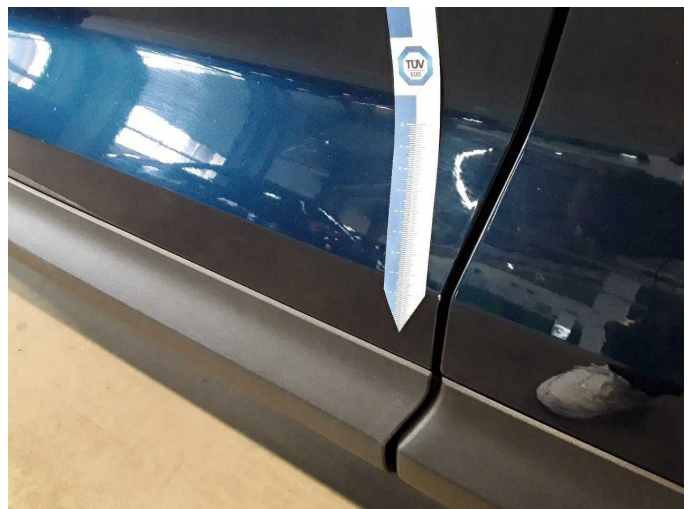
| No. | Component group | Description |
|---|---|---|
| 8 | Door - front left side | Door edge - Scratch(es) - Smart repair |

**Wear and tear 8:** Door - front left side: Door edge - Scratch(es) - Smart repair

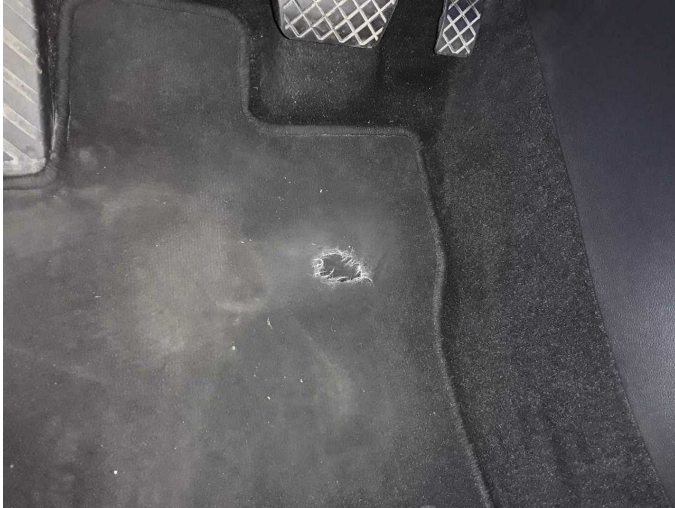
| No. | Component group | Description |
|---|---|---|
| 9 | Trim / covers | Floor mats - Broken / torn - No deduction |

**Wear and tear 9:** Trim / covers: Floor mats - Broken / torn - No deduction

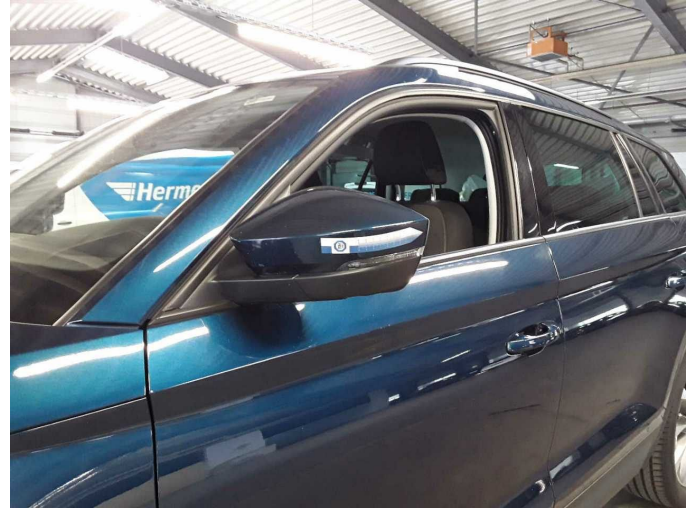
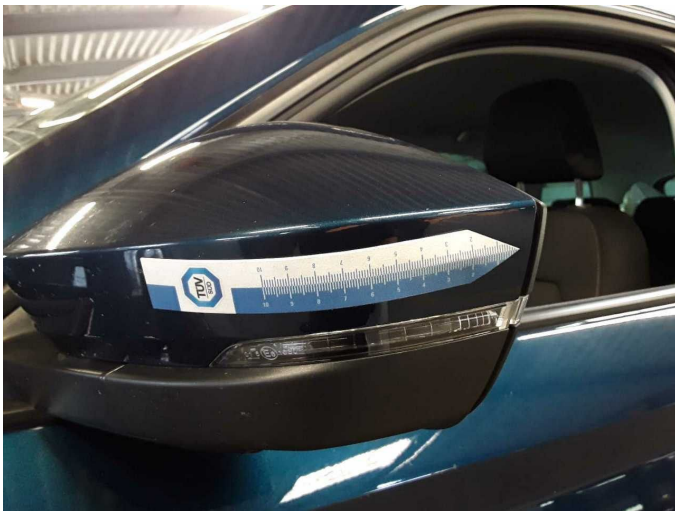
| No. | Component group | Description |
|---|---|---|
| 10 | Wing mirror - left side | Cap - Scratch(es) - Cover / polish |

**Wear and tear 10:** Wing mirror - left side: Cap - Scratch(es) - Cover / polish
