Expertise

Protocol number: 45908895  
Order No. / Reference: 26309690  
Inspection date: 12 Jun 2026

Model: Astra Sports Tourer 1.2 Turbo Automatik GS

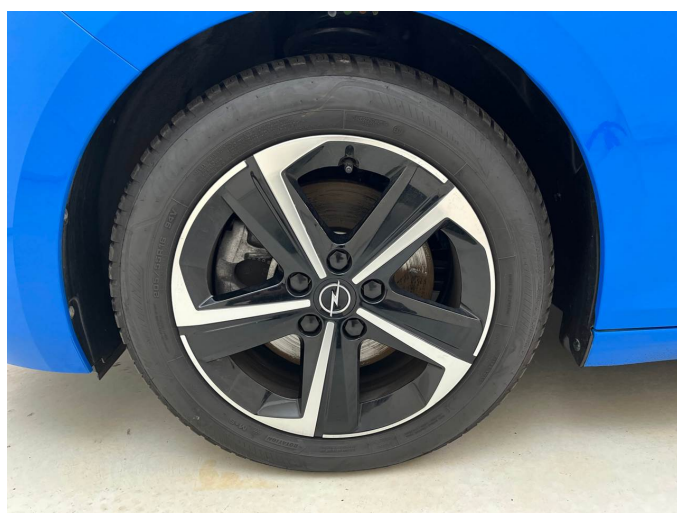
| # | Tyre size | Type of tyre | Manufacturer | Tread depth |
|---|---|---|---|---|
| 1) | 205/55 R16 94V | All-season tyres on Light alloy | Goodyear | 7mm / 7mm |
| 2) | 205/55 R16 94V | All-season tyres on Light alloy | Goodyear | 7mm / 7mm |

Figure 12: Mounted tyres

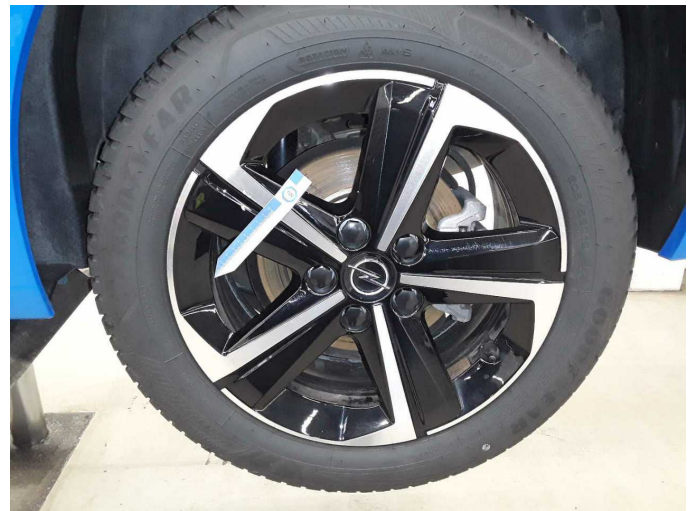
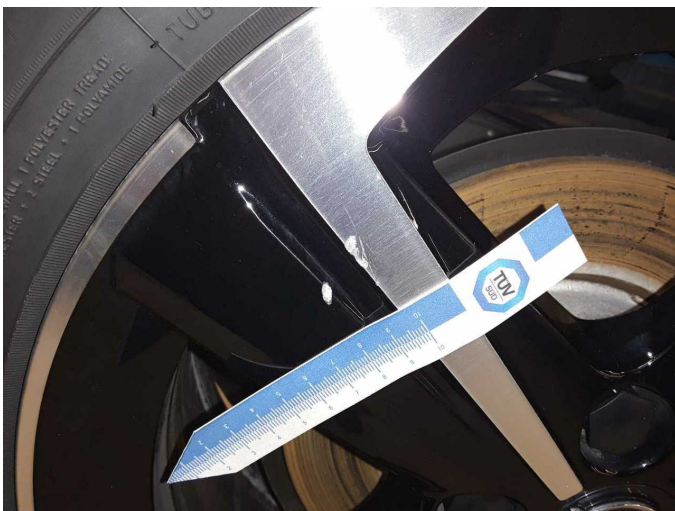
| No. | Component group | Description |
|---|---|---|
| 1 | Wheel / tyres | Alloy rim - rear left side - Scratch(es) - Loss in value |

Damage 1: Wheel / tyres: Alloy rim - rear left side - Scratch(es) - Loss in value

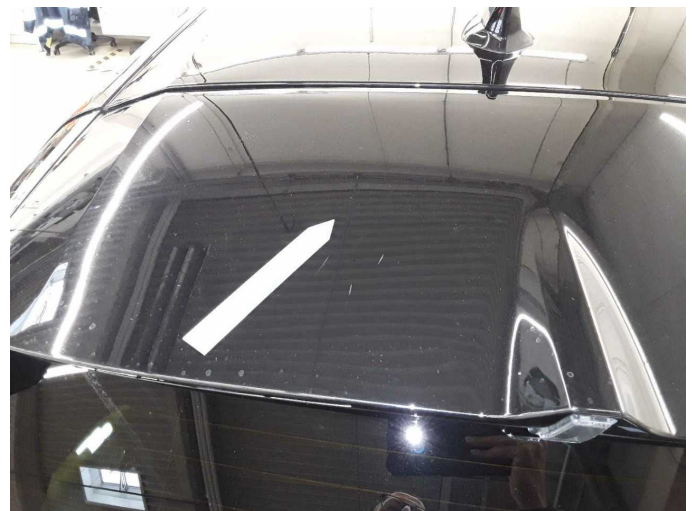
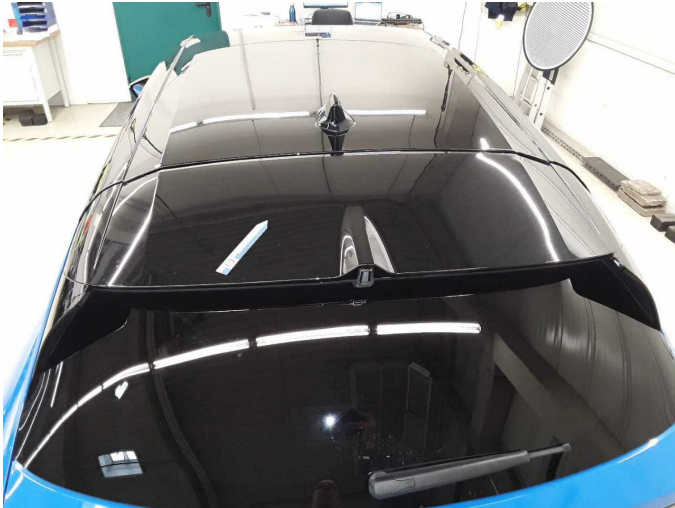
| No. | Component group | Description |
|---|---|---|
| 2 | Boot lid / rear door | Rear spoiler - Scratch(es) - Smart repair |

Damage 2: Boot lid / rear door: Rear spoiler - Scratch(es) - Smart repair value

**Damage 2:** Boot lid / rear door: Rear spoiler - Scratch(es) - Smart repair

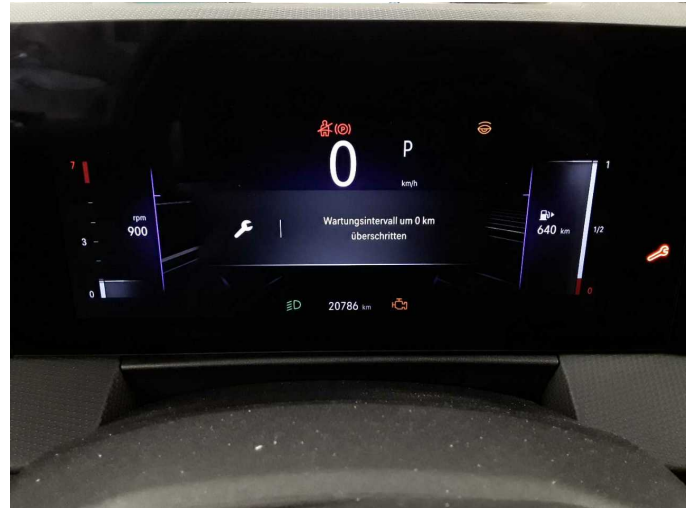
| No. | Component group | Description |
|---|---|---|
| 3 | Misc. | Inspection / maintenance - Due - Perform |

**Damage 3:** Misc.: Inspection / maintenance - Due - Perform

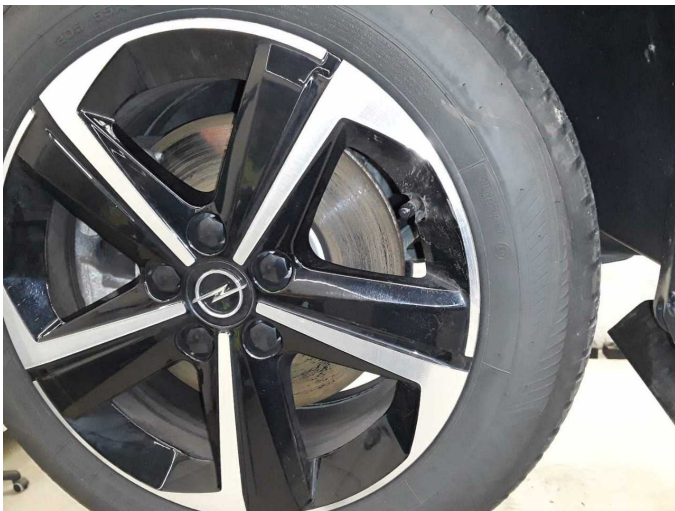
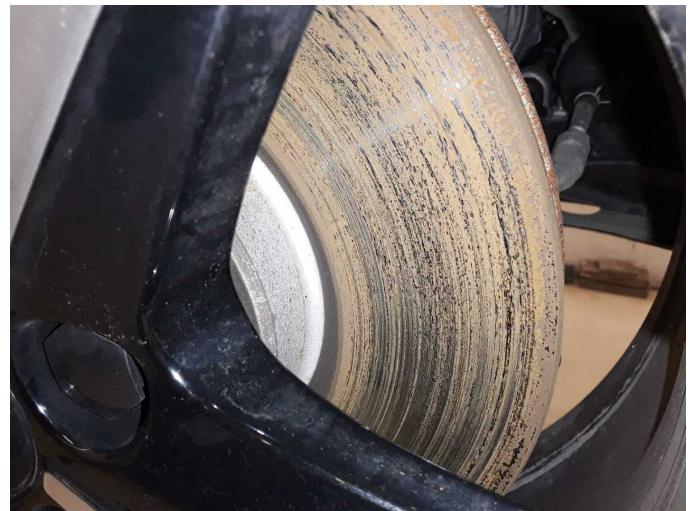
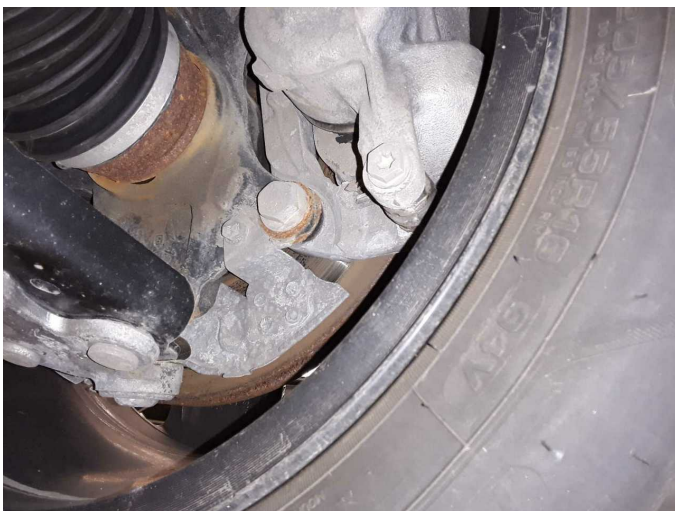
| No. | Component group | Description |
|---|---|---|
| 4 | Braking system | Brake discs and brake pads - front - Corrosion - Replace |

**Damage 4:** Braking system: Brake discs and brake pads - front - Corrosion - Replace

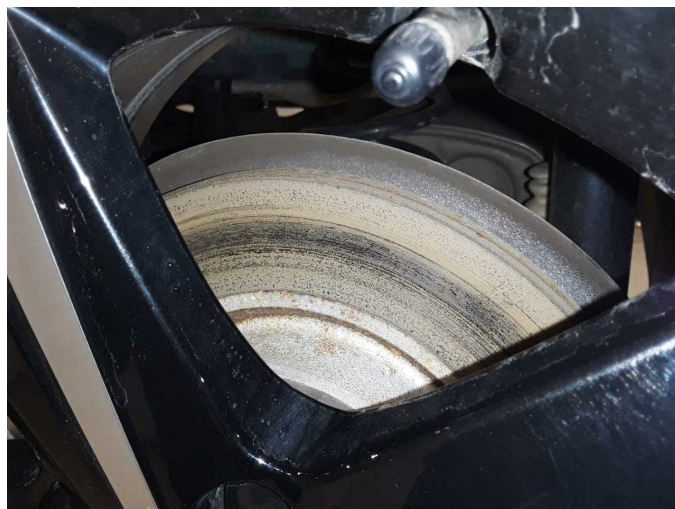
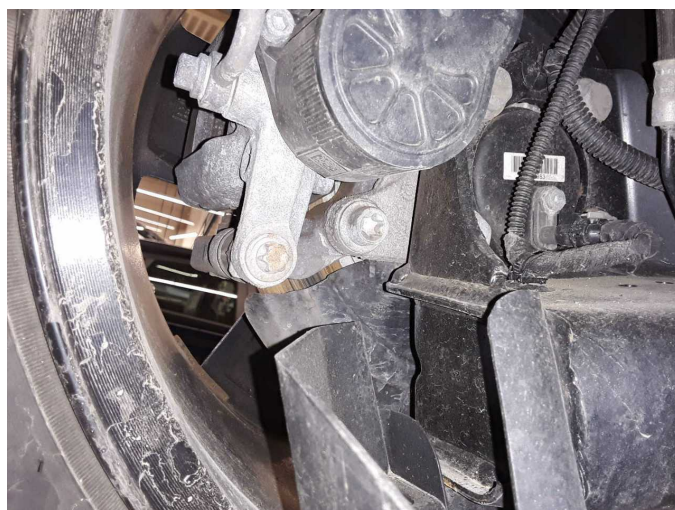
| No. | Component group | Description |
|---|---|---|
| 5 | Braking system | Brake discs and pads - rear - Corrosion - Replace |

**Damage 5:** Braking system: Brake discs and pads - rear - Corrosion - Replace
