Expertise

Protocol number: 46555887  
Order No. / Reference: 26543119  
Inspection date: 14 Jul 2026

Model: E 220 d T 9G-TRONIC AMG Line

VIN: W1K2132041A987991

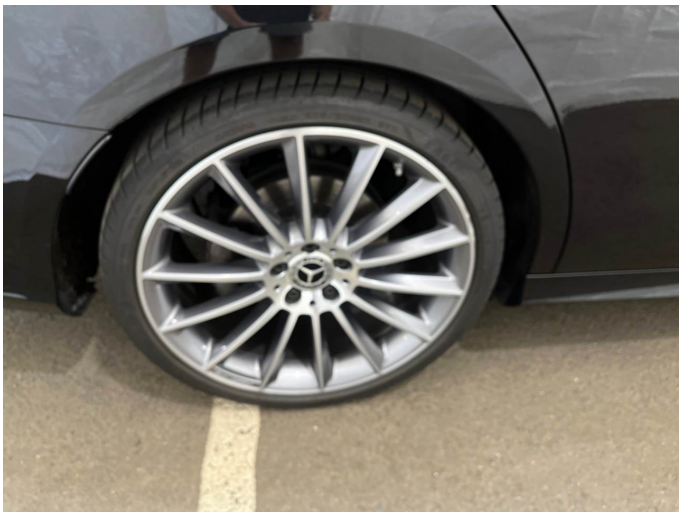
| # | Tyre size | Type of tyre | Manufacturer | Tread depth |
|---|---|---|---|---|
| 1) | 245/35 R20 95Y | Summer tires (with run-flat tires) on Light alloy | Goodyear | 5mm / 5mm |
| 2) | 275/30 R20 97Y | Summer tires (with run-flat tires) on Light alloy | Goodyear | 5mm / 5mm |

Figure 12: Mounted tyres

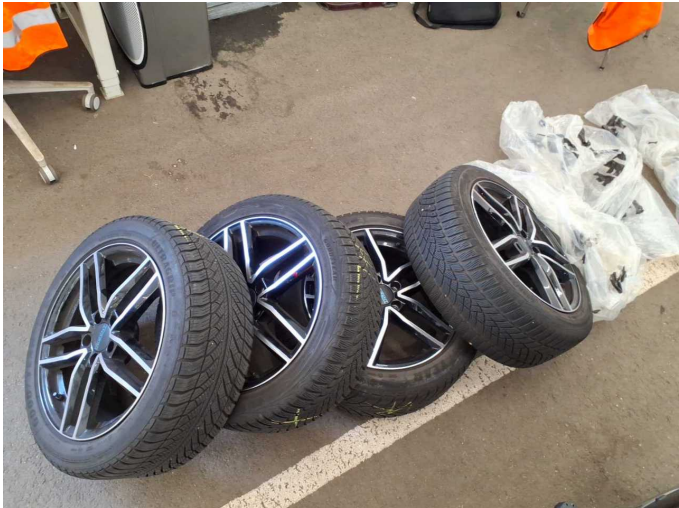
| # | Tyre size | Type of tyre | Manufacturer | Tread depth |
|---|---|---|---|---|
| 1) | 245/45 R18 100V | Winter tyres on Light alloy | Goodyear | 6mm / 6mm |
| 2) | 245/45 R18 100V | Winter tyres on Light alloy | Goodyear | 6mm / 6mm |

Figure 16: Additional tyres

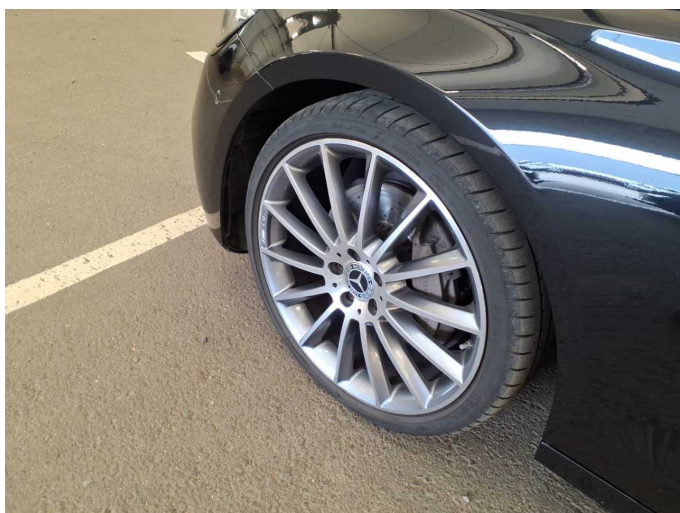
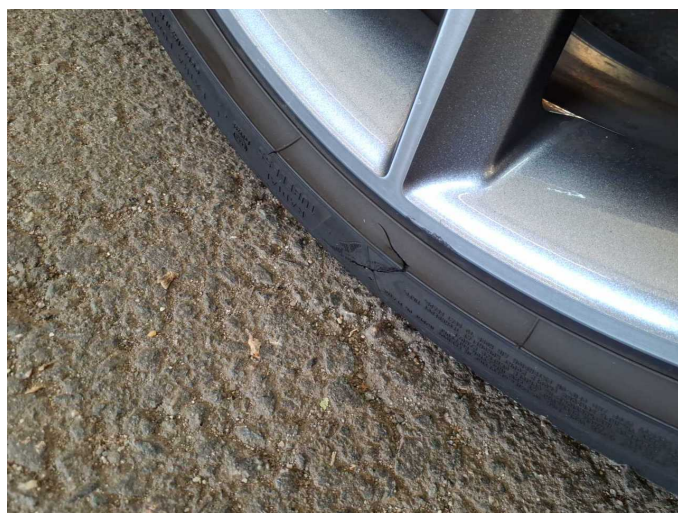
| No. | Component group | Description |
|---|---|---|
| 1 | Wheel / tyres | Tyre - front left side (Flankenbeschädigung) - Damaged - Replace |

**Damage 1:** Wheel / tyres: Tyre - front left side (Flankenbeschädigung) - Damaged - Replace

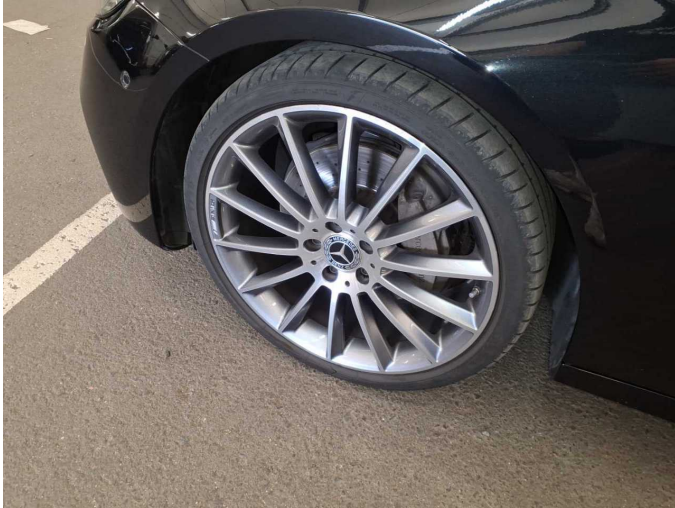
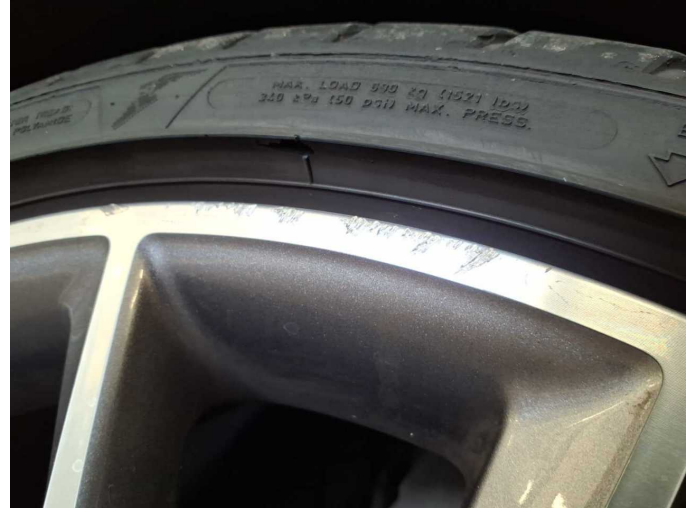
| No. | Component group | Description |
|---|---|---|
| 2 | Wheel / tyres | Alloy rim - front left side - Scratch(es) - Loss in value |

**Damage 2:** Wheel / tyres: Alloy rim - front left side - Scratch(es) - Loss in value

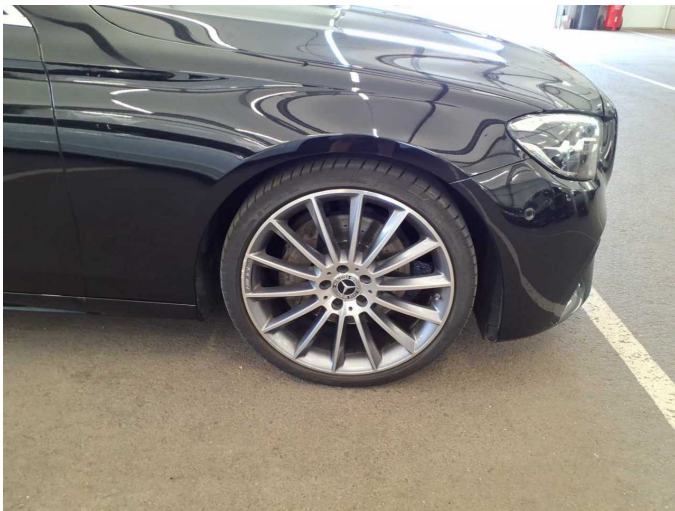
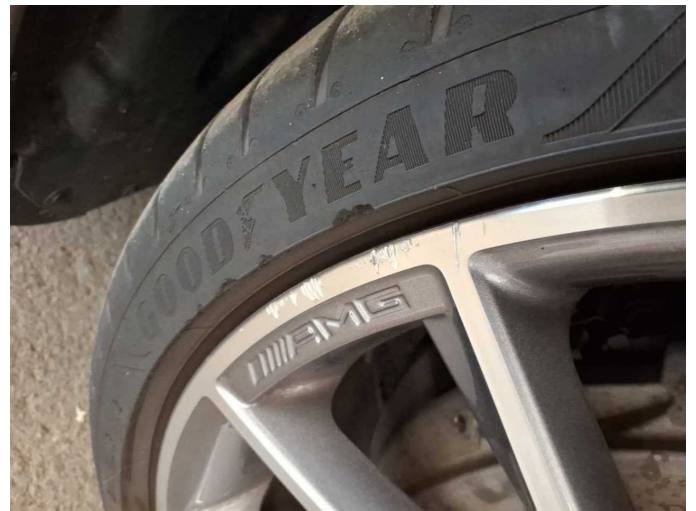
| No. | Component group | Description |
|---|---|---|
| 3 | Wheel / tyres | Alloy rim - front right side - Scratch(es) - Loss in value |

**Damage 3:** Wheel / tyres: Alloy rim - front right side - Scratch(es) - Loss in value

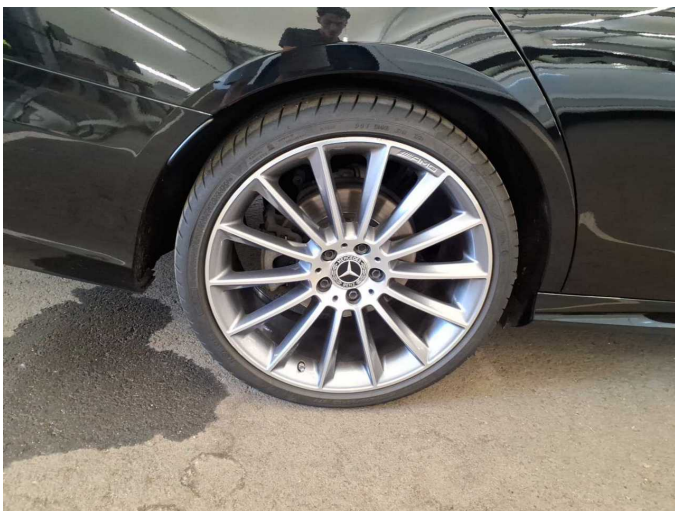
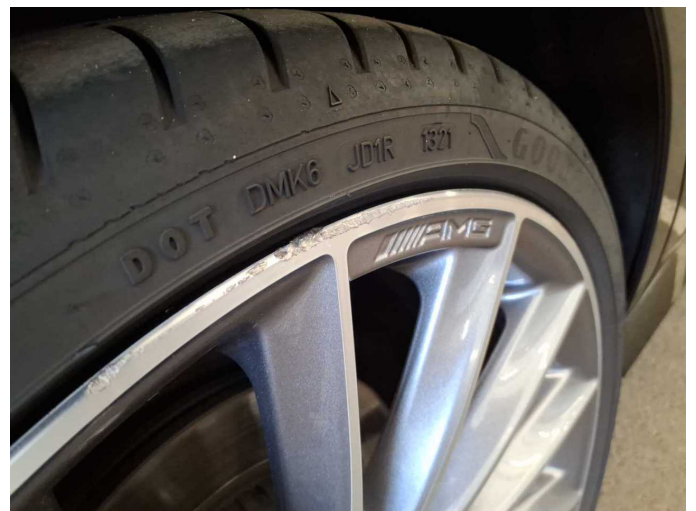
| No. | Component group | Description |
|---|---|---|
| 4 | Wheel / tyres | Alloy rim - rear right side - Scratch(es) - Loss in value |

**Damage 4:** Wheel / tyres: Alloy rim - rear right side - Scratch(es) - Loss in value

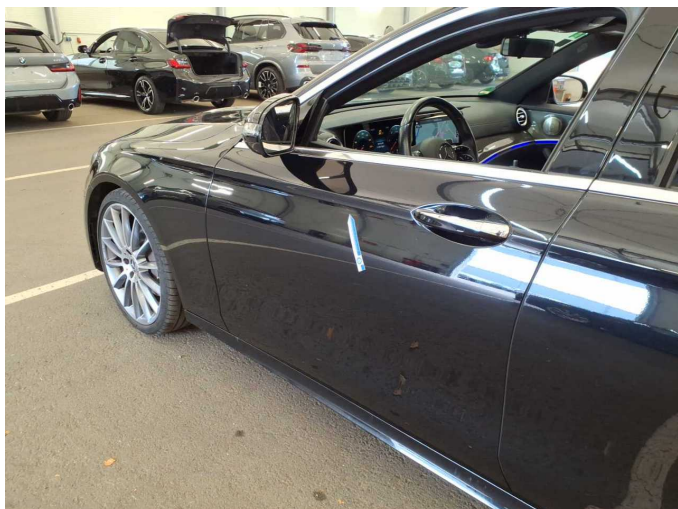
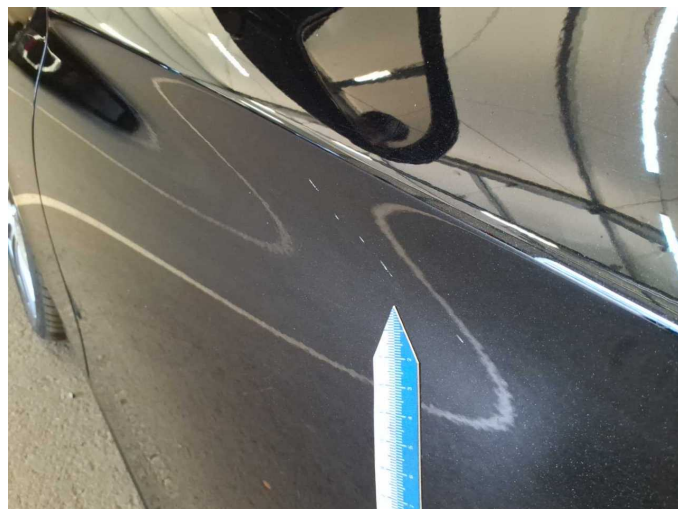
| No. | Component group | Description |
|---|---|---|
| 5 | Door - front left side | Door - Scratch(es) - Paint |

**Damage 5:** Door - front left side: Door - Scratch(es) - Paint

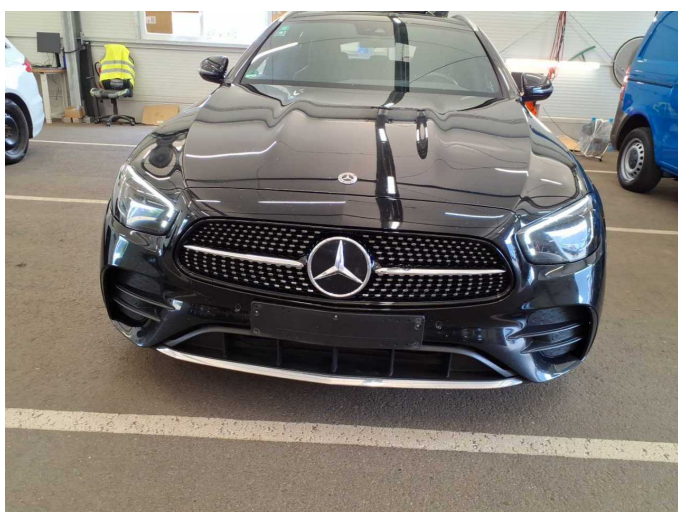
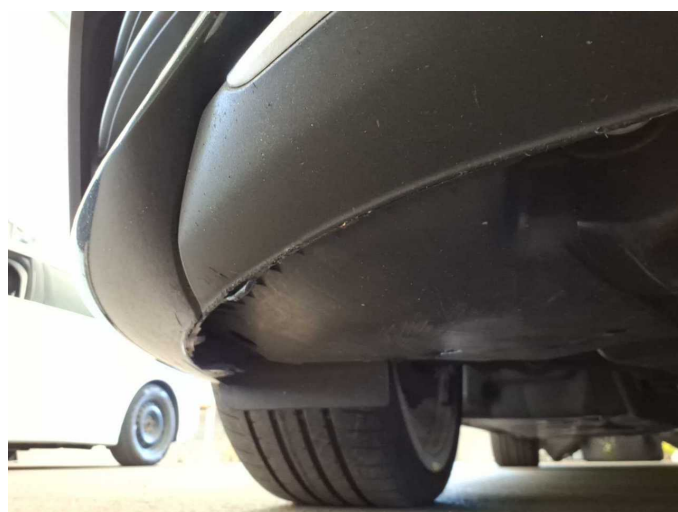
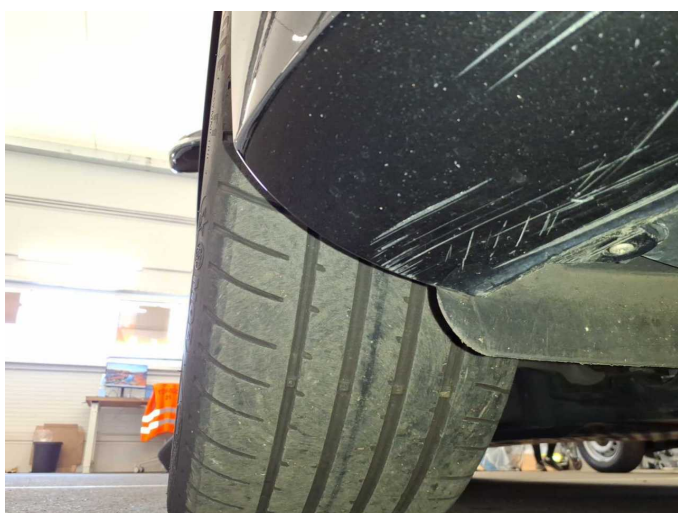
| No. | Component group | Description |
|---|---|---|
| 6 | Front bumper | Front bumper - Scratched - Repair and paint |

**Damage 6:** Front bumper: Front bumper - Scratched - Repair and paint

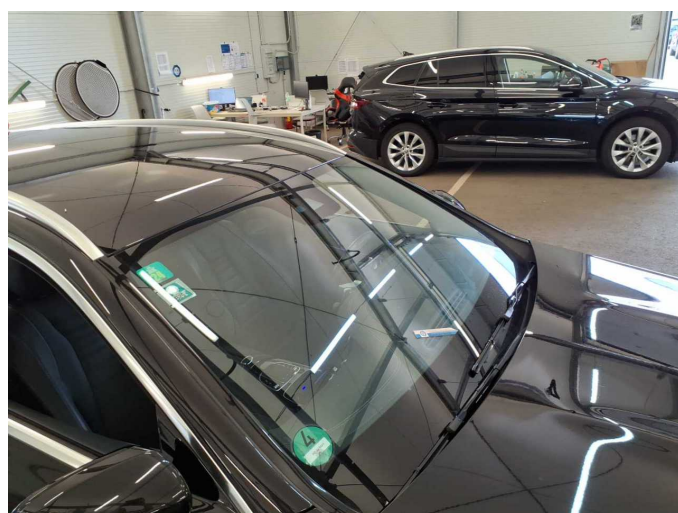
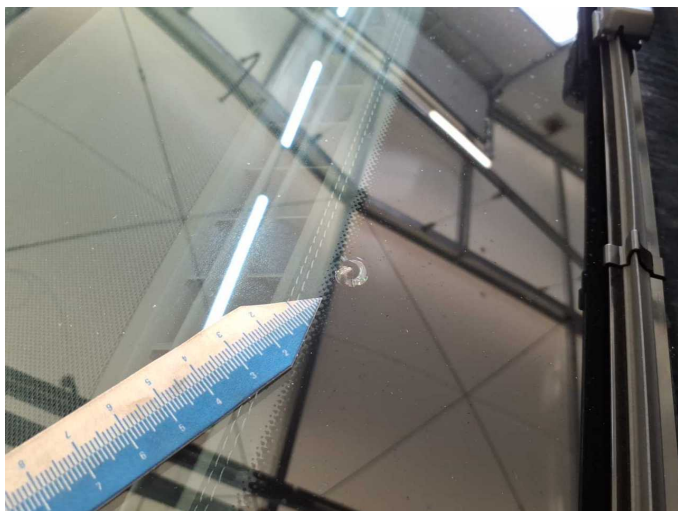
| No. | Component group | Description |
|---|---|---|
| 7 | Vehicle glazing | Windscreen (Mit Rissbildung im Randbereich) - Stone chips - Replace |

**Damage 7:** Vehicle glazing: Windscreen (Mit Rissbildung im Randbereich) - Stone chips - Replace
