Expertise

Protocol number: 46186578
Order No. / Reference: 26152470
Inspection date: 22 Jun 2026

Model: Vito 116 CDI Tourer Lang Aut. SELECT

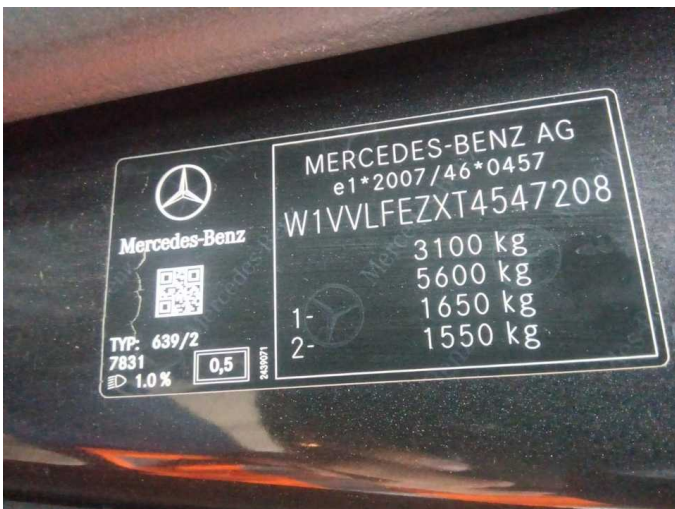
Figure 11: VIN

Documents submitted	At the time of the inspection, the vehicle registration certificate Part 2 (title) was available, but the vehicle registration certificate Part 1 (document) was not. (Copy)
VIN comparison	The vehicle identification number (VIN) was read from the vehicle and its conformity with the submitted documents was confirmed by the undersigned during the inspection.
Inspection	The inspection conditions were sufficient for the assessment of the vehicle. Lifting equipment and/or a pit were available for examining the vehicle.
Test drive	No test drive/shunting maneuver was carried out during the inspection of the vehicle.
Engine function test	An engine test run was performed.
readiness to drive	The vehicle was roadworthy at the time of inspection.

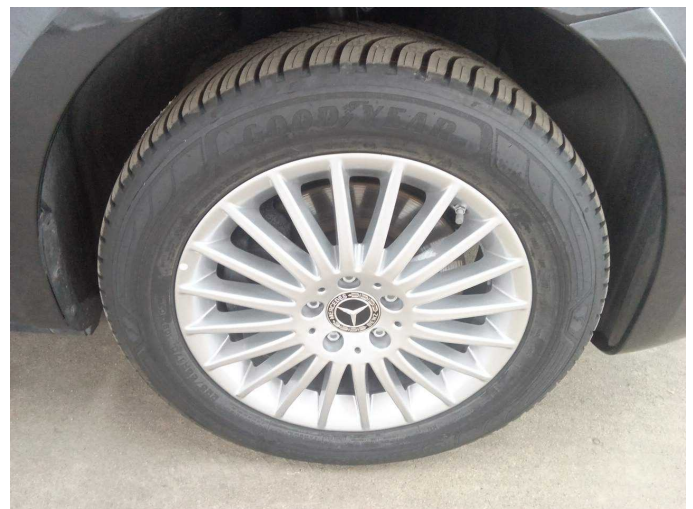
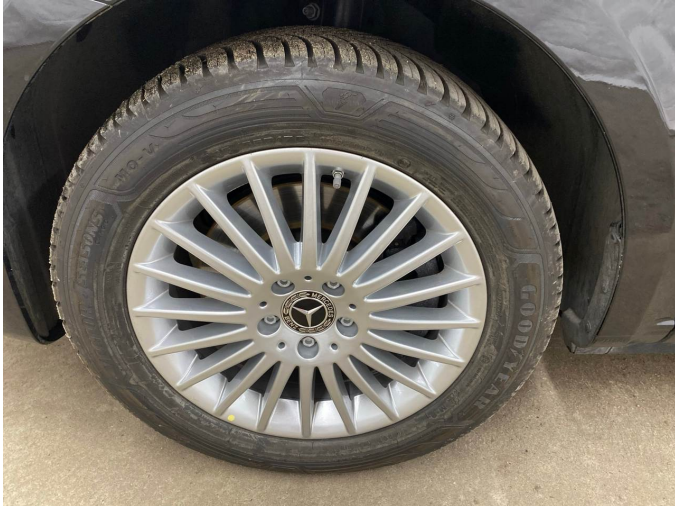
Figure 12: Mounted tyres

#	Tyre size	Type of tyre	Manufacturer	Tread depth
1)	225/55 R17 109H	All-season tyres on Light alloy	Goodyear	7mm / 7mm
2)	225/55 R17 109H	All-season tyres on Light alloy	Goodyear	7mm / 7mm

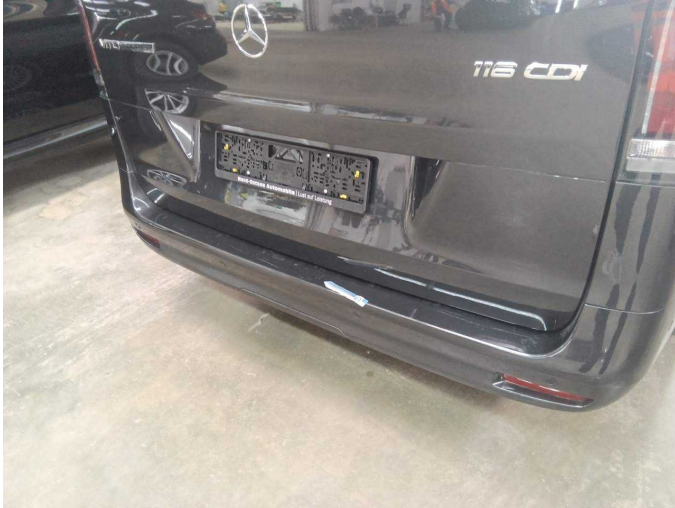
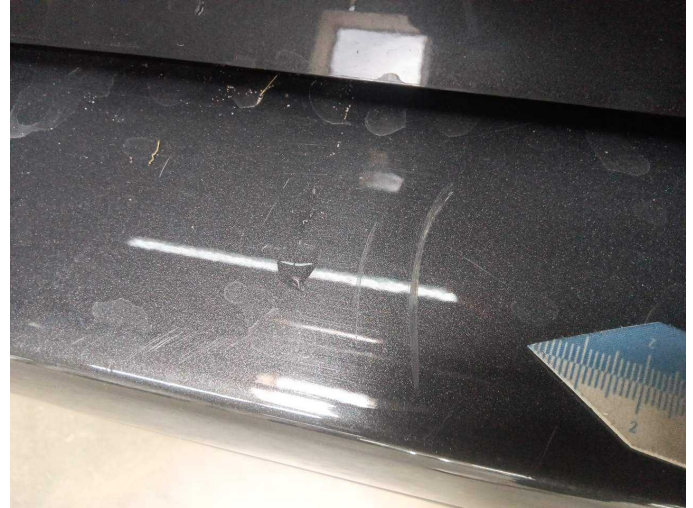
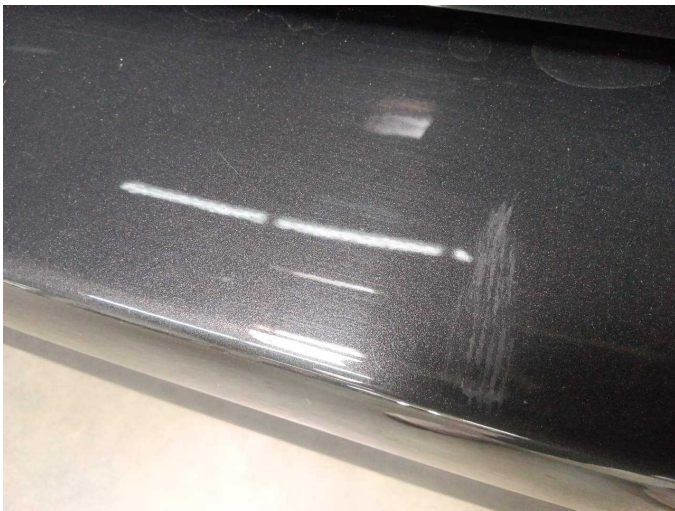
Damage 1: Rear bumper: Rear bumper - Scratch(es) - Smart repair

No.	Component group	Description
1	Rear bumper	Rear bumper - Scratch(es) - Smart repair
2	Sliding door, right	Sliding door - Scratch(es) - Paint
3	Vehicle glazing	Windscreen - Stone chips - Replace

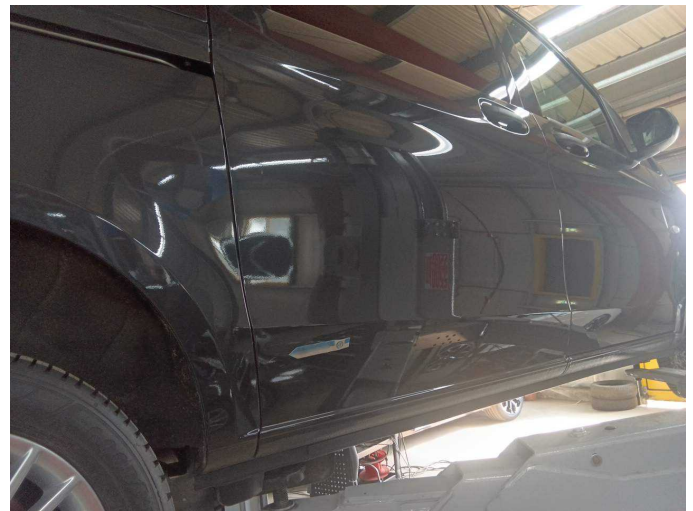
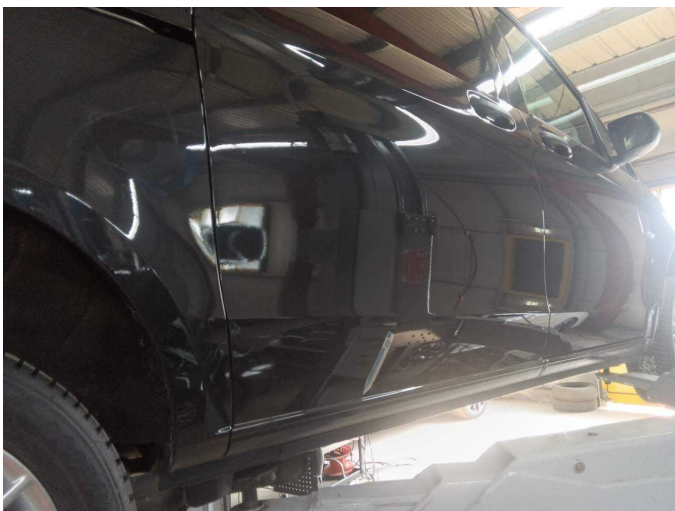
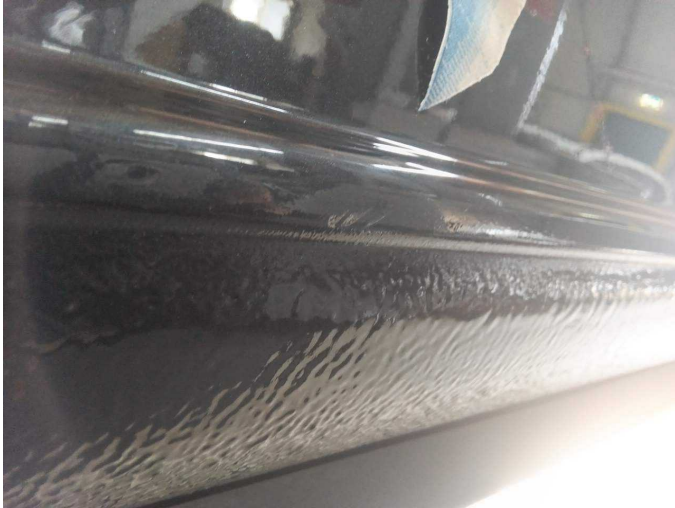
Damage 2: Sliding door, right: Sliding door - Scratch(es) - Paint

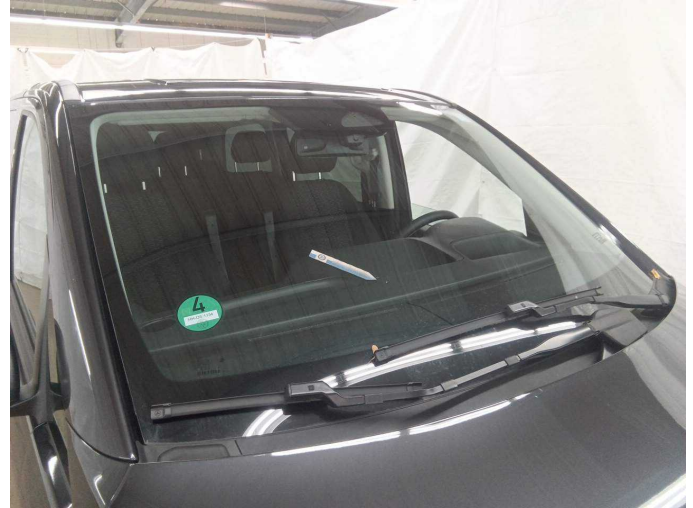
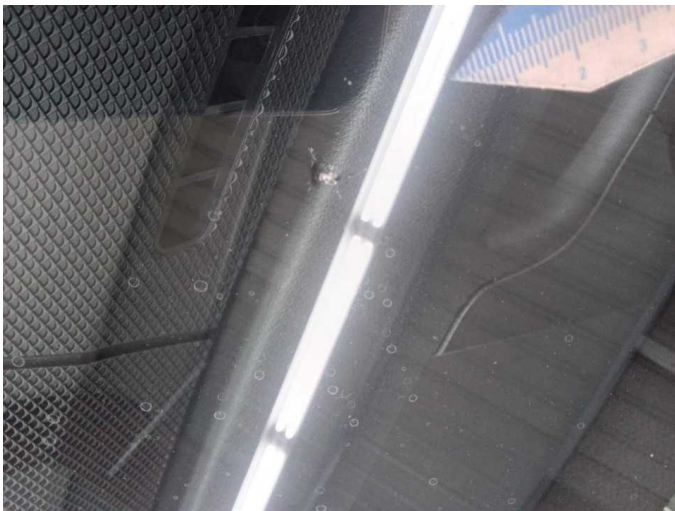
Damage 3: Vehicle glazing: Windscreen - Stone chips - Replace

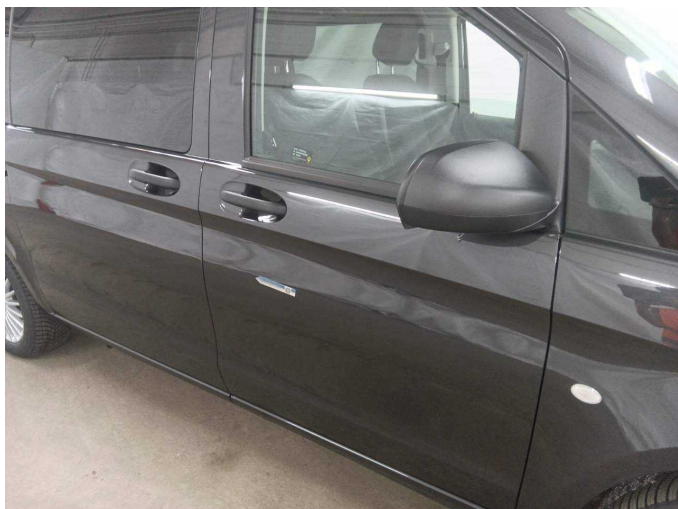
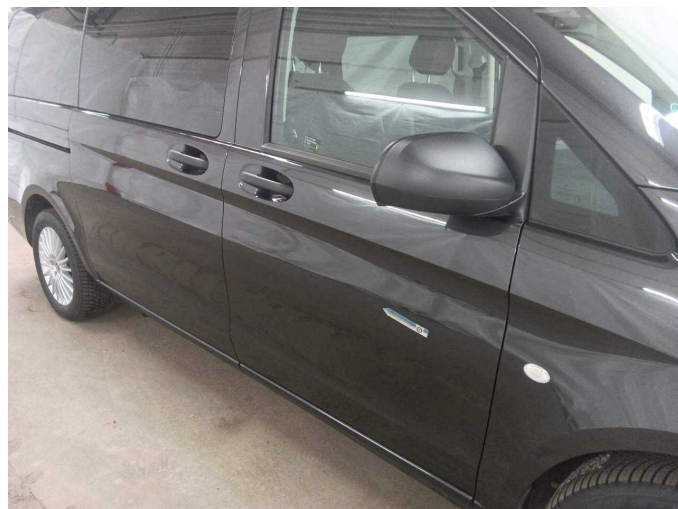
Wear and tear 4: Door - front right side: Door - dent(s) - No deduction

No.	Component group	Description
1	Bonnet	Bonnet - Stone chips - No deduction
2	Front bumper	Front bumper - Stone chips - No deduction
3	Roof	Roof - dent(s) - No deduction
4	Door - front right side	Door - dent(s) - No deduction
