Expertise

Protocol number: 46200553  
Order No. / Reference: 26497126  
Inspection date: 18 Jun 2026

Manufacturer: Volvo

Model: XC40 Recharge 69 kWh Single Motor Plus

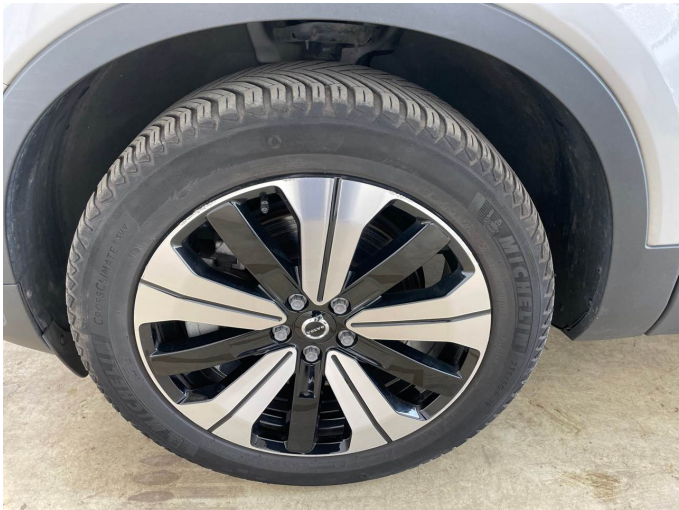
Figure 12: Mounted tyres

| Tyres | | | | |
|---|---|---|---|---|
| 1) | 235/50 R19 103H | All-season tyres on Light alloy | Michelin | 5mm / 5mm |
| 2) | 255/45 R19 104H | All-season tyres on Light alloy | Michelin | 6mm / 6mm |

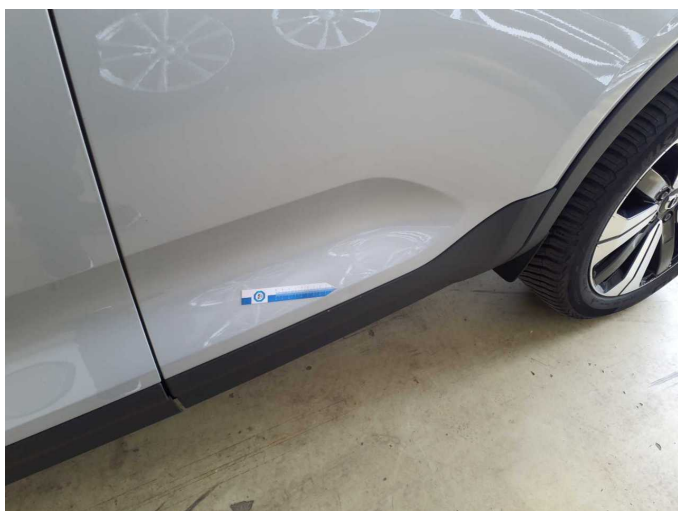
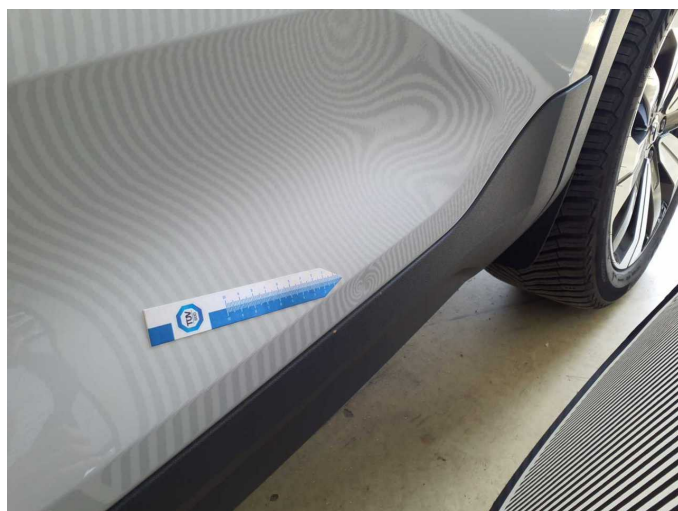
| No. | Component group | Description |
|---|---|---|
| 2 | Door - rear left side | Door - dent(s) - Smooth repair work |

**Damage 2:** Door - rear left side: Door - dent(s) - Smooth repair work

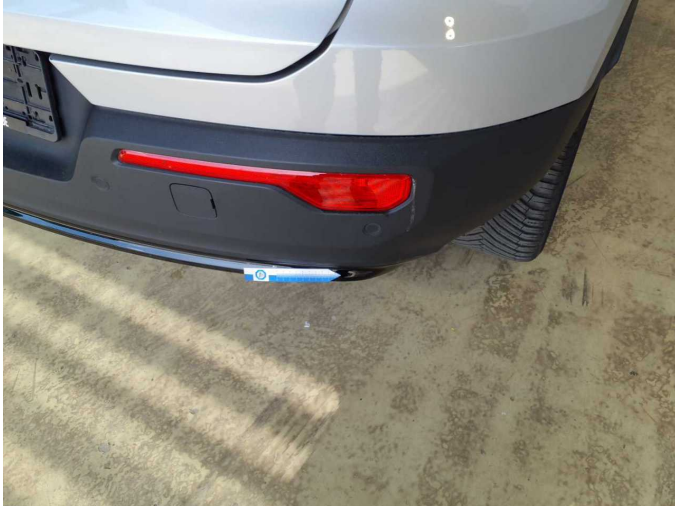
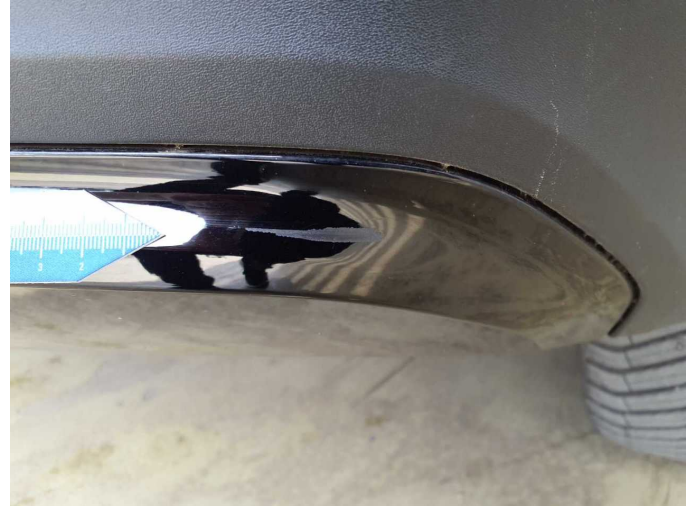
| No. | Component group | Description |
|---|---|---|
| 3 | Rear bumper | Spoiler - Scratched - Smart repair |

**Damage 3:** Rear bumper: Spoiler - Scratched - Smart repair

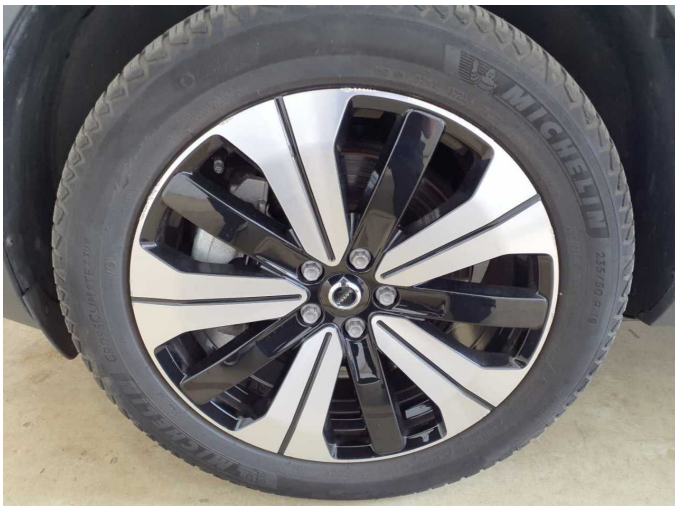
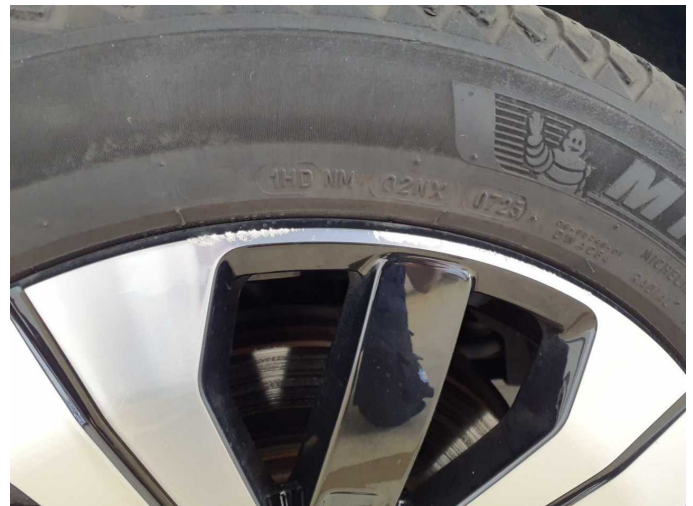
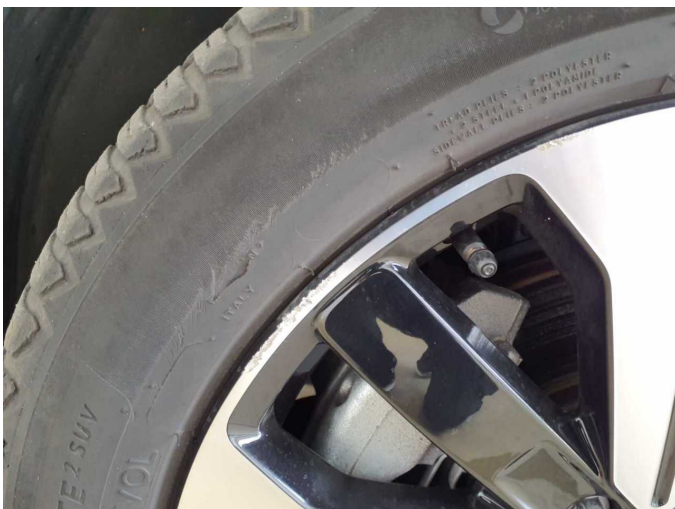
| No. | Component group | Description |
|---|---|---|
| 5 | Wheel / tyres | Alloy rim - front left side - Scratched - Loss in value |

**Damage 5:** Wheel / tyres: Alloy rim - front left side - Scratched - Loss in value

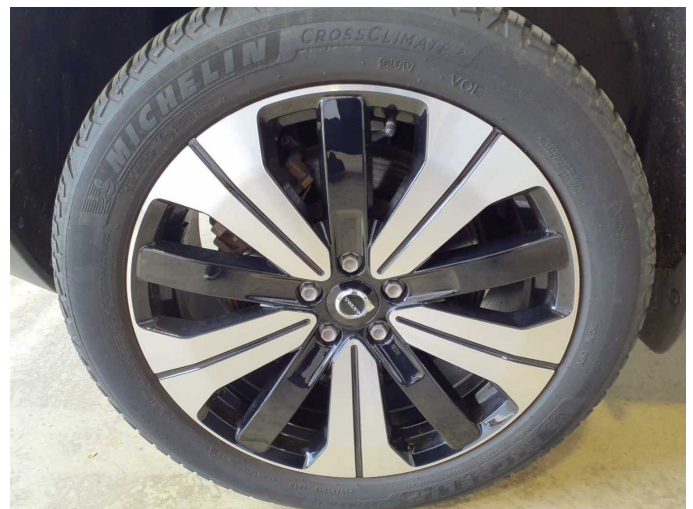
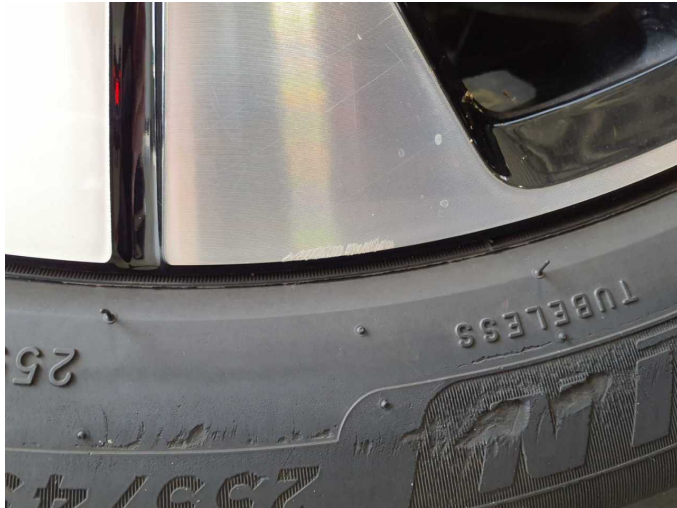
| No. | Component group | Description |
|---|---|---|
| 6 | Wheel / tyres | Alloy rim - rear right side - Scratched - Loss in value |

**Damage 6:** Wheel / tyres: Alloy rim - rear right side - Scratched - Loss in value

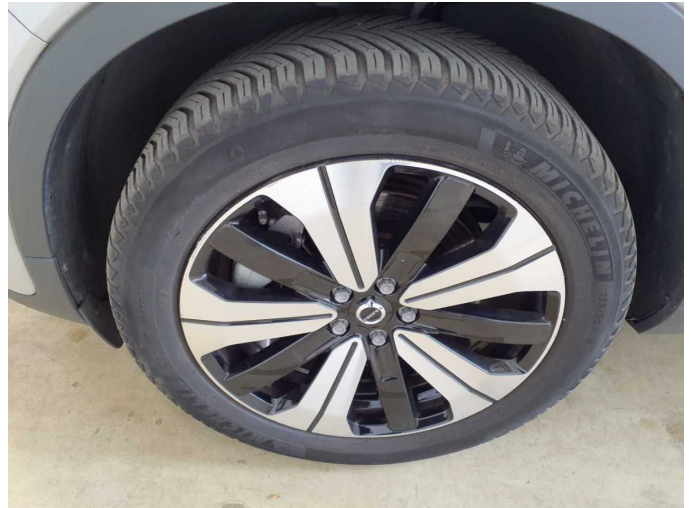
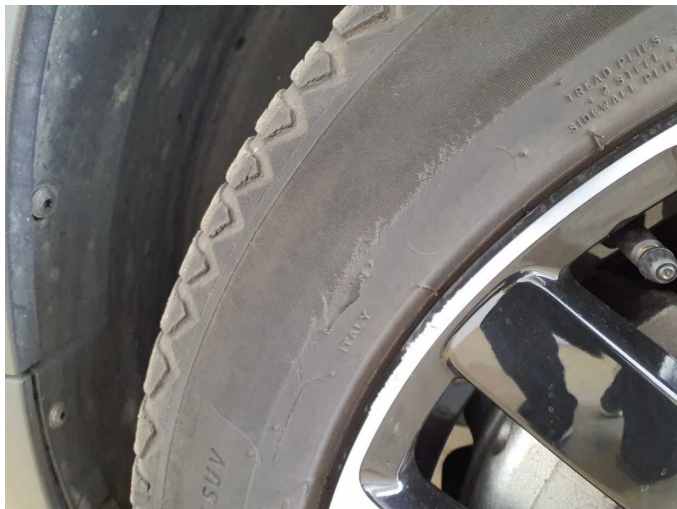
| No. | Component group | Description |
|---|---|---|
| 7 | Wheel / tyres | Tyre - front left side - Damaged - Replace |

**Damage 7:** Wheel / tyres: Tyre - front left side - Damaged - Replace

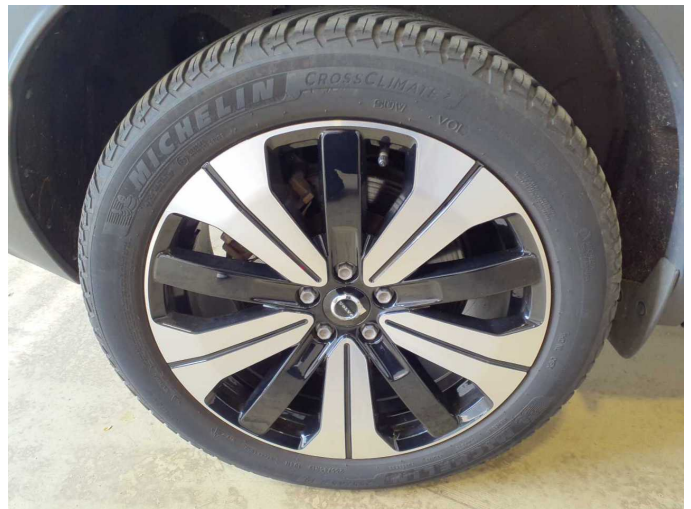
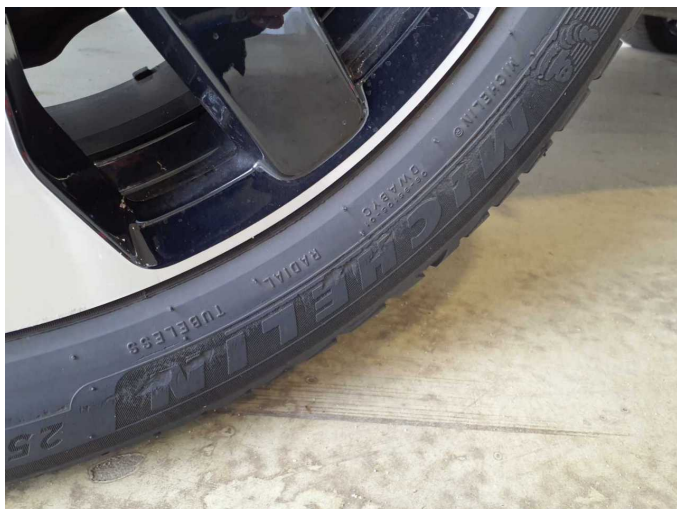
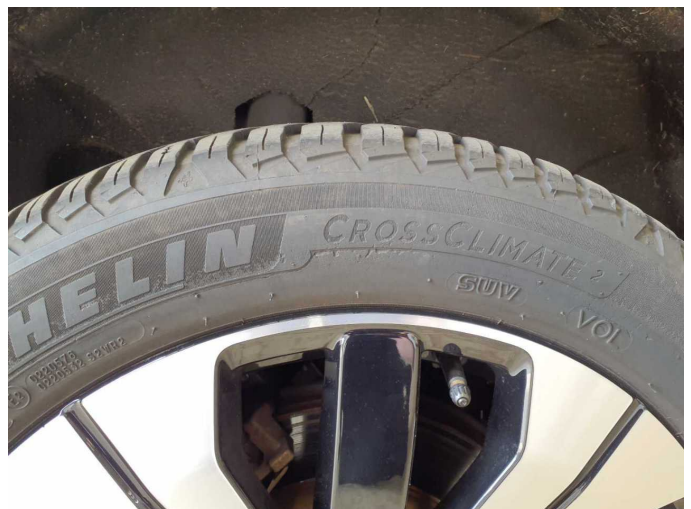
| No. | Component group | Description |
|---|---|---|
| 8 | Wheel / tyres | Tyre - rear right side - Damaged - Replace |

**Damage 8:** Wheel / tyres: Tyre - rear right side - Damaged - Replace

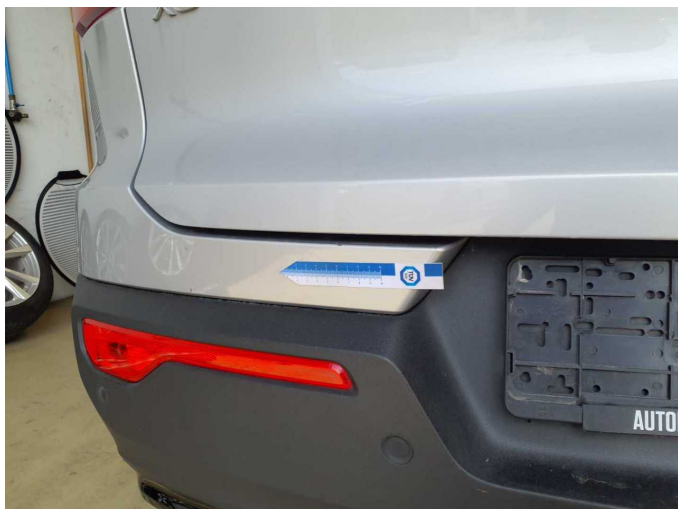
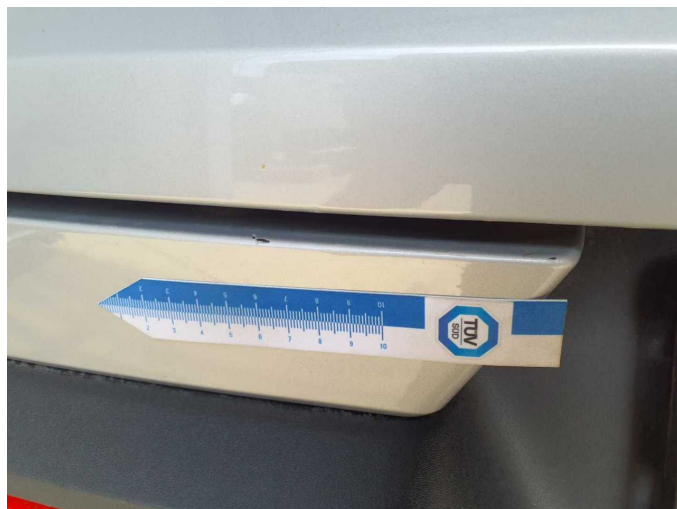
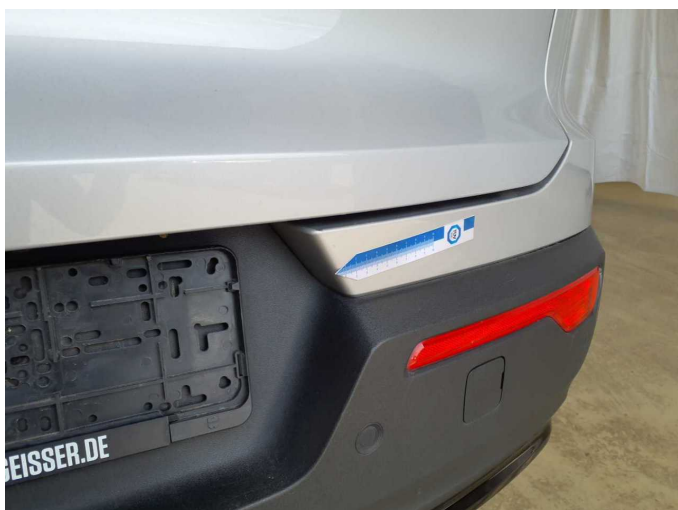
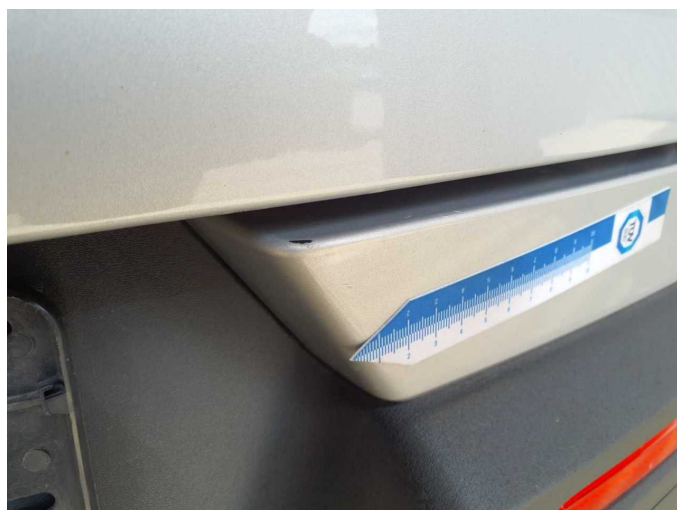
| No. | Component group | Description |
|---|---|---|
| 9 | Rear bumper | Rear bumper (Links und rechts) - Scratched - Smart repair |

**Damage 9:** Rear bumper: Rear bumper (Links und rechts) - Scratched - Smart repair

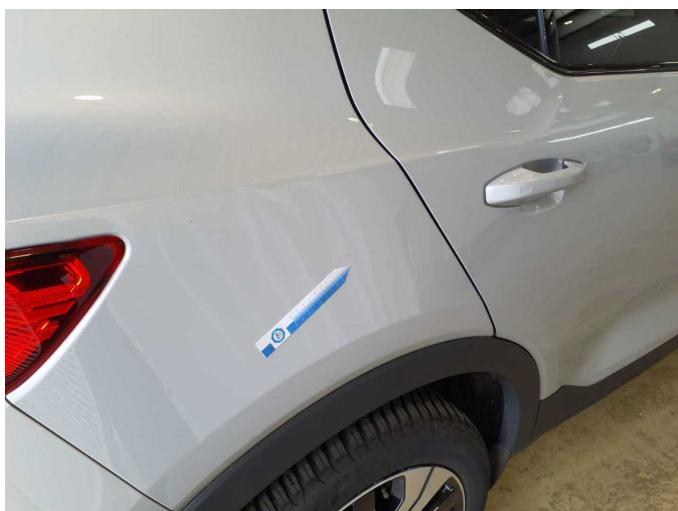
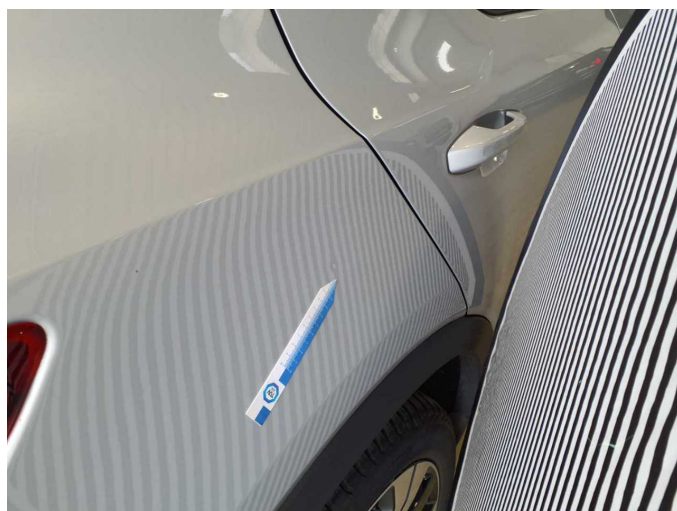
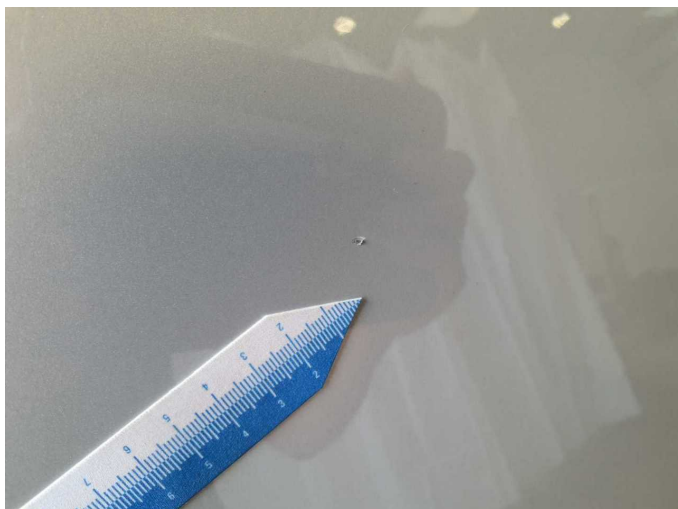
| No. | Component group | Description |
|---|---|---|
| 10 | Side panel - rear right side | Side panel - Dent / paintcoat damage - Repair and paint |

**Damage 10:** Side panel - rear right side: Side panel - Dent / paintcoat damage - Repair and paint

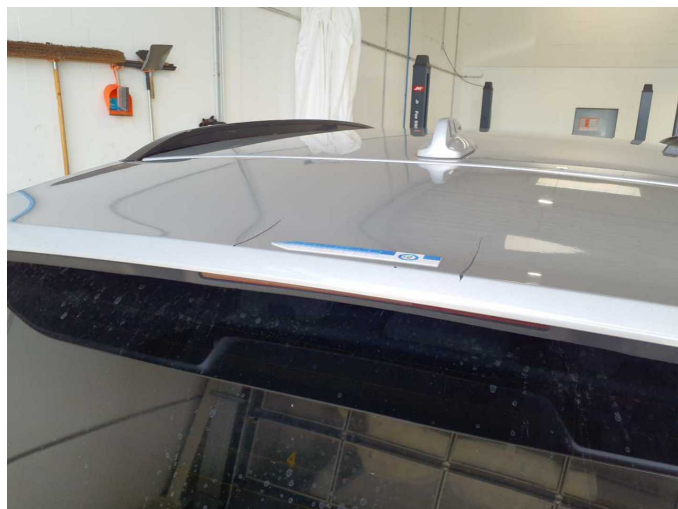
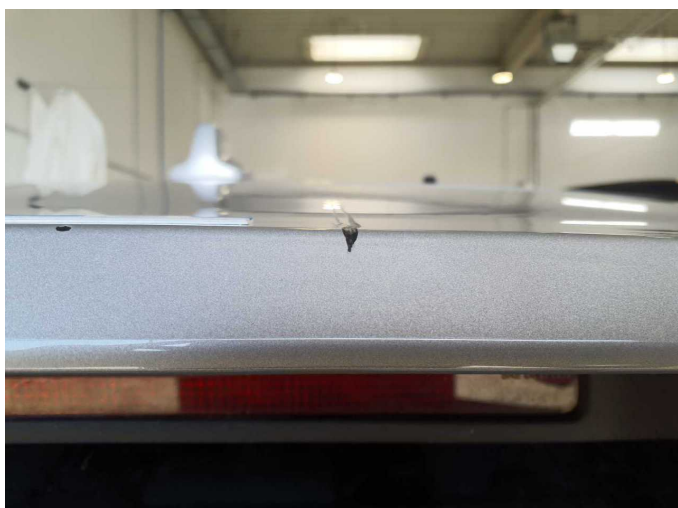
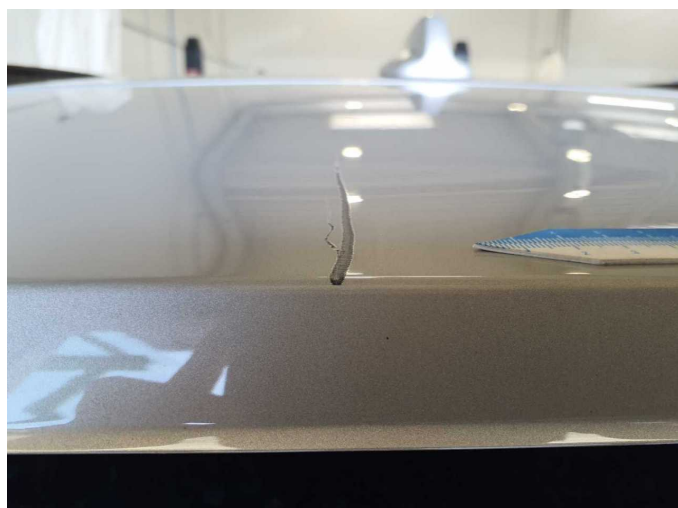
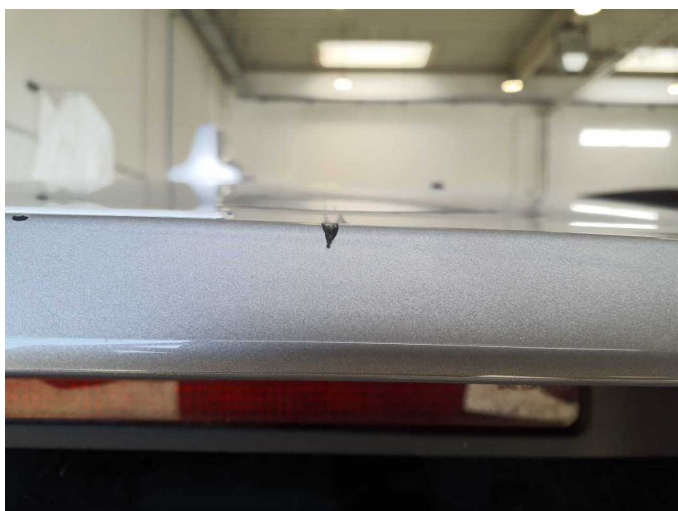
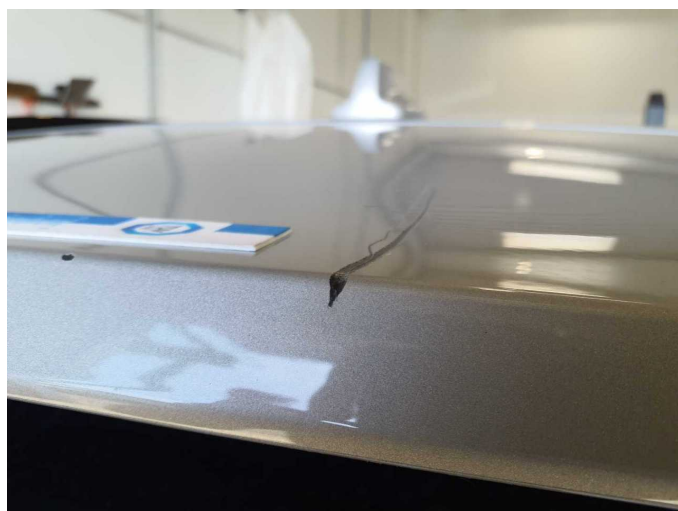
| No. | Component group | Description |
|---|---|---|
| 11 | Boot lid / rear door | Rear spoiler - Scratched - Repair and paint |

**Damage 11:** Boot lid / rear door: Rear spoiler - Scratched - Repair and paint
