Expertise

Protocol number: 46628723  
Order No. / Reference: 26631783  
Inspection date: 14 Jul 2026

Manufacturer: Skoda  
VIN: TMBJJ8NX8NY029003

Model: Octavia Combi 2.0 TDI DSG Style

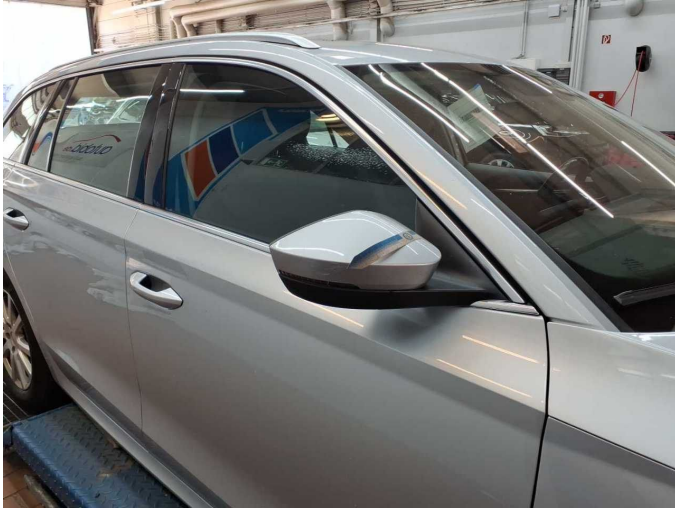
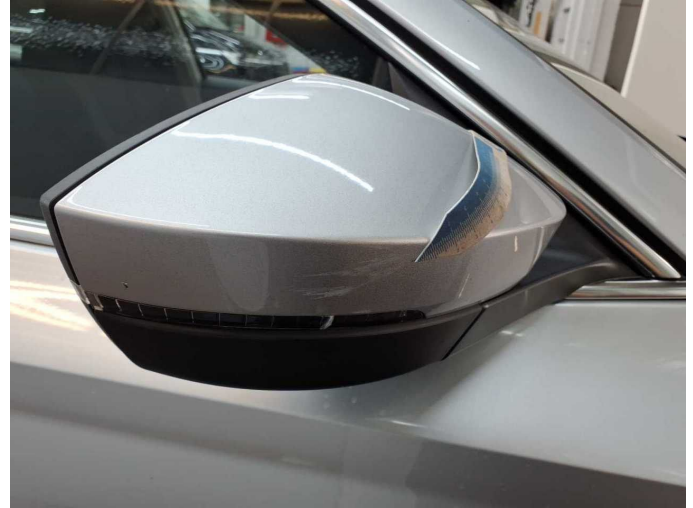
| No. | Component group | Description |
|---|---|---|
| 1 | Wing mirror - right side | Cap - Scratch(es) - Smart repair |

**Damage 1:** Wing mirror - right side: Cap - Scratch(es) - Smart repair

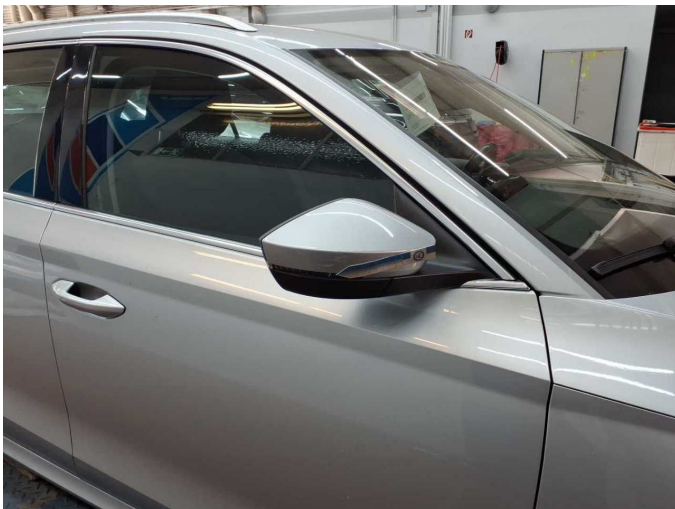
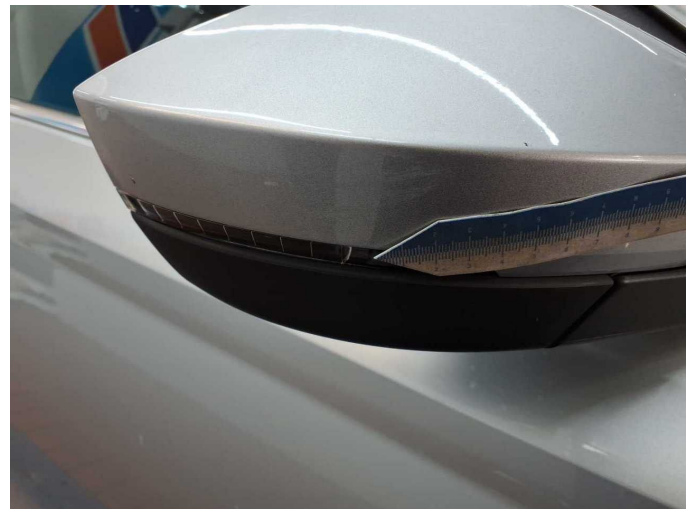
| No. | Component group | Description |
|---|---|---|
| 2 | Indicator - front | Mirror - right side - Broken / torn - Replace |

**Damage 2:** Indicator - front: Mirror - right side - Broken / torn - Replace

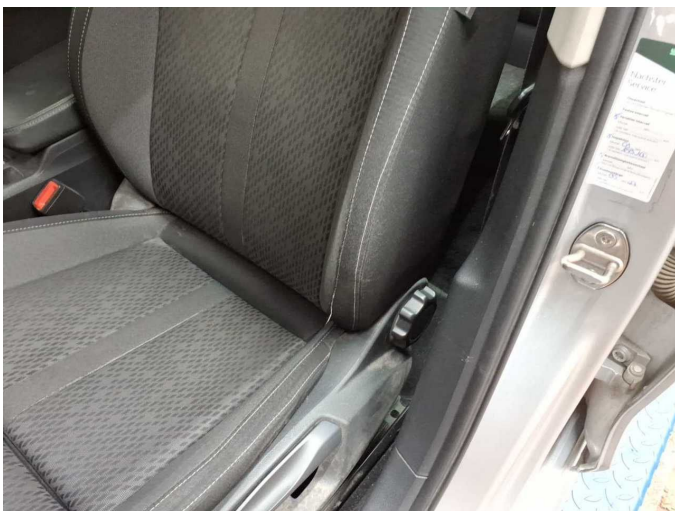
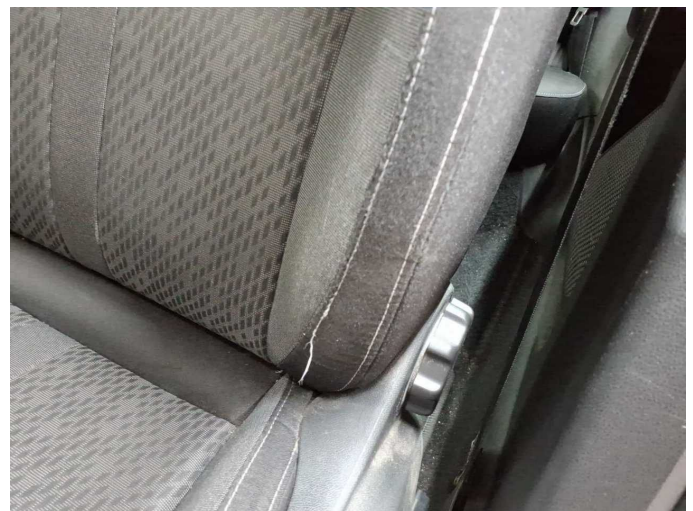
| No. | Component group | Description |
|---|---|---|
| 3 | Seat - front | Seat cover - left side - Abrasion - Loss in value |

**Damage 3:** Seat - front: Seat cover - left side - Abrasion - Loss in value

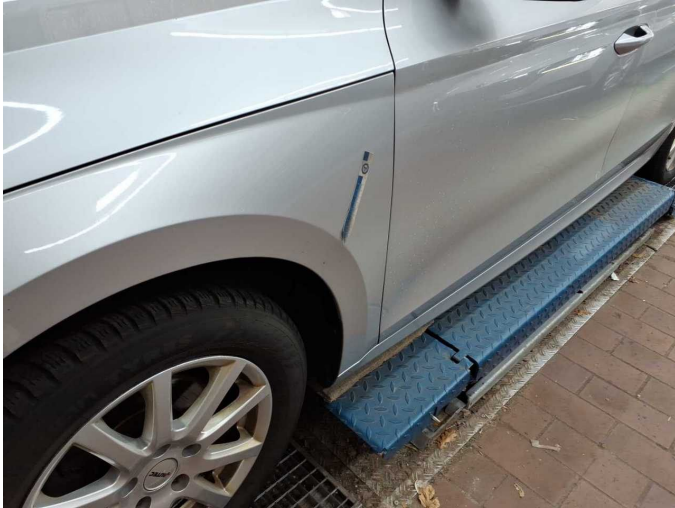
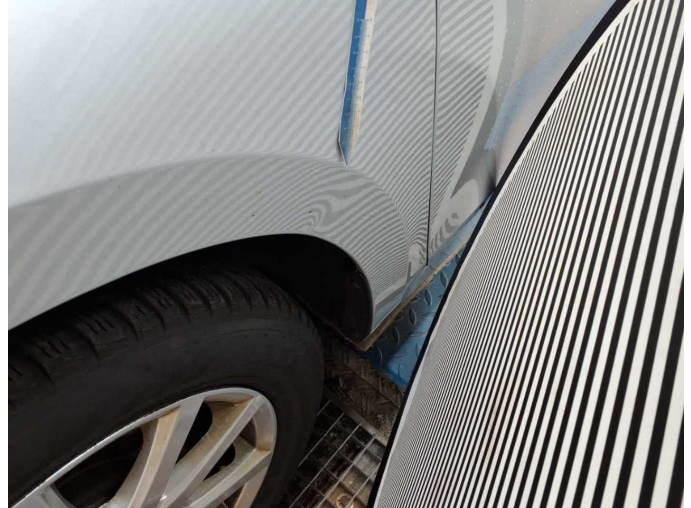
| No. | Component group | Description |
|---|---|---|
| 4 | Mudguard - left side | Mudguard - left side - dent(s) - Smart repair |

**Damage 4:** Mudguard - left side: Mudguard - left side - dent(s) - Smart repair

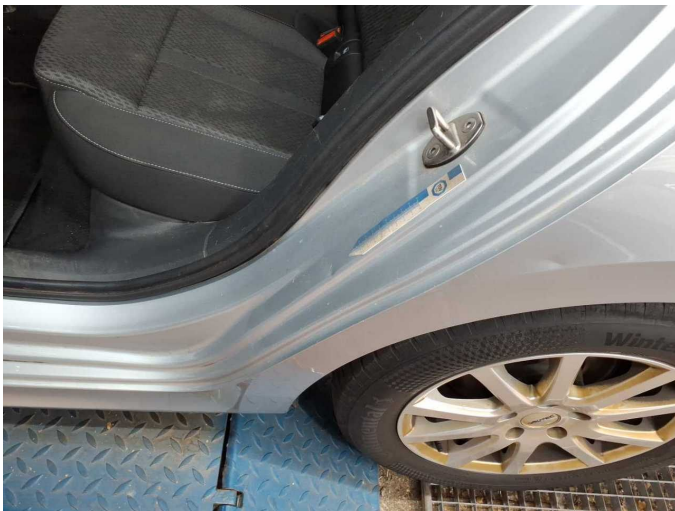
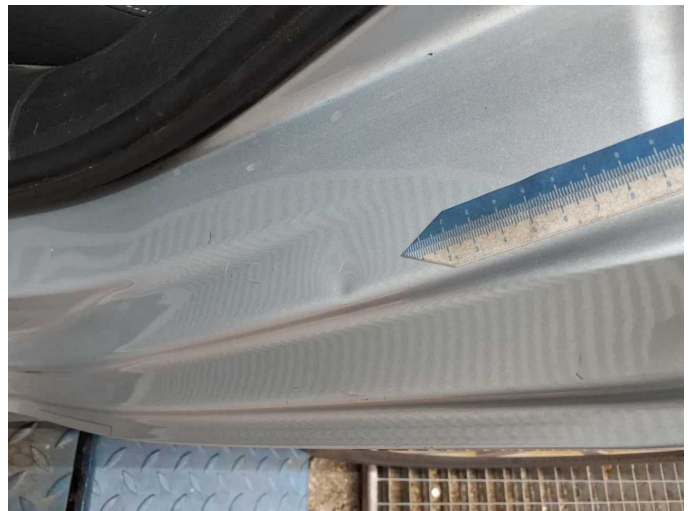
| No. | Component group | Description |
|---|---|---|
| 5 | Side panel - rear left side | Sill - dent(s) - Smart repair |

**Damage 5:** Side panel - rear left side: Sill - dent(s) - Smart repair

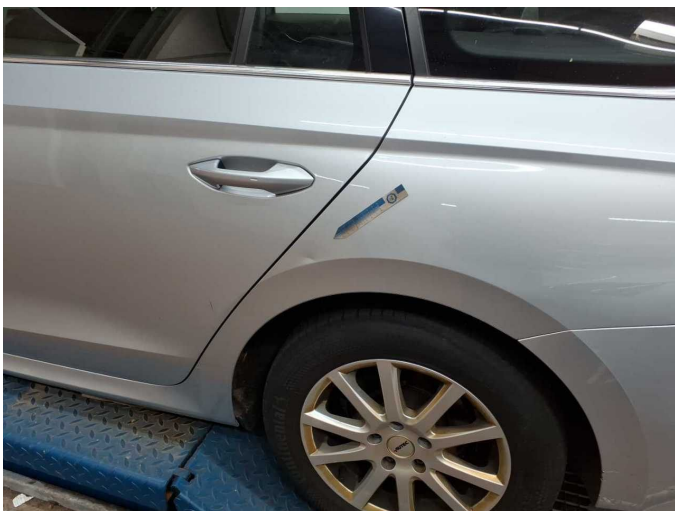
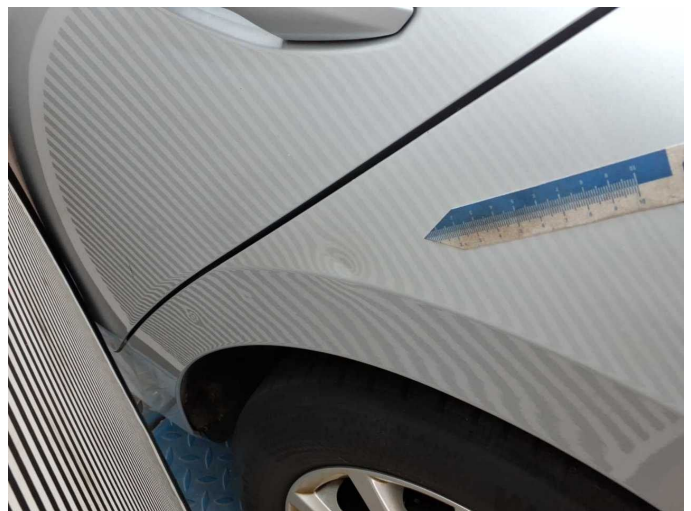
| No. | Component group | Description |
|---|---|---|
| 7 | Side panel - rear left side | Side panel - dent(s) - Smart repair |

**Damage 7:** Side panel - rear left side: Side panel - dent(s) - Smart repair

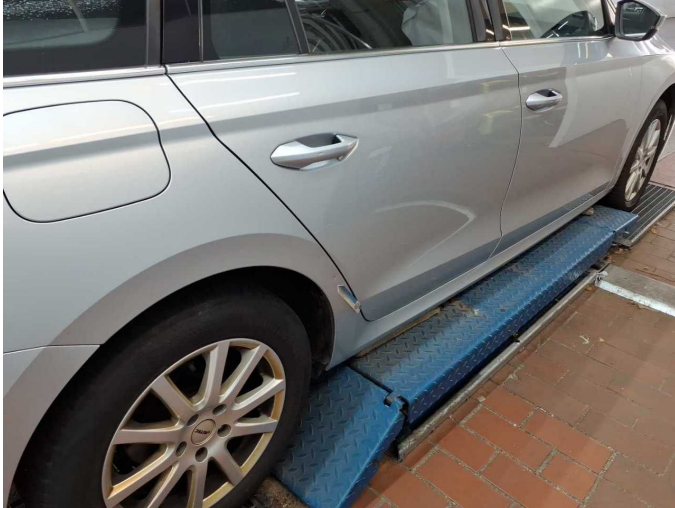
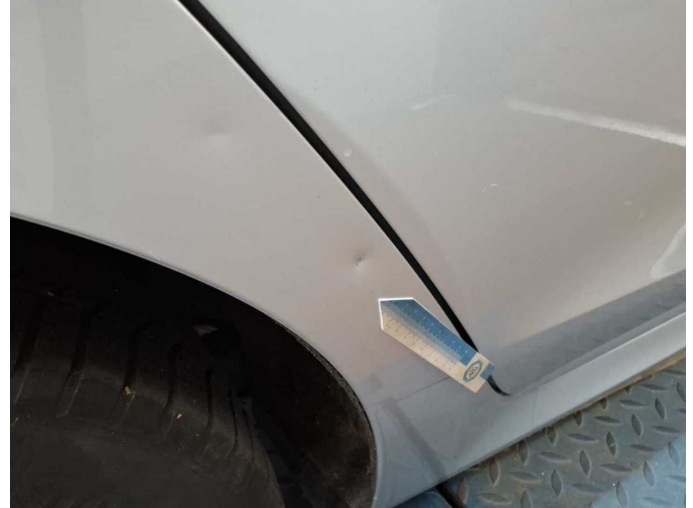
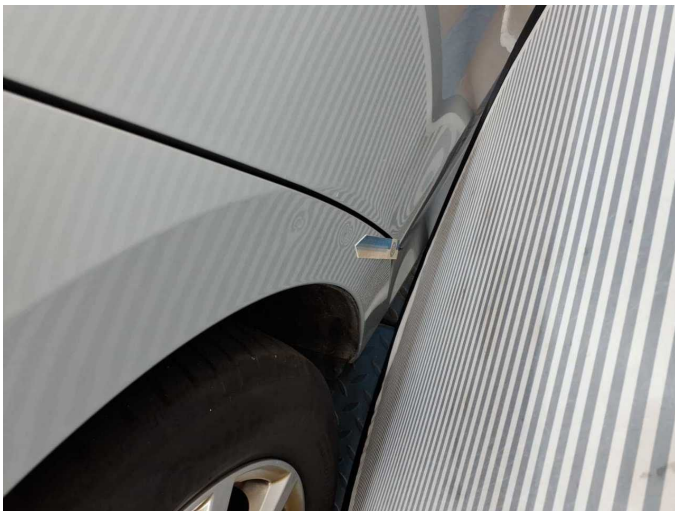
| No. | Component group | Description |
|---|---|---|
| 8 | Side panel - rear right side | Elbow - Dent / paintcoat damage - Smart repair |

**Damage 8:** Side panel - rear right side: Elbow - Dent / paintcoat damage  
- Smart repair

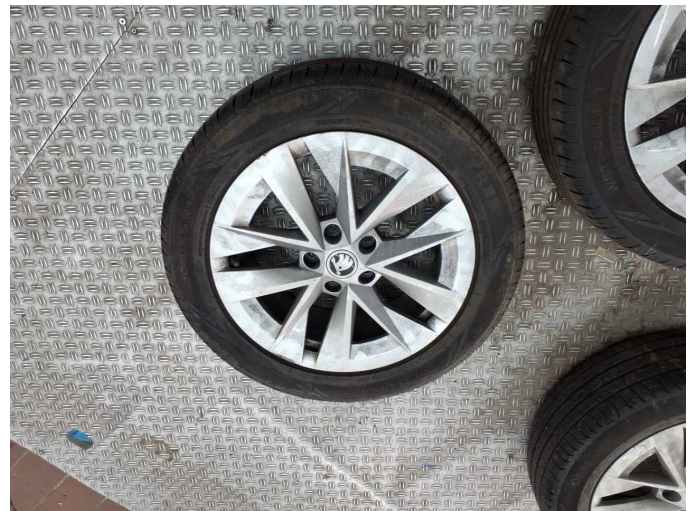
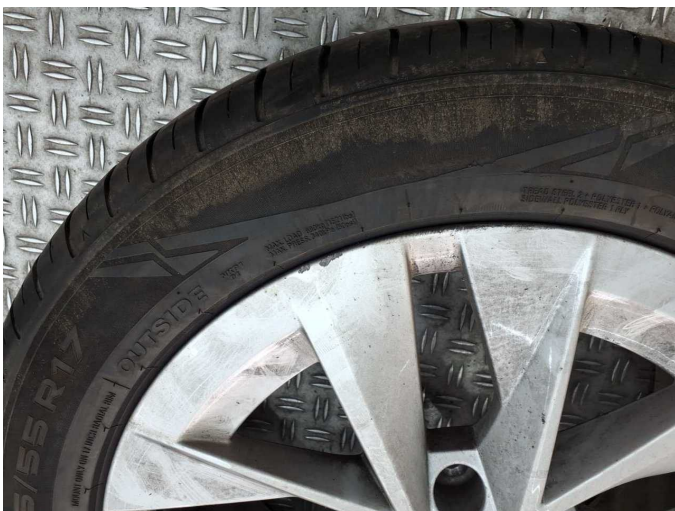
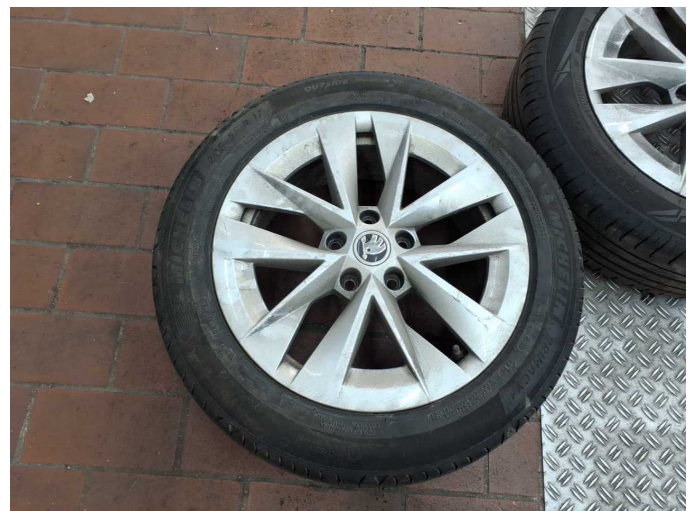
| No. | Component group | Description |
|---|---|---|
| 9 | 2nd wheel set | 2 alloy rims - Scratch(es) - Loss in value |

**Damage 9:** 2nd wheel set: 2 alloy rims - Scratch(es) - Loss in value

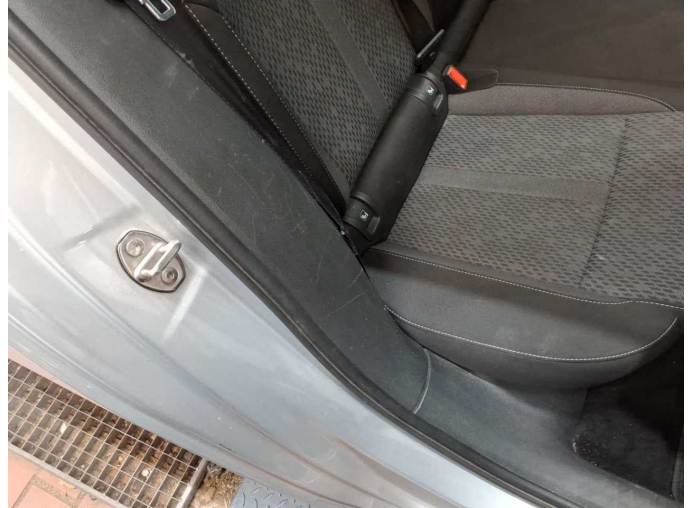
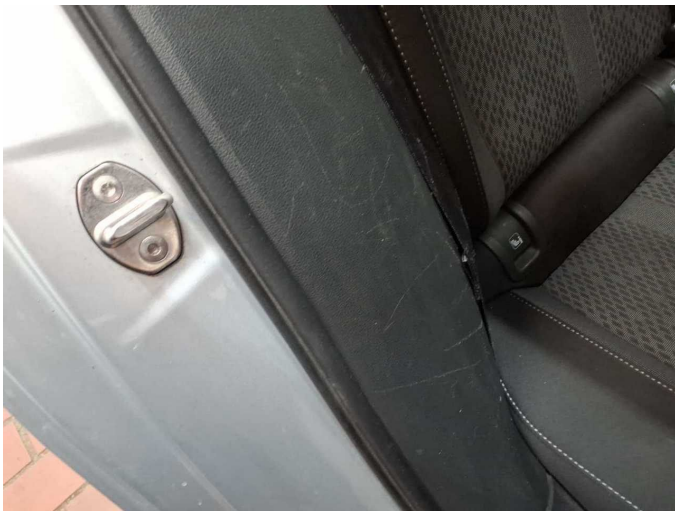
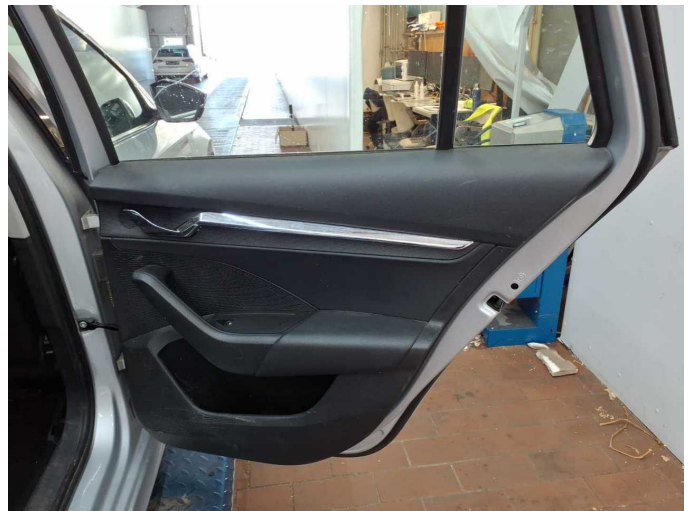
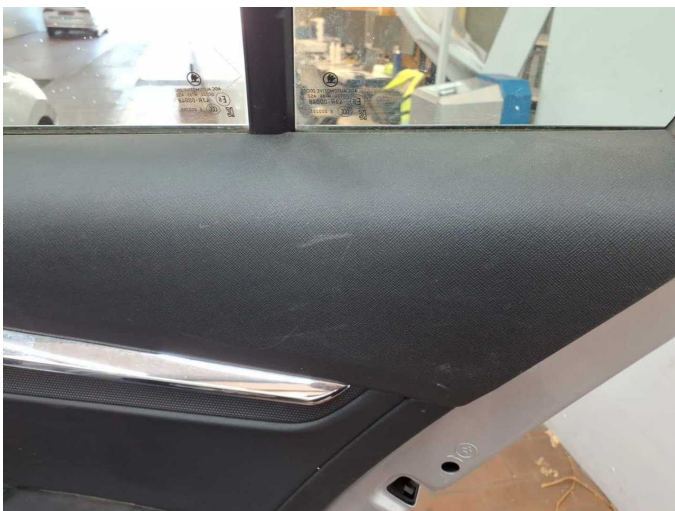
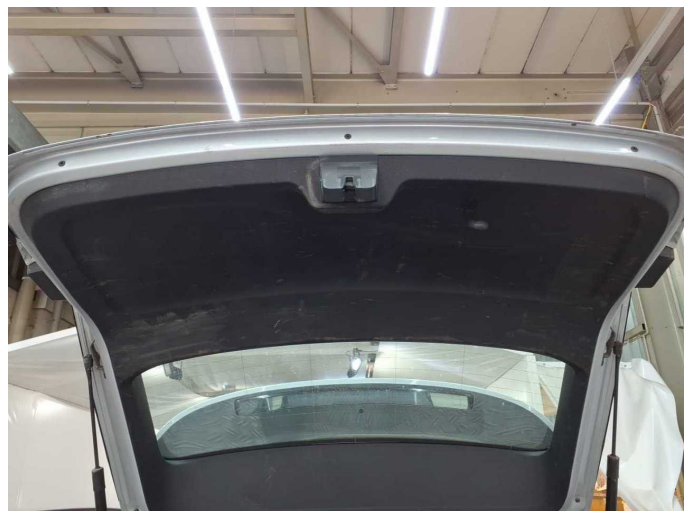
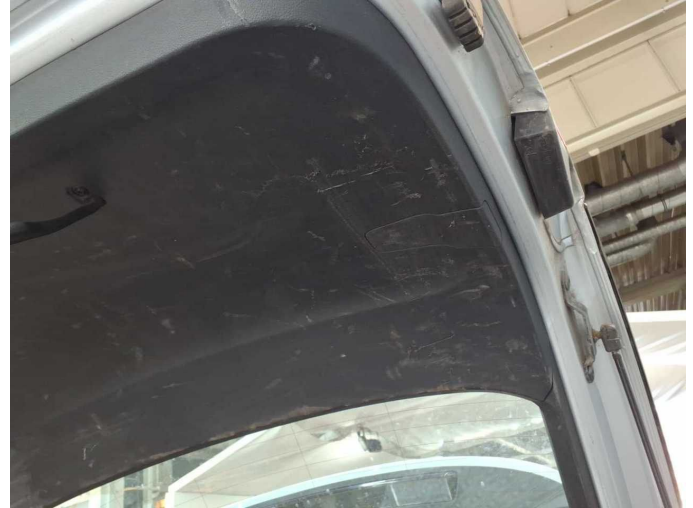
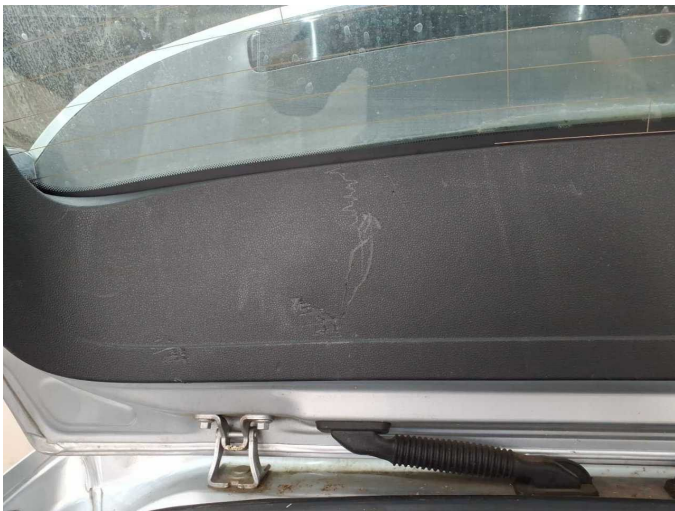
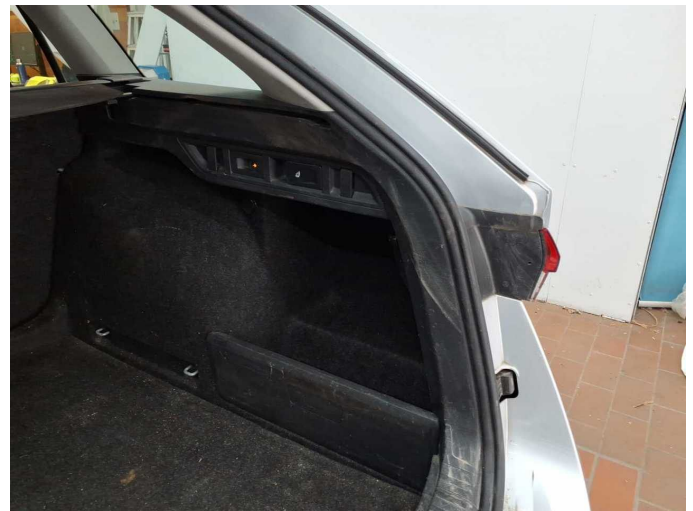
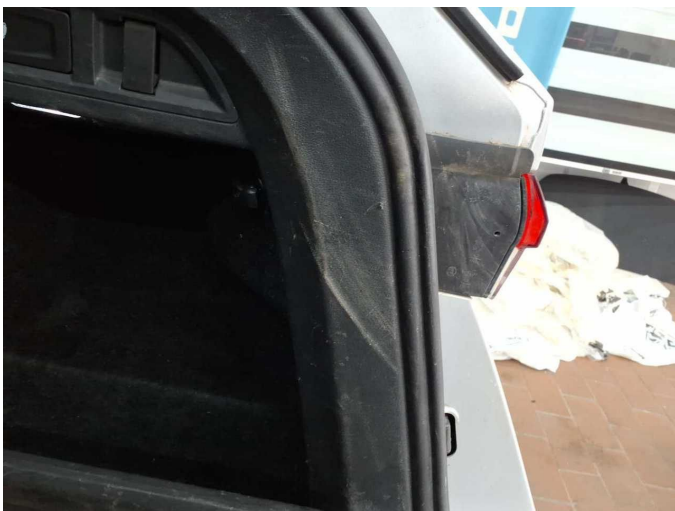
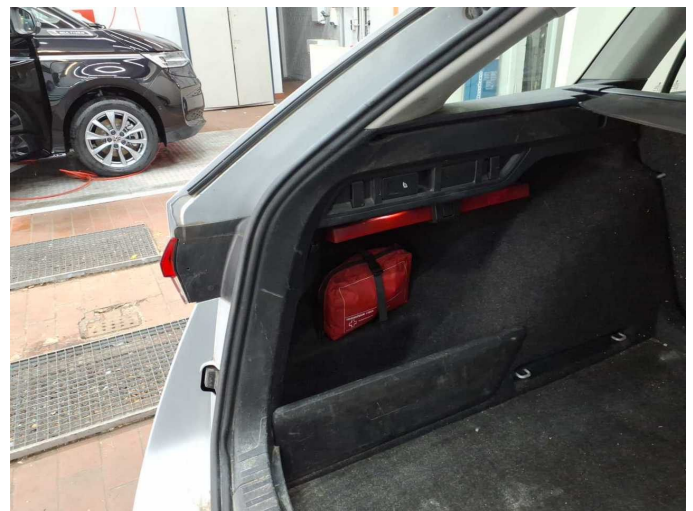
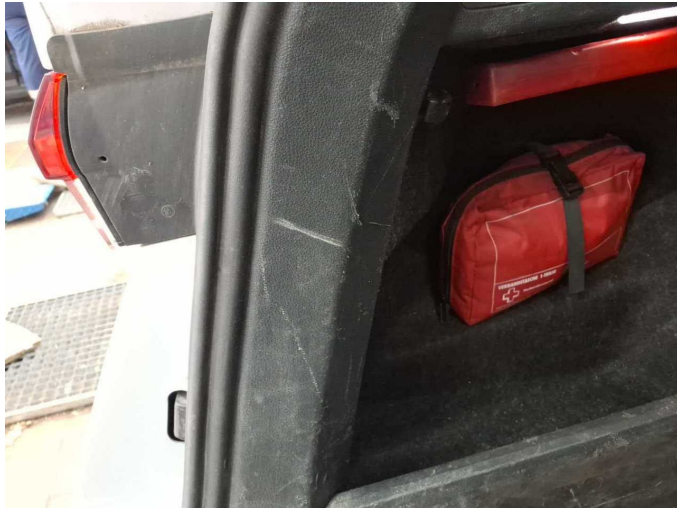
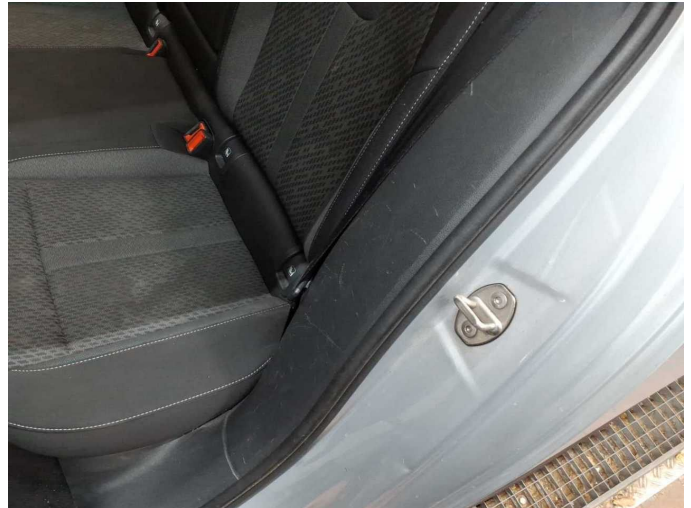
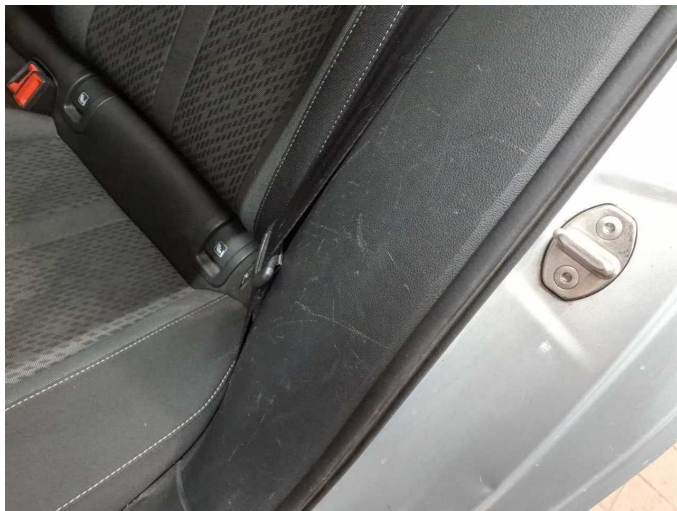
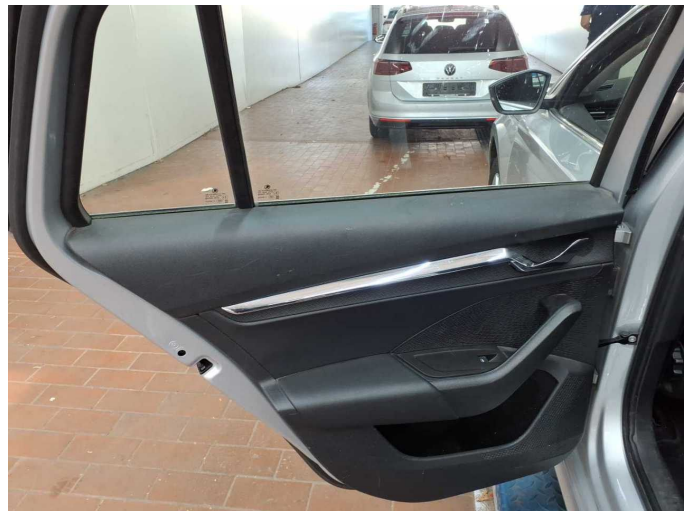
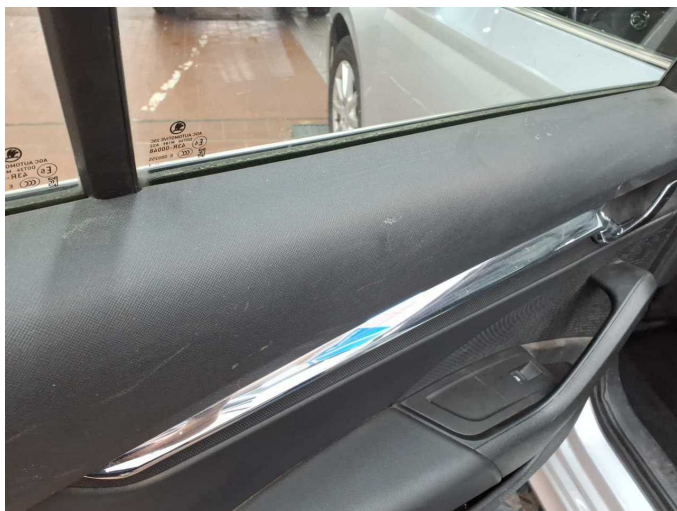
| No. | Component group | Description |
|---|---|---|
| 10 | Interior | Interior - Scratch(es) - Loss in value |

**Damage 10:** Interior: Interior - Scratch(es) - Loss in value

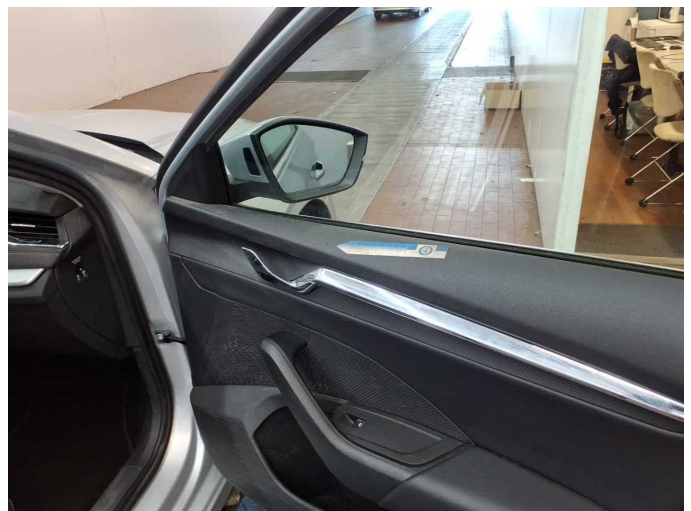
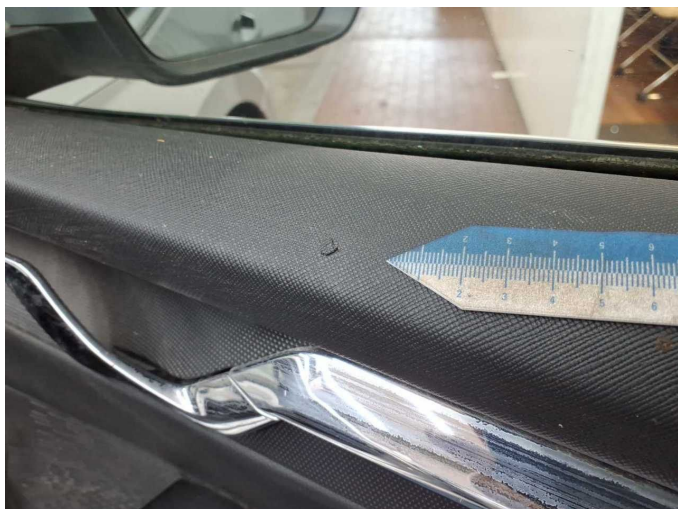
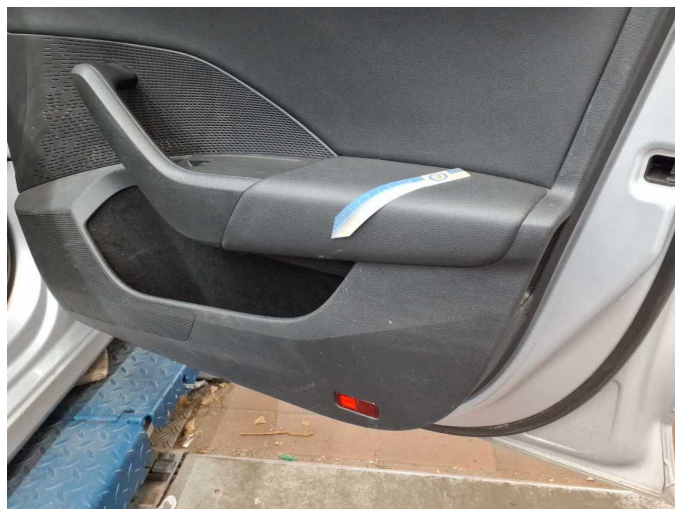
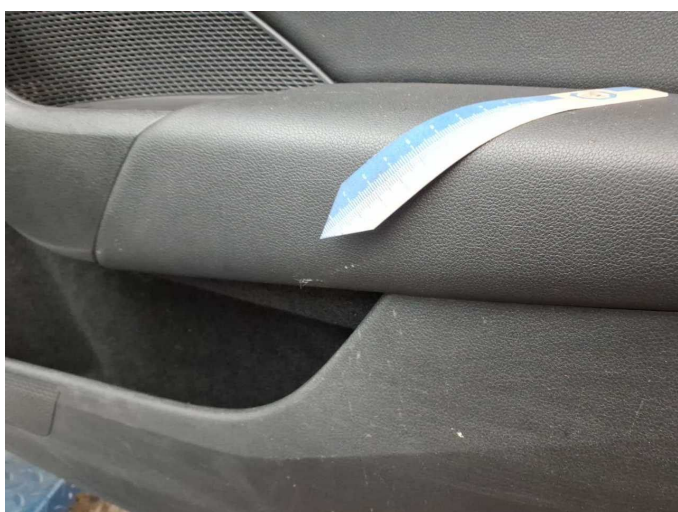
| No. | Component group | Description |
|---|---|---|
| 11 | Door - front right side | Door - Broken / torn - Replace |

**Damage 11:** Door - front right side: Door - Broken / torn - Replace

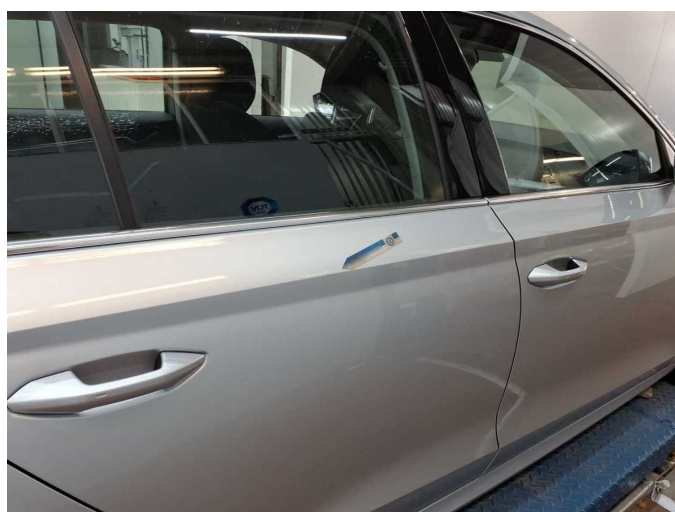
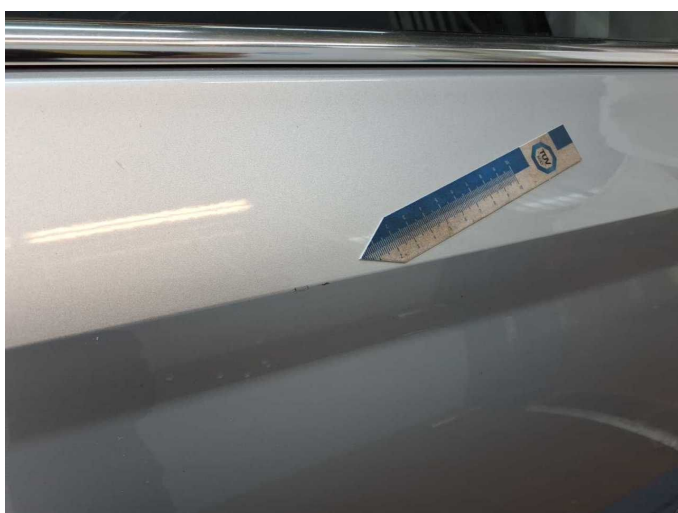
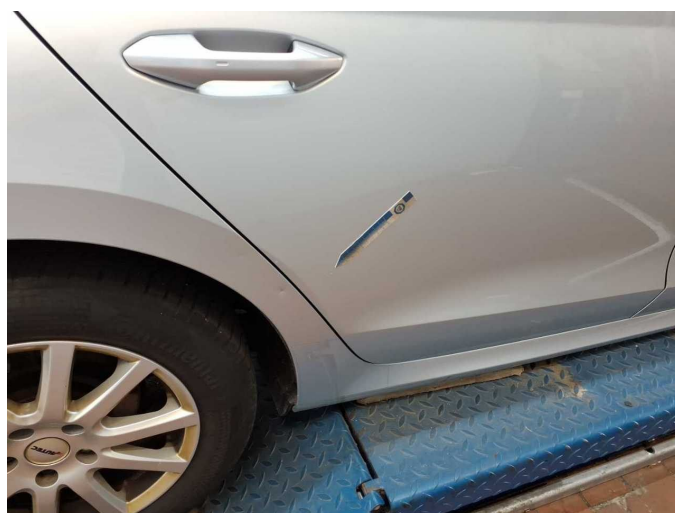
| No. | Component group | Description |
|---|---|---|
| 12 | Door - rear right side | Door - Scratch(es) - Paint |

**Damage 12:** Door - rear right side: Door - Scratch(es) - Paint

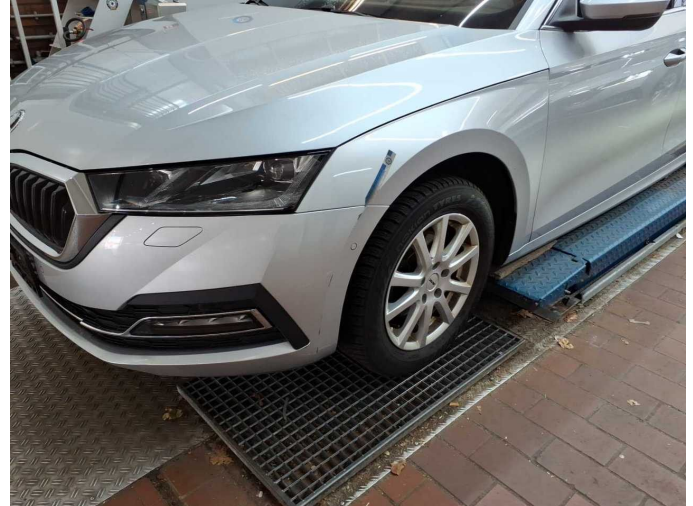
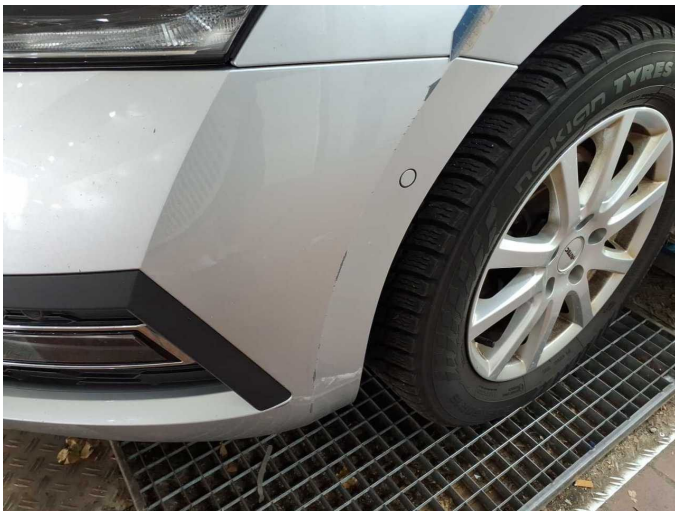
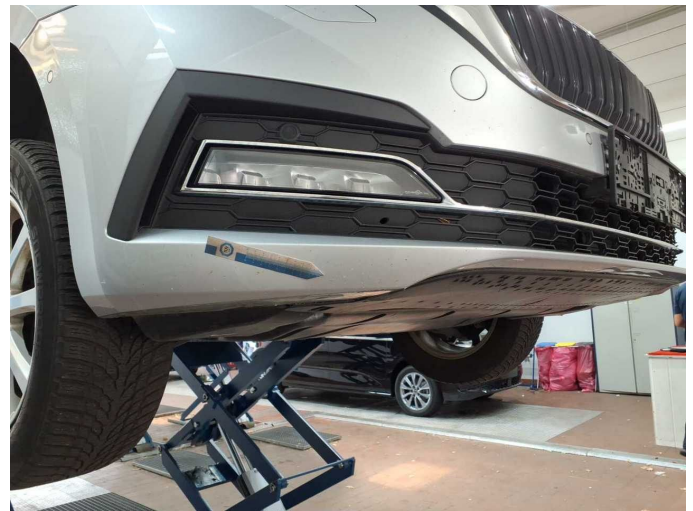
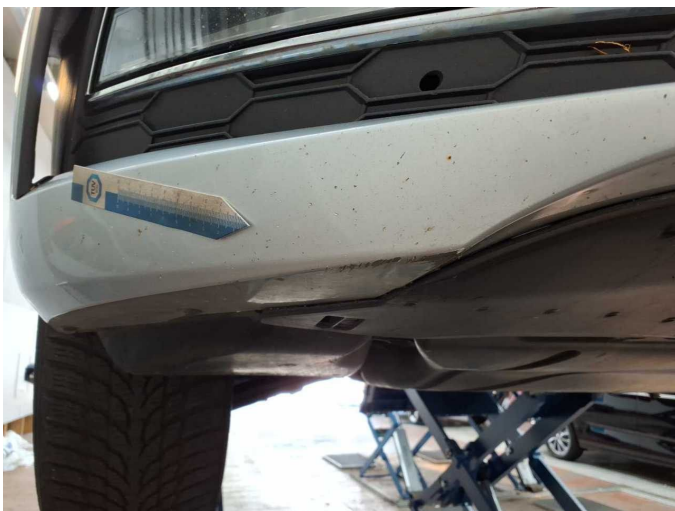
| No. | Component group | Description |
|---|---|---|
| 13 | Front bumper | Front bumper - Scratch(es) - Paint |

**Damage 13:** Front bumper: Front bumper - Scratch(es) - Paint

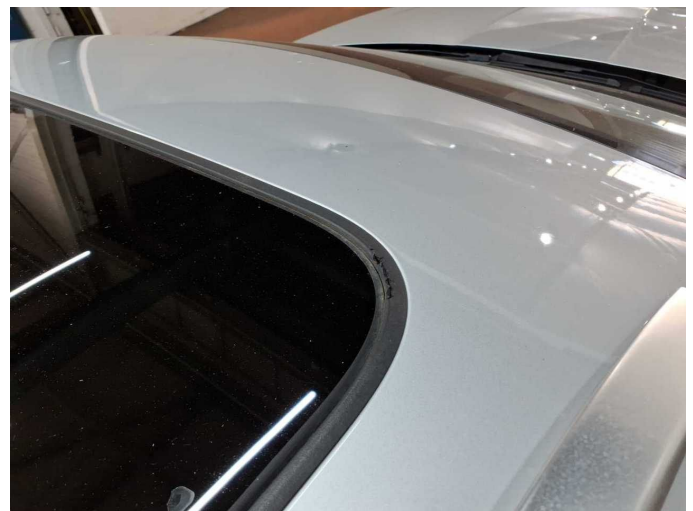
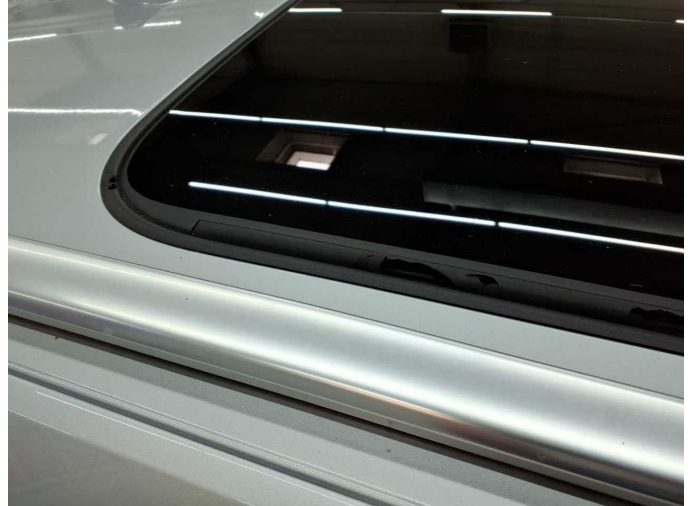
| No. | Component group | Description |
|---|---|---|
| 14 | Roof | Roof hatch / sliding roof - seal - Broken / torn - Replace |

**Damage 14:** Roof: Roof hatch / sliding roof - seal - Broken / torn - Replace

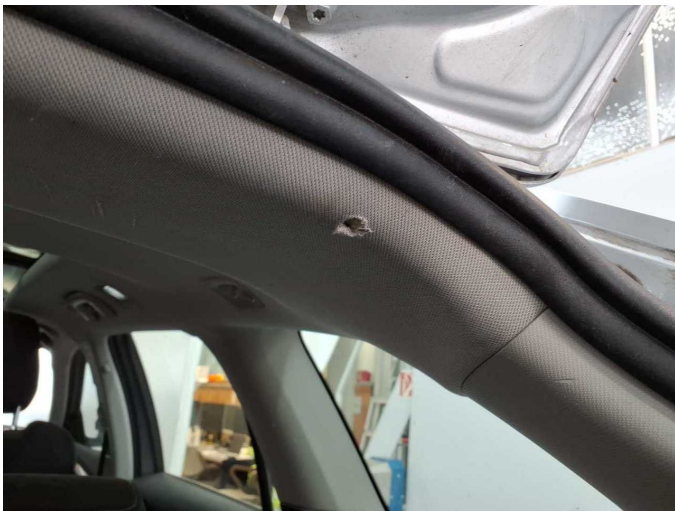
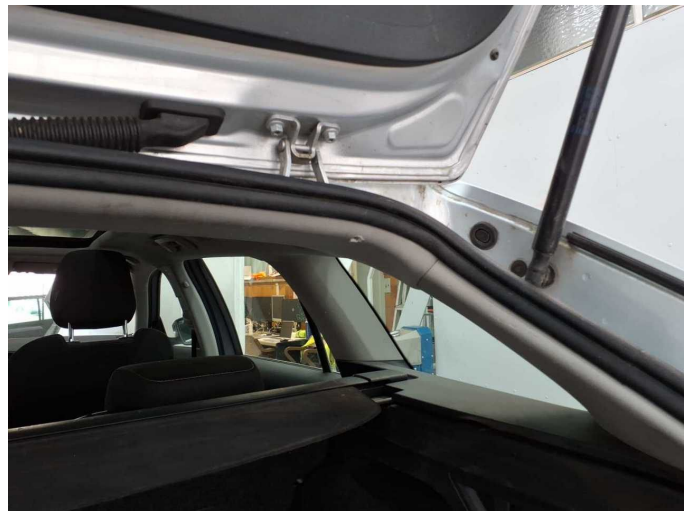
| No. | Component group | Description |
|---|---|---|
| 15 | Trim / covers | Roof lining - Holes - Replace |

**Damage 15:** Trim / covers: Roof lining - Holes - Replace

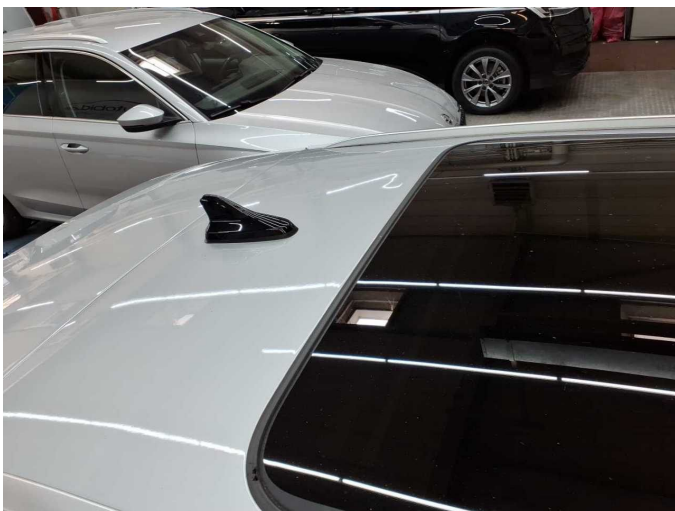
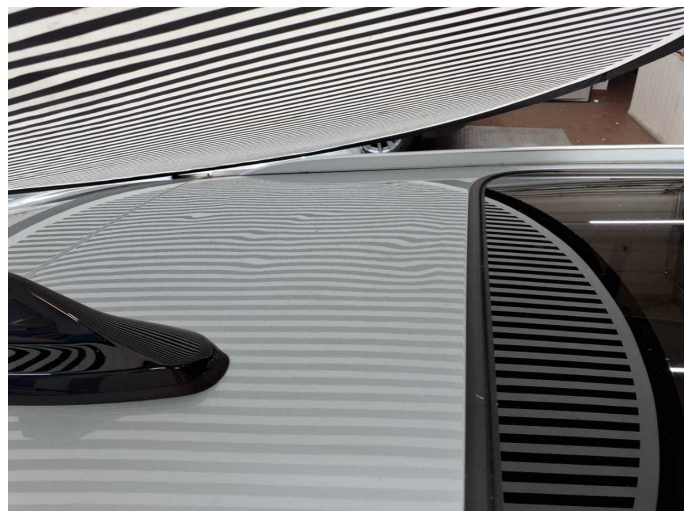
| No. | Component group | Description |
|---|---|---|
| 16 | Roof | Roof - Deformed - Repair and paint |

**Damage 16:** Roof: Roof - Deformed - Repair and paint

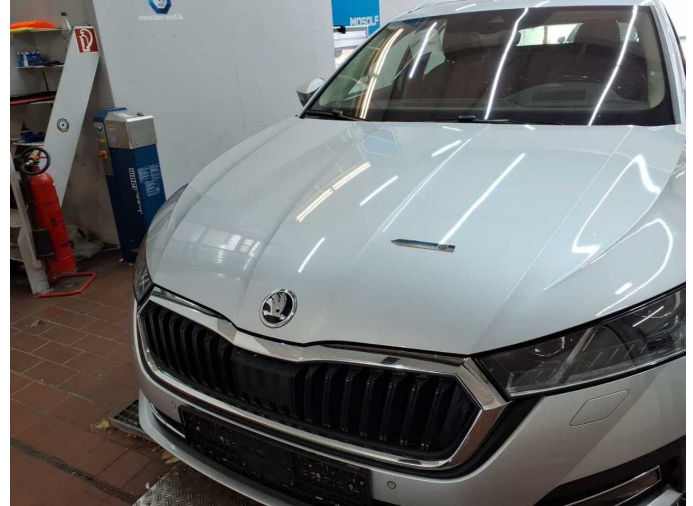
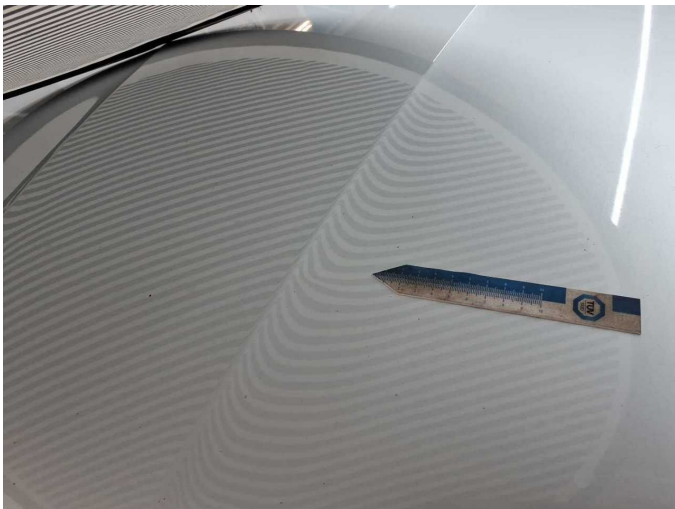
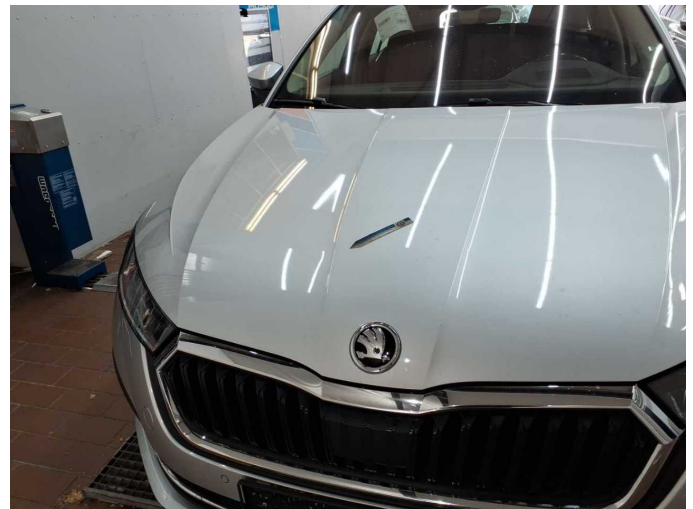
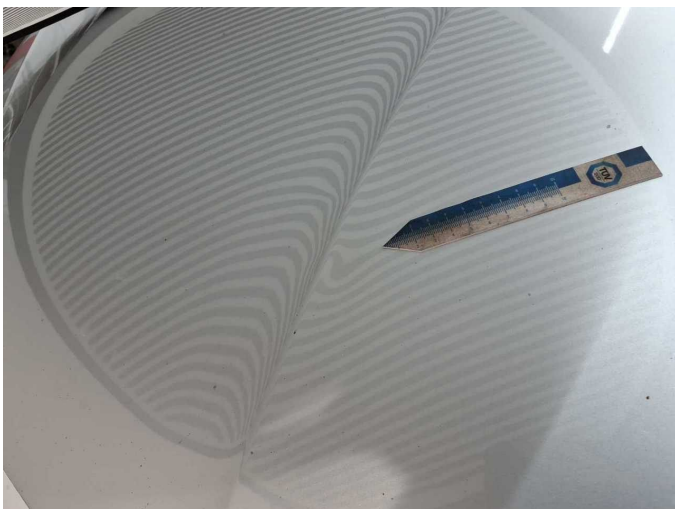
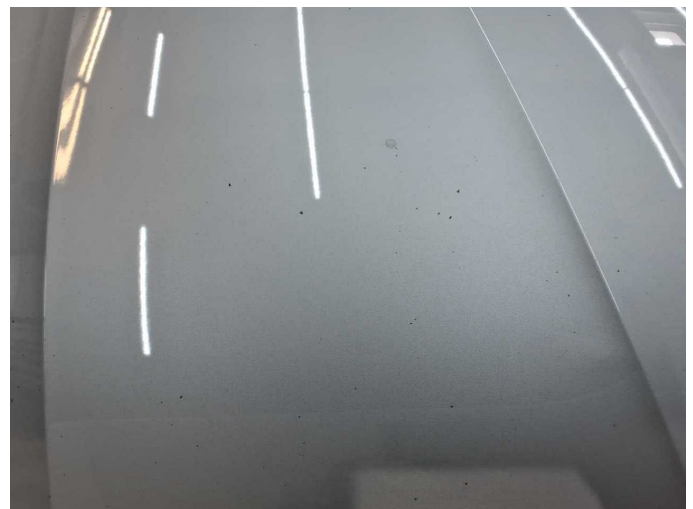
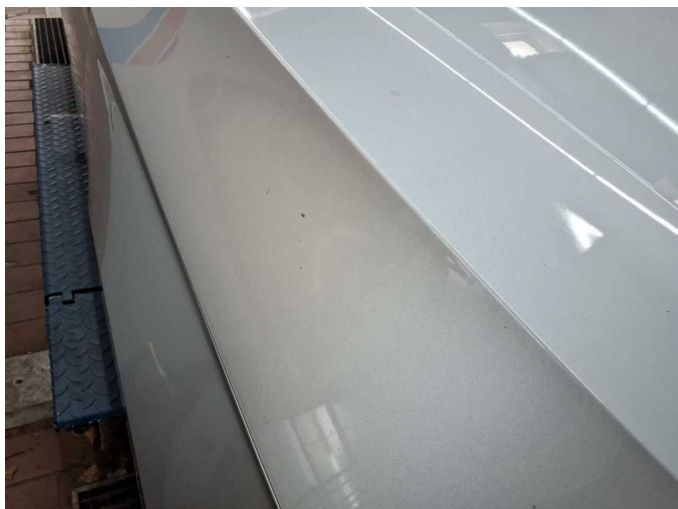
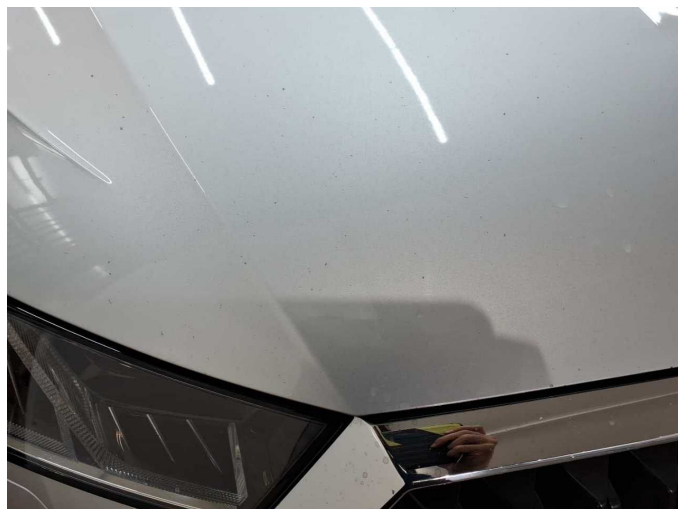
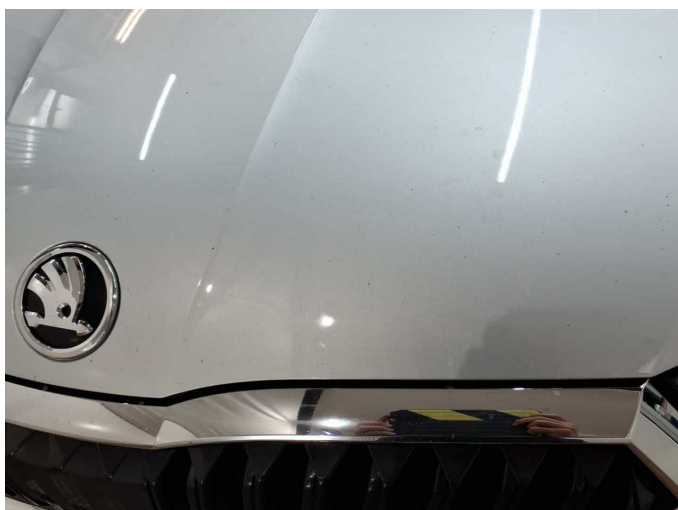
| No. | Component group | Description |
|---|---|---|
| 17 | Bonnet | Bonnet - Dent / paintcoat damage - Repair and paint |

**Damage 17:** Bonnet: Bonnet - Dent / paintcoat damage - Repair and paint

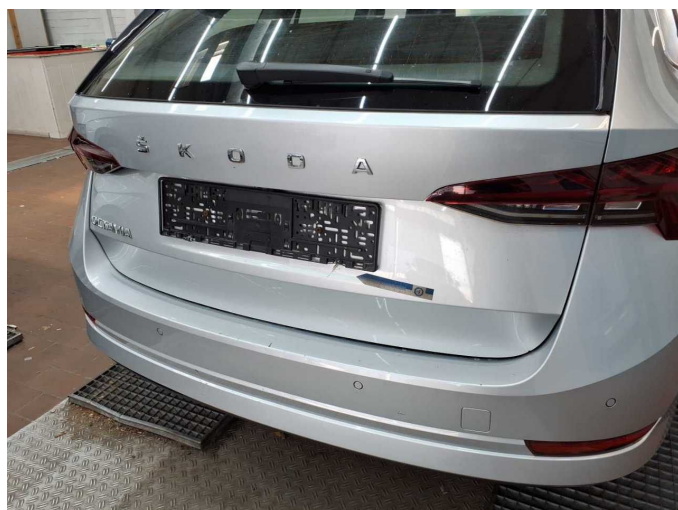
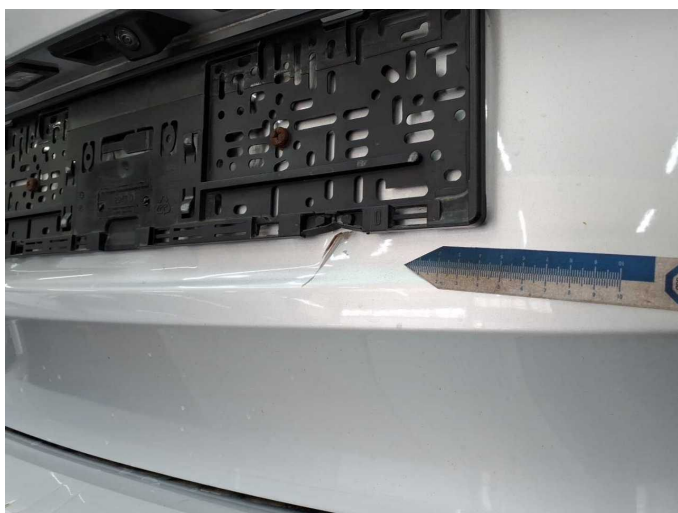
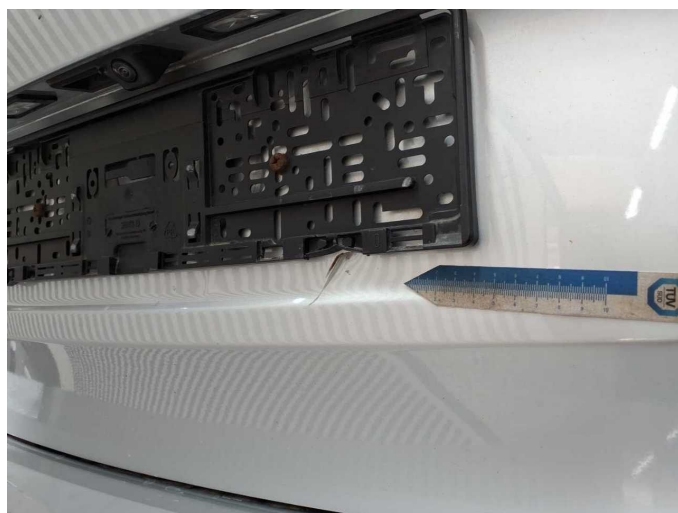
| No. | Component group | Description |
|---|---|---|
| 18 | Boot lid / rear door | Boot lid (Mit Korrosion) - Dent / paintcoat damage - Repair and paint |

**Damage 18:** Boot lid / rear door: Boot lid (Mit Korrosion) - Dent / paintcoat damage - Repair and paint
