Expertise

Protocol number: 46628723  
Order No. / Reference: 26631783  
Inspection date: 14 Jul 2026

Manufacturer: Skoda  
VIN: TMBJJ8NX8NY029003

Model: Octavia Combi 2.0 TDI DSG Style

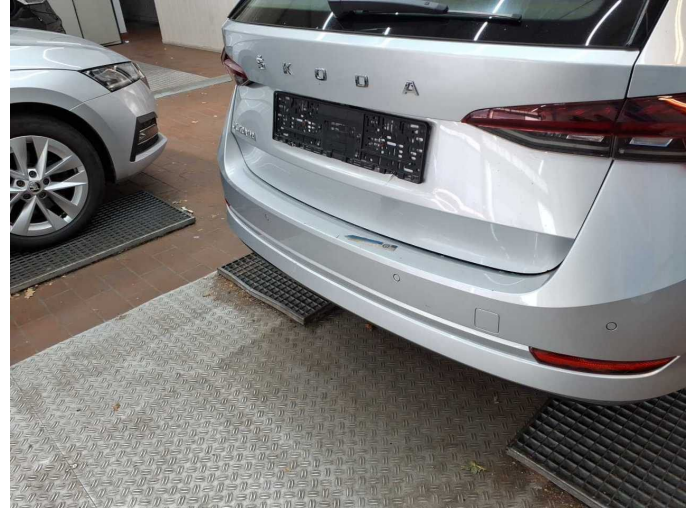
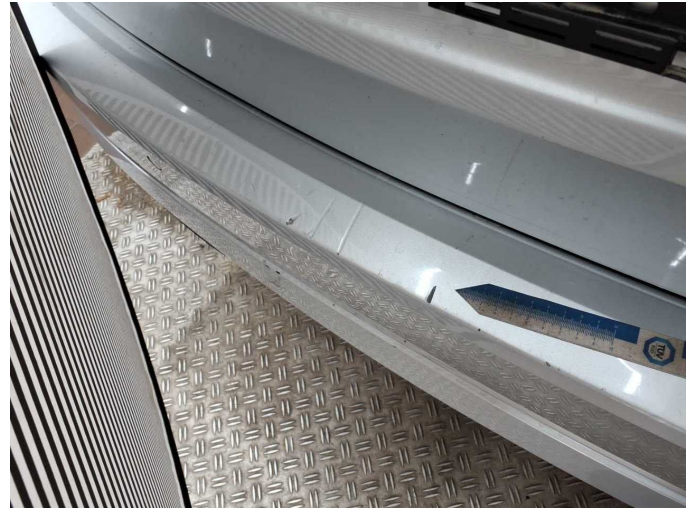
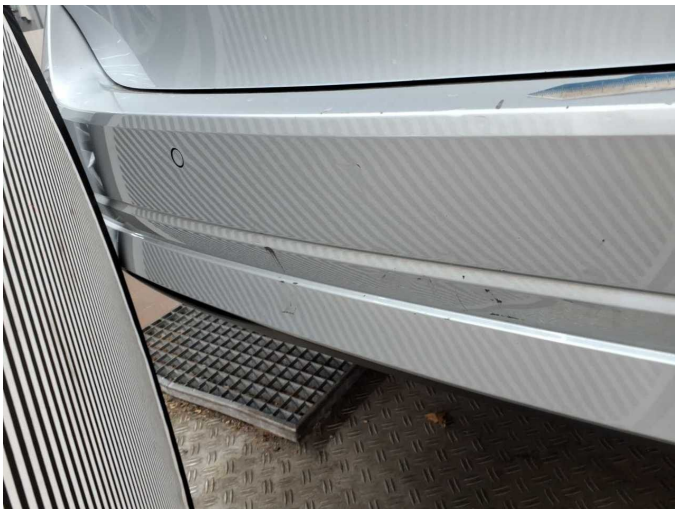
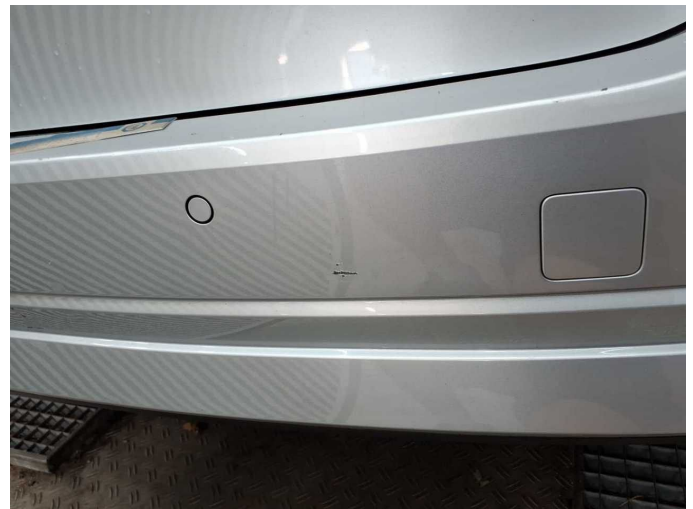
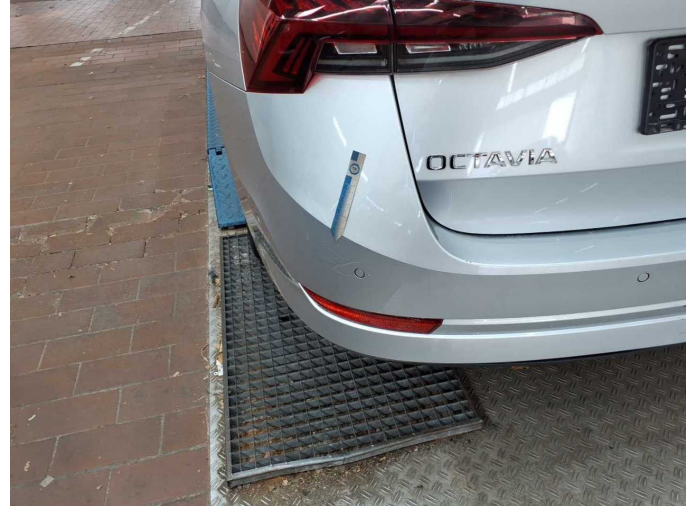
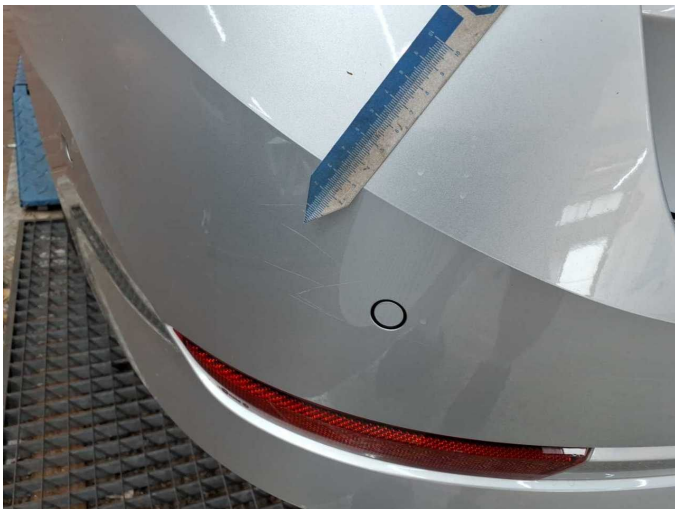
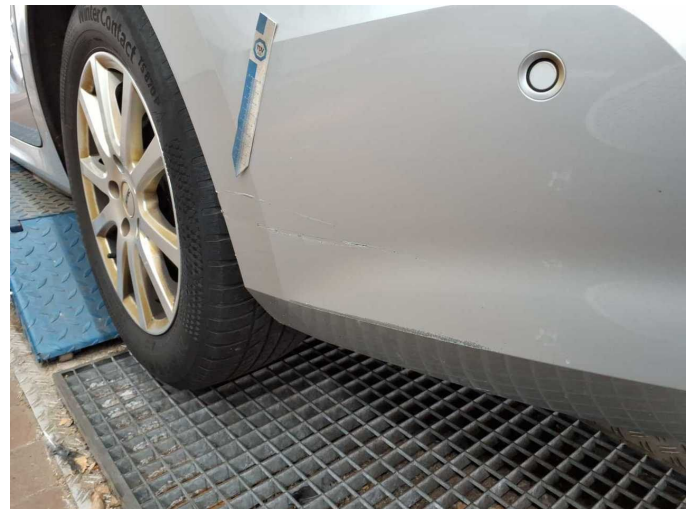
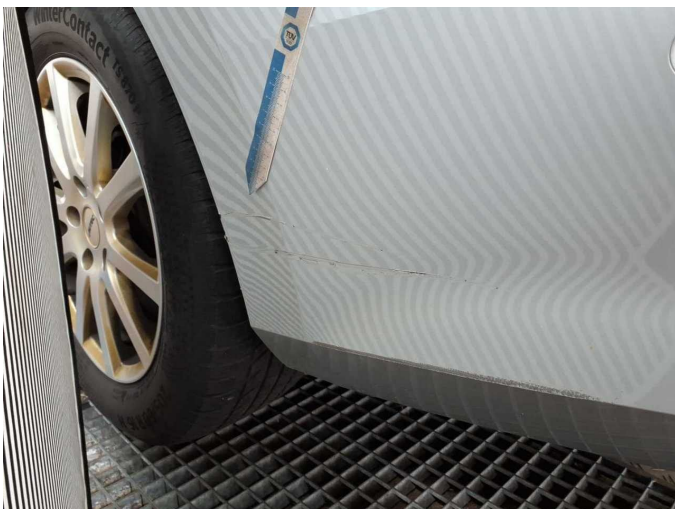
| No. | Component group | Description |
|---|---|---|
| 19 | Rear bumper | Rear bumper - Dent / paintcoat damage - Replace |

**Damage 19:** Rear bumper: Rear bumper - Dent / paintcoat damage - Replace

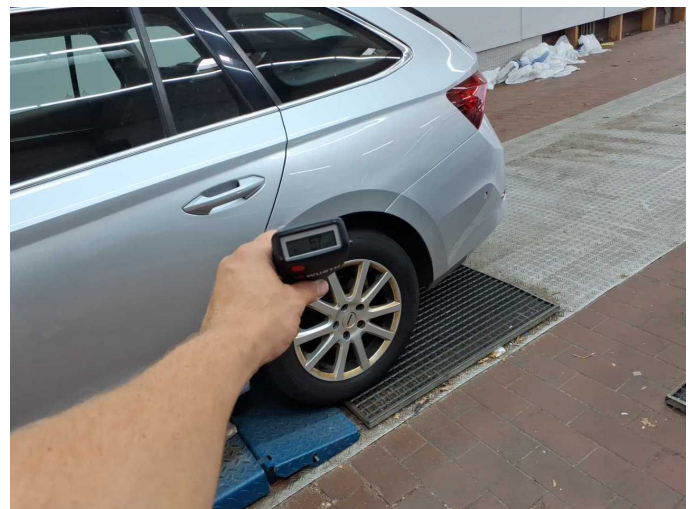
**Repainting 1:** Side panel - rear left side

| 1 | Side panel - rear left side, Professionally carried out, Invoice of repair done Non-existent |

| Side panel - rear left side | 57 µm |
