## Expertise

Protocol number: 45921890  
Order No. / Reference: 26461263  
Inspection date: 12 Jun 2026

Model: Astra Sports Tourer 1.5 D Automatik Business Elegance

VIN: VXKFCYHZTP1099361

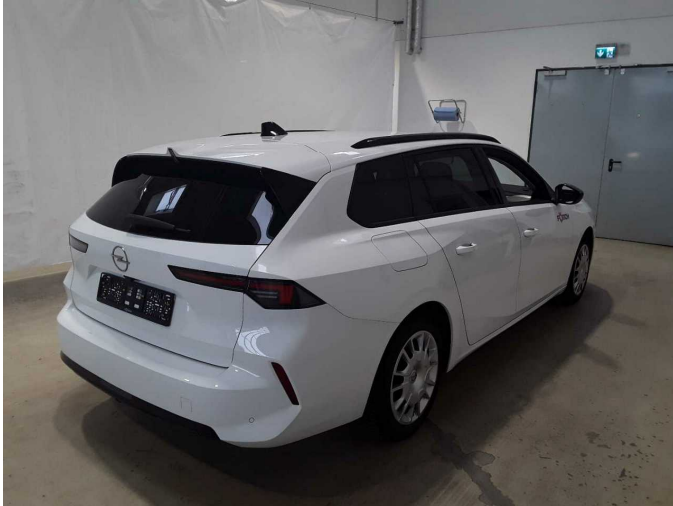
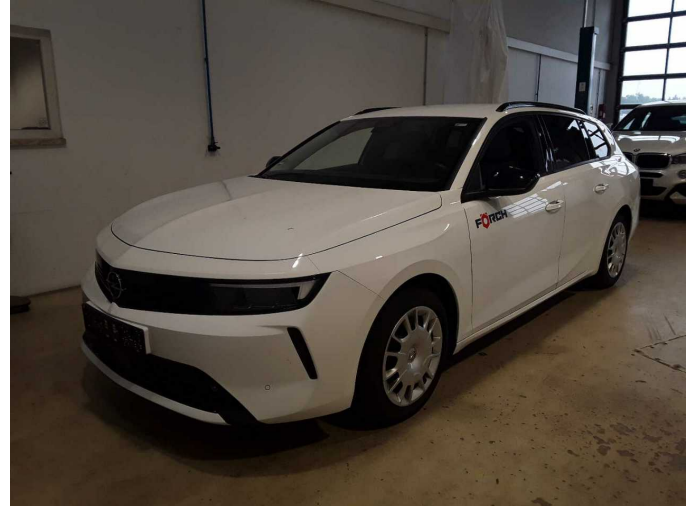
**Damage 1:** Body: Body - Glued / labelled - De-glue / neutralise

No.	Component group	Description
1	Body	Body - Glued / labelled - De-glue / neutralise
2	2nd wheel set	1 alloy rim - Scratch(es) - Loss in value

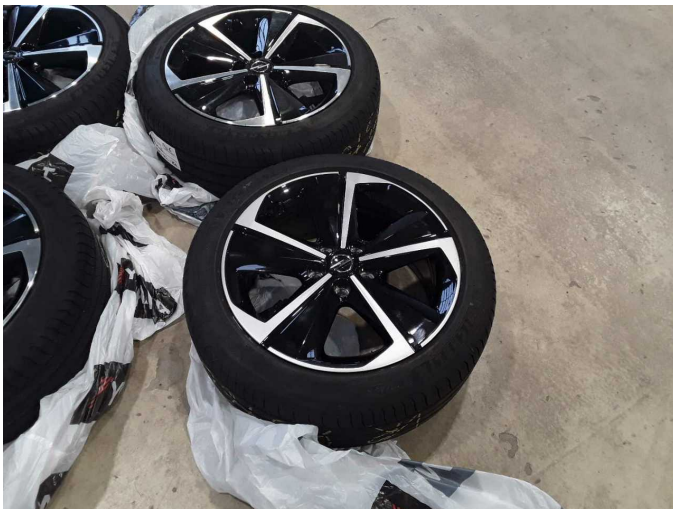
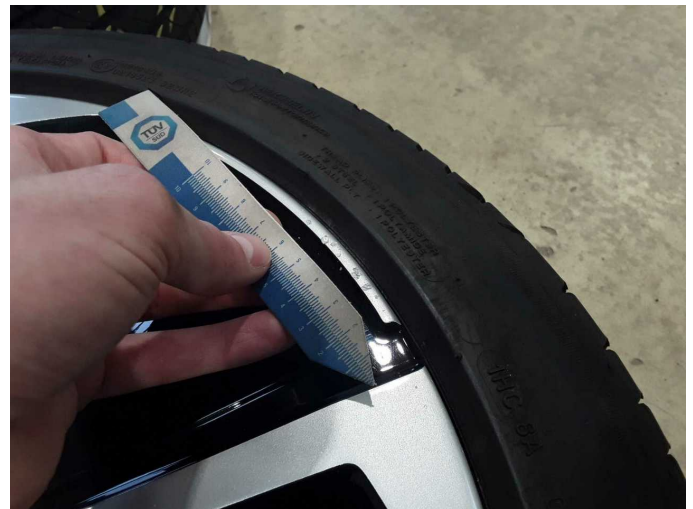
**Damage 2:** 2nd wheel set: 1 alloy rim - Scratch(es) - Loss in value

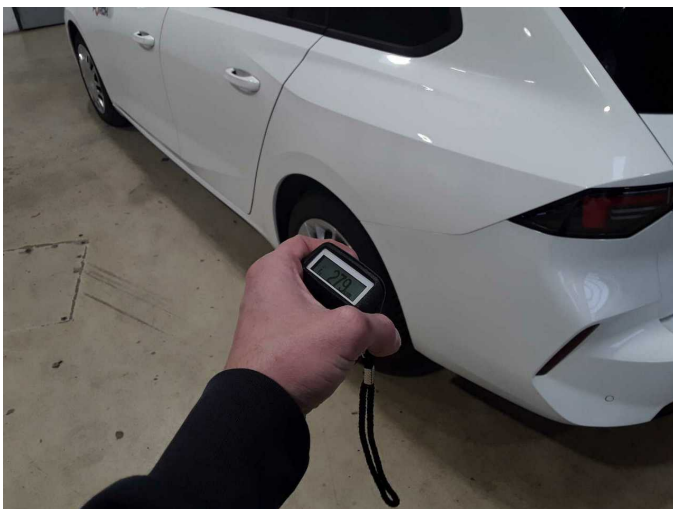
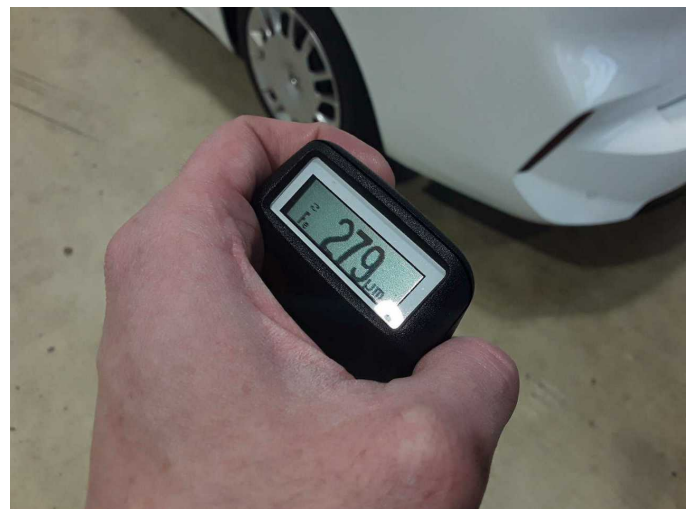
**Repainting 1:** Side panel - rear left side

No.	Repainting
1	Side panel - rear left side, Professionally carried out, Invoice of repair done Non-existent
2	Door - rear left side, Professionally carried out, Invoice of repair done Non-existent

Side panel - rear left side	279 µm	Door - rear left side	197 µm
-----------------------------	--------	-----------------------	--------

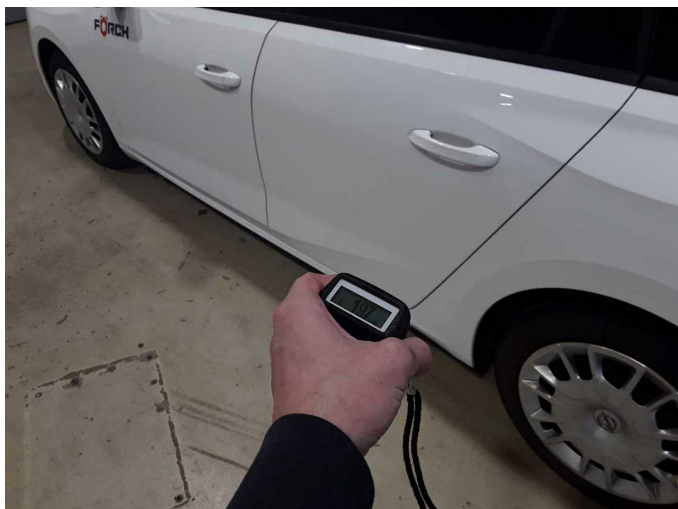
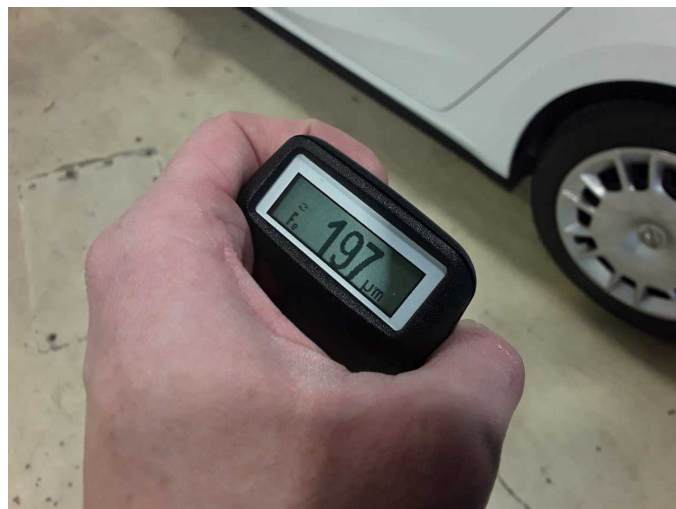
Repainting 2: Door - rear left side
