Expertise

Protocol number: 46674526  
Order No. / Reference: 26657732  
Inspection date: 23 Jul 2026

Manufacturer: Mercedes-Benz  
VIN: W1N9N0BB1PJ079148

Model: EQA 250 Progressive

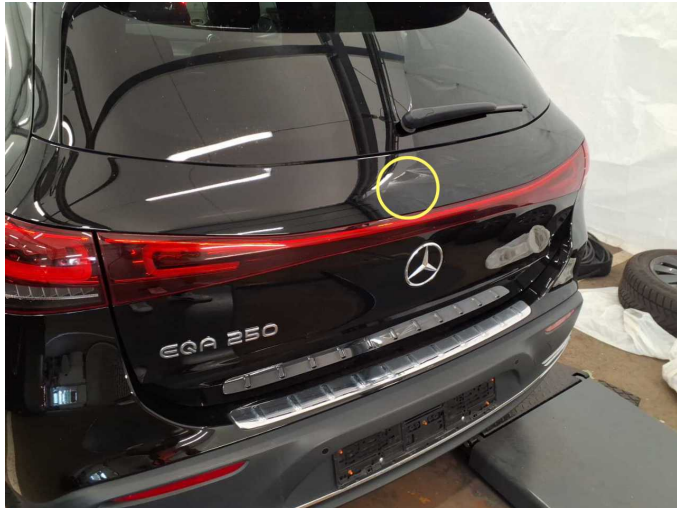
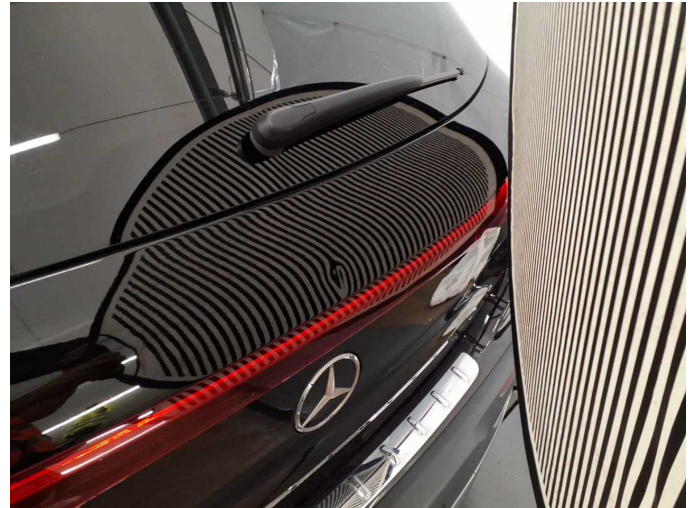
| No. | Component group | Description |
|---|---|---|
| 1 | Boot lid / rear door | Boot lid - dent(s) - Smooth repair work |

**Damage 1:** Boot lid / rear door: Boot lid - dent(s) - Smooth repair work

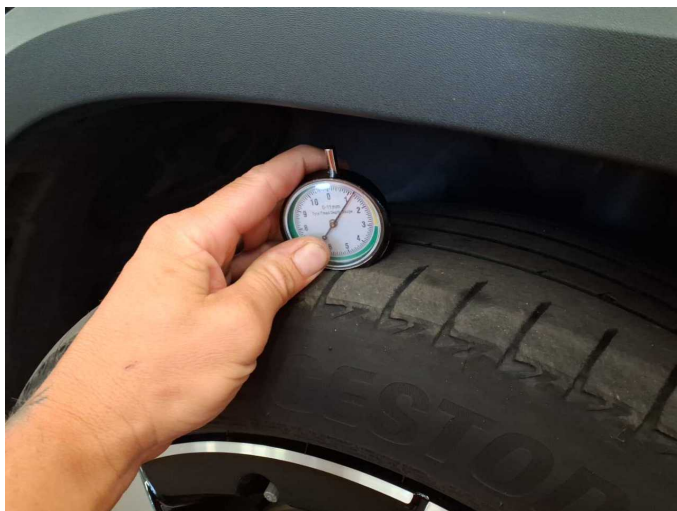
| No. | Component group | Description |
|---|---|---|
| 2 | Wheel / tyres | Alloy rim - front left side - Worn - Replace |

**Damage 2:** Wheel / tyres: Alloy rim - front left side - Worn - Replace

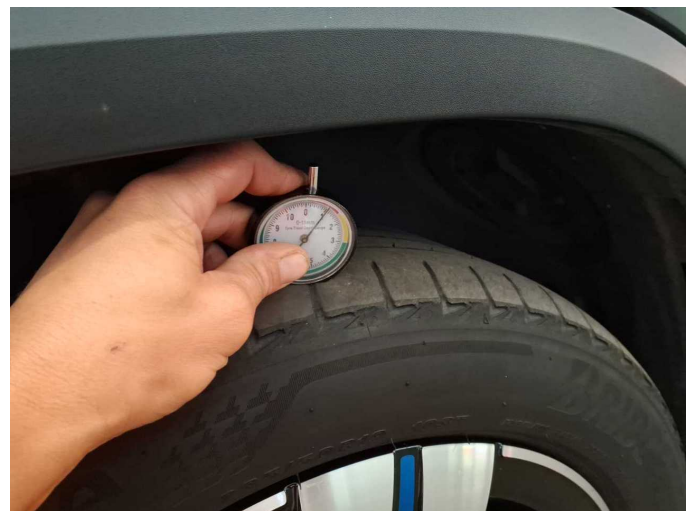
| No. | Component group | Description |
|---|---|---|
| 3 | Wheel / tyres | Tyre - front right side - Worn - Replace |

**Damage 3:** Wheel / tyres: Tyre - front right side - Worn - Replace

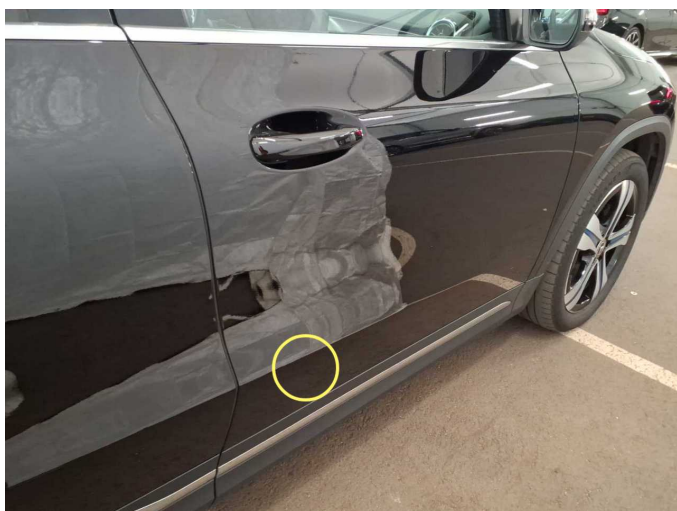
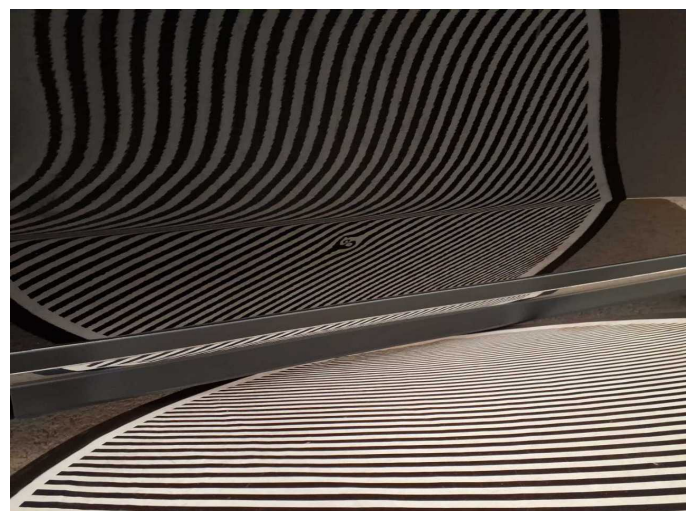
| No. | Component group | Description |
|---|---|---|
| 5 | Door - front right side | Door - dent(s) - No deduction |

**Wear and tear 5:** Door - front right side: Door - dent(s) - No deduction
