Expertise

Protocol number: 46505713  
Order No. / Reference: 26466691  
Inspection date: 8 Jul 2026

Manufacturer: Skoda  
VIN: TMBJW8NX5PY101084

Model: Octavia Combi 1.4 TSI iV DSG RS

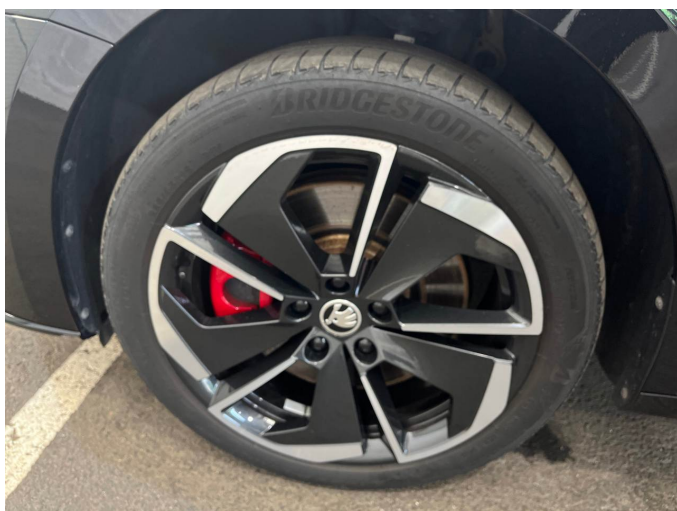
Figure 11: Mounted tyres

| Tyres | | | | |
|---|---|---|---|---|
| 1) | 225/45 R18 91Y | Summer tyres on Light alloy | Bridgestone | 3mm / 3mm |
| 2) | 225/45 R18 91Y | Summer tyres on Light alloy | Bridgestone | 4mm / 4mm |

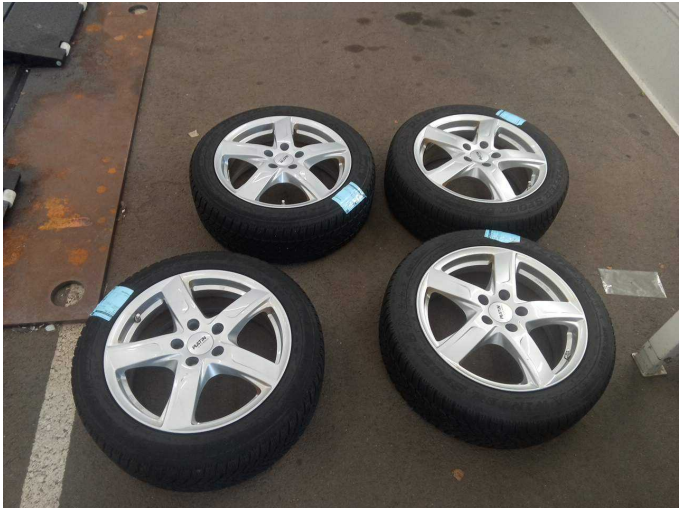
Figure 16: Additional tyres

| Tyres | | | | |
|---|---|---|---|---|
| 1) | 205/55 R17 95V | Winter tyres on Light alloy | Dunlop | 5mm / 5mm |
| 2) | 205/55 R17 95V | Winter tyres on Light alloy | Dunlop | 6mm / 6mm |

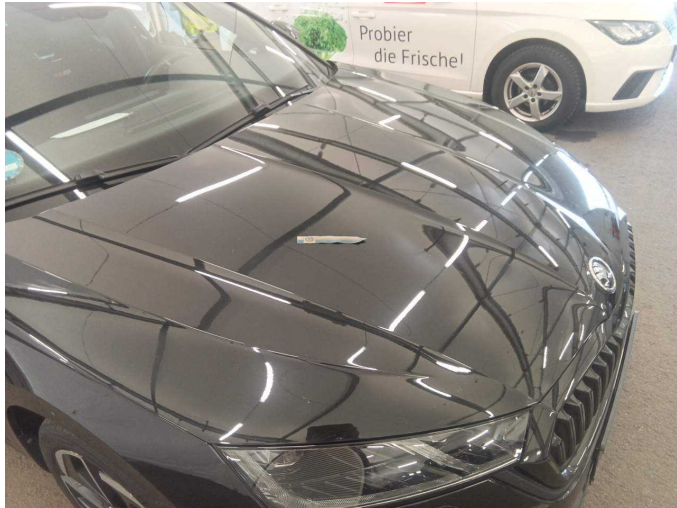
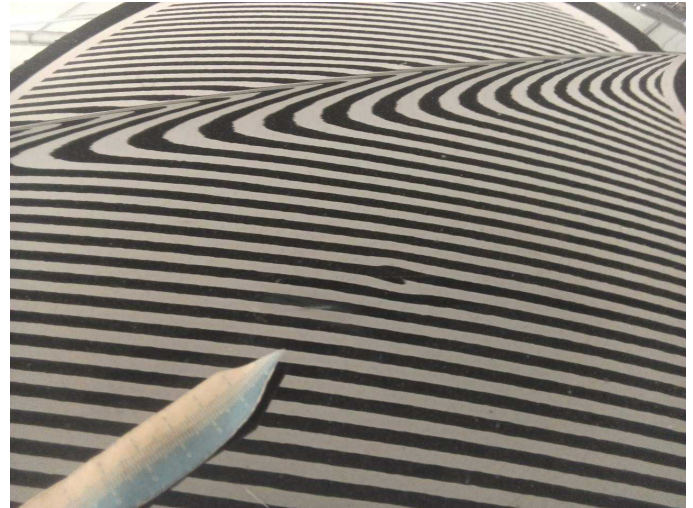
**Damage 1:** Bonnet: Bonnet - dent(s) - Smooth repair work

| No. | Component group | Description |
|---|---|---|
| 1 | Bonnet | Bonnet - dent(s) - Smooth repair work |

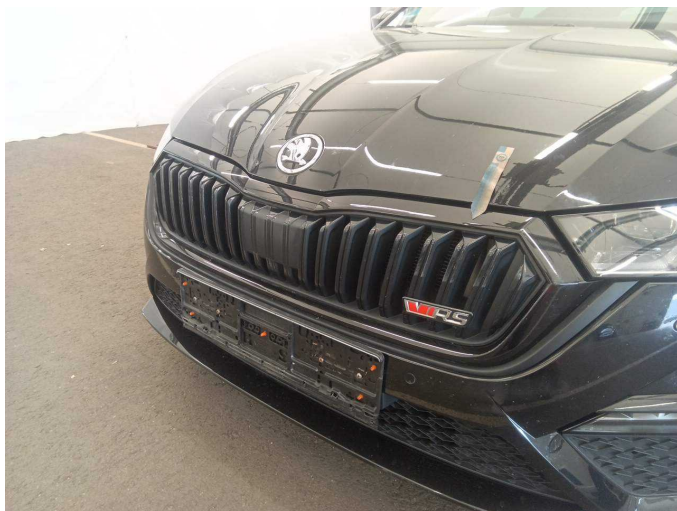
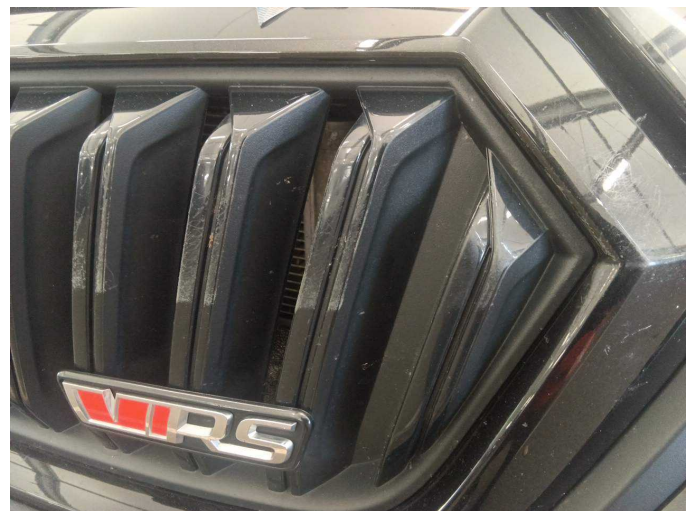
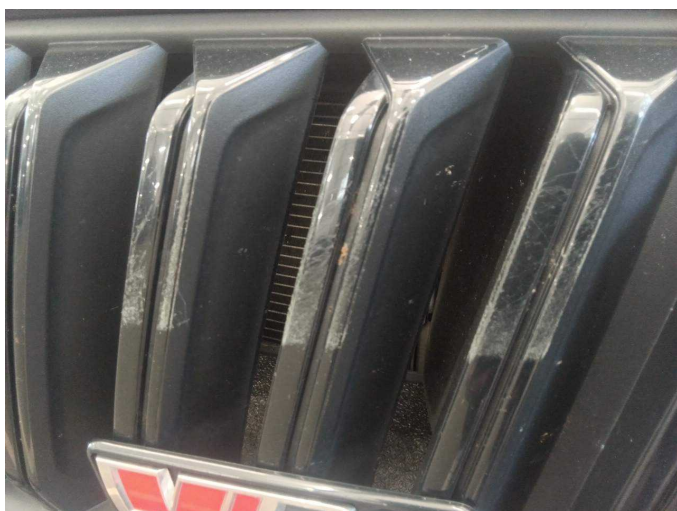
**Damage 2:** Bonnet: Radiator grille - Scratched - Replace

| No. | Component group | Description |
|---|---|---|
| 2 | Bonnet | Radiator grille - Scratched - Replace |

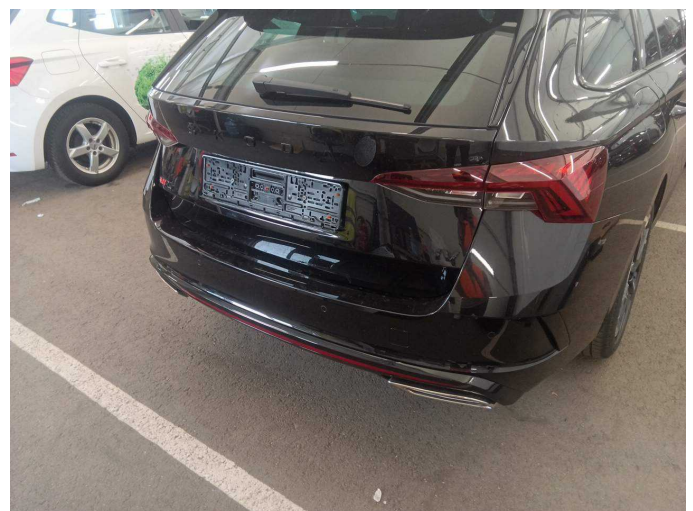
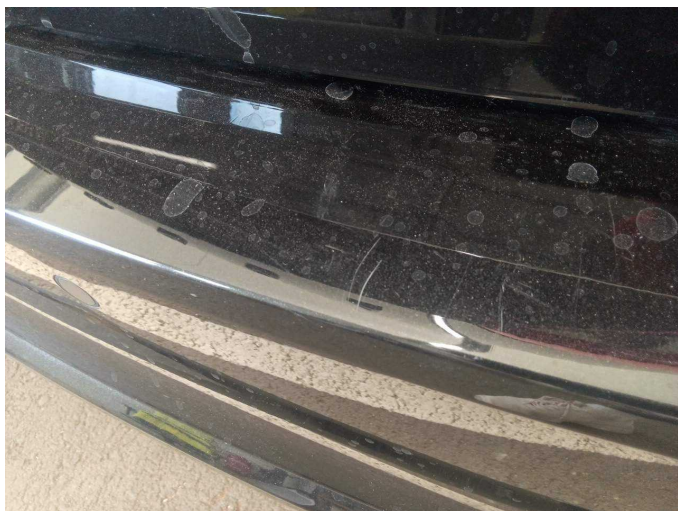
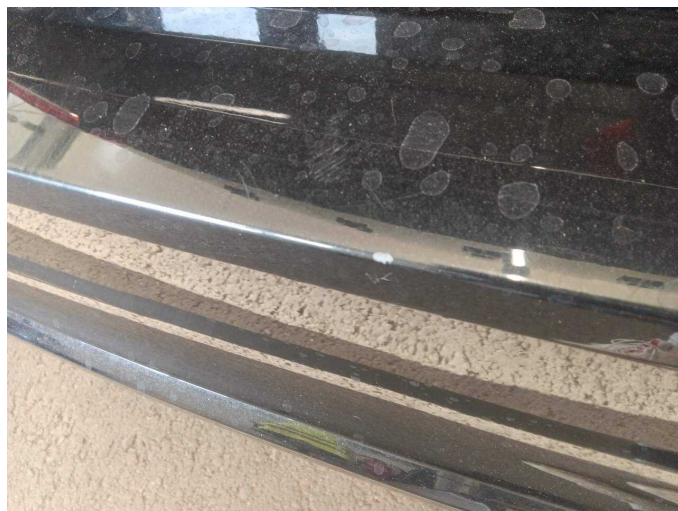
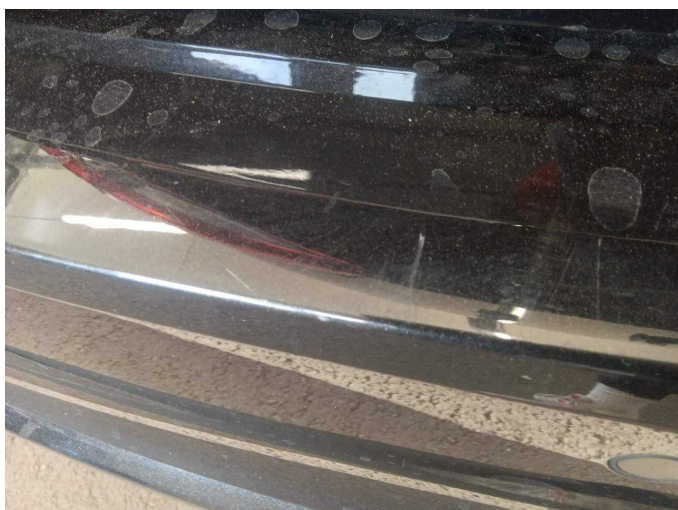
**Damage 3:** Rear bumper: Rear bumper - Scratch(es) - Paint

| No. | Component group | Description |
|---|---|---|
| 3 | Rear bumper | Rear bumper - Scratch(es) - Paint |

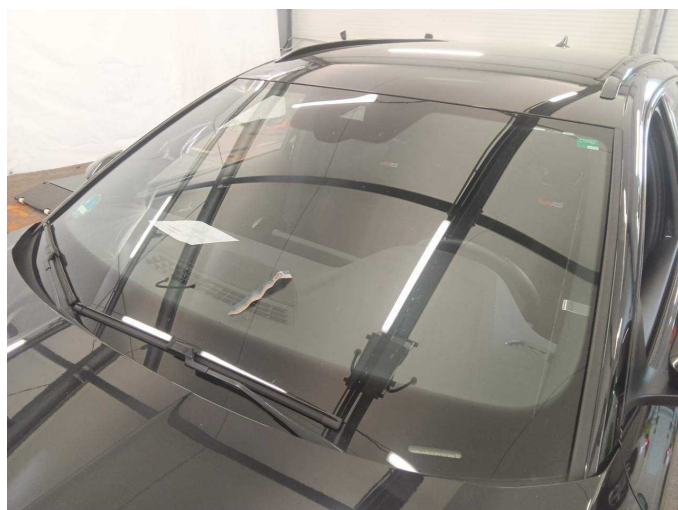
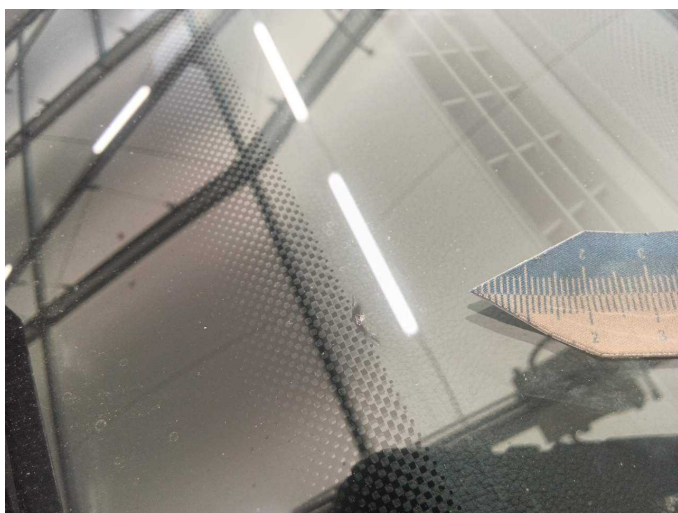
**Damage 4:** Vehicle glazing: Windscreen (Mit Rissbildung im Randbereich) - Stone chips - Replace

| No. | Component group | Description |
|---|---|---|
| 4 | Vehicle glazing | Windscreen (Mit Rissbildung im Randbereich) - Stone chips - Replace |
