Expertise

Protocol number: 46386936  
Order No. / Reference: 26543441  
Inspection date: 7 Jul 2026

Manufacturer: Skoda  
VIN: TMBLN7NSXP8045802

Model: Kodiah 2.0 TDI 4x4 DSG Sportline

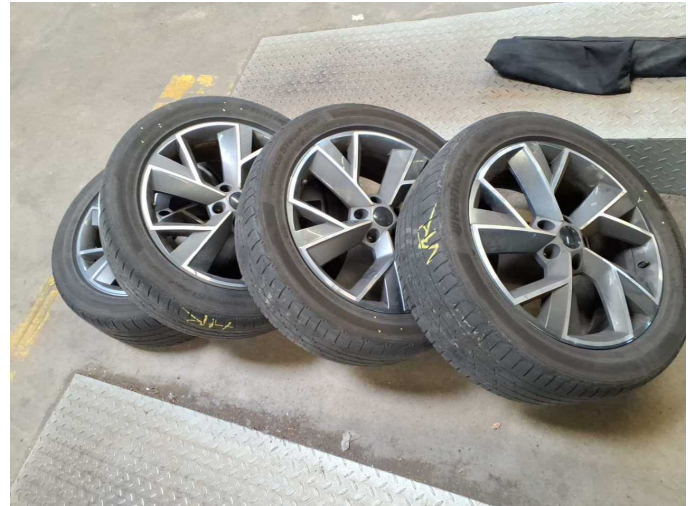
Figure 14: Additional tyres

| No. | Component group | Description |
|---|---|---|
| 7 | 2nd wheel set | 3 tyres (Flanke) - Damaged - Replace |

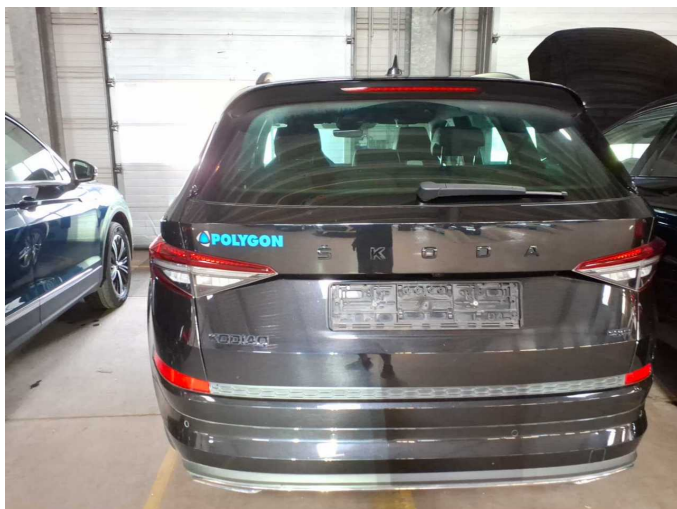
**Damage 2:** Boot lid / rear door: Boot lid - Glued / labelled - De-glue / neutralise

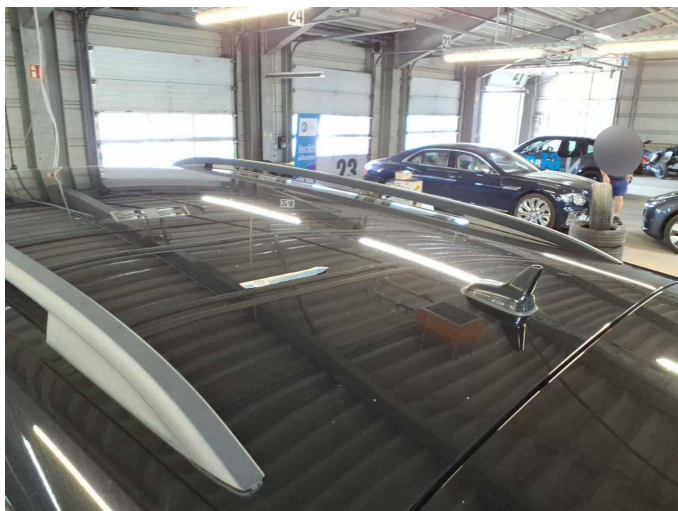
| No. | Component group | Description |
|---|---|---|
| 3 | Roof | Roof - dent(s) - Smooth repair work |

**Damage 3:** Roof: Roof - dent(s) - Smooth repair work

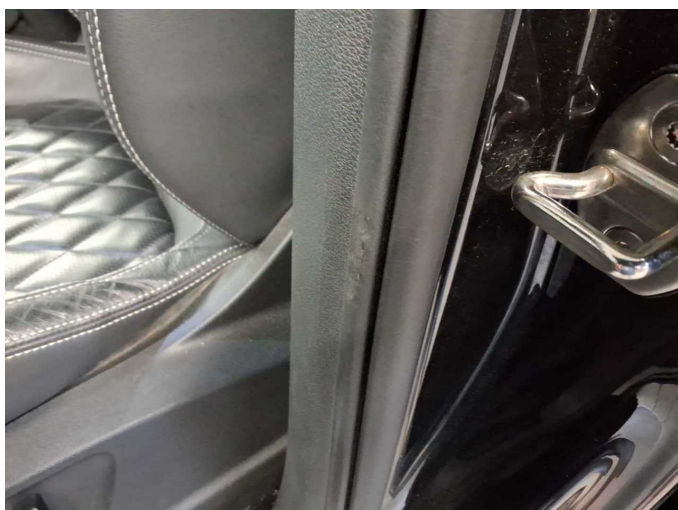
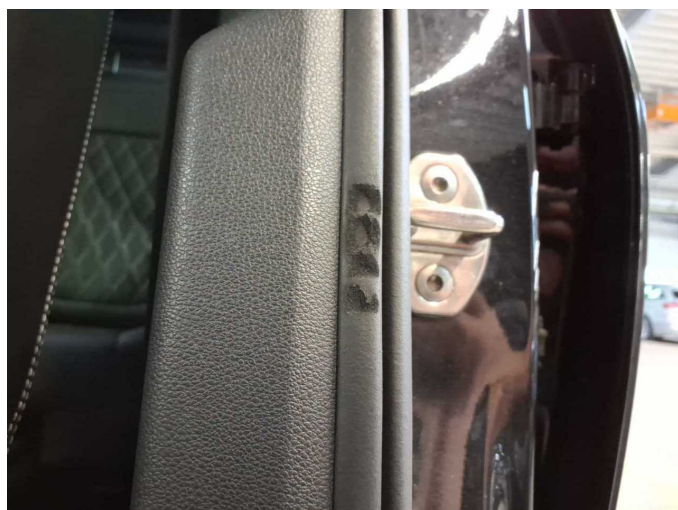
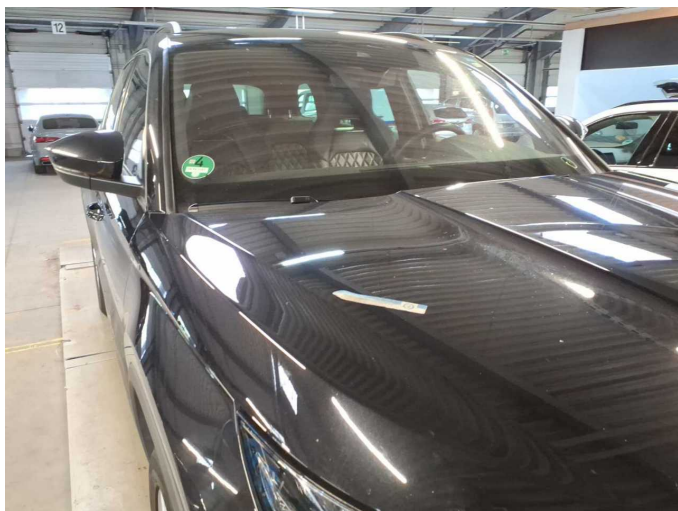
| No. | Component group | Description |
|---|---|---|
| 4 | Body | Door seal - front left side - Broken / torn - Replace |

**Damage 4:** Body: Door seal - front left side - Broken / torn - Replace

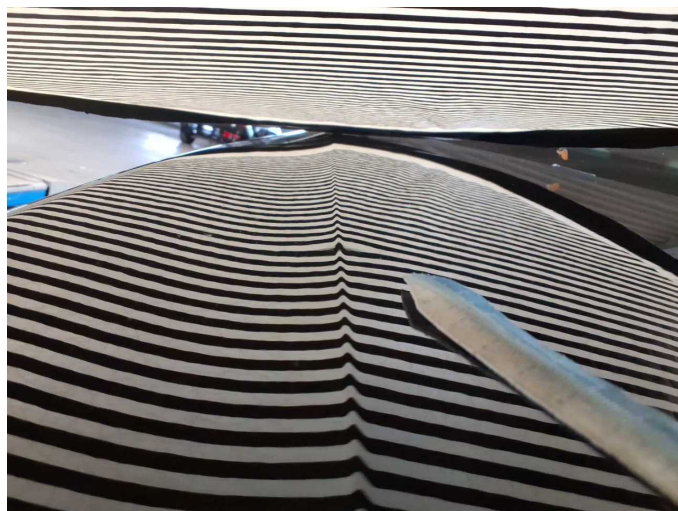
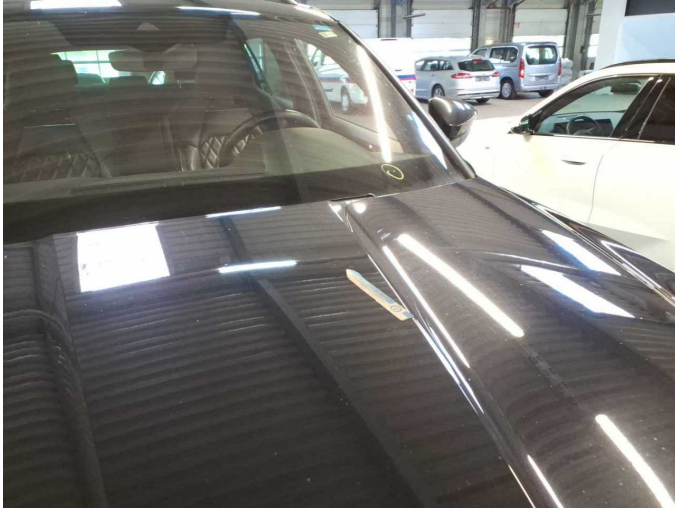
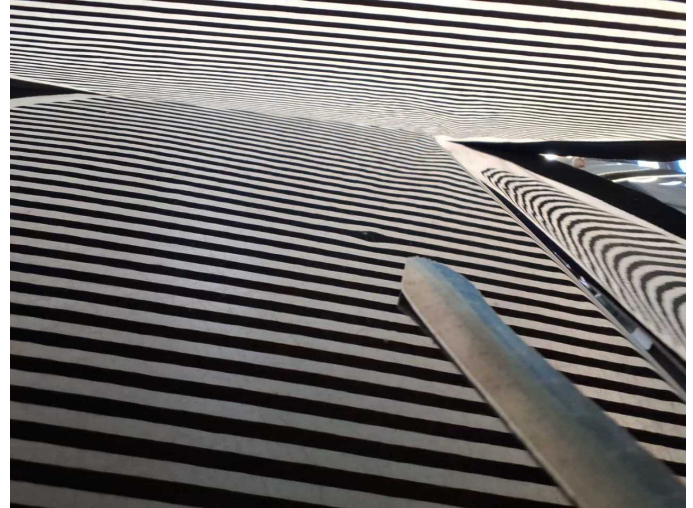
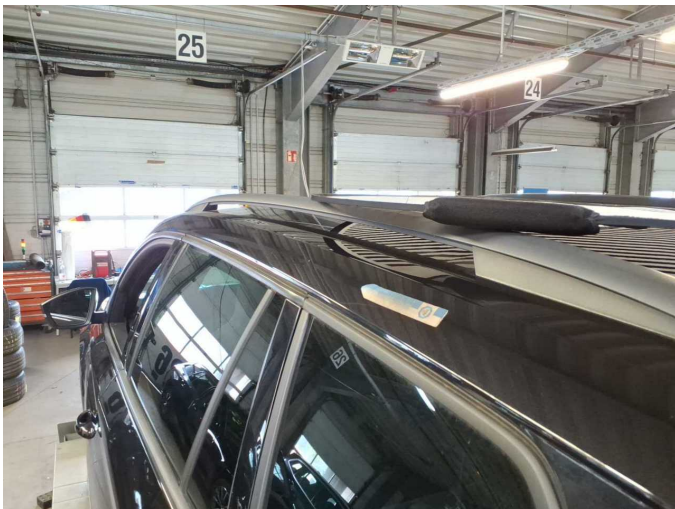
| No. | Component group | Description |
|---|---|---|
| 5 | Bonnet | Bonnet - dent(s) - Smooth repair work |

**Damage 5:** Bonnet: Bonnet - dent(s) - Smooth repair work

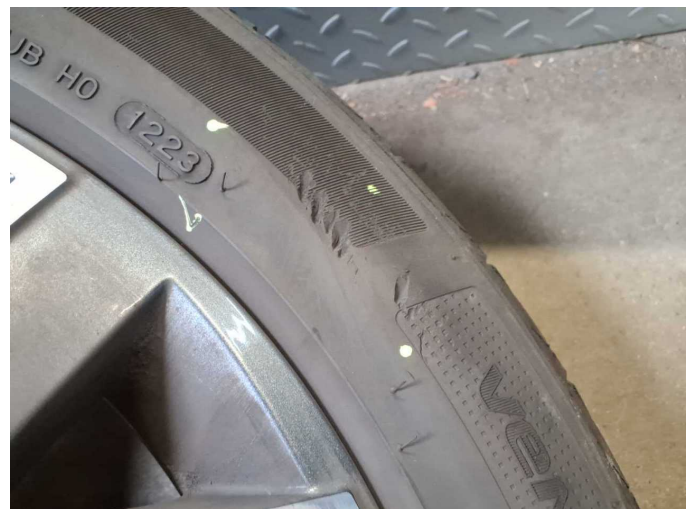
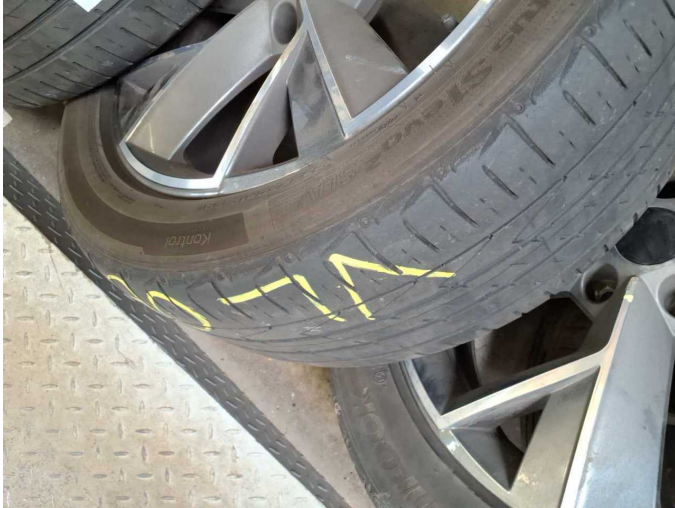
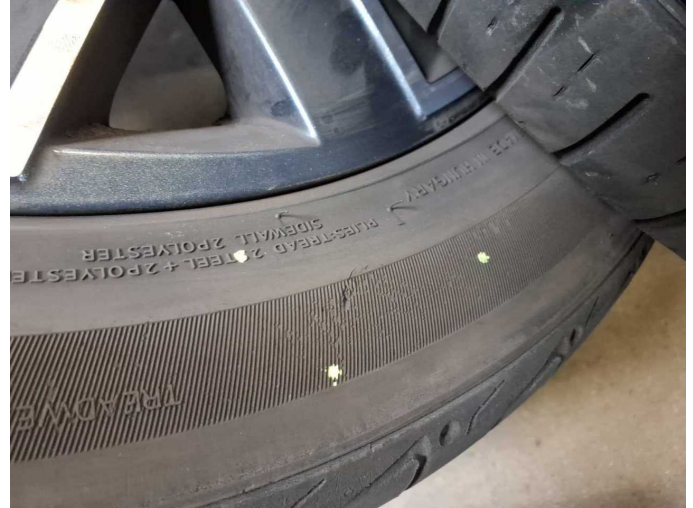
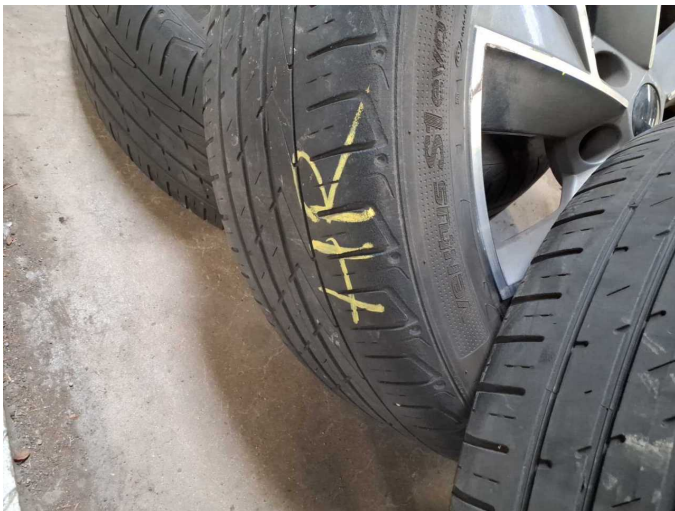
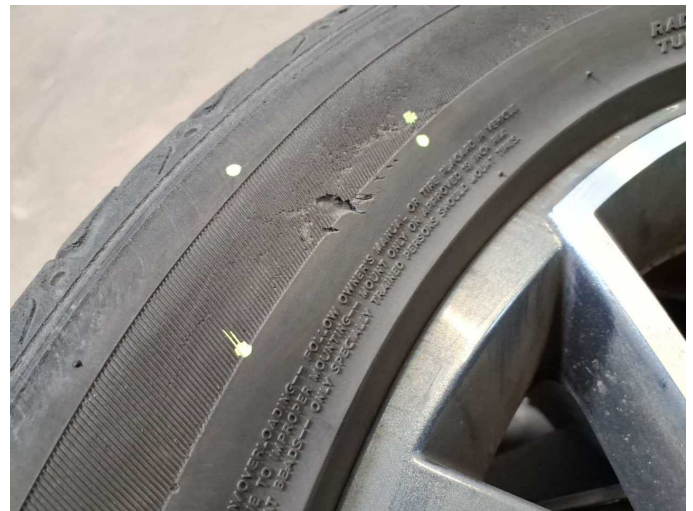
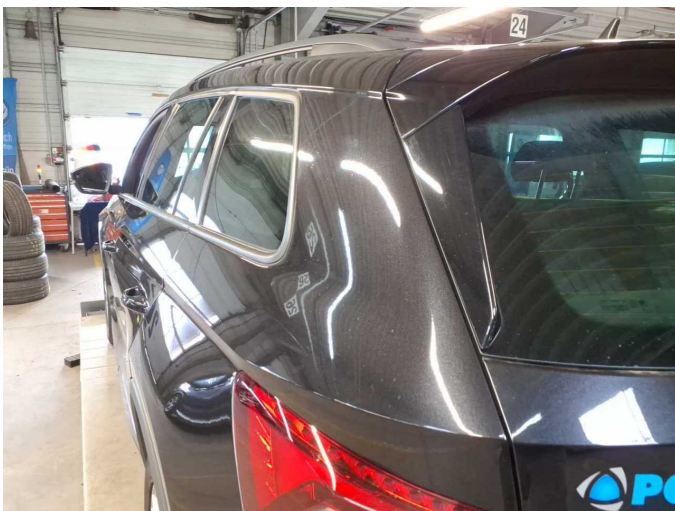
**Damage 7:** 2nd wheel set: 3 tyres (Flanke) - Damaged - Replace

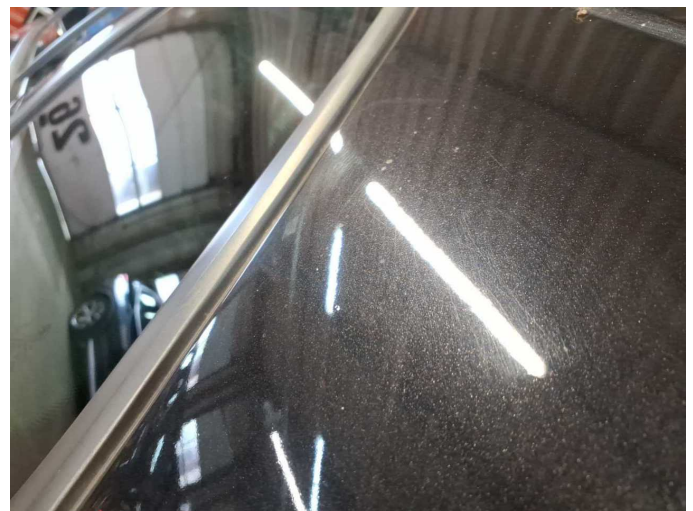
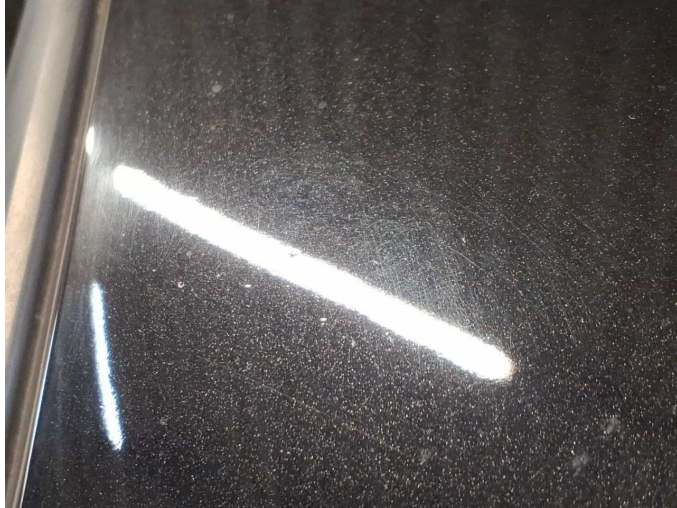
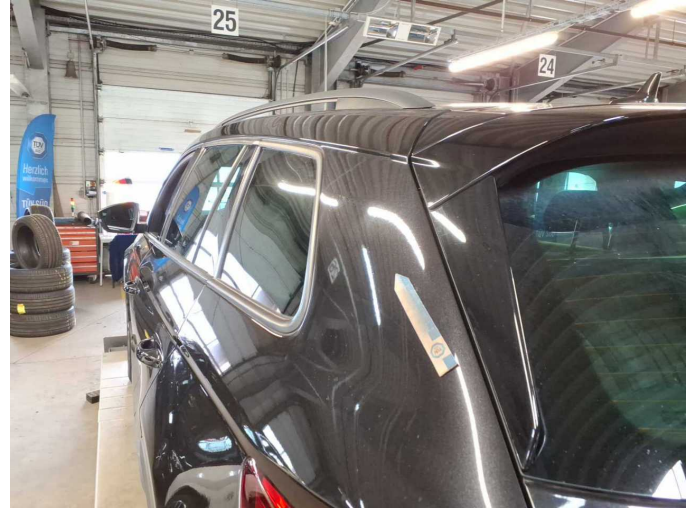
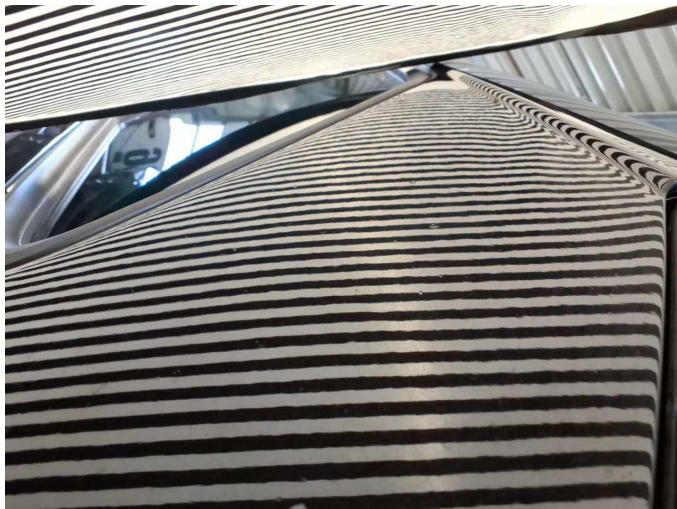
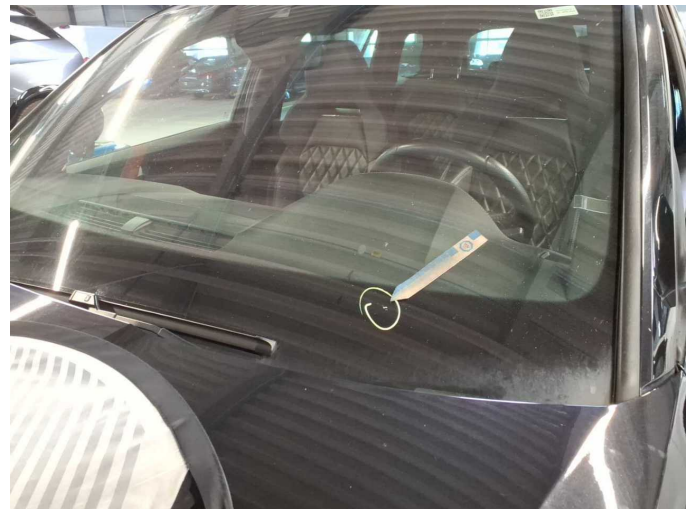
| No. | Component group | Description |
|---|---|---|
| 8 | Side panel - rear left side | Side panel (Einschlüsse) - Unprofessionally repaired - Repair and paint |

| No. | Previous damage | Extent of damage (Net) |
|---|---|---|
| 1 | Rear, Side - left, not professionally repaired, Invoice of repair done Non-existent, from 29 Oct 2024 | 5.936,94 € |

| Side panel - rear left side | 208 µm | Door - front left side | 166 µm |

**Damage 8:** Side panel - rear left side: Side panel (Einschlüsse) - Unprofessionally repaired - Repair and paint

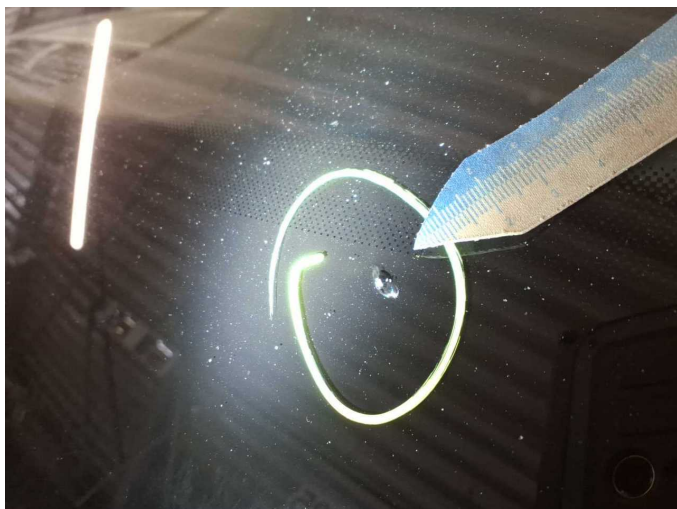
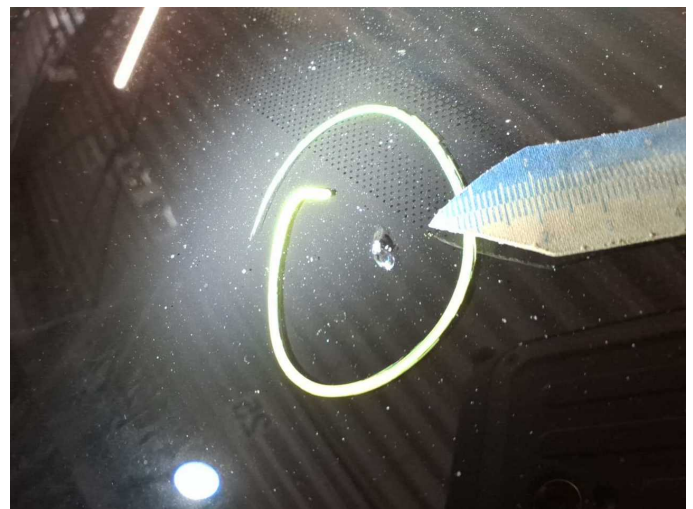
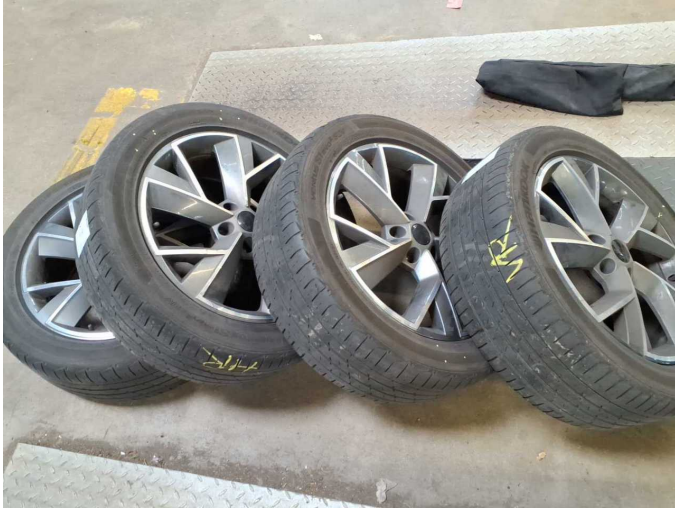
| No. | Component group | Description |
|---|---|---|
| 9 | Vehicle glazing | Windscreen with lane departure assistant (durch Steinschlag) - Broken / torn - Replace |

**Damage 9:** Vehicle glazing: Windscreen with lane departure assistant (durch Steinschlag) - Broken / torn - Replace

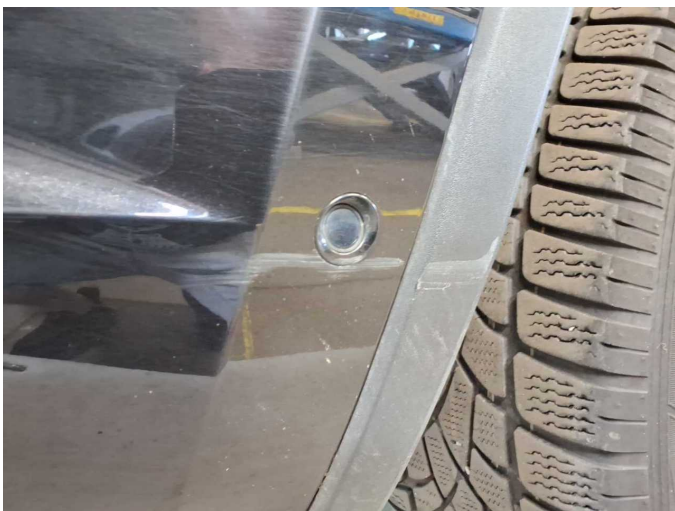
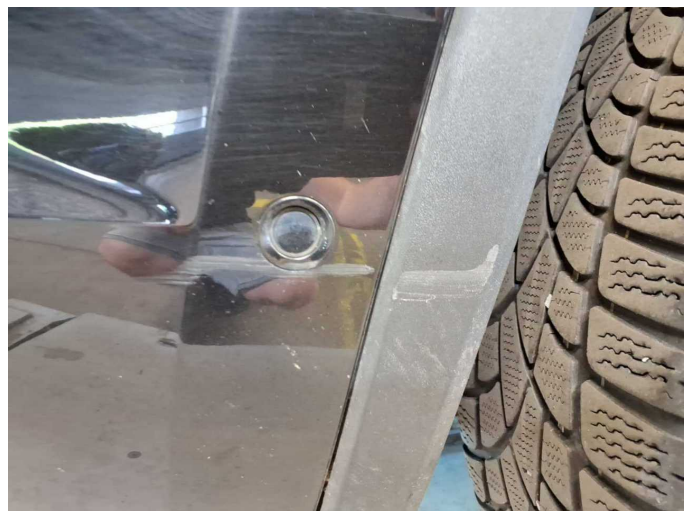
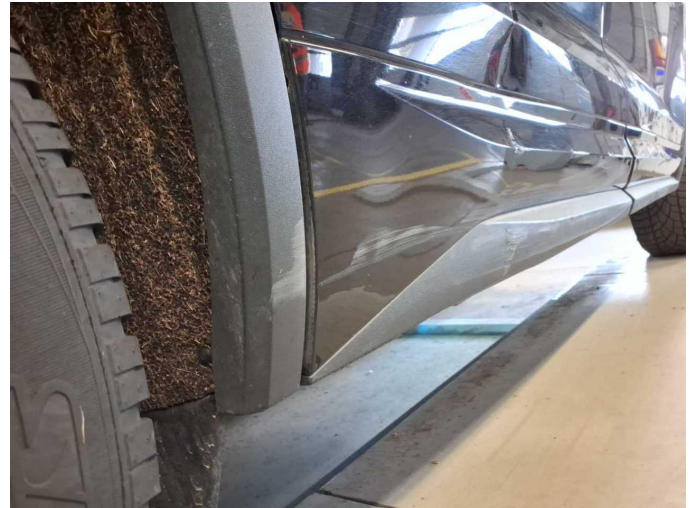
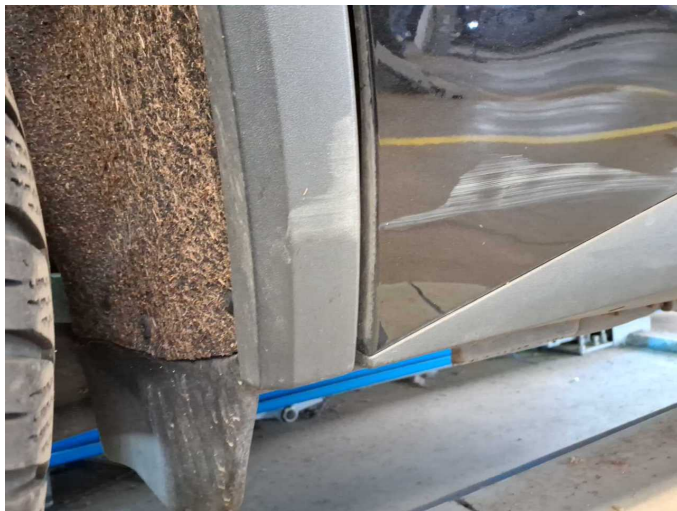
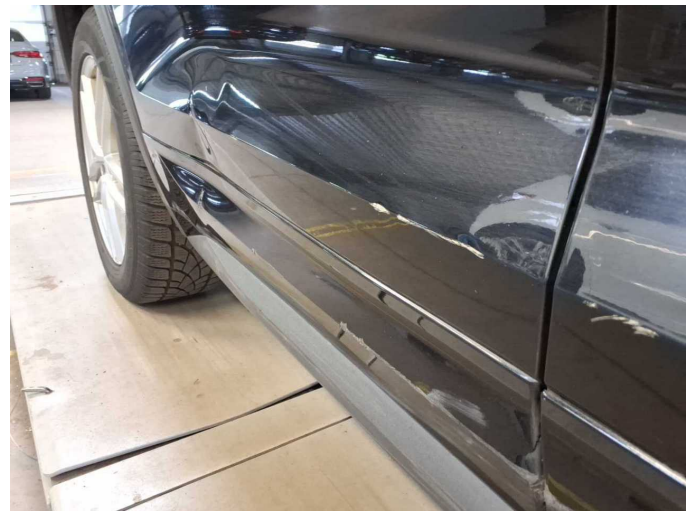
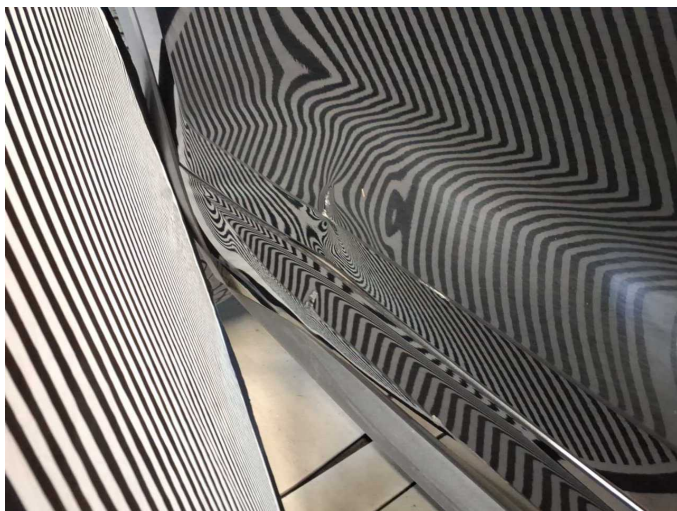
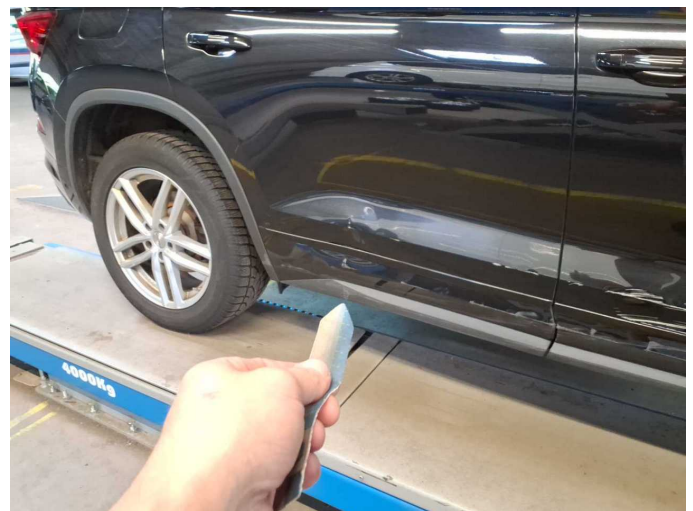
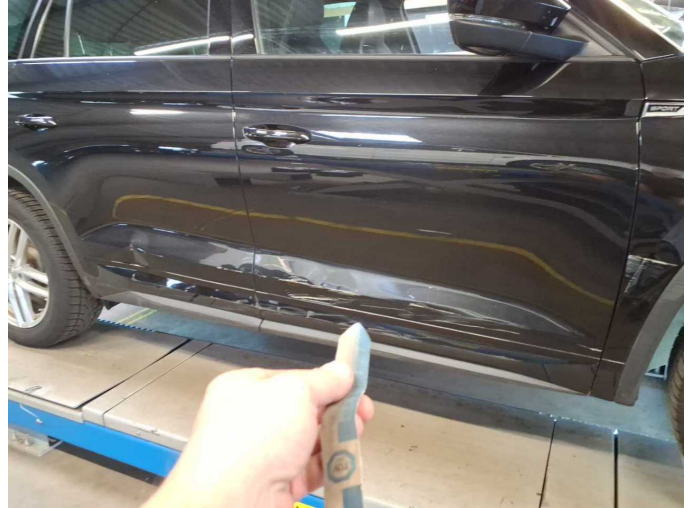
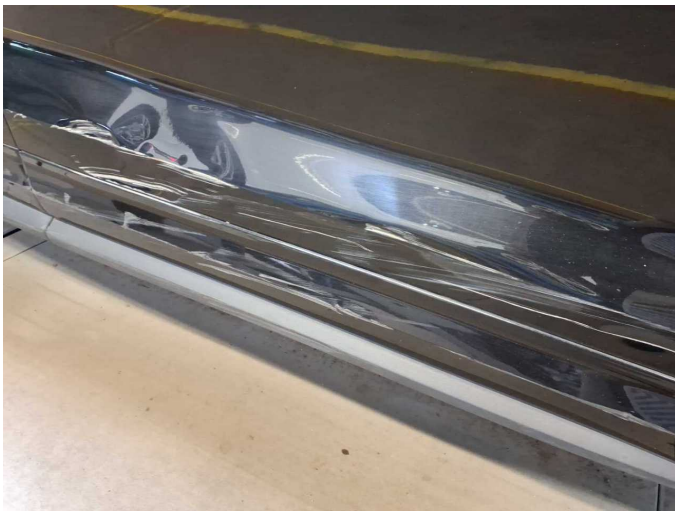
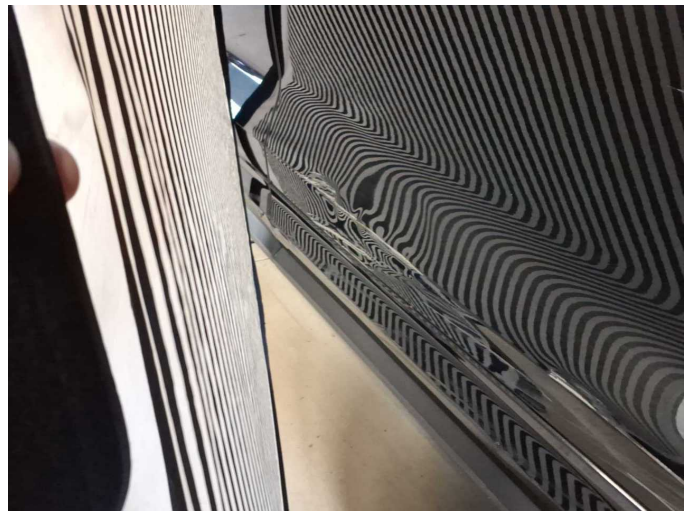
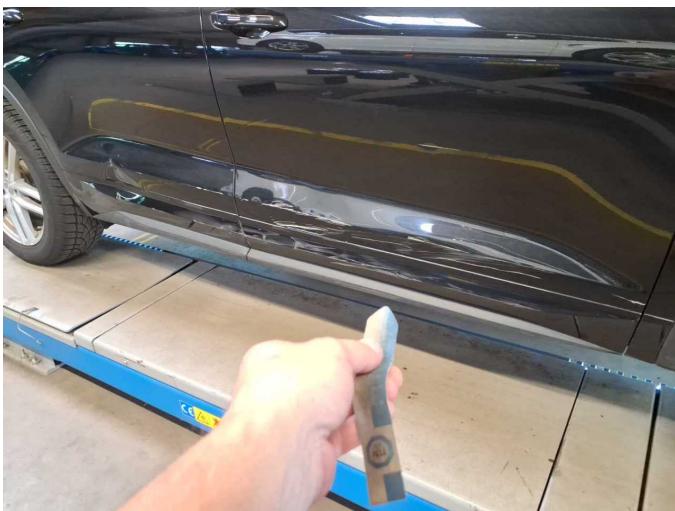
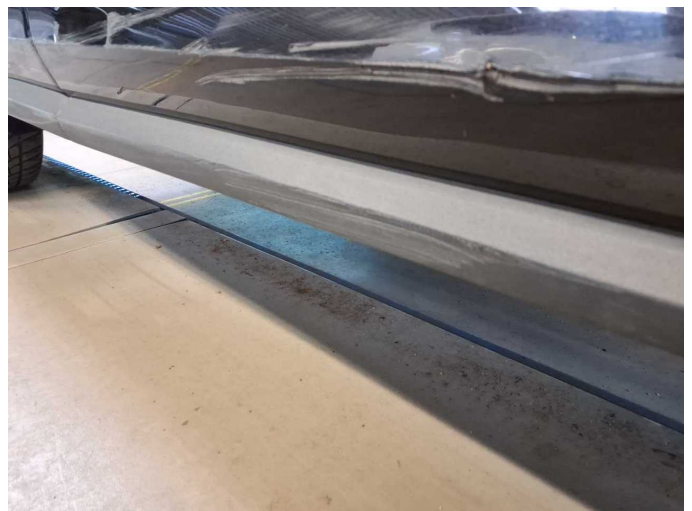
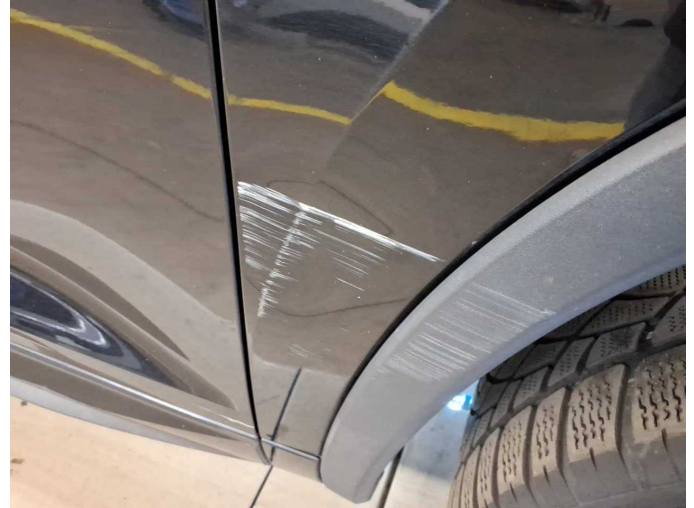
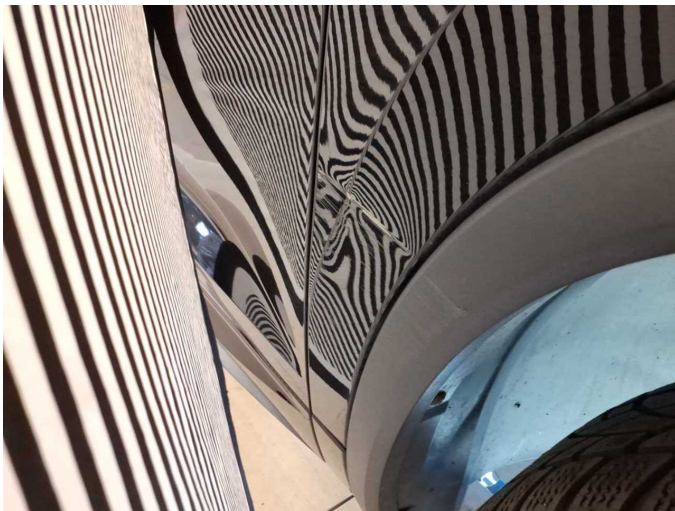
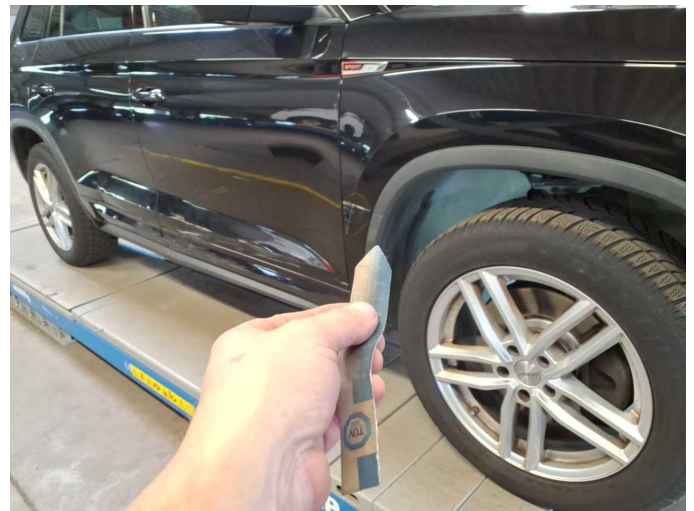
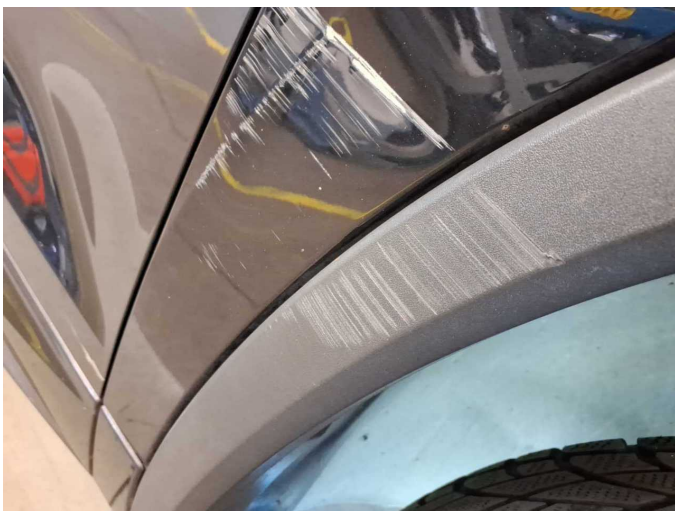
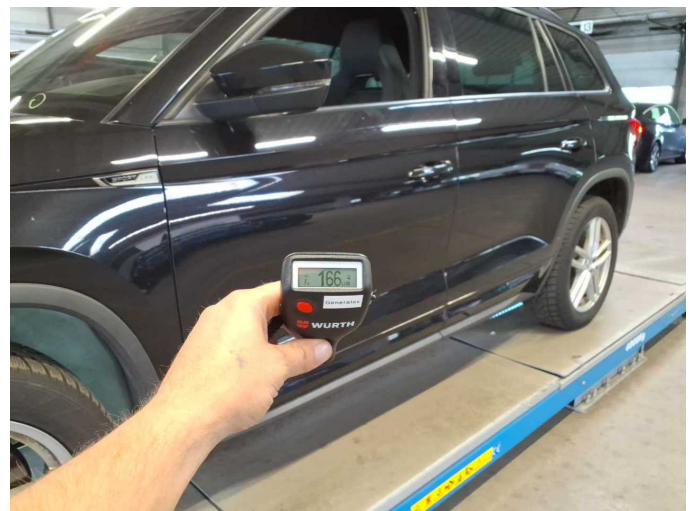
**Accident 1:** Side right

1 Side right

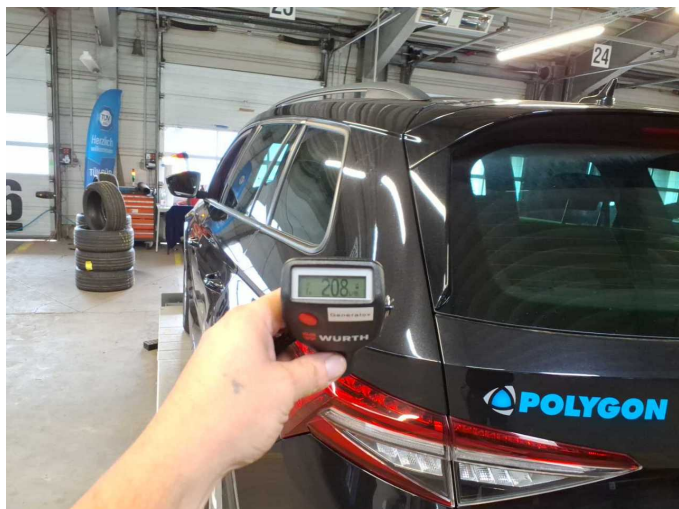
**Repainting 1: Door - front left side**

- Door - front left side, Professionally carried out, Invoice of repair done Non-existent
- Side panel - rear left side, Unprofessionally carried out, Invoice of repair done Non-existent
