Expertise

Protocol number: 46125411  
Order No. / Reference: 26422060  
Inspection date: 16 Jun 2026

Manufacturer: Volkswagen

Model: Tiguan Allspace 2.0 TDI SCR 4Motion DSG Life

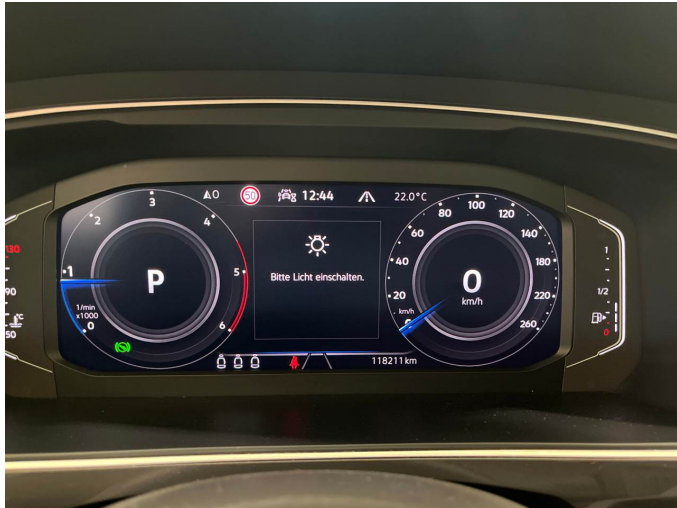
| Vehicle details | |
|---|---|
| Mileage (Read) | 118,211 km |

Figure 7: Instrument cluster

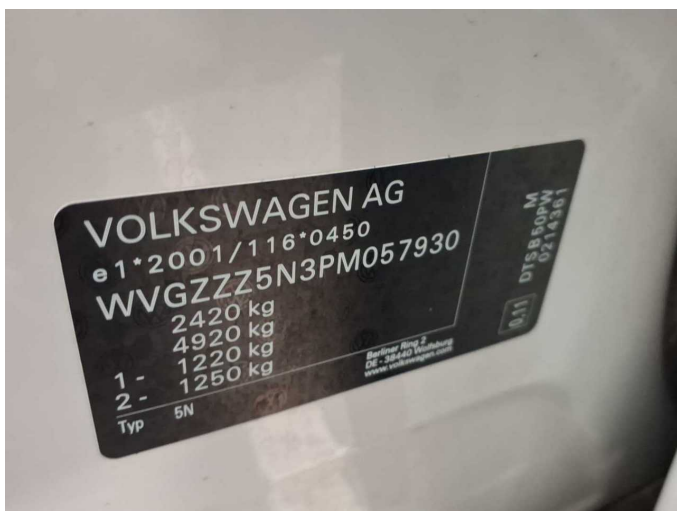
Figure 11: VIN

| VIN comparison | The vehicle identification number (VIN) was read from the vehicle and its conformity with the submitted documents was confirmed by the undersigned during the inspection. |

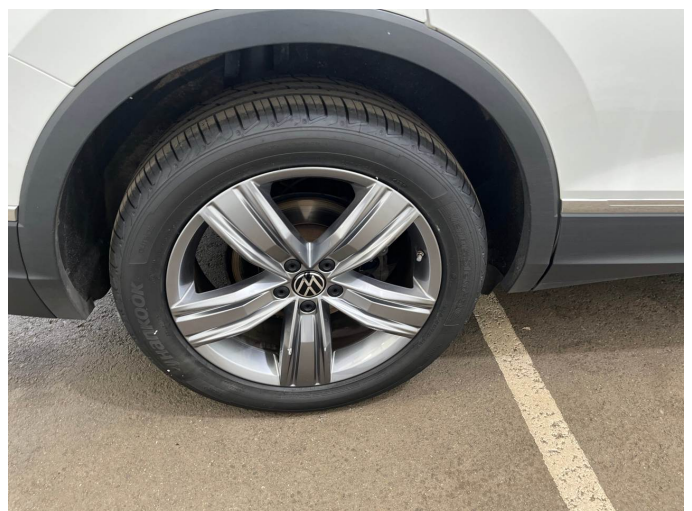
| # | Tyre size | Type of tyre | Manufacturer | Tread depth |
|---|---|---|---|---|
| 1) | 235/50 R19 99V | Summer tyres on Light alloy | Hankook | 6mm / 6mm |
| 2) | 235/50 R19 99V | Summer tyres on Light alloy | Hankook | 6mm / 6mm |

Figure 12: Mounted tyres

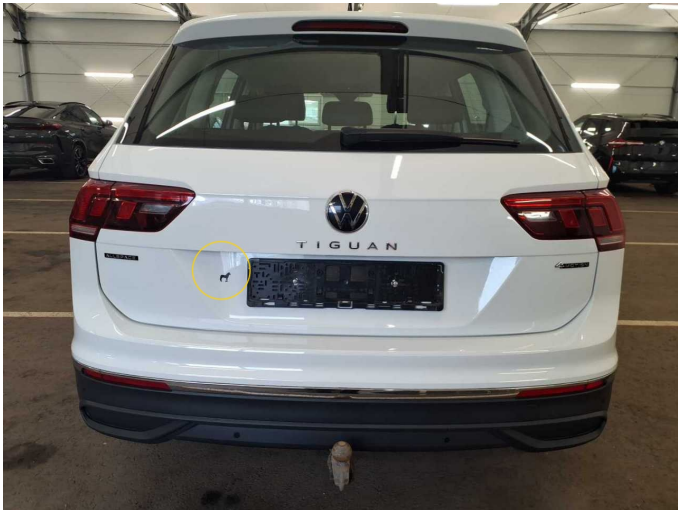
| No. | Component group | Description |
|---|---|---|
| 1 | Boot lid / rear door | Boot lid - Glued / labelled - De-glue / neutralise |

Damage 1: Boot lid / rear door: Boot lid - Glued / labelled - De-glue / neutralise

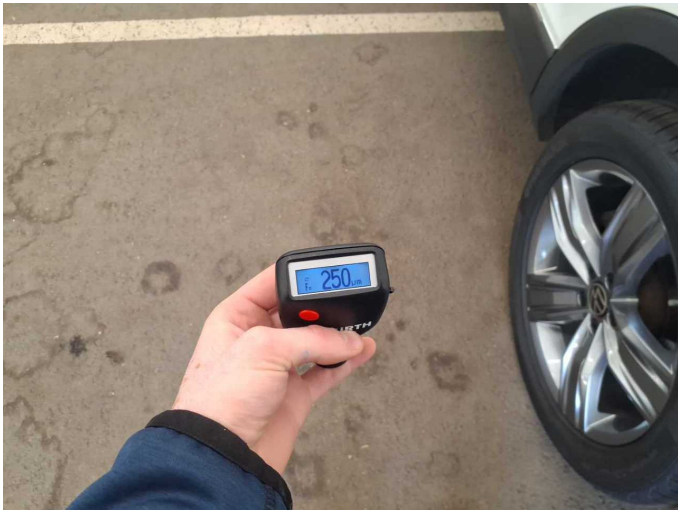
1 Side panel - rear left side

Side panel - rear left side 250 µm |

Repainting 1: Side panel - rear left side

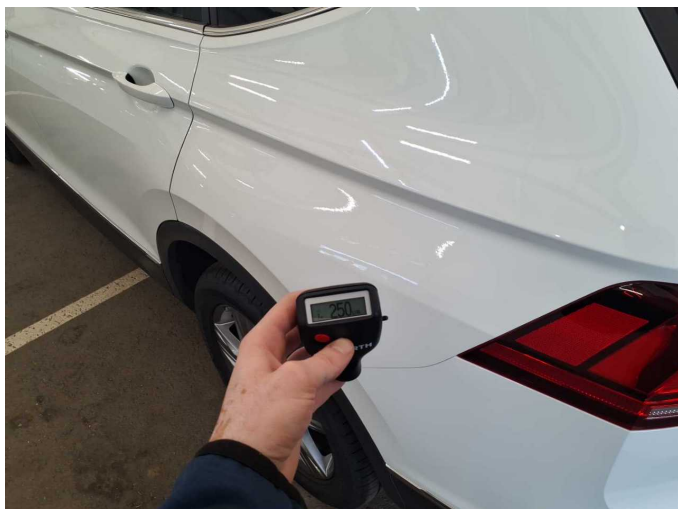
**Repainting 1:** Side panel - rear left side
