Expertise

Protocol number: 46473873  
Order No. / Reference: 26673427  
Inspection date: 10 Jul 2026

Manufacturer: Skoda  
VIN: TMBJJ8NX8RY133884

Model: Octavia Combi 2.0 TDI DSG Sportline

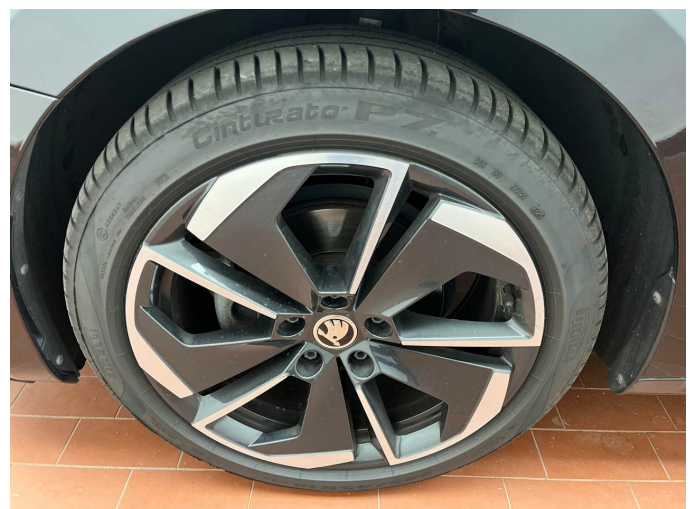
Figure 12: Mounted tyres

| # | Tyre size | Type of tyre | Manufacturer | Tread depth |
|---|---|---|---|---|
| 1) | 225/45 R18 91Y | Summer tyres on Light alloy | Pirelli | 4mm / 4mm |
| 2) | 225/45 R18 91Y | Summer tyres on Light alloy | Pirelli | 4mm / 4mm |

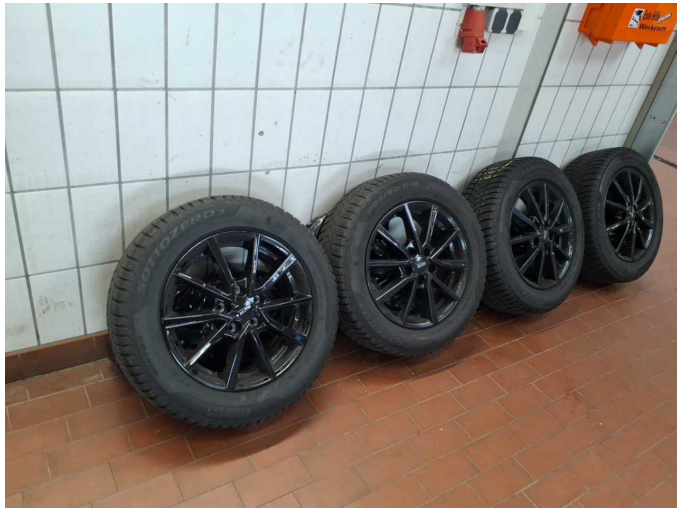
Figure 15: Additional tyres

| # | Tyre size | Type of tyre | Manufacturer | Tread depth |
|---|---|---|---|---|
| 1) | 205/60 R16 96H | Winter tyres on Light alloy | Pirelli | 4mm / 4mm |
| 2) | 205/60 R16 96H | Winter tyres on Light alloy | Pirelli | 8mm / 8mm |

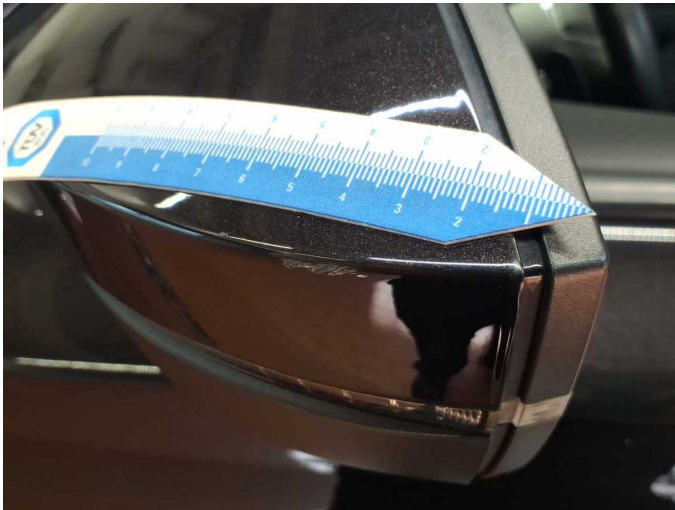
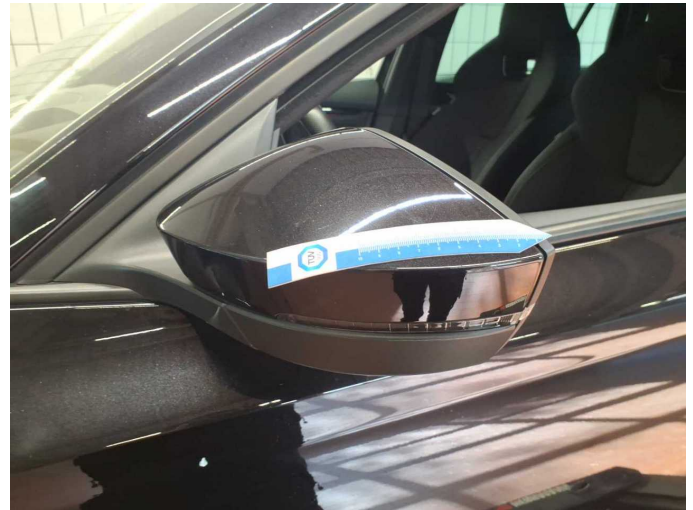
**Damage 1:** Wing mirror - left side: Cap - Scratch(es) - Smart repair

| No. | Component group | Description |
|---|---|---|
| 1 | Wing mirror - left side | Cap - Scratch(es) - Smart repair |

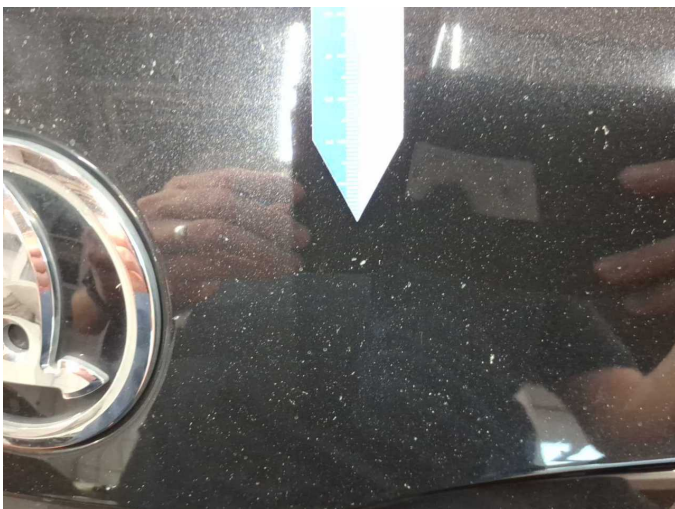
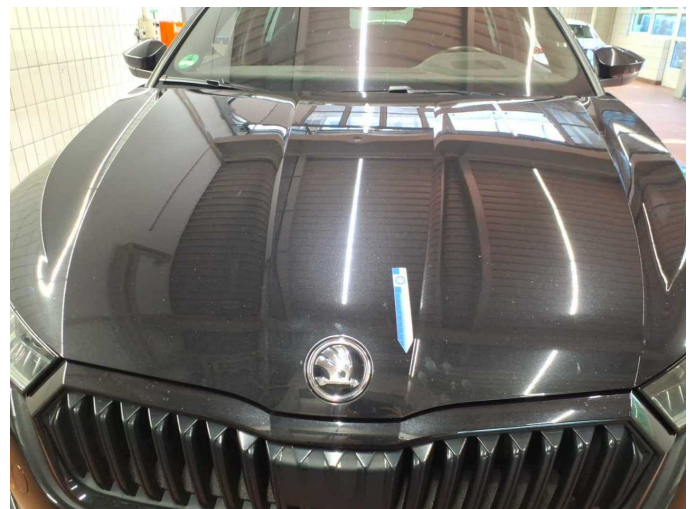
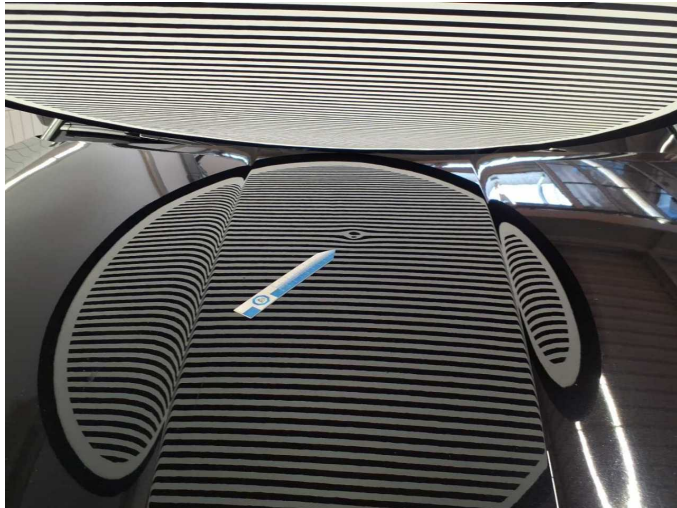
**Damage 2:** Bonnet: Bonnet - dent(s) - Smooth repair work

| No. | Component group | Description |
|---|---|---|
| 2 | Bonnet | Bonnet - dent(s) - Smooth repair work |

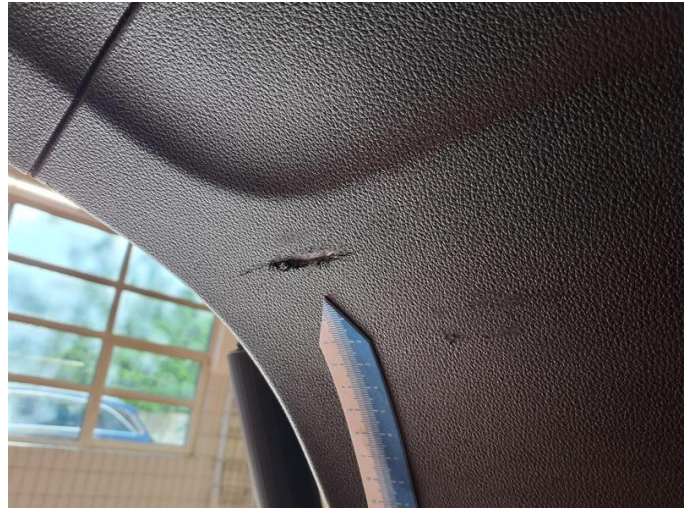
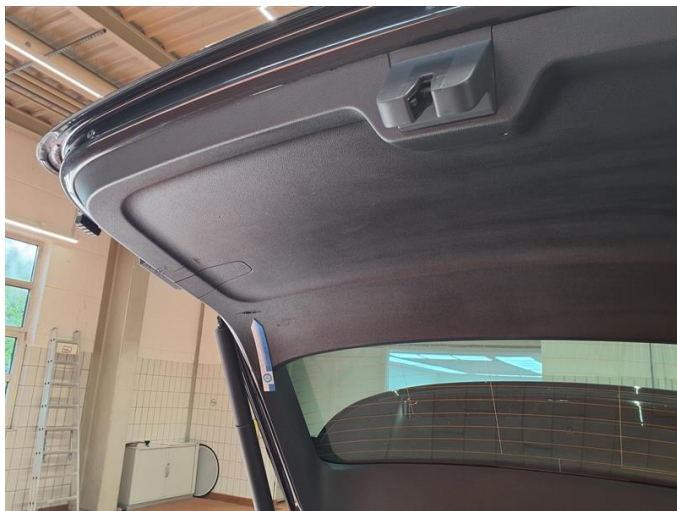
**Damage 3:** Trim / covers: Boot lid - interior trim - Scratched - Replace

| No. | Component group | Description |
|---|---|---|
| 3 | Trim / covers | Boot lid - interior trim - Scratched - Replace |

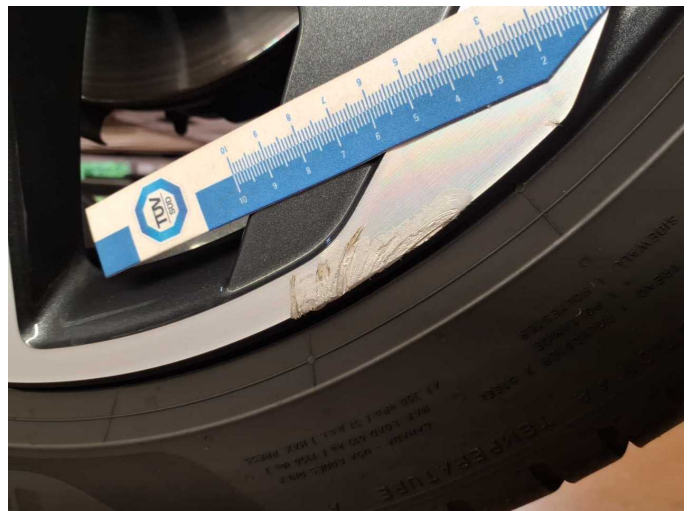
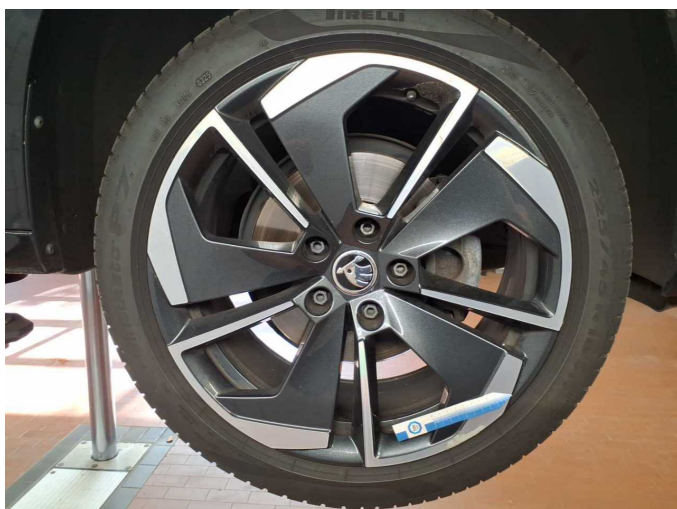
**Damage 4:** Wheel / tyres: Alloy rim - front right side - Scratch(es) - Replace

| No. | Component group | Description |
|---|---|---|
| 4 | Wheel / tyres | Alloy rim - front right side - Scratch(es) - Replace |

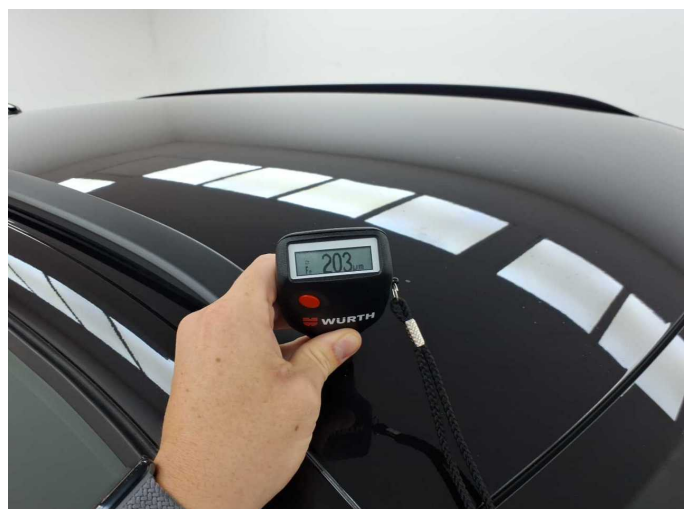
| No. | Repainting |
|---|---|
| 1 | Roof, Professionally carried out, Invoice of repair done Non-existent |

| Roof | 203 µm | Side panel - rear right side | 217 µm |

**Repainting 1:** Roof

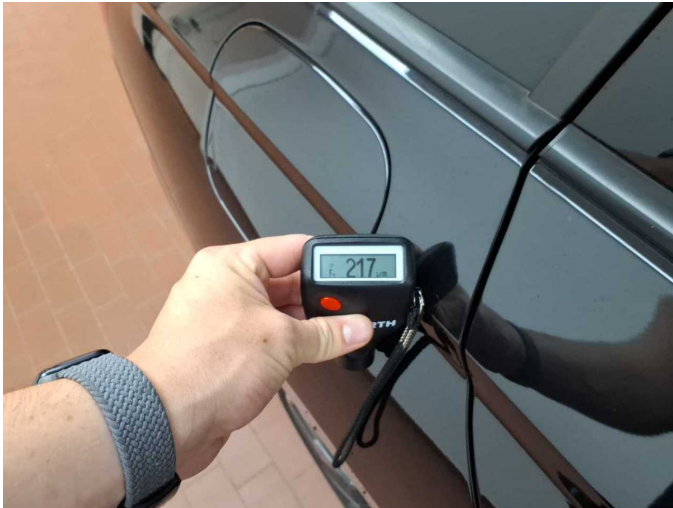
| No. | Repainting |
|---|---|
| 2 | Side panel - rear right side, Professionally carried out, Invoice of repair done Non-existent |

**Repainting 2:** Side panel - rear right side
