Expertise

Protocol number: 46219606  
Order No. / Reference: 26575011  
Inspection date: 29 Jun 2026

Manufacturer: Volvo

Model: XC60 T6 AWD Recharge Plus Bright

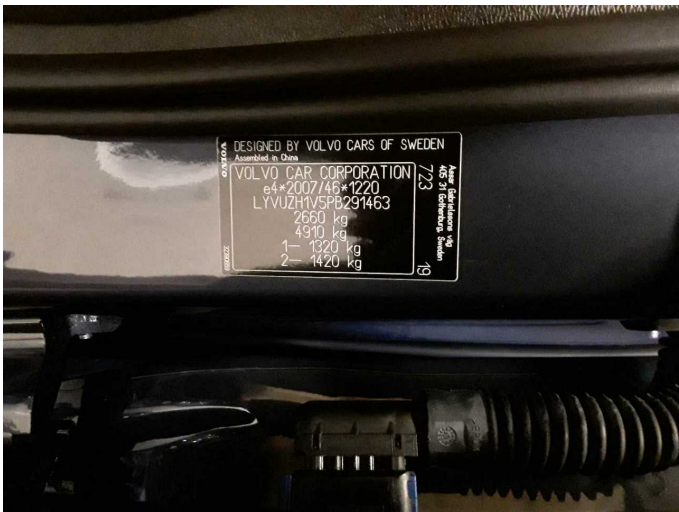
Figure 12: VIN

| VIN comparison | The vehicle identification number (VIN) was read from the vehicle and its conformity with the submitted documents was confirmed by the undersigned during the inspection. |

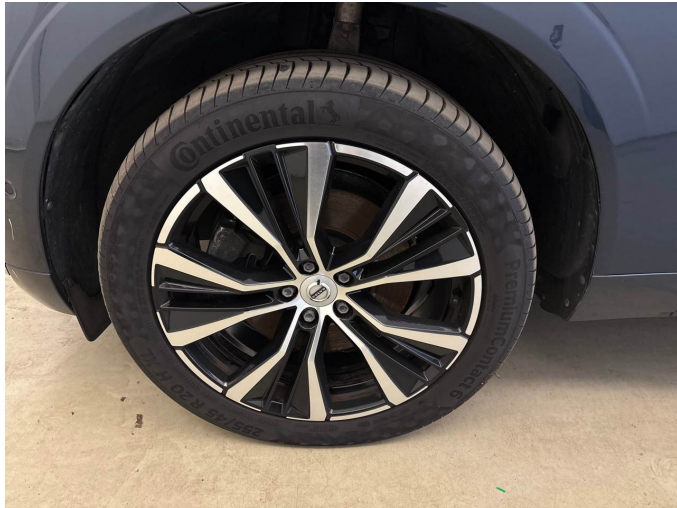
Figure 13: Mounted tyres

| # | Tyre size | Type of tyre | Manufacturer | Tread depth |
|---|---|---|---|---|
| 1) | 255/45 R20 105H | Summer tyres on Light alloy | Continental | 5mm / 5mm |
| 2) | 255/45 R20 105H | Summer tyres on Light alloy | Continental | 5mm / 5mm |

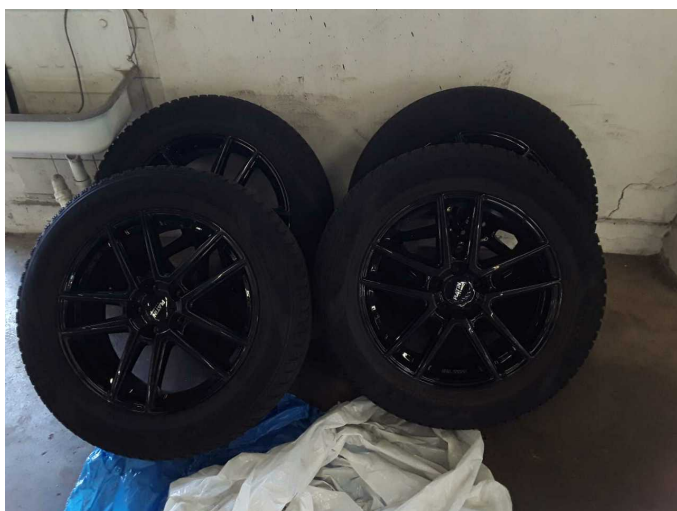
Figure 17: Additional tyres

| # | Tyre size | Type of tyre | Manufacturer | Tread depth |
|---|---|---|---|---|
| 1) | 235/60 R18 107V | Winter tyres on Light alloy | Pirelli | 5mm / 5mm |
| 2) | 235/60 R18 107V | Winter tyres on Light alloy | Pirelli | 5mm / 5mm |

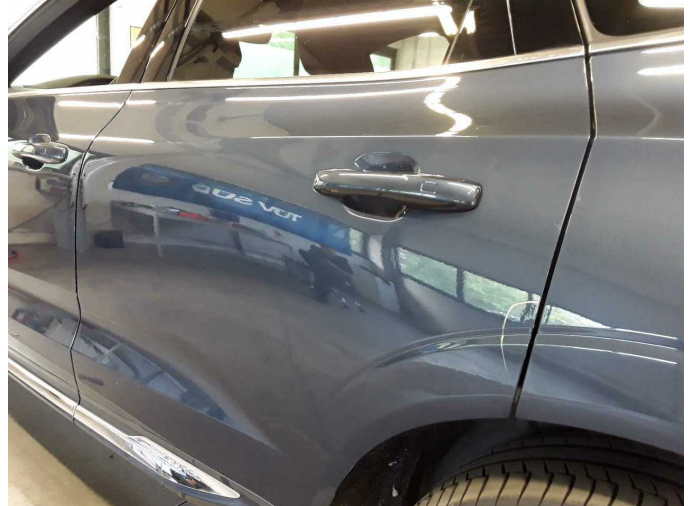
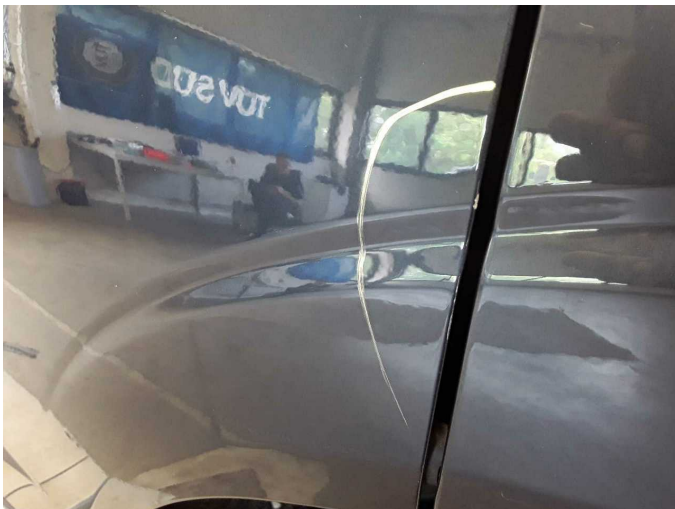
| No. | Component group | Description |
|---|---|---|
| 1 | Door - rear left side | Door - Scratch(es) - Smart repair |

**Damage 1:** Door - rear left side: Door - Scratch(es) - Smart repair

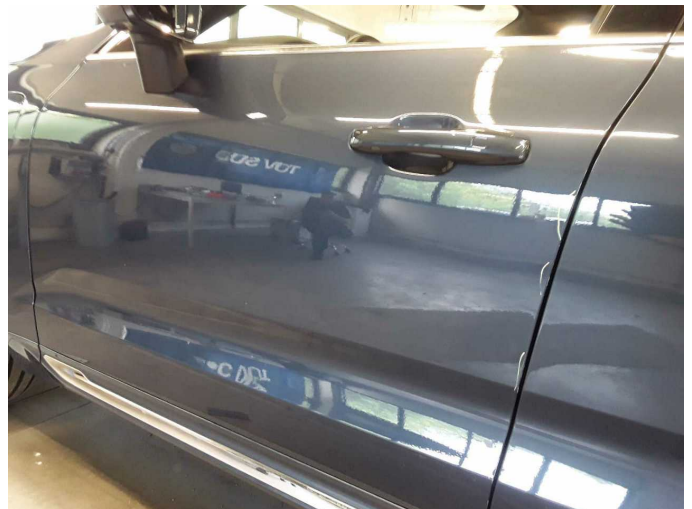
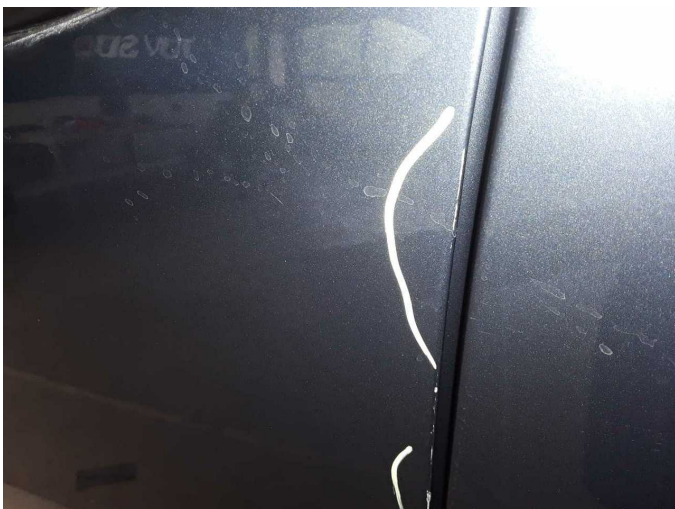
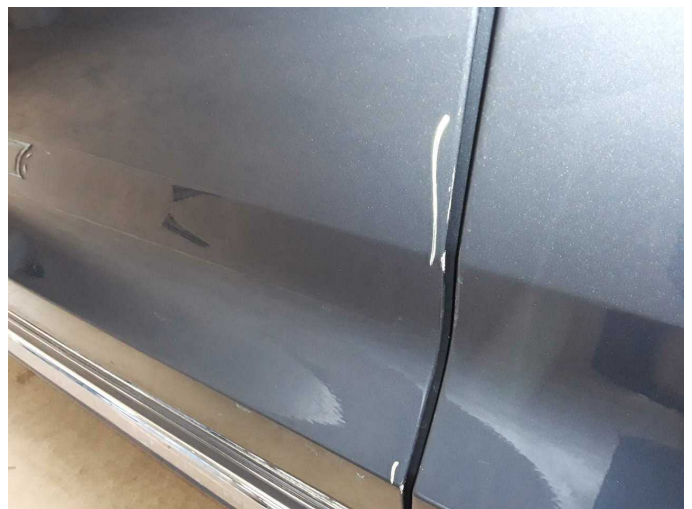
| No. | Component group | Description |
|---|---|---|
| 2 | Door - front left side | Door - Scratch(es) - Smart repair |

**Damage 2:** Door - front left side: Door - Scratch(es) - Smart repair

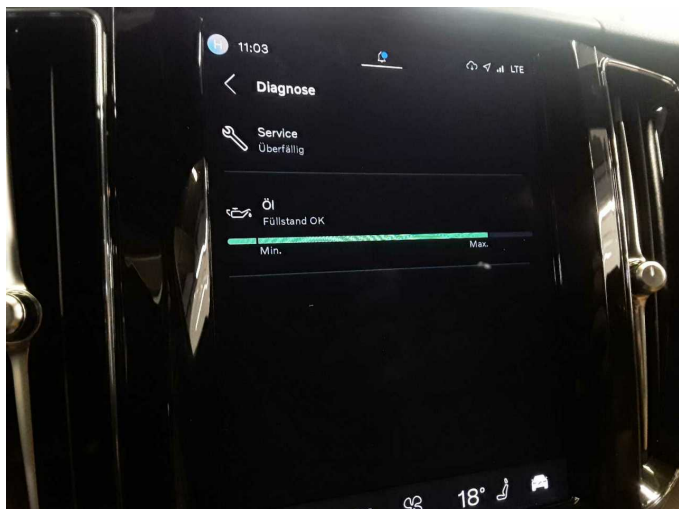
| No. | Component group | Description |
|---|---|---|
| 3 | Misc. | Inspection / maintenance - Due - Perform |

**Damage 3:** Misc.: Inspection / maintenance - Due - Perform

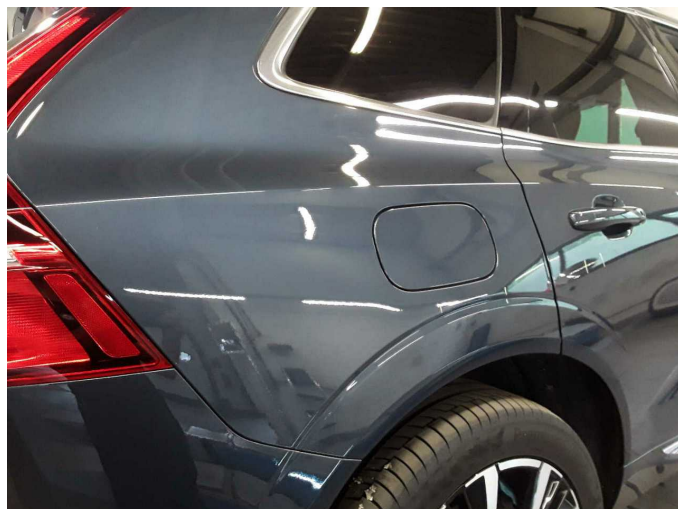
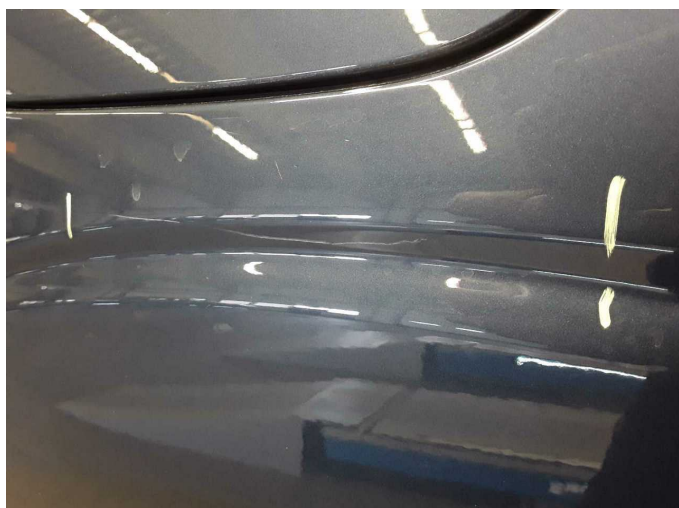
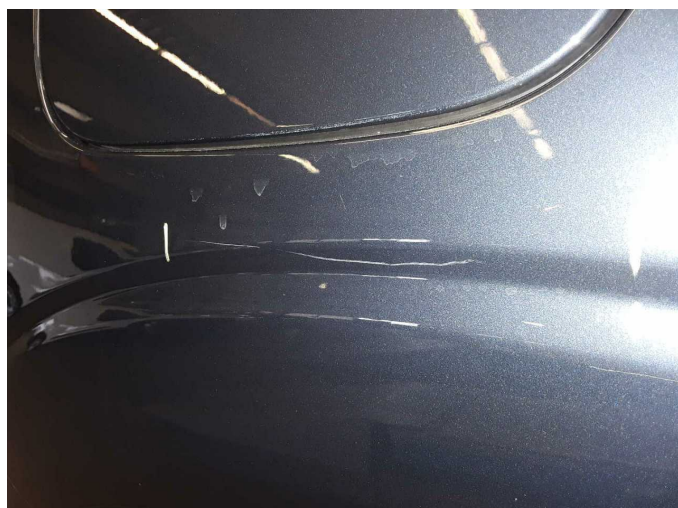
| No. | Component group | Description |
|---|---|---|
| 4 | Side panel - rear right side | Side panel - Scratch(es) - Paint |

**Damage 4:** Side panel - rear right side: Side panel - Scratch(es) - Paint

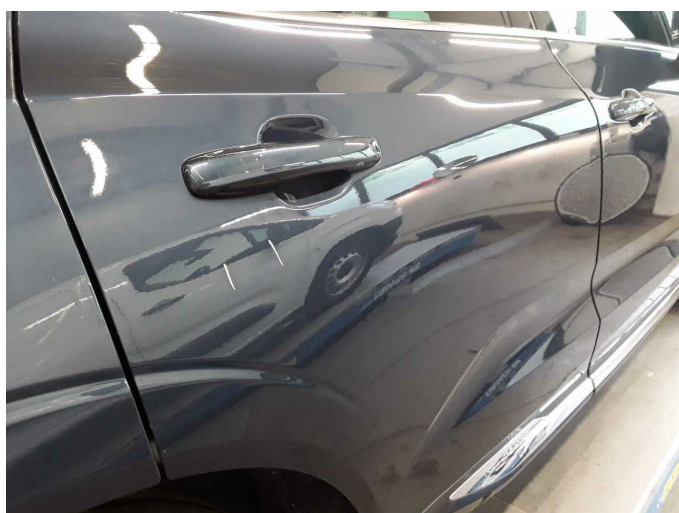
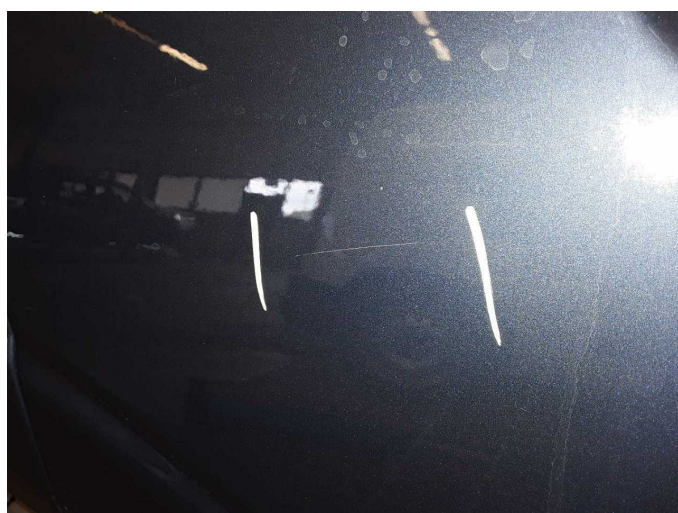
| No. | Component group | Description |
|---|---|---|
| 5 | Door - rear right side | Door - Scratch(es) - Paint |

**Damage 5:** Door - rear right side: Door - Scratch(es) - Paint

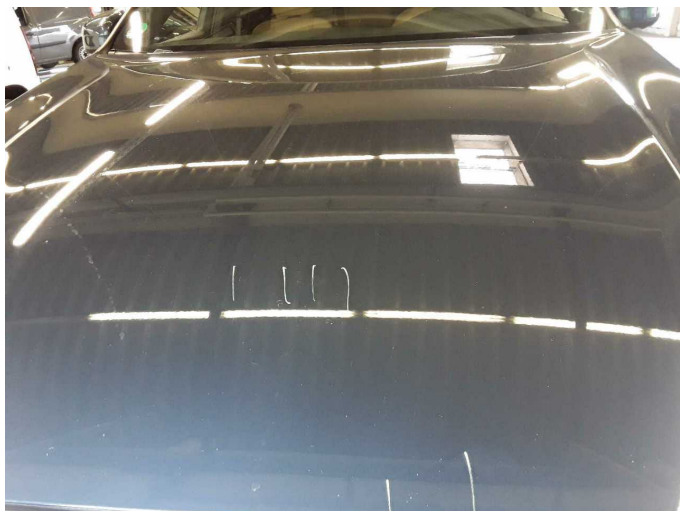
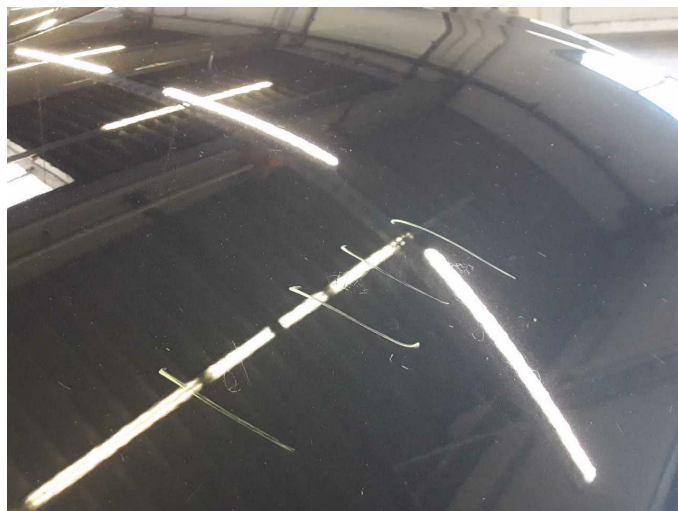
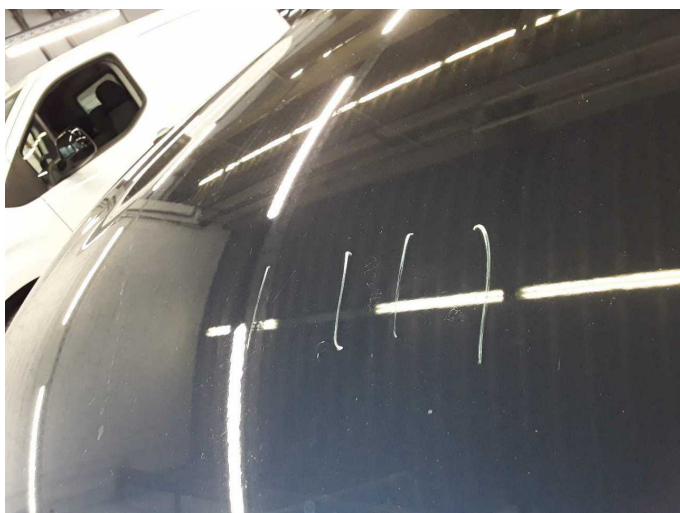
| No. | Component group | Description |
|---|---|---|
| 6 | Bonnet | Bonnet (Vogelkot eingebrannt) - Paint defect - Paint |

**Damage 6:** Bonnet: Bonnet (Vogelkot eingebrannt) - Paint defect - Paint

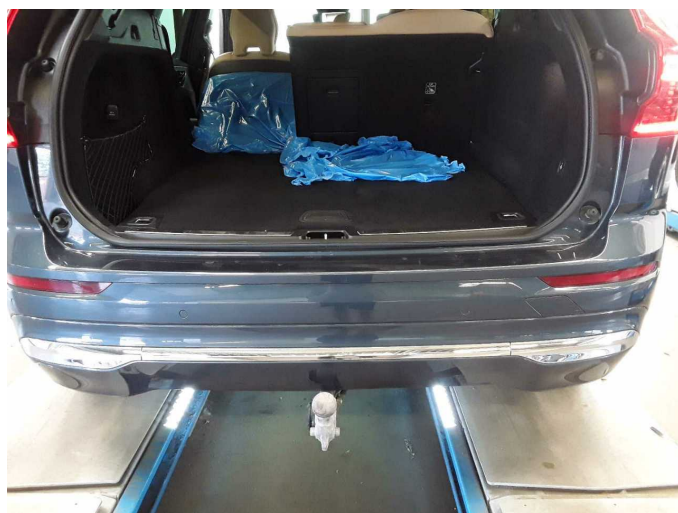
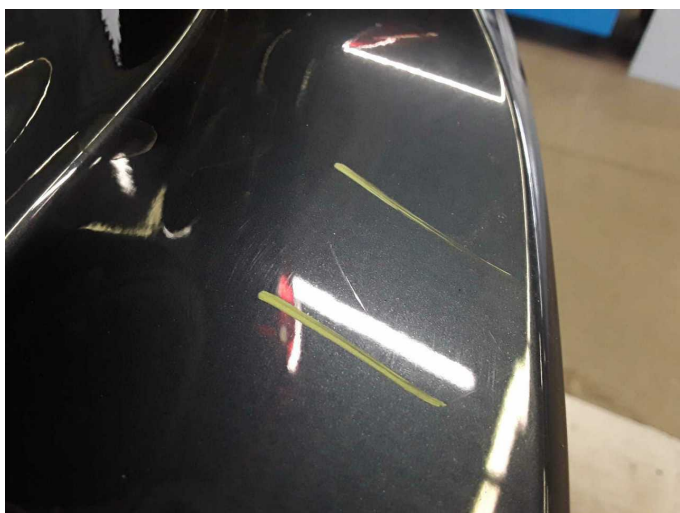
| No. | Component group | Description |
|---|---|---|
| 2 | Rear bumper | Rear bumper (Verladebereich) - Scratch(es) - No deduction |

**Wear and tear 2:** Rear bumper: Rear bumper (Verladebereich) - Scratch(es) - No deduction

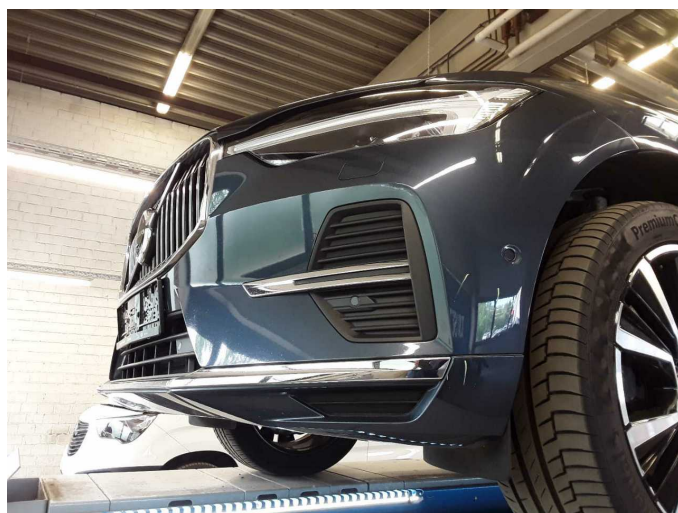
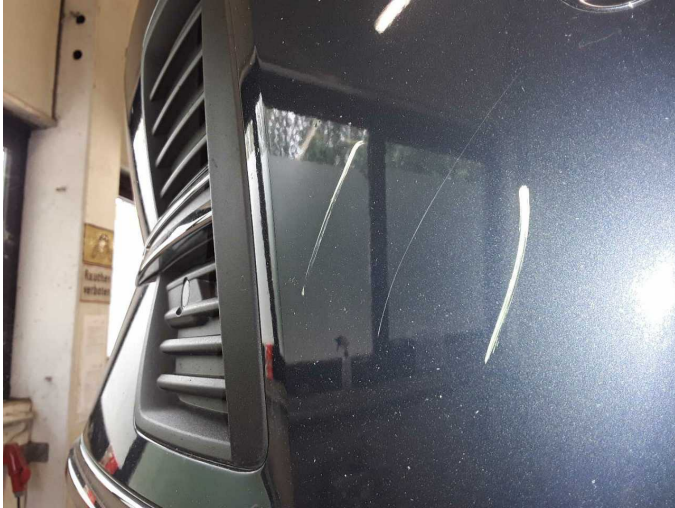
| No. | Component group | Description |
|---|---|---|
| 3 | Front bumper | Front bumper (polierbar) - Scratch(es) - No deduction |

**Wear and tear 3:** Front bumper: Front bumper (polierbar) - Scratch(es) - No deduction

**Wear and tear 3:** Front bumper: Front bumper (polierbar) - Scratch(es) -  
No deduction
