Expertise

Protocol number: 46926978  
Order No. / Reference: 26498197  
Inspection date: 6 Aug 2026

Model: C 200 d T 9G-TRONIC Avantgarde

VIN: W1KAH0DB8PF108033

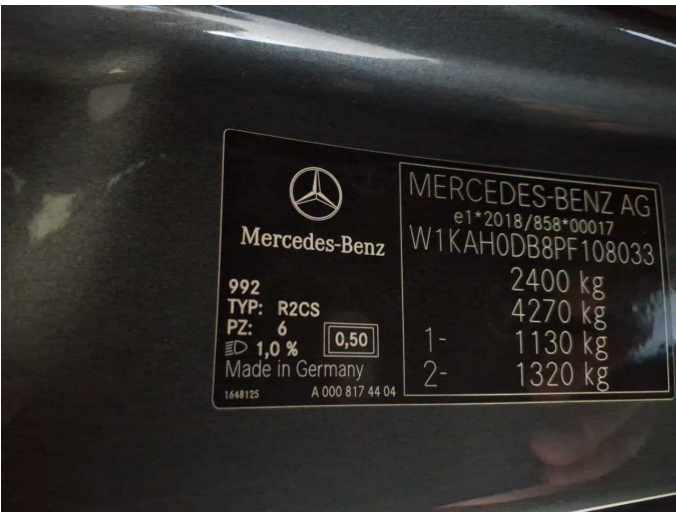
Figure 11: VIN

| VIN comparison | The vehicle identification number (VIN) was read from the vehicle and its conformity with the submitted documents was confirmed by the undersigned during the inspection. |

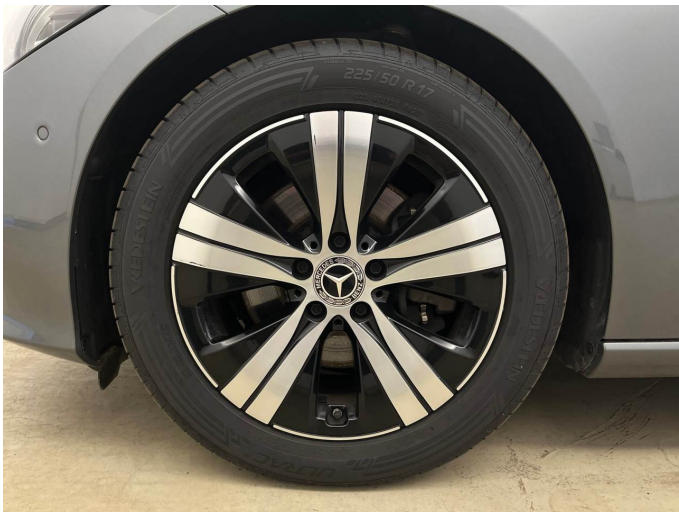
Figure 12: Mounted tyres

| # | Tyre size | Type of tyre | Manufacturer | Tread depth |
|---|---|---|---|---|
| 1) | 225/50 R17 98V | Summer tyres on Light alloy | Vredestein | 6mm / 6mm |
| 2) | 225/50 R17 98V | Summer tyres on Light alloy | Vredestein | 6mm / 6mm |

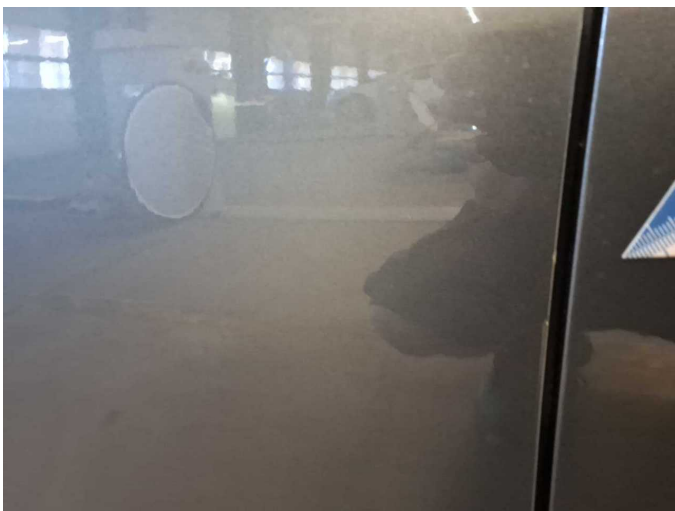
| No. | Component group | Description |
|---|---|---|
| 3 | Door - front left side | Door - Scratch(es) - Smart repair |

**Damage 3:** Door - front left side: Door - Scratch(es) - Smart repair

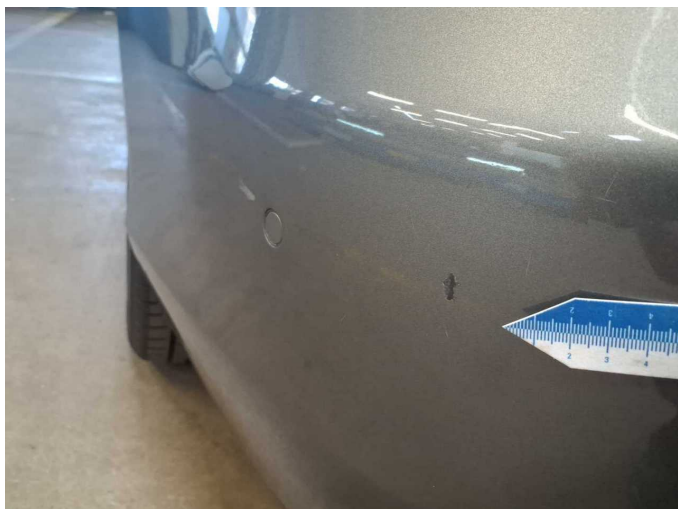
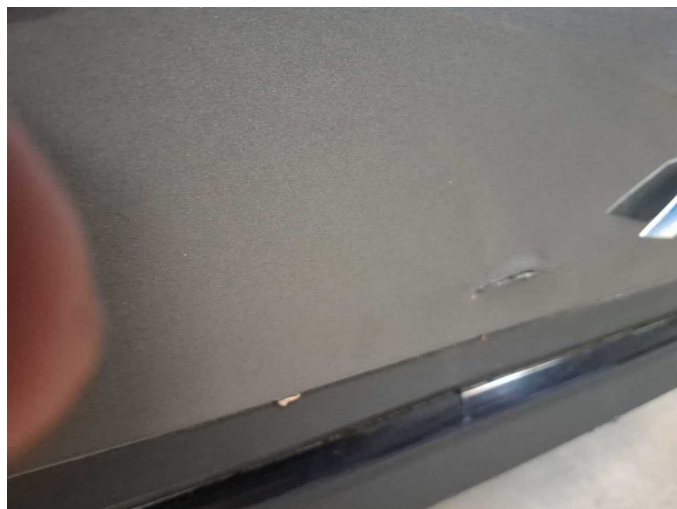
| No. | Component group | Description |
|---|---|---|
| 6 | Rear bumper | Rear bumper - Scratch(es) - Paint |

**Damage 6:** Rear bumper: Rear bumper - Scratch(es) - Paint
