Expertise

Protocol number: 45104238
Order No. / Reference: 26291863
Inspection date: 22 Apr 2026

Model: Kuga 2.0 EcoBlue 4x4 Aut. VIGNALE

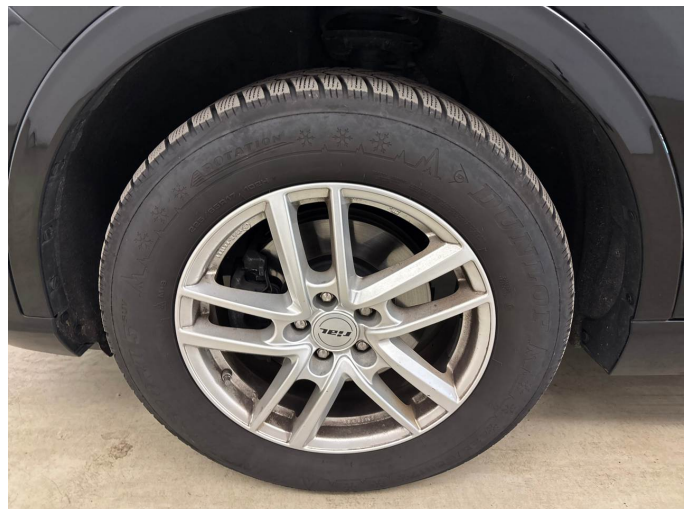
Figure 12: Mounted tyres

| # | Tyre size | Type of tyre | Manufacturer | Tread depth |
|---|---|---|---|---|
| 1) | 225/65 R17 102H | Winter tyres on Light alloy | Dunlop | 6mm / 6mm |
| 2) | 225/65 R17 102H | Winter tyres on Light alloy | Dunlop | 7mm / 7mm |

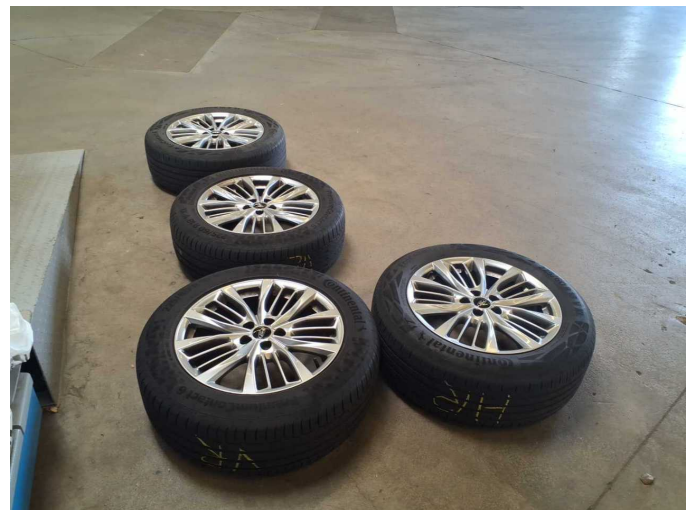
Figure 16: Additional tyres

| # | Tyre size | Type of tyre | Manufacturer | Tread depth |
|---|---|---|---|---|
| 1) | 225/60 R18 104V | Summer tyres on Light alloy | Continental | 5mm / 5mm |
| 2) | 225/60 R18 104V | Summer tyres on Light alloy | Continental | 6mm / 6mm |

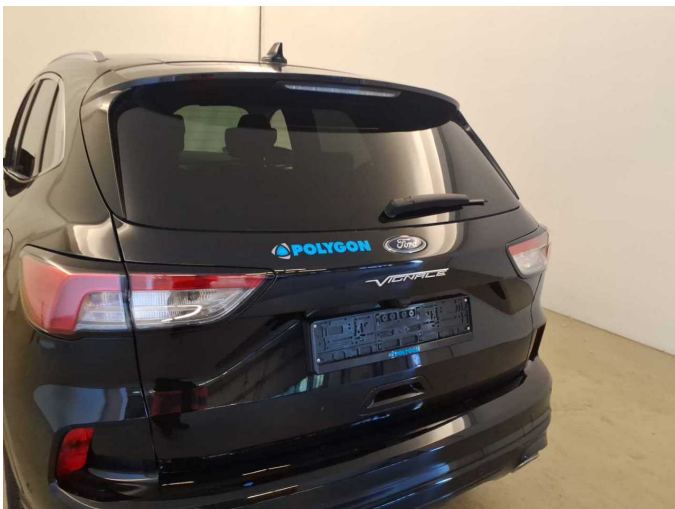
Damage 1: Boot lid / rear door: Boot lid - Glued / labelled - De-glu / neutralise

| No. | Component group | Description |
|---|---|--|
| 1 | Boot lid / rear door | Boot lid - Glued / labelled - De-glue / neutralise |

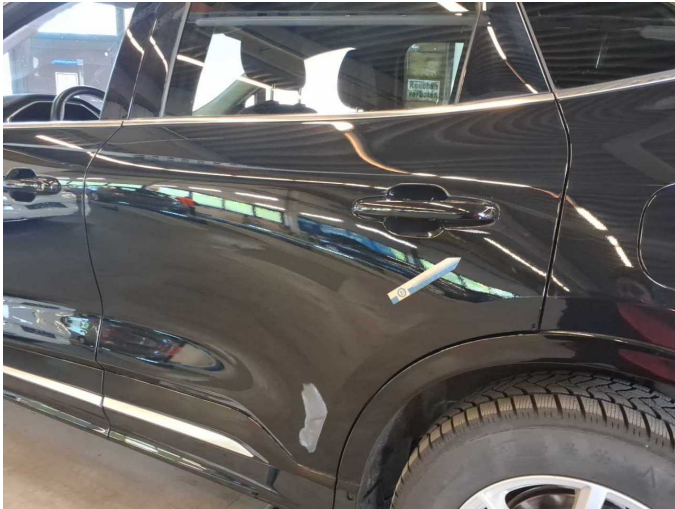
Damage 3: Door - rear left side: Door (Auspolieren) - Scratch(es) - Smart repair

| No. | Component group | Description |
|---|---|--|
| 3 | Door - rear left side | Door (Auspolieren) - Scratch(es) - Smart repair |

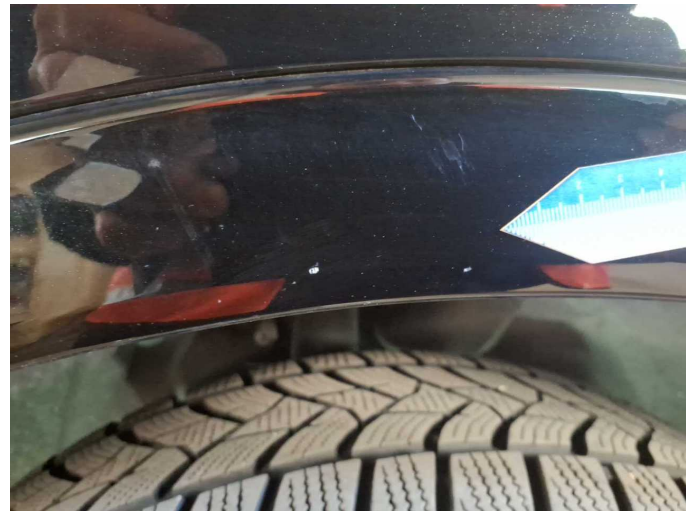
Damage 4: Mudguard - right side: Wheel well extension - Scratched - Smart repair

| No. | Component group | Description |
|---|---|--|
| 4 | Mudguard - right side | Wheel well extension - Scratched - Smart repair |

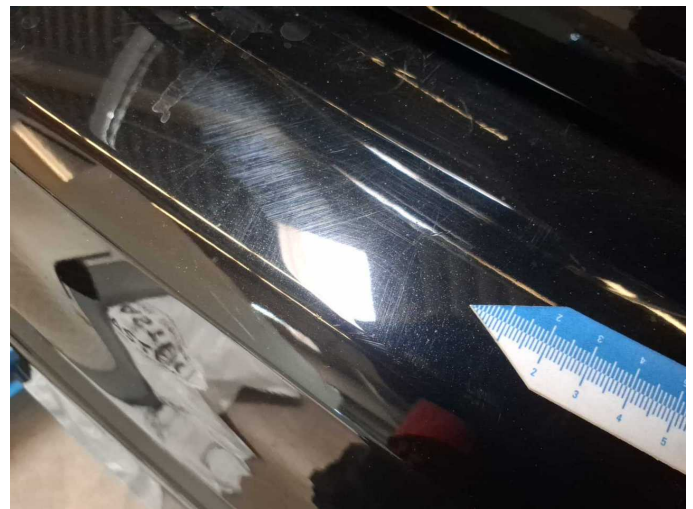
Damage 5: Rear bumper: Rear bumper - Scratched - Smart repair

| No. | Component group | Description |
|---|---|--|
| 5 | Rear bumper | Rear bumper - Scratched - Smart repair |

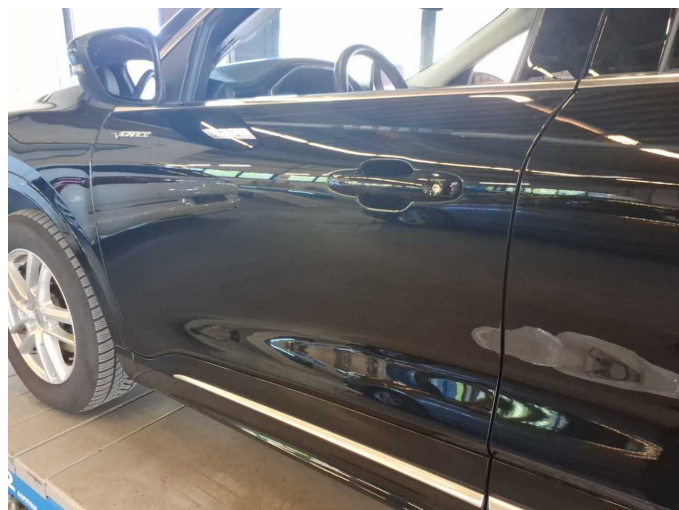
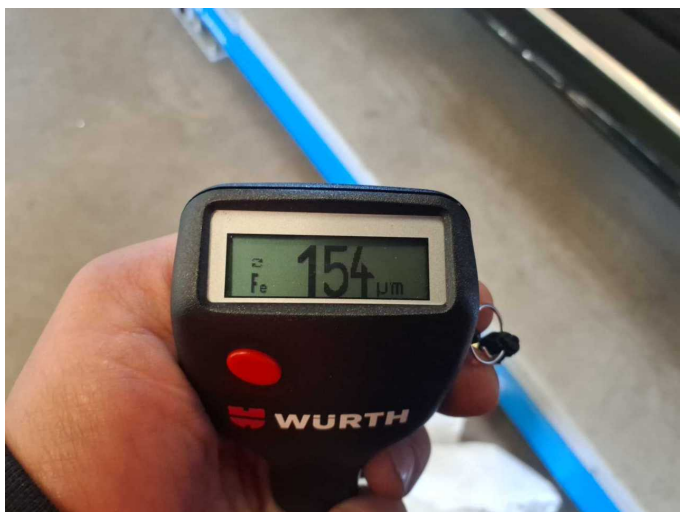
| No. | Repainting |
|---|---|
| 1 | Door - front left side |

| Door - front left side | 154 µm |

Repainting 1: Door - front left side
