Expertise

Protocol number: 45986496  
Order No. / Reference: 26307900  
Inspection date: 17 Jun 2026

Manufacturer: Opel

Model: Astra Sports Tourer 1.2 Turbo Automatik GS

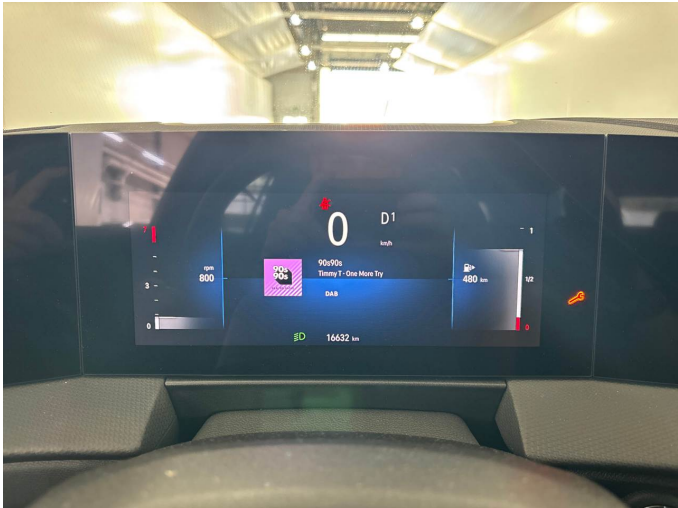
Figure 7: Instrument cluster

**Vehicle Identification number** VXXFRHNS3R1089981  
**Mileage (Read)** 16,632 km  
**First registration** 14 Apr 2025  
**Number of holders** 1  
**Next periodical technical inspection** 04/2028  
(Report not on hand)

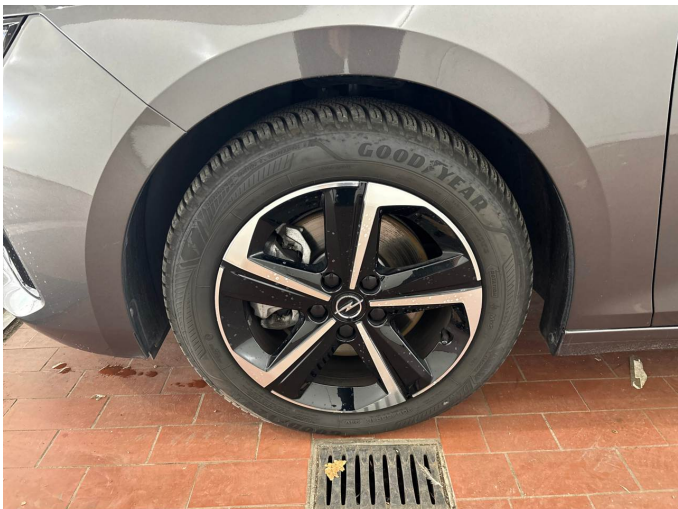
Figure 12: Mounted tyres

| # | Tyre size | Type of tyre | Manufacturer | Tread depth |
|---|---|---|---|---|
| 1) | 205/55 R16 94V | All-season tyres on Light alloy | Goodyear | 7mm / 7mm |
| 2) | 205/55 R16 94V | All-season tyres on Light alloy | Goodyear | 7mm / 7mm |

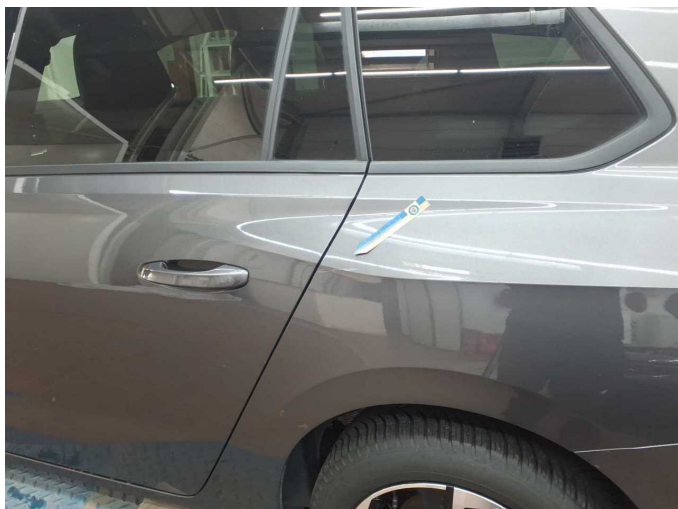
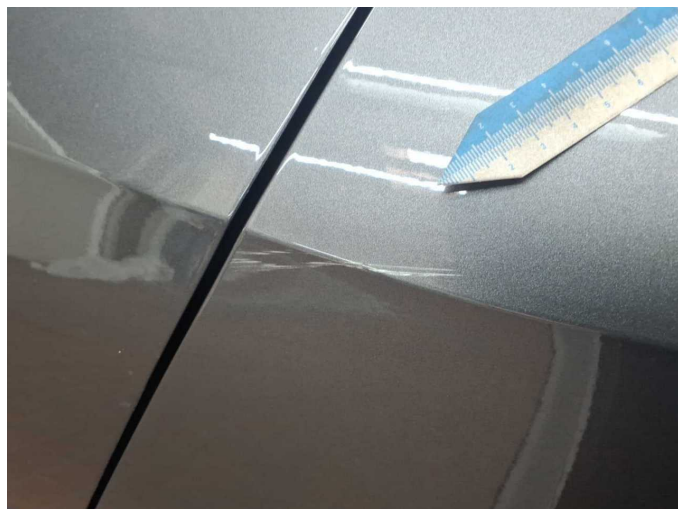
| No. | Component group | Description |
|---|---|---|
| 1 | Side panel - rear left side | Side panel - Scratch(es) - Smart repair |

**Damage 1:** Side panel - rear left side: Side panel - Scratch(es) - Smart repair

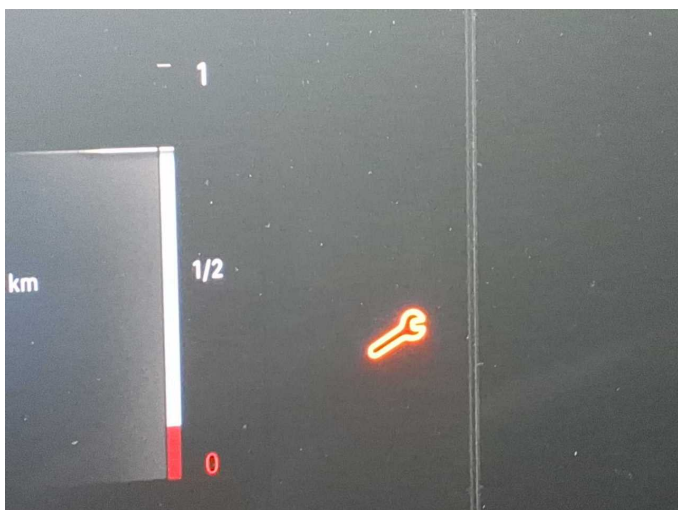
| No. | Component group | Description |
|---|---|---|
| 2 | Misc. | Inspection / maintenance - Due - Perform diagnosis |

**Damage 2:** Misc.: Inspection / maintenance - Due - Perform diagnosis
