## Expertise

Protocol number: 46205237  
Order No. / Reference: 26511990  
Inspection date: 24 Jun 2026

Model: GLC 220 d 4Matic 9G-TRONIC Avantgarde Advanced

VIN: W1NKM0FB6PU032498

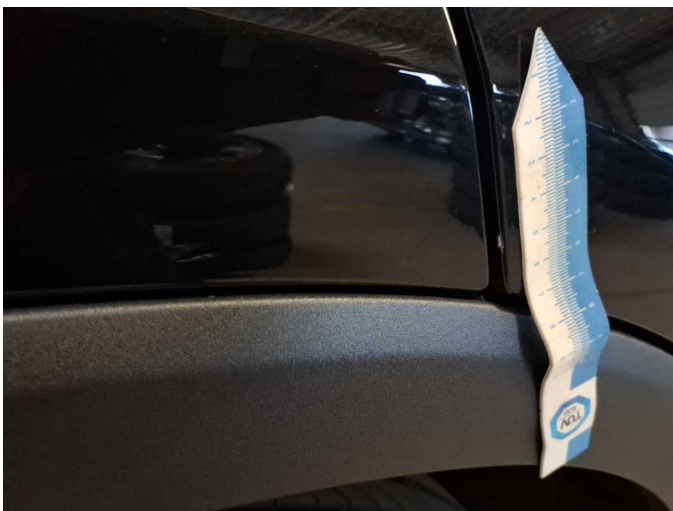
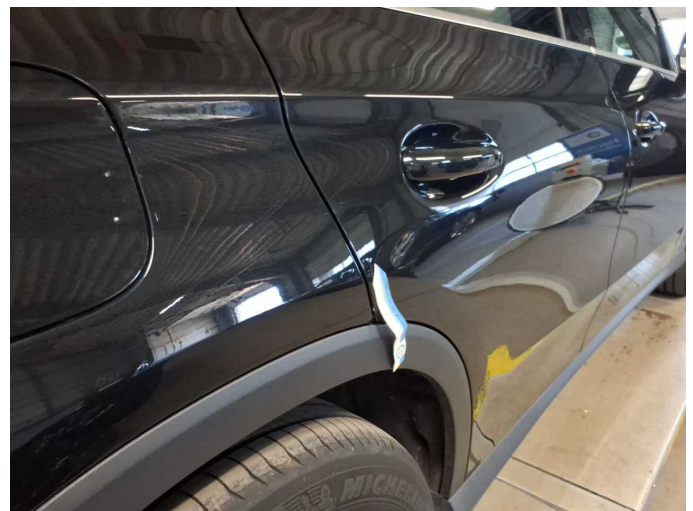
| No. | Component group | Description |
|---|---|---|
| 1 | Door - rear right side | Door edge - Scratch(es) - Smart repair |

Damage 1: Door - rear right side: Door edge - Scratch(es) - Smart repair

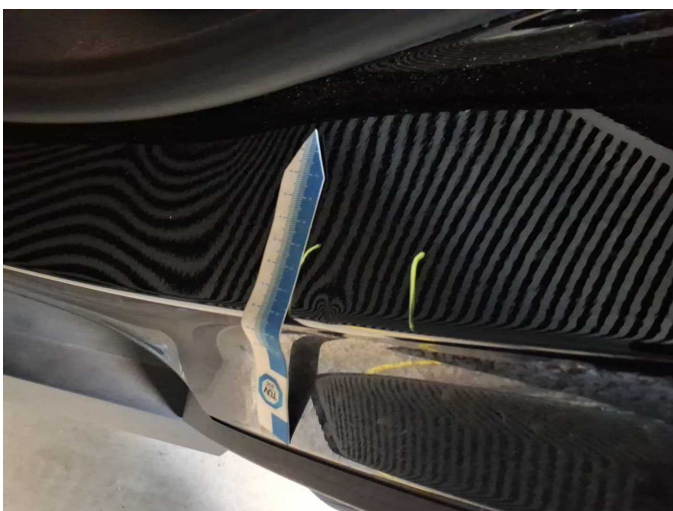
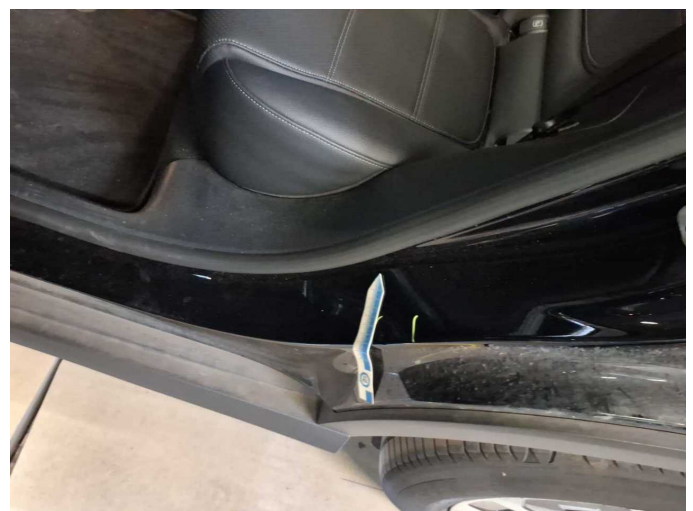
| No. | Component group | Description |
|---|---|---|
| 2 | Side panel - rear left side | Sill - dent(s) - Smooth repair work |

Damage 2: Side panel - rear left side: Sill - dent(s) - Smooth repair work

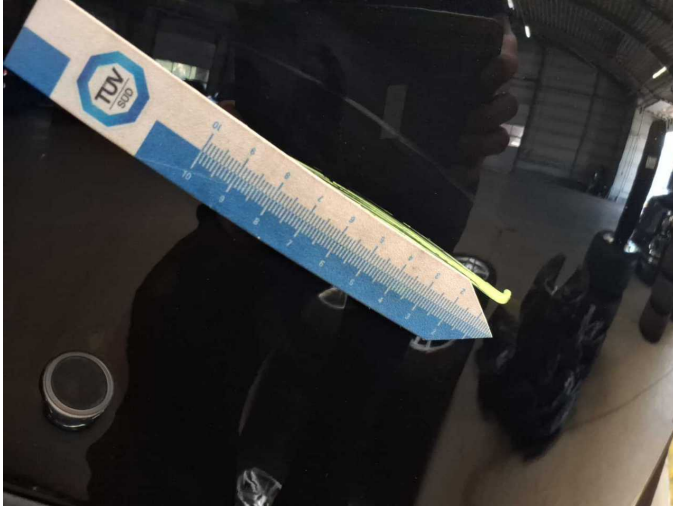
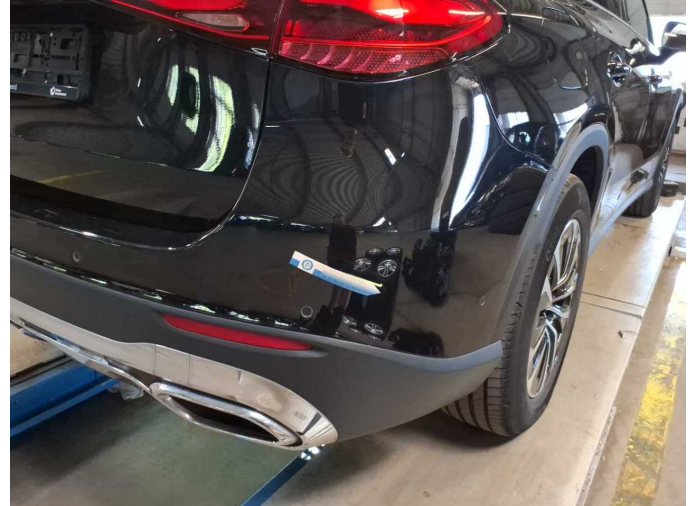
| No. | Component group | Description |
|---|---|---|
| 3 | Rear bumper | Rear bumper - Scratch(es) - Smart repair |

**Damage 3:** Rear bumper: Rear bumper - Scratch(es) - Smart repair

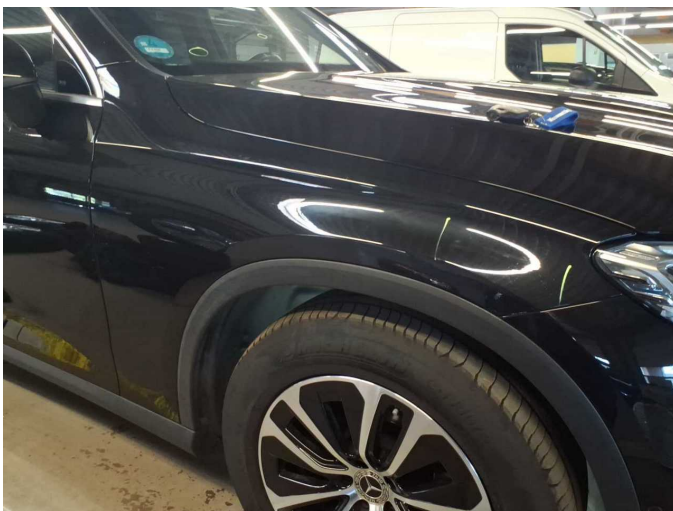
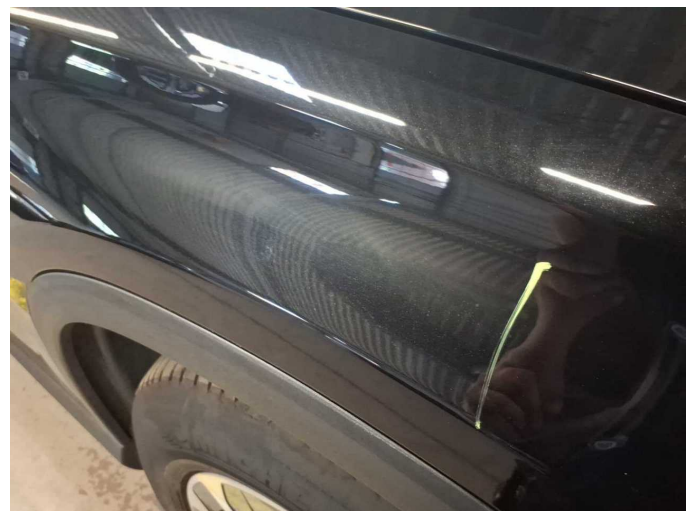
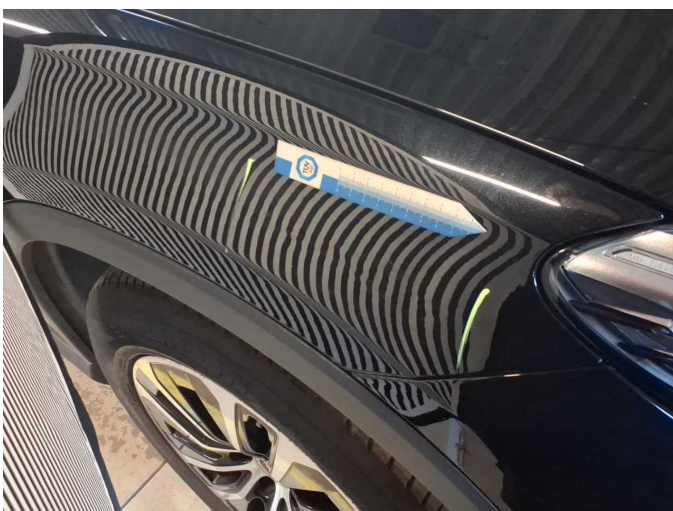
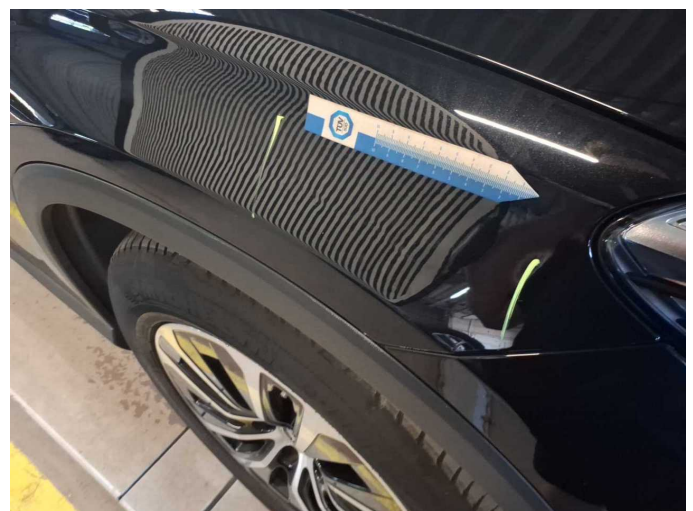
| No. | Component group | Description |
|---|---|---|
| 4 | Mudguard - right side | Mudguard - right side (Klarlack milchig + Dellen) - Unprofessionally repaired - Paint |

**Damage 4:** Mudguard - right side: Mudguard - right side (Klarlack milchig + Dellen) - Unprofessionally repaired - Paint

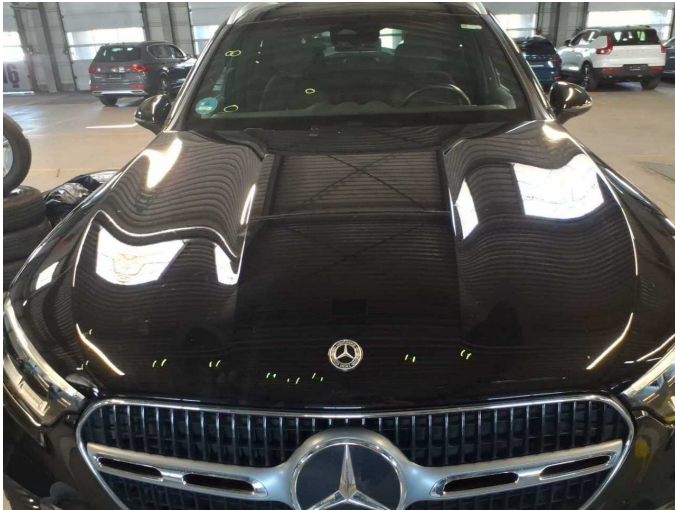
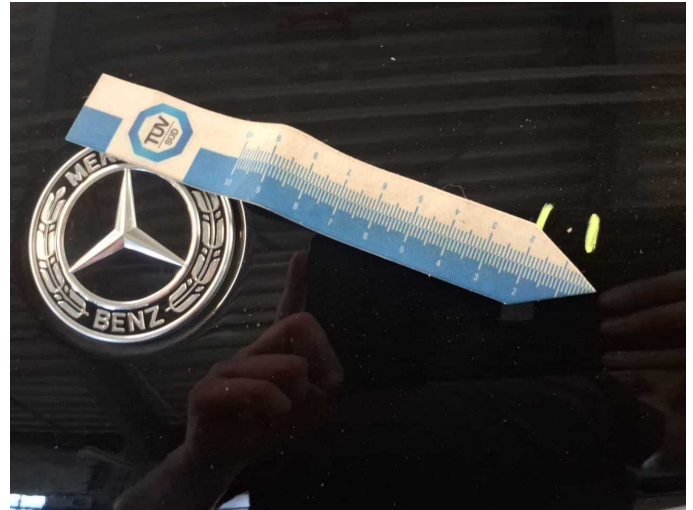
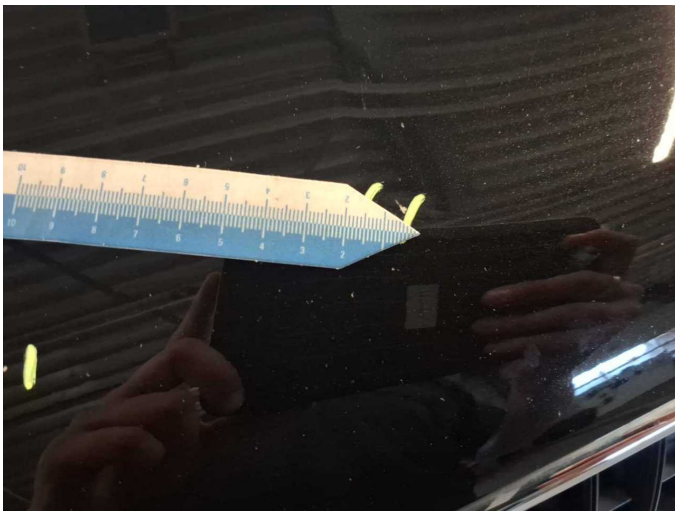
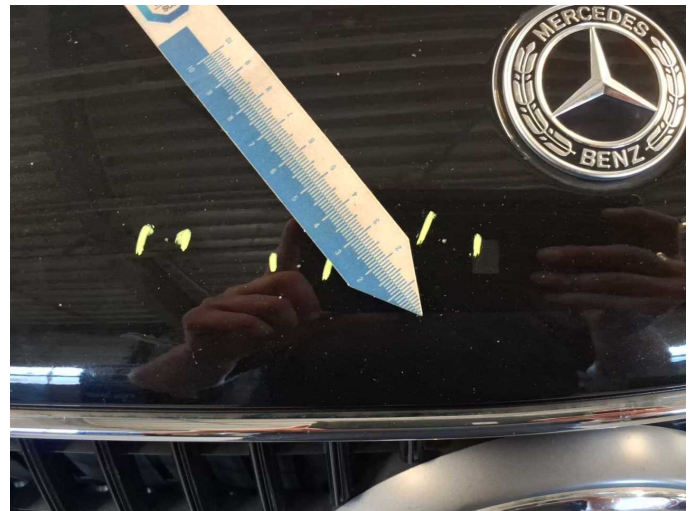
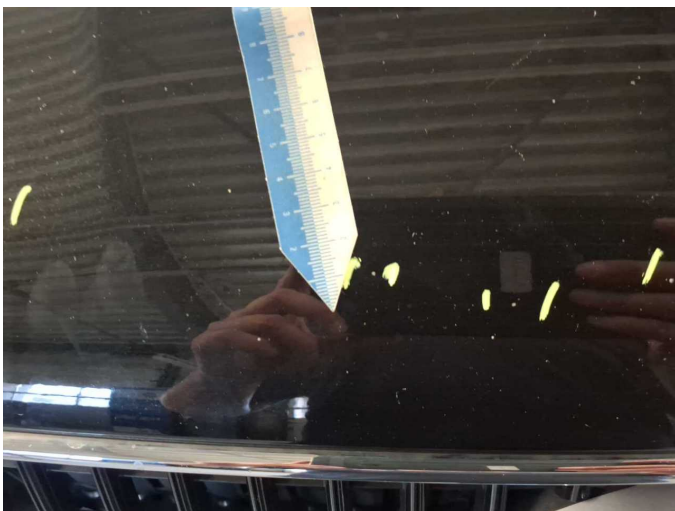
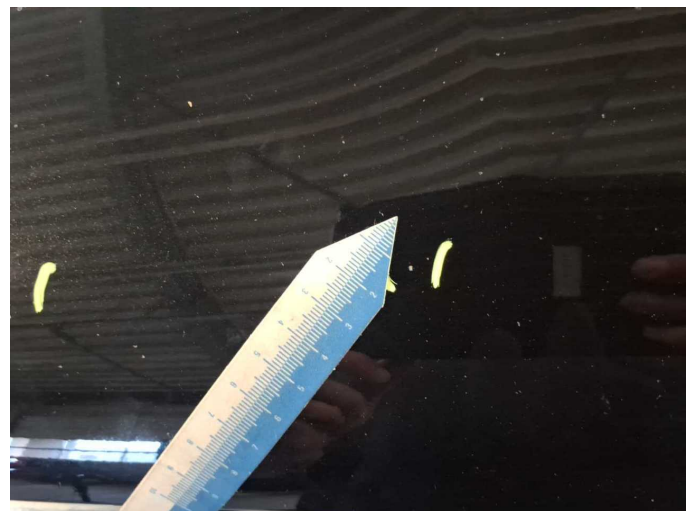
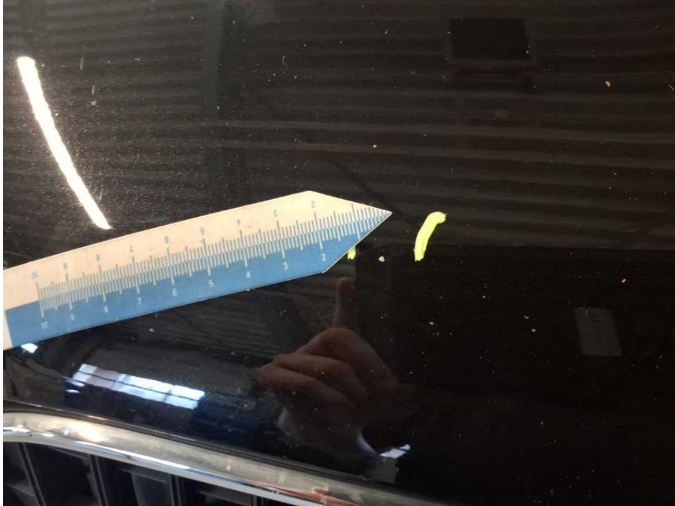
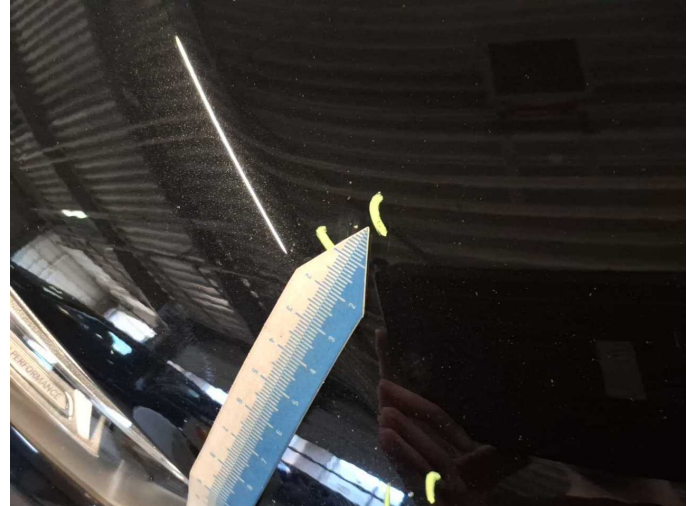
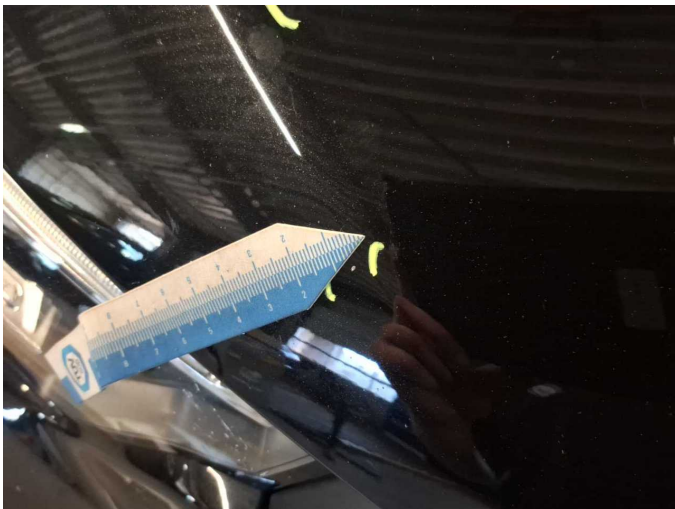
| No. | Component group | Description |
|---|---|---|
| 5 | Bonnet | Bonnet - Stone chips - Paint |

**Damage 5:** Bonnet: Bonnet - Stone chips - Paint

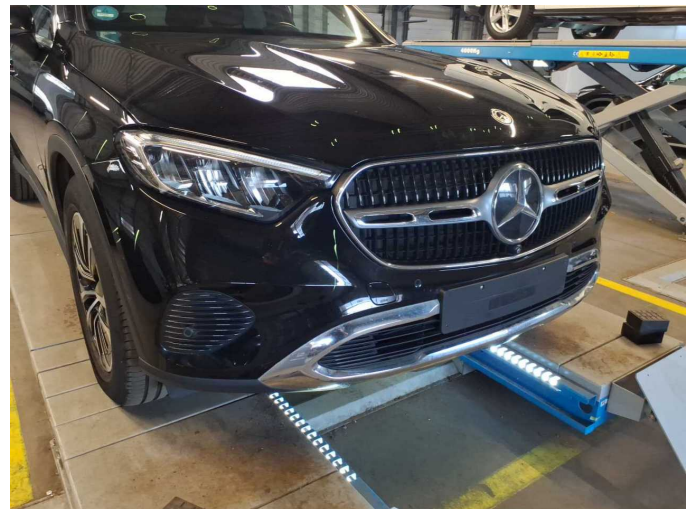
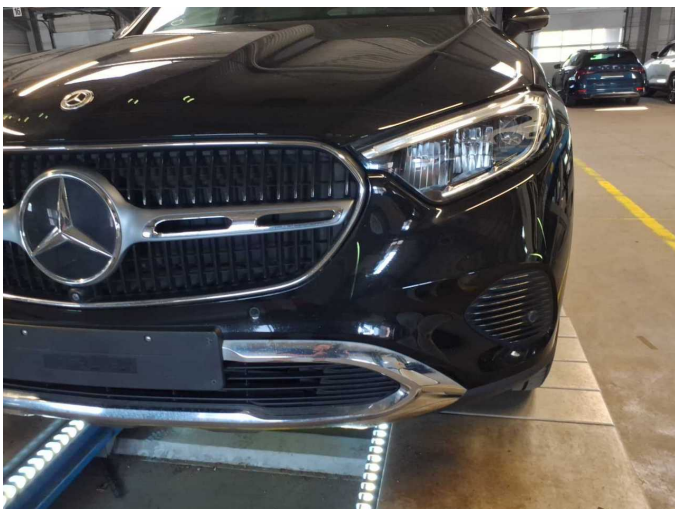
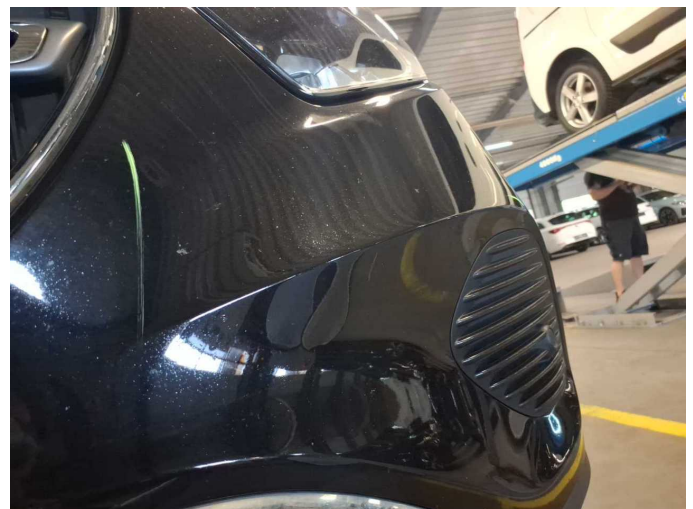
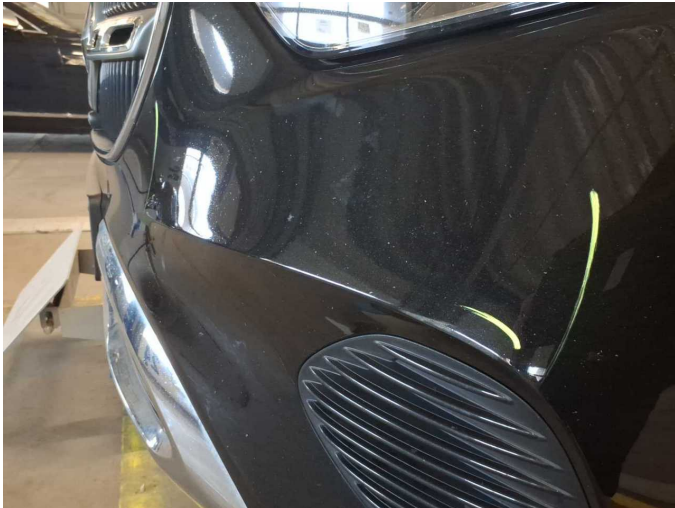
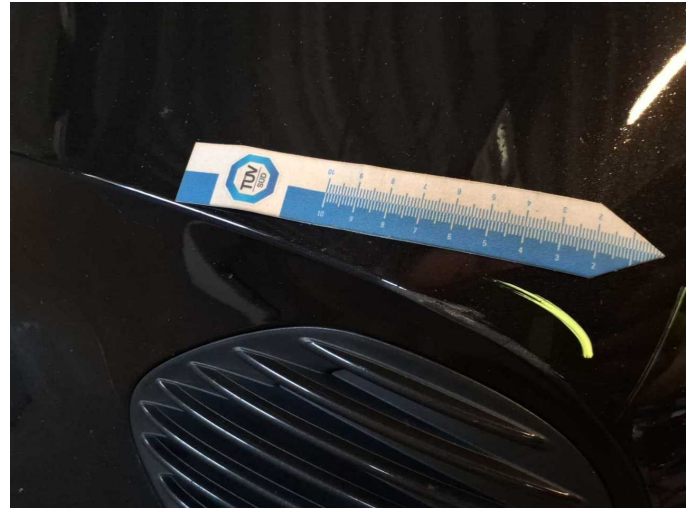
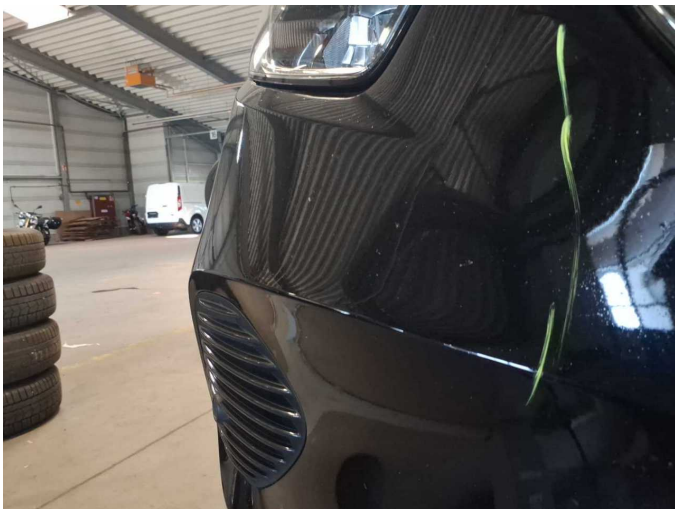
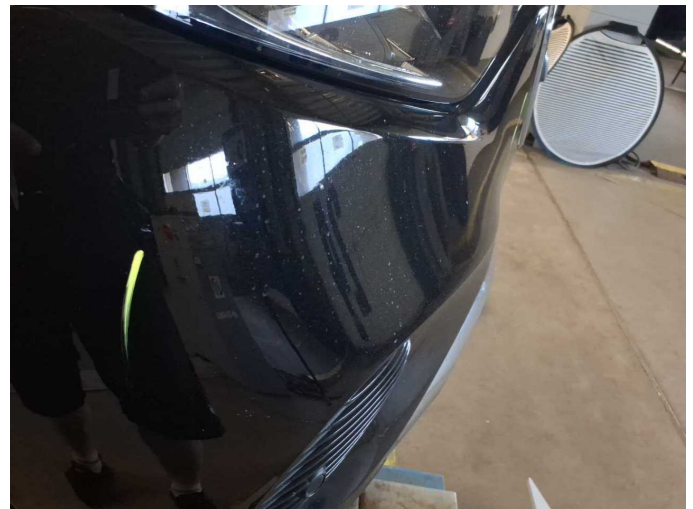
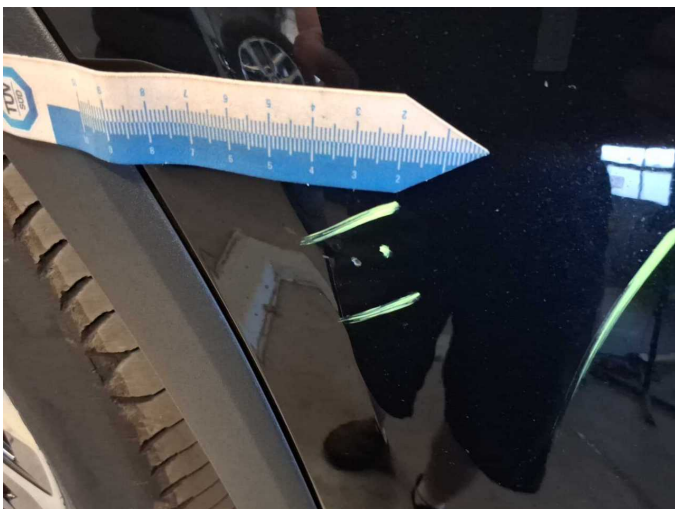
| No. | Component group | Description |
|---|---|---|
| 6 | Front bumper | Front bumper (Sandstrahleffekt) - Stone chips - Paint |

**Damage 6:** Front bumper: Front bumper (Sandstrahleffekt) - Stone chips - Paint

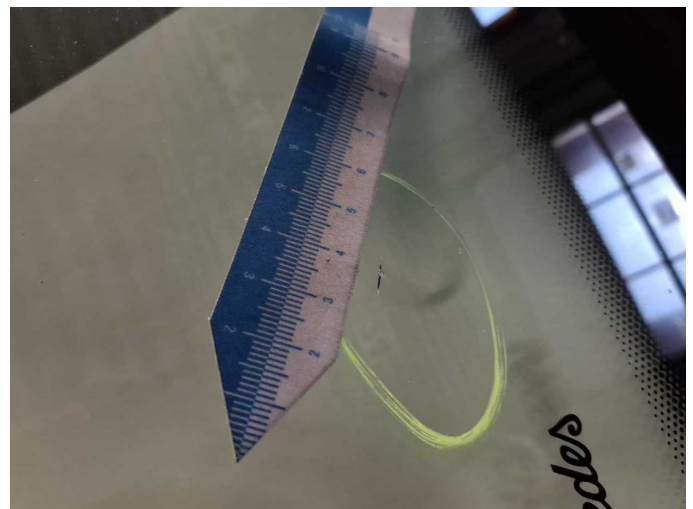
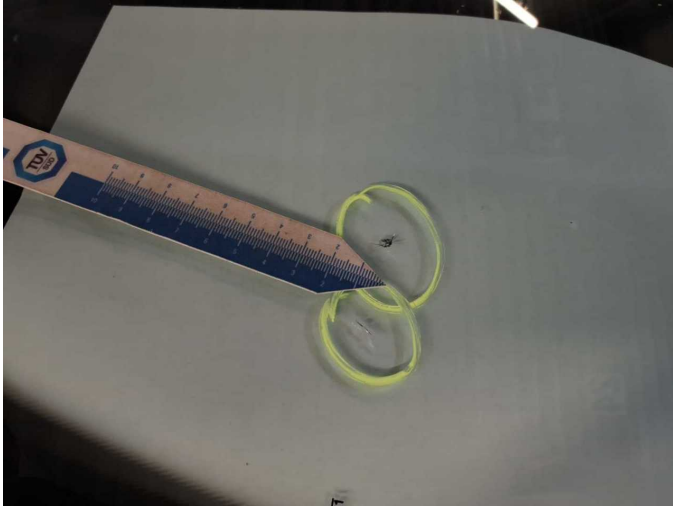
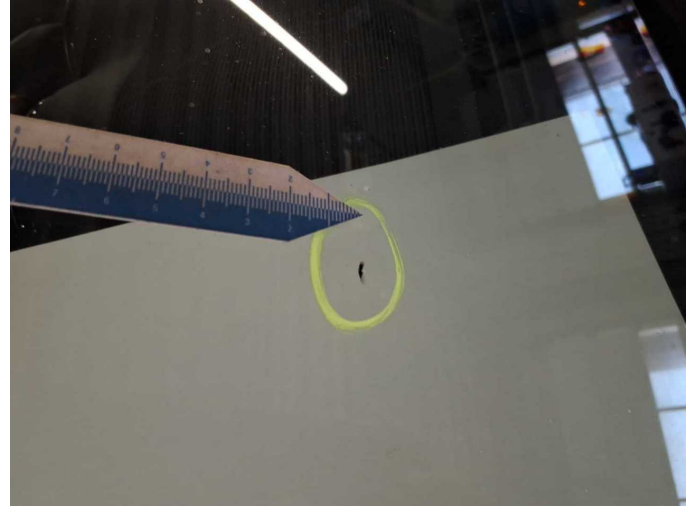
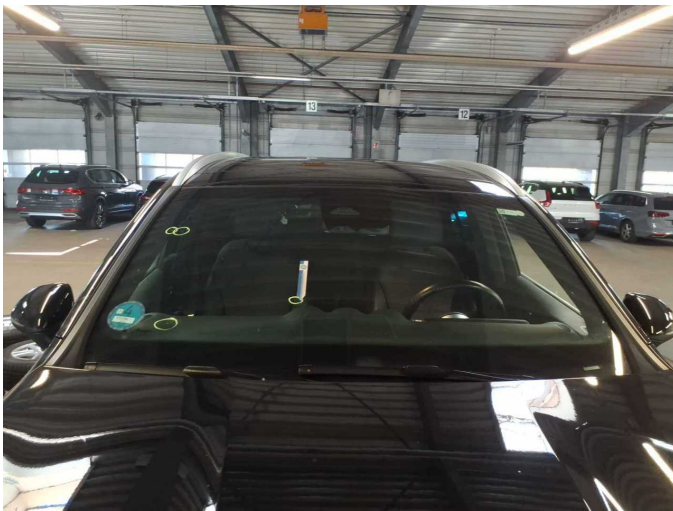
| No. | Component group | Description |
|---|---|---|
| 7 | Vehicle glazing | Windscreen - Stone chips - Replace |

**Damage 7:** Vehicle glazing: Windscreen - Stone chips - Replace

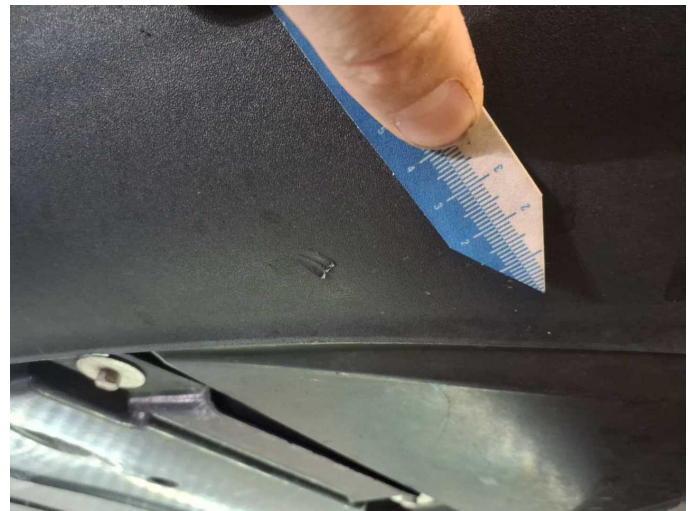
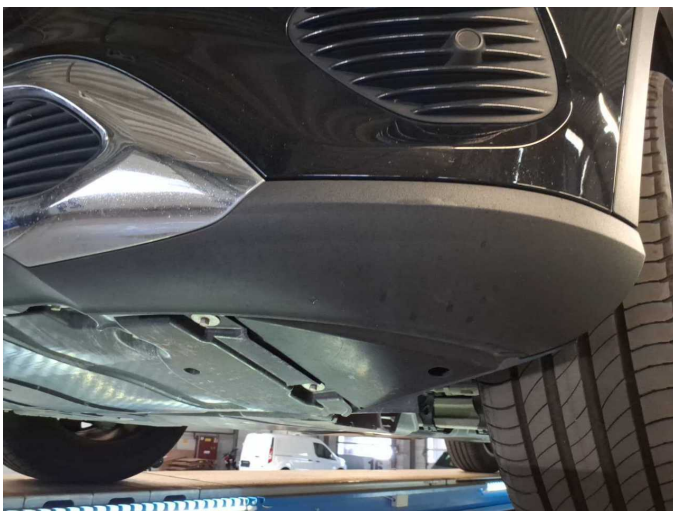
| No. | Component group | Description |
|---|---|---|
| 1 | Front bumper | Spoiler - Scratch(es) |

**Wear and tear 1:** Front bumper: Spoiler - Scratch(es)

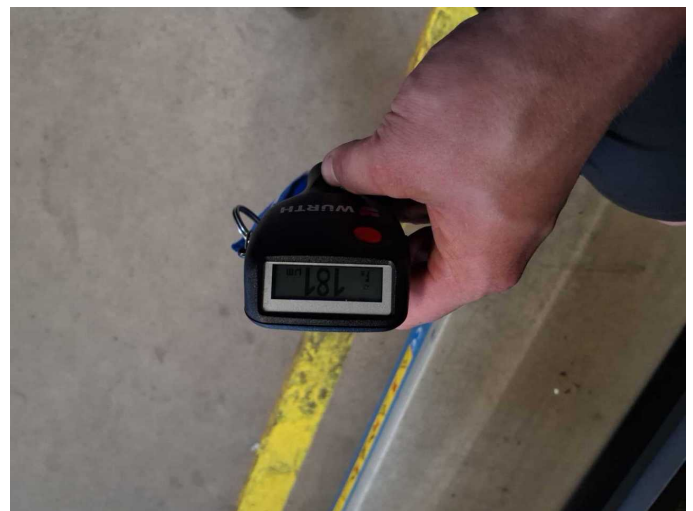
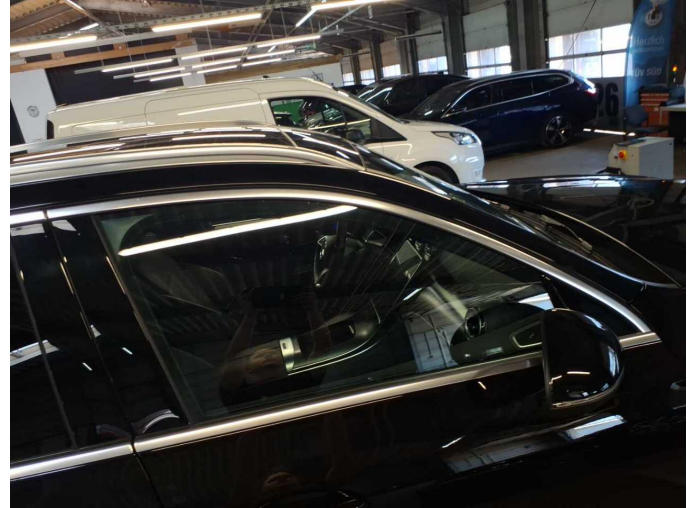
| No. | Repainting |
|---|--|
| 1 | Roof rail - right side, Professionally carried out, Invoice of repair done Non-existent |

**Repainting 1:** Roof rail - right side

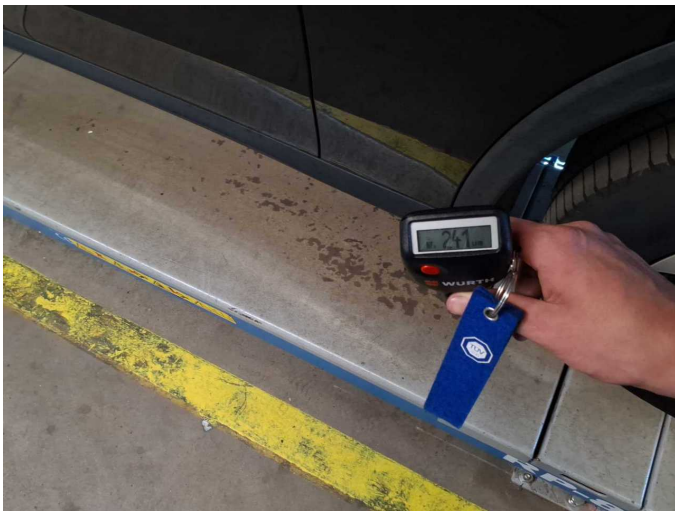
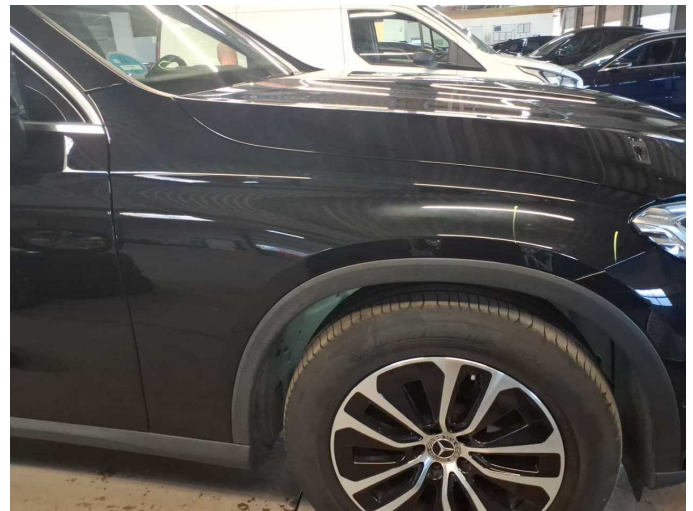
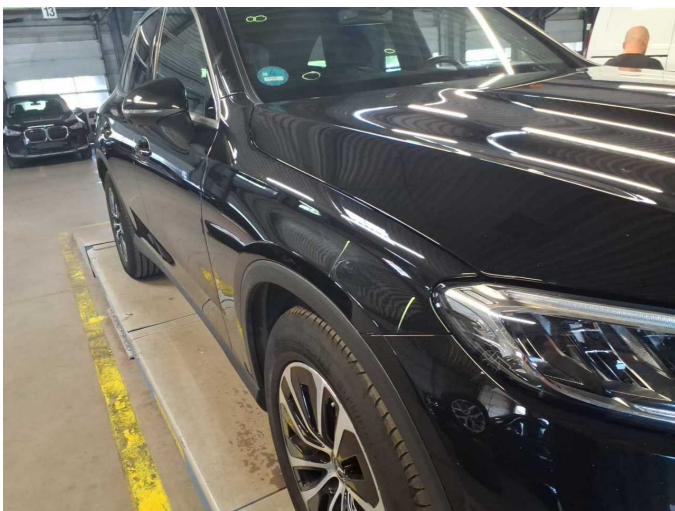
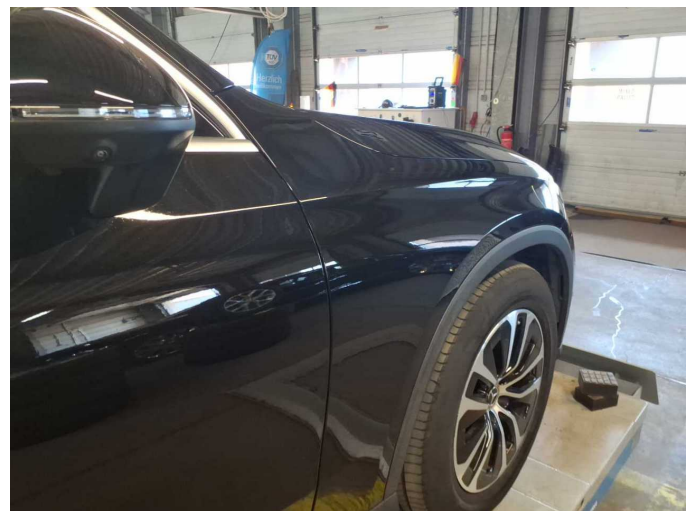
| No. | Repainting |
|---|--|
| 2 | Mudguard - right side, Unprofessionally carried out, Invoice of repair done Non-existent |

**Repainting 2:** Mudguard - right side

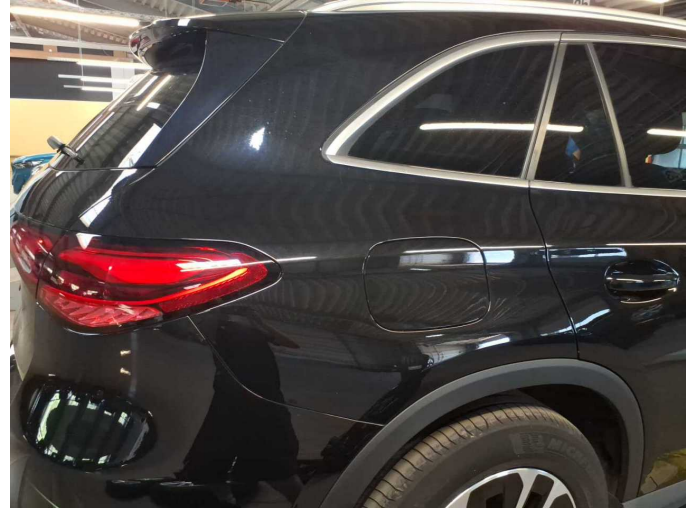
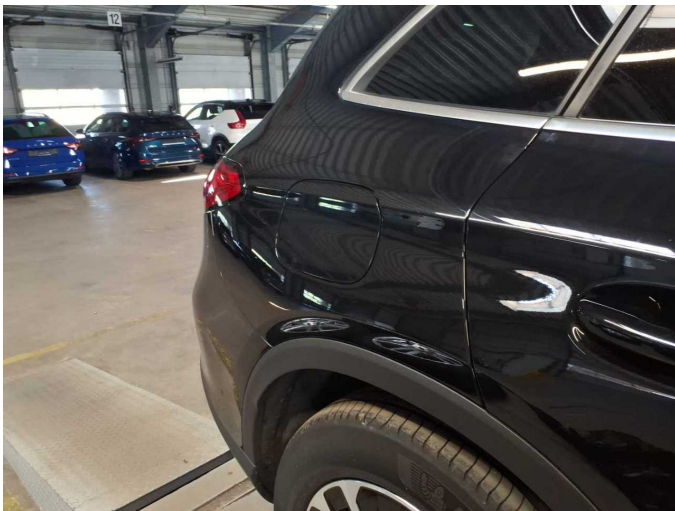
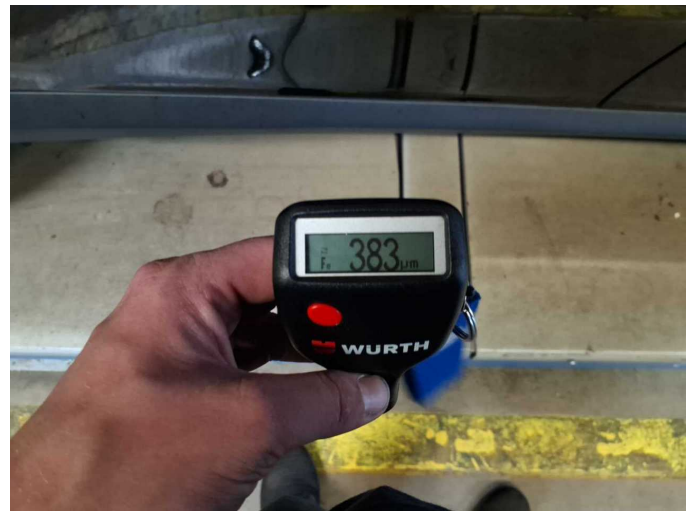
| No. | Repainting |
|---|--|
| 3 | Side panel - rear right side |

Repainting 3: Side panel - rear right side

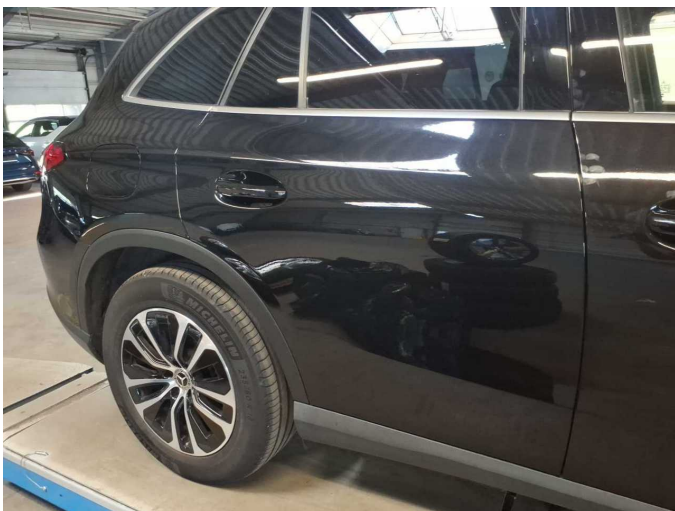
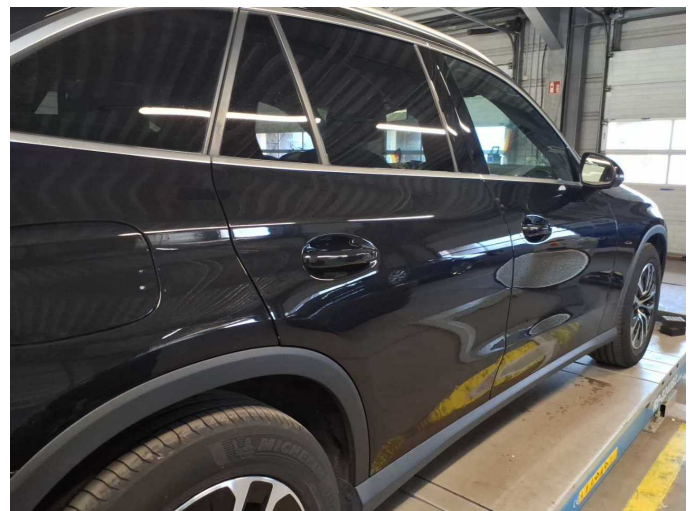
| No. | Repainting |
|---|--|
| 4 | Door - rear right side, Professionally carried out, Invoice of repair done Non-existent |

Repainting 4: Door - rear right side

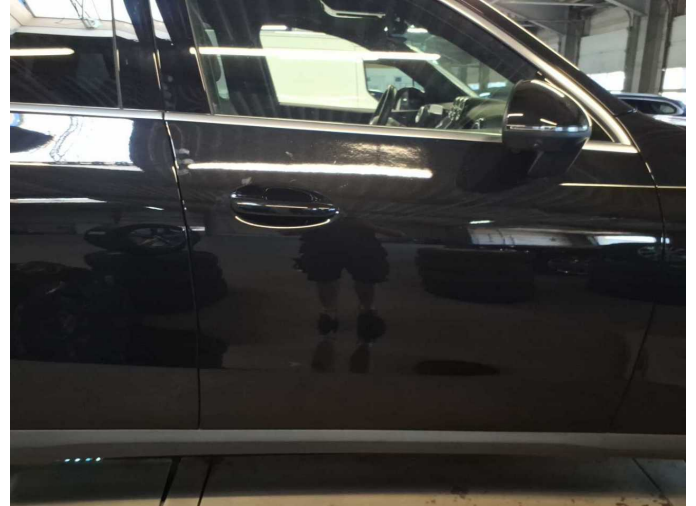
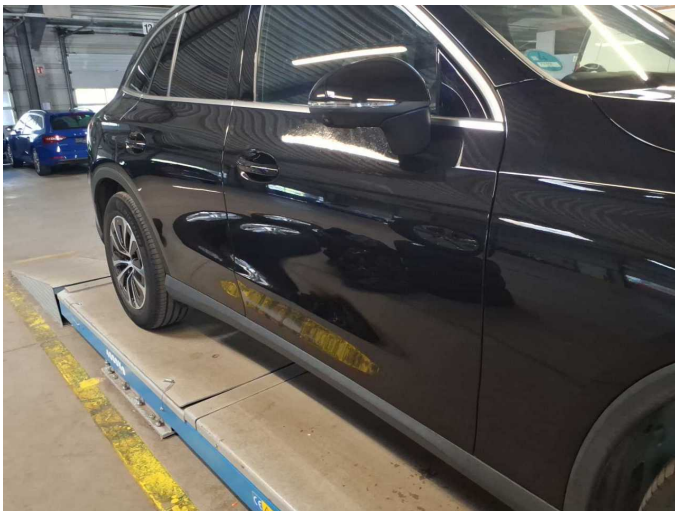
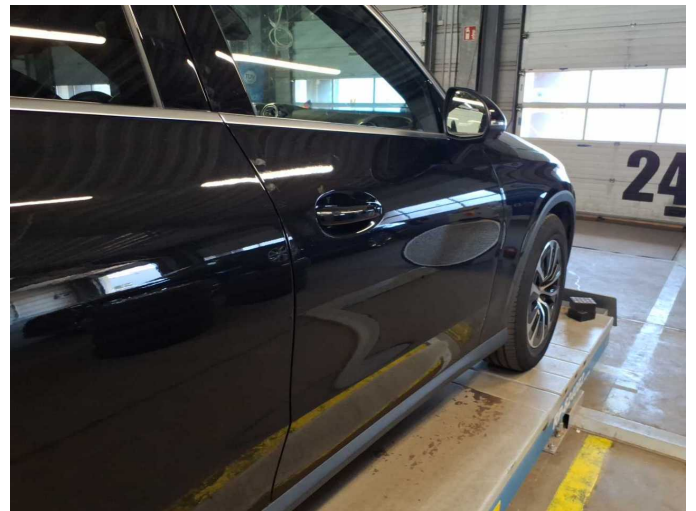
| No. | Repainting |
|---|--|
| 5 | Door - front right side, Professionally carried out, Invoice of repair done Non-existent |

Repainting 5: Door - front right side

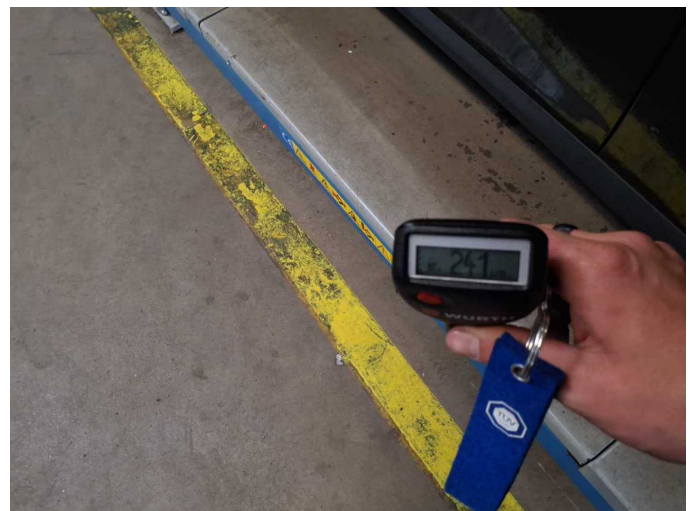
Roof rail - right side: 181  $\mu\text{m}$

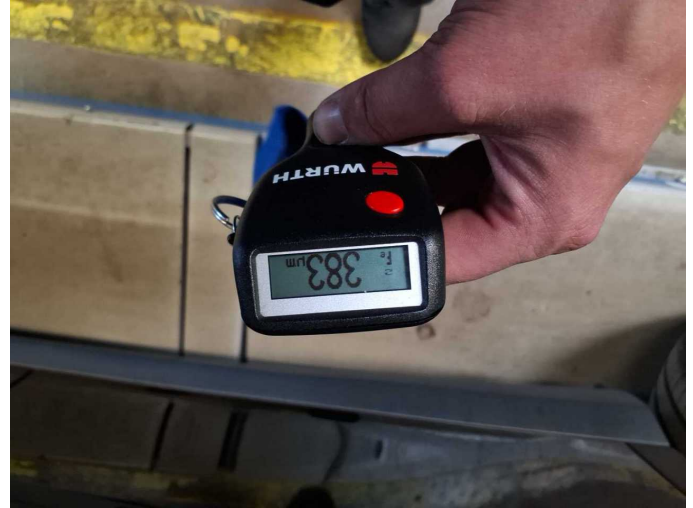
Side panel - rear right side: 701  $\mu\text{m}$
