Expertise

Protocol number: 46292930  
Order No. / Reference: 26637562  
Inspection date: 1 Jul 2026

Manufacturer: Ford

Model: Kuga 2.5 Duratec PHEV TITANIUM

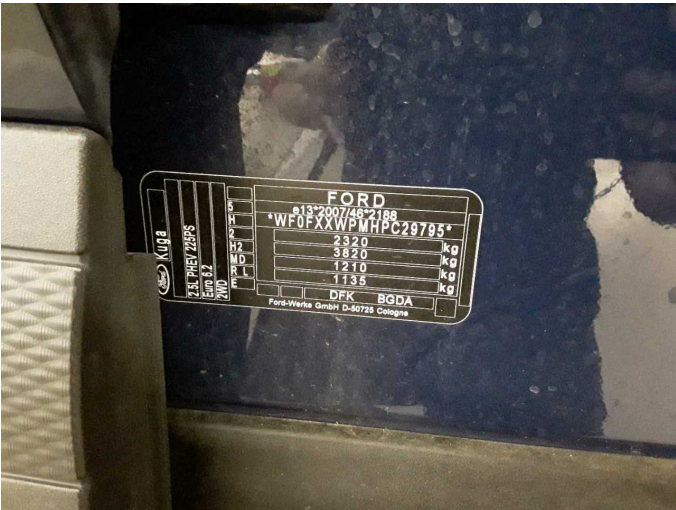
Figure 11: VIN

| VIN comparison | The vehicle identification number (VIN) was read from the vehicle and its conformity with the submitted documents was confirmed by the undersigned during the inspection. |

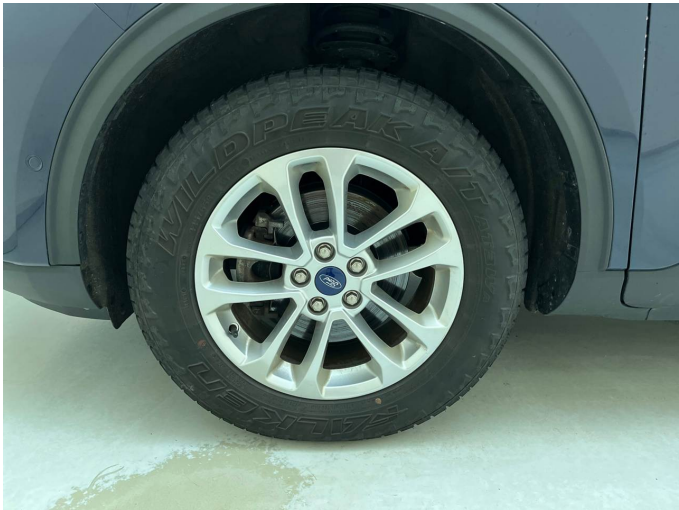
Figure 12: Mounted tyres

| # | Tyre size | Type of tyre | Manufacturer | Tread depth |
|---|---|---|---|---|
| 1) | 225/65 R17 102H | All-season tyres on Light alloy | Falken | 5mm / 5mm |
| 2) | 225/65 R17 102H | All-season tyres on Light alloy | Falken | 3mm / 3mm |

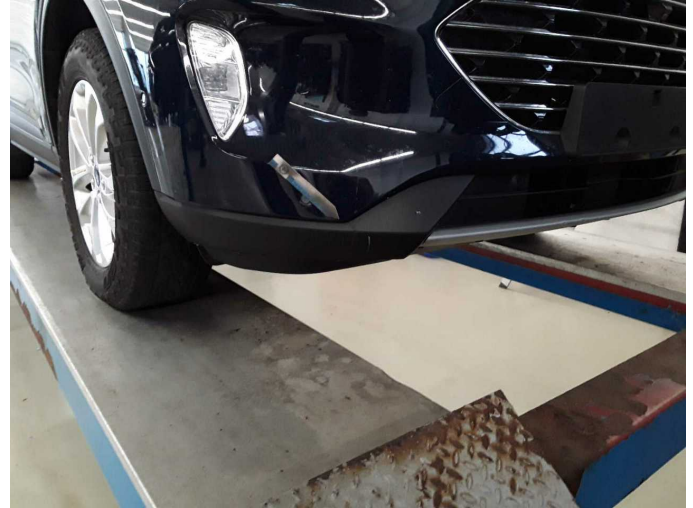
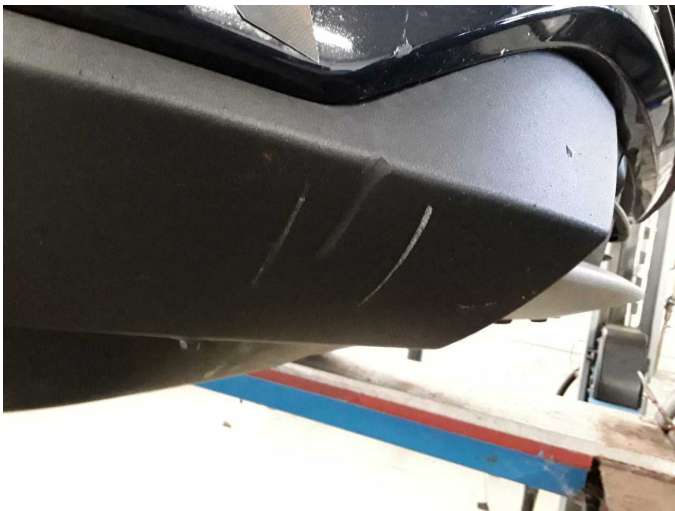
**Damage 2:** Front bumper: Spoiler - Deformed - Replace

| No. | Component group | Description |
|---|---|---|
| 2 | Front bumper | Spoiler - Deformed - Replace |

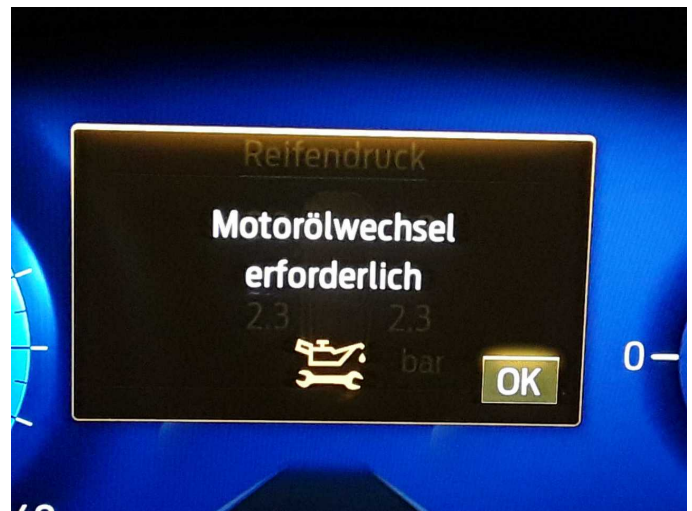
**Damage 3:** Misc.: Inspection / maintenance - Due - Perform

| No. | Component group | Description |
|---|---|---|
| 3 | Misc. | Inspection / maintenance - Due - Perform |

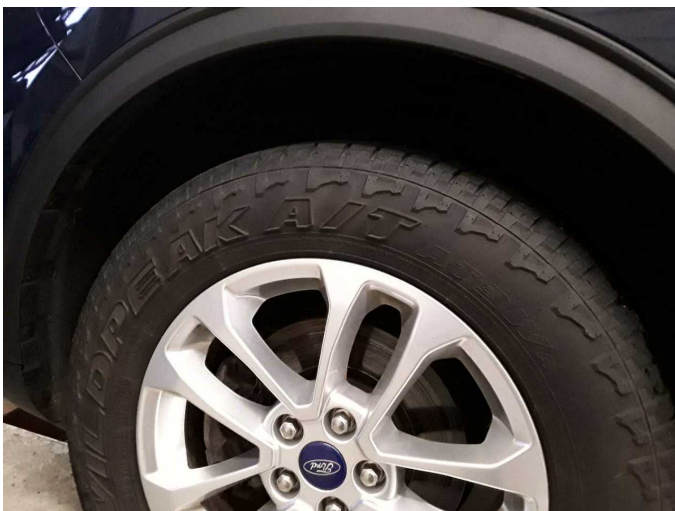
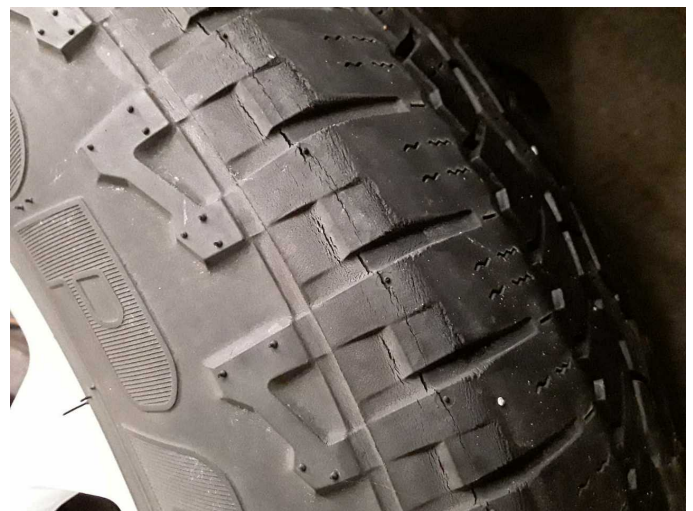
**Damage 4:** Wheel / tyres: Tyres - complete set (rissig) - Differs from the original configuration - Replace

| No. | Component group | Description |
|---|---|---|
| 4 | Wheel / tyres | Tyres - complete set (rissig) - Differs from the original configuration - Replace |

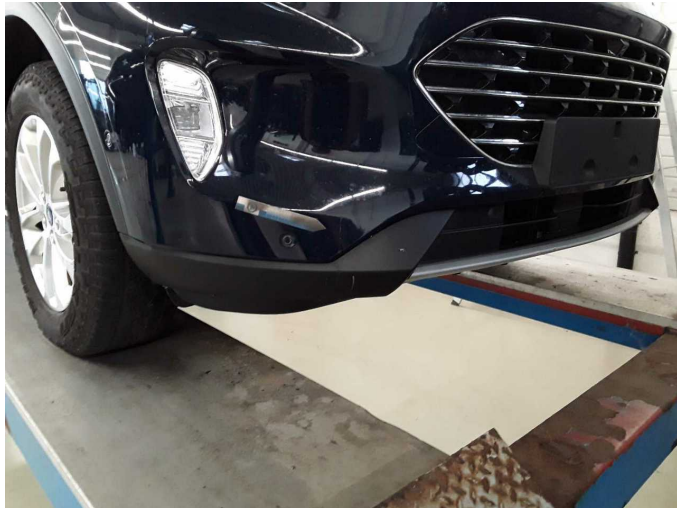
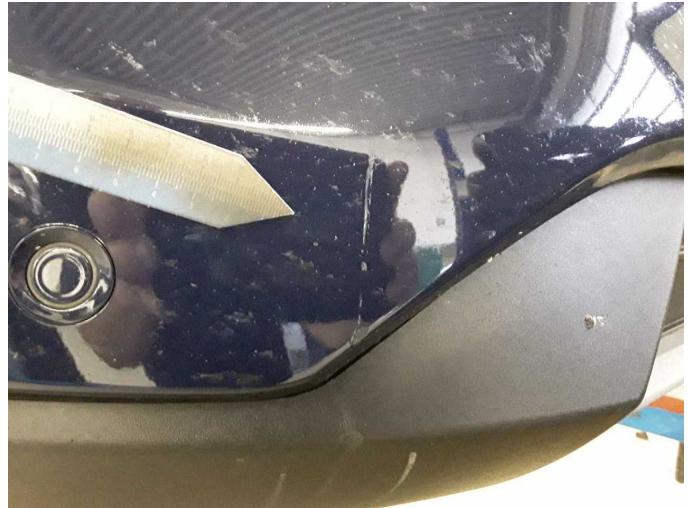
**Damage 5:** Front bumper: Bumper with Parktronic - Scratch(es) - Paint

| No. | Component group | Description |
|---|---|---|
| 5 | Front bumper | Bumper with Parktronic - Scratch(es) - Paint |

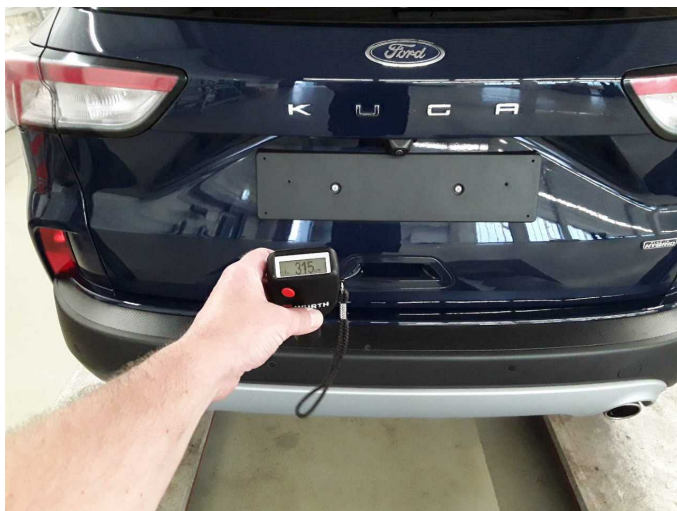
| No. | Repainting |
|---|---|
| 1 | Boot lid / rear door, Professionally carried out |

| Boot lid / rear door | 315 µm |

**Boot lid / rear door:** 315 µm
