Expertise

Protocol number: 46902434  
Order No. / Reference: 26726622  
Inspection date: 3 Aug 2026

Manufacturer: Volkswagen

Model: Passat Variant 2.0 TDI SCR DSG Business

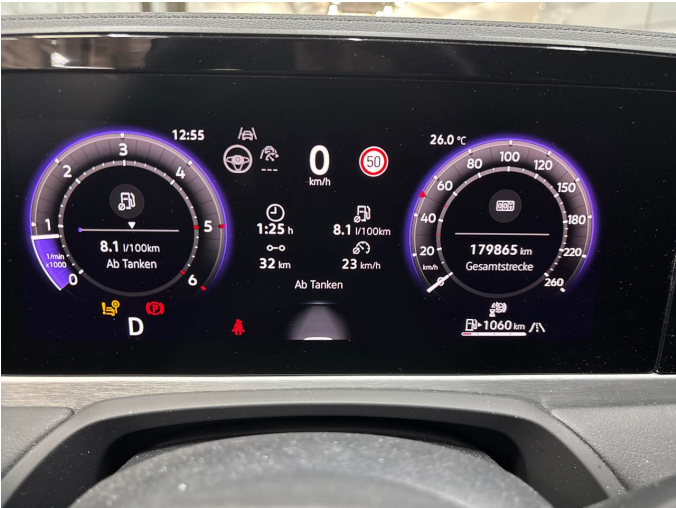
Figure 7: Instrument cluster

| Vehicle details | |
|---|---|
| Mileage (Read) | 179,865 km |

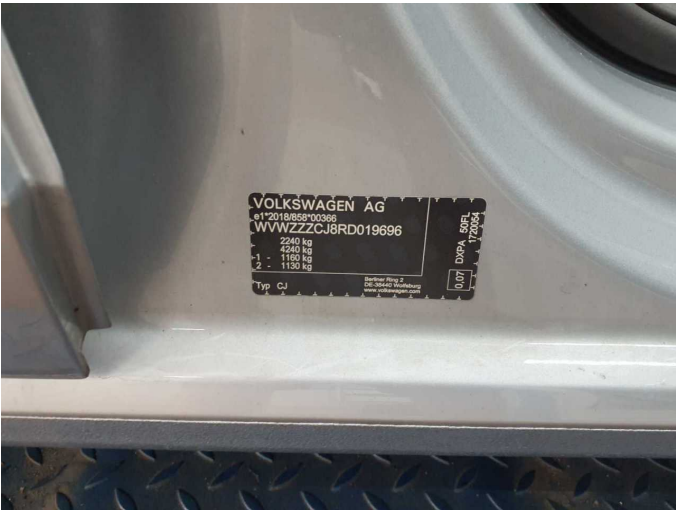
Figure 11: VIN

| VIN comparison | The vehicle identification number (VIN) was read from the vehicle and its conformity with the submitted documents was confirmed by the undersigned during the inspection. |

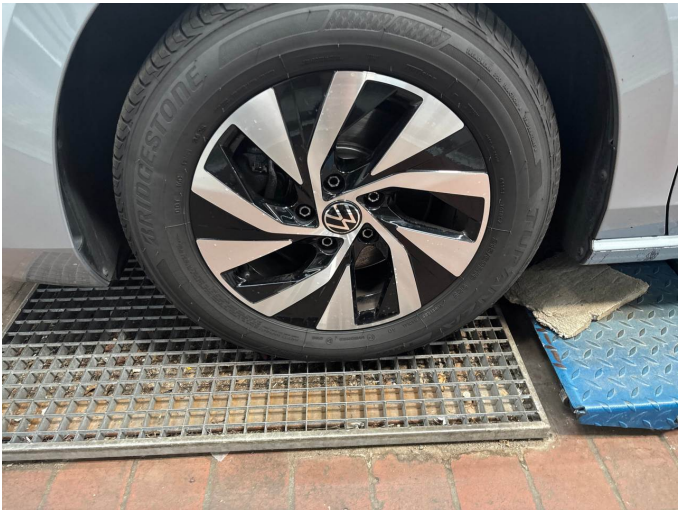
Figure 12: Mounted tyres

| # | Tyre size | Type of tyre | Manufacturer | Tread depth |
|---|---|---|---|---|
| 1) | 215/60 R16 95V | Summer tyres on Light alloy | Bridgestone | 6mm / 6mm |
| 2) | 215/60 R16 95V | Summer tyres on Light alloy | Bridgestone | 6mm / 6mm |

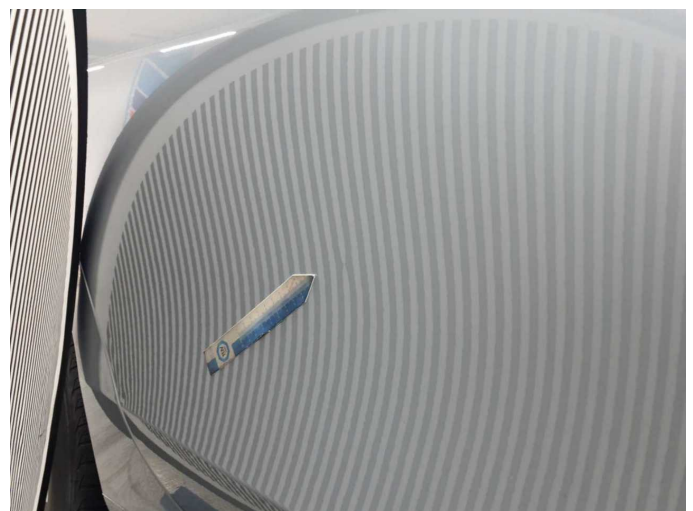
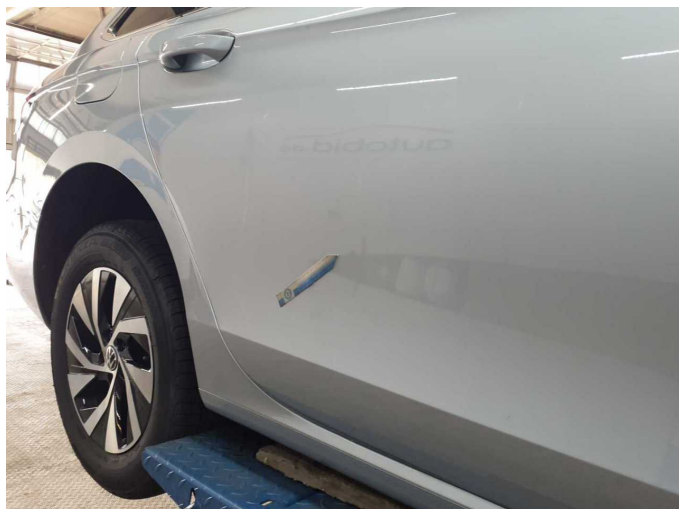
| No. | Component group | Description |
|---|---|---|
| 1 | Door - rear right side | Door - dent(s) - Smart repair |

Damage 1: Door - rear right side: Door - dent(s) - Smart repair

**Damage 1:** Door - rear right side: Door - dent(s) - Smart repair

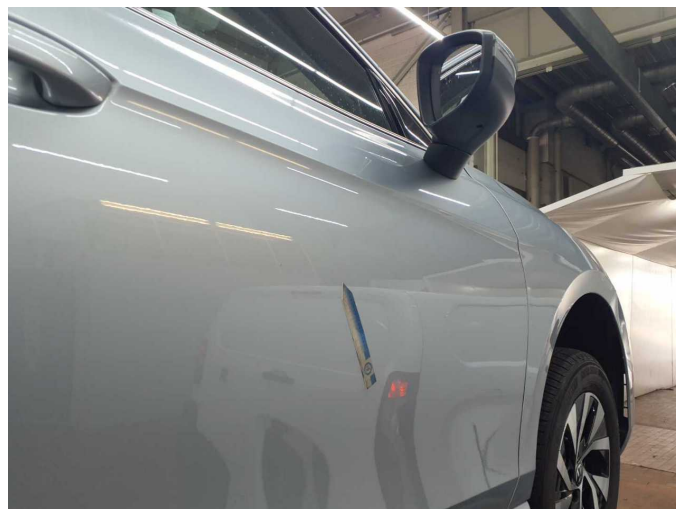
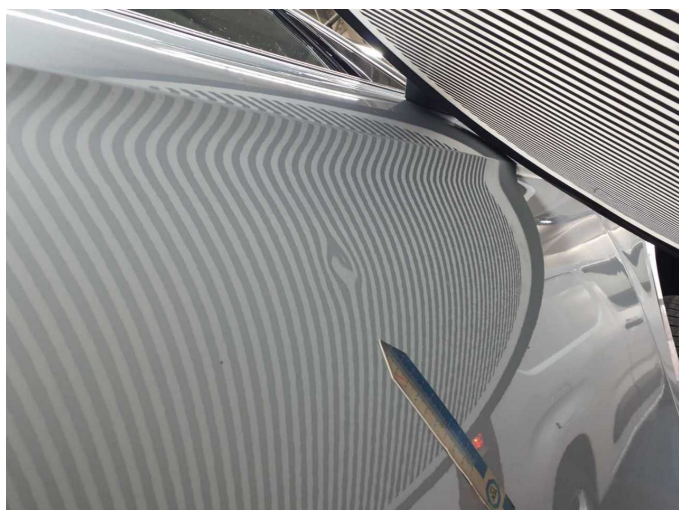
| No. | Component group | Description |
|---|---|---|
| 2 | Door - front right side | Door - dent(s) - Smart repair |

**Damage 2:** Door - front right side: Door - dent(s) - Smart repair

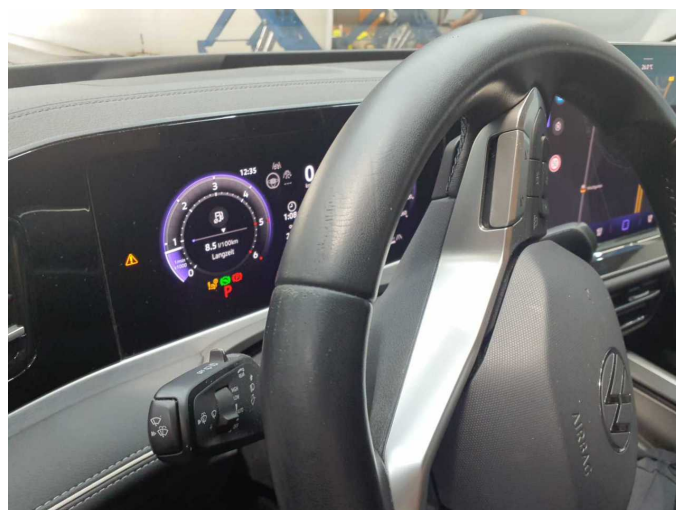
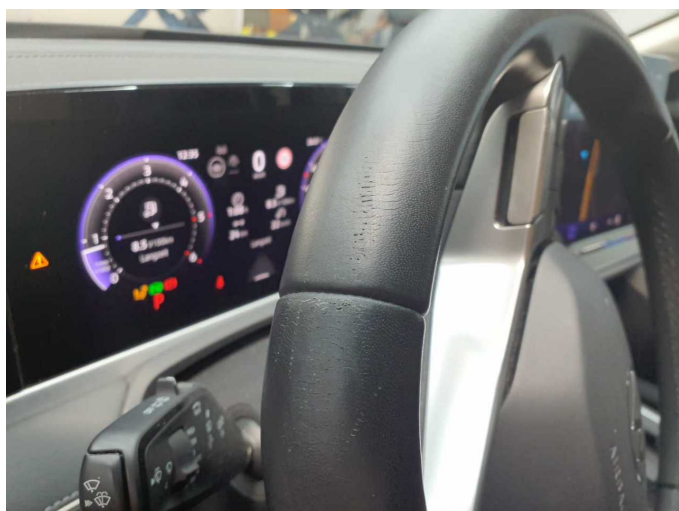
| No. | Component group | Description |
|---|---|---|
| 3 | Steering system | Steering wheel - Scratch(es) - Smart repair |

**Damage 3:** Steering system: Steering wheel - Scratch(es) - Smart repair

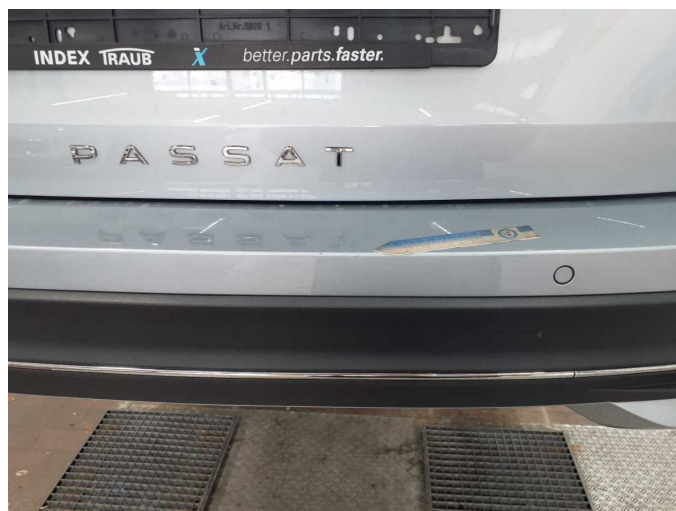
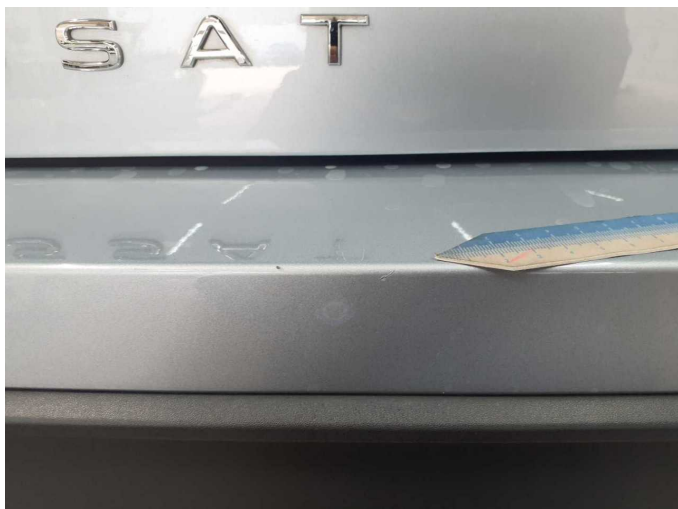
| No. | Component group | Description |
|---|---|---|
| 4 | Rear bumper | Rear bumper - Scratch(es) - Smart repair |

**Damage 4:** Rear bumper: Rear bumper - Scratch(es) - Smart repair

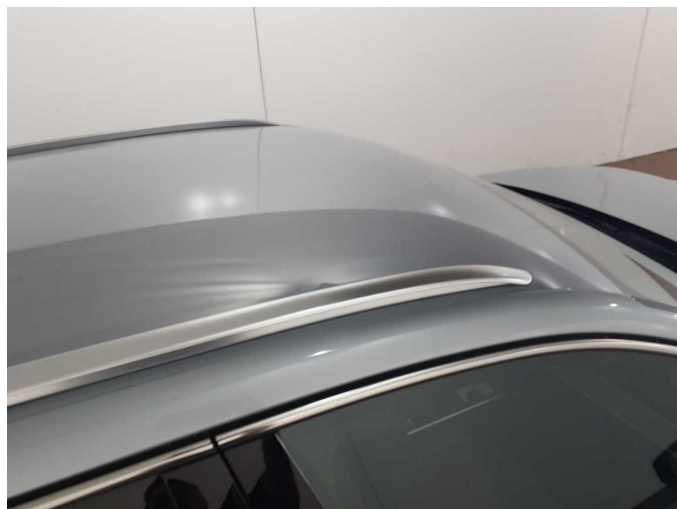
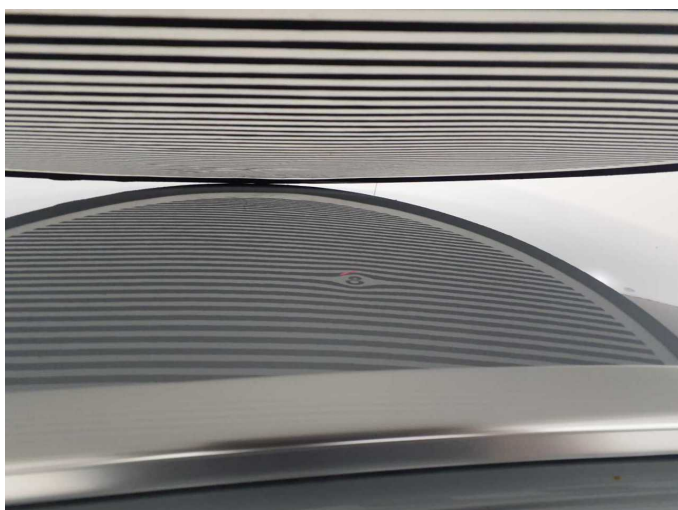
| No. | Component group | Description |
|---|---|---|
| 5 | Roof | Roof - dent(s) - Smart repair |

**Damage 5:** Roof: Roof - dent(s) - Smart repair

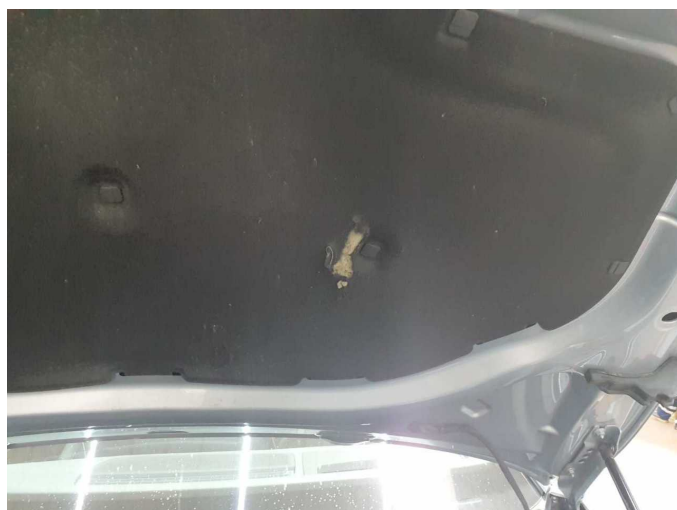
| No. | Component group | Description |
|---|---|---|
| 6 | Bonnet | Insulation lining - Damaged - Replace |

**Damage 6:** Bonnet: Insulation lining - Damaged - Replace

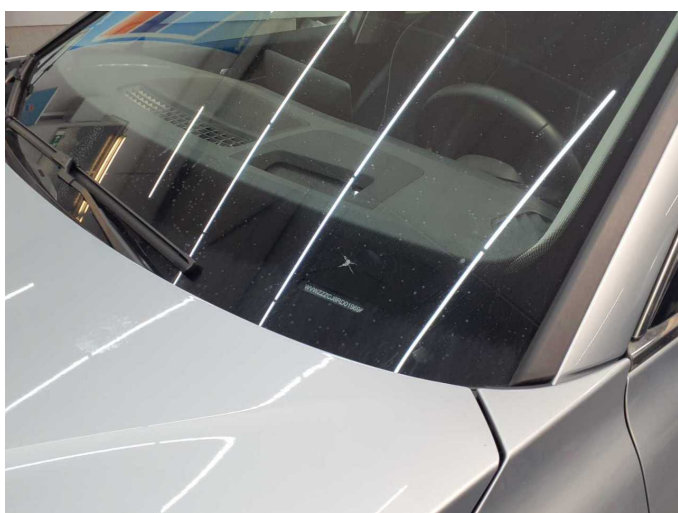
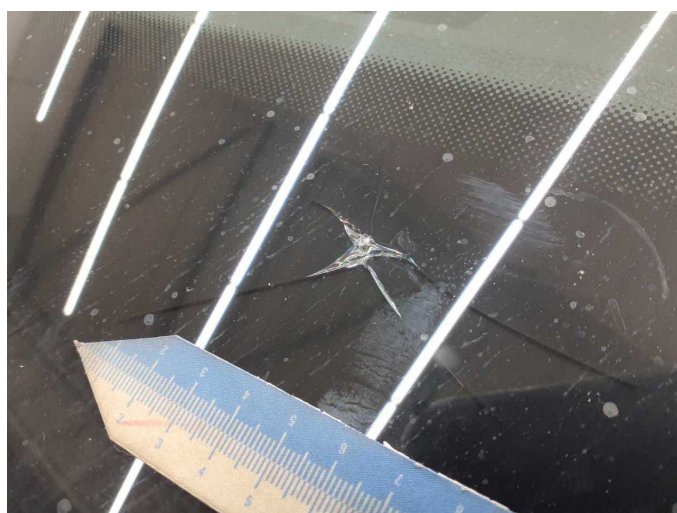
| No. | Component group | Description |
|---|---|---|
| 7 | Vehicle glazing | Windscreen - Broken / torn - Replace |

**Damage 7:** Vehicle glazing: Windscreen - Broken / torn - Replace
