Expertise

Protocol number: 46678966  
Order No. / Reference: 26513182  
Inspection date: 23 Jul 2026

Manufacturer: Opel

Model: Astra 1.5 D Start/Stop Sports Tourer Business Edition

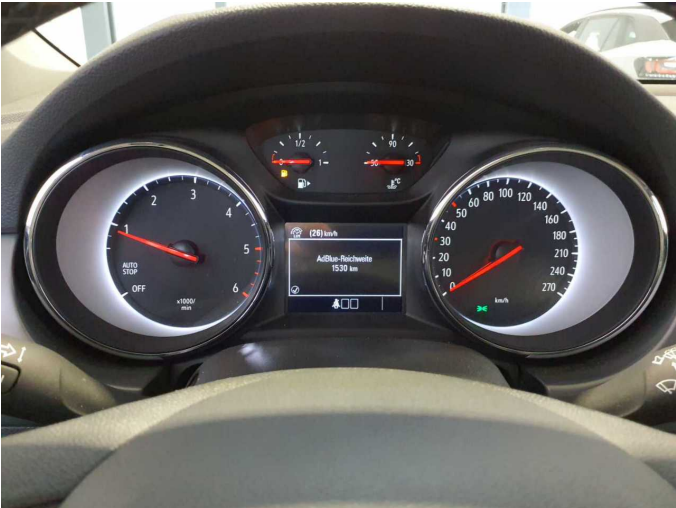
Figure 7: Instrument cluster

| Vehicle details | |
|---|---|
| Mileage (Read) | 74,096 km |

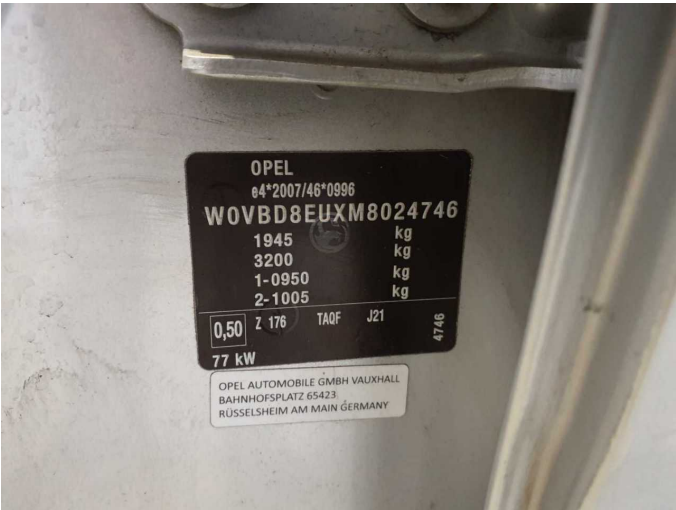
Figure 11: VIN

| VIN comparison | The vehicle identification number (VIN) was read from the vehicle and its conformity with the submitted documents was confirmed by the undersigned during the inspection. |

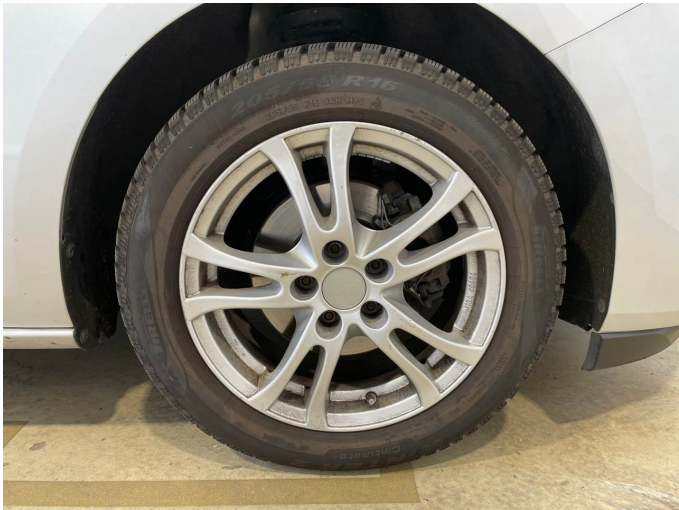
Figure 12: Mounted tyres

| # | Tyre size | Type of tyre | Manufacturer | Tread depth |
|---|---|---|---|---|
| 1) | 205/55 R16 94H | Winter tyres on Light alloy | Pirelli | 7mm / 7mm |
| 2) | 205/55 R16 94H | Winter tyres on Light alloy | Pirelli | 7mm / 7mm |

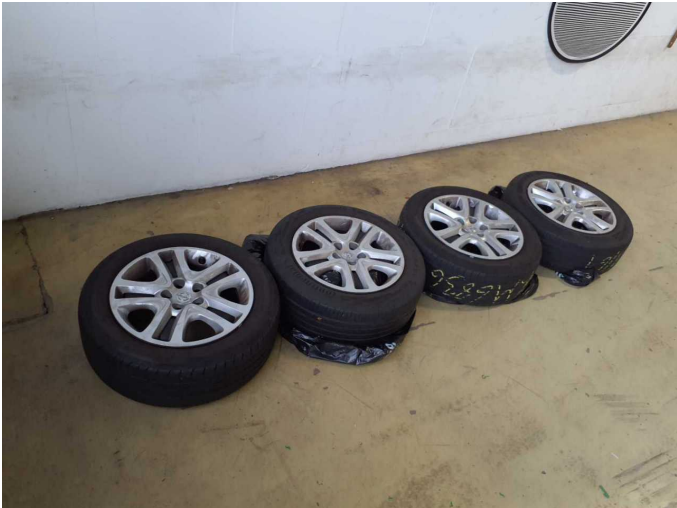
Figure 14: Additional tyres

| # | Tyre size | Type of tyre | Manufacturer | Tread depth |
|---|---|---|---|---|
| 1) | 205/55 R16 91V | Summer tyres on Steel rim with wheel cover | Goodyear | 5mm / 5mm |
| 2) | 205/55 R16 91V | Summer tyres on Steel rim with wheel cover | Goodyear | 7mm / 6mm |

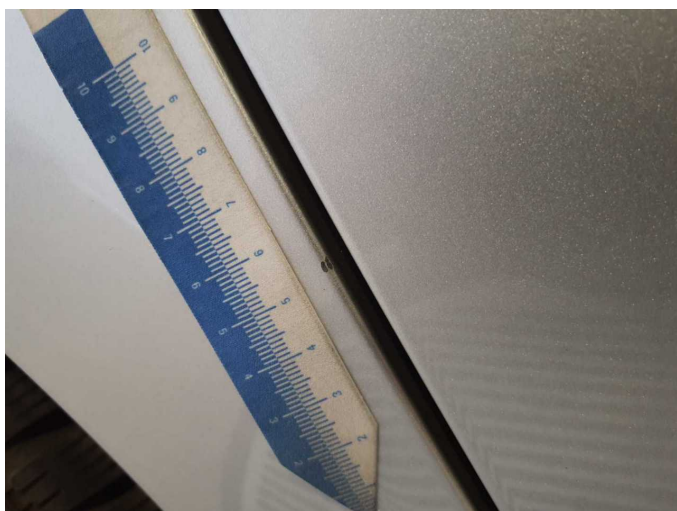
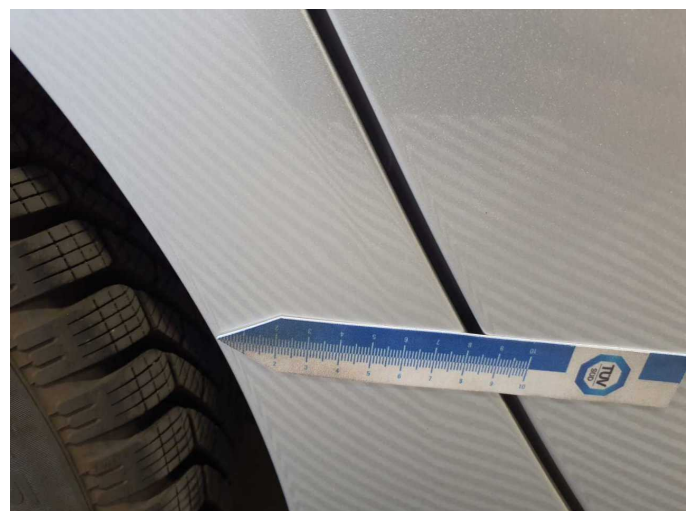
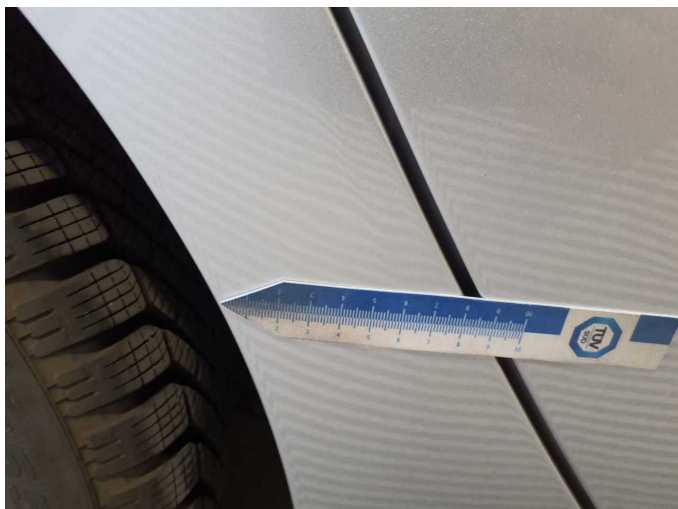
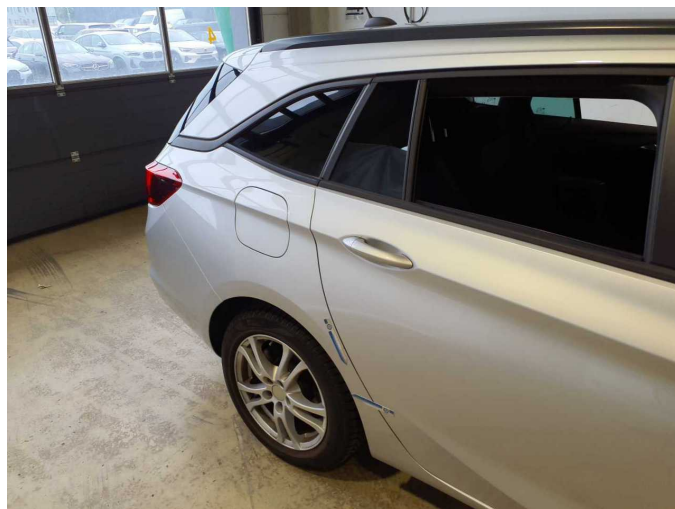
**Damage 2:** Side panel - rear right side: Side panel - Dent / paintcoat damage - Smart repair

| No. | Component group | Description |
|---|---|---|
| 2 | Side panel - rear right side | Side panel - Dent / paintcoat damage - Smart repair |

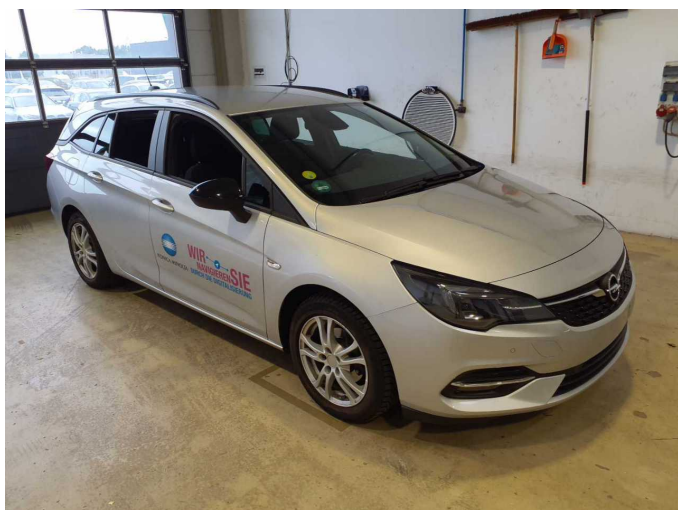
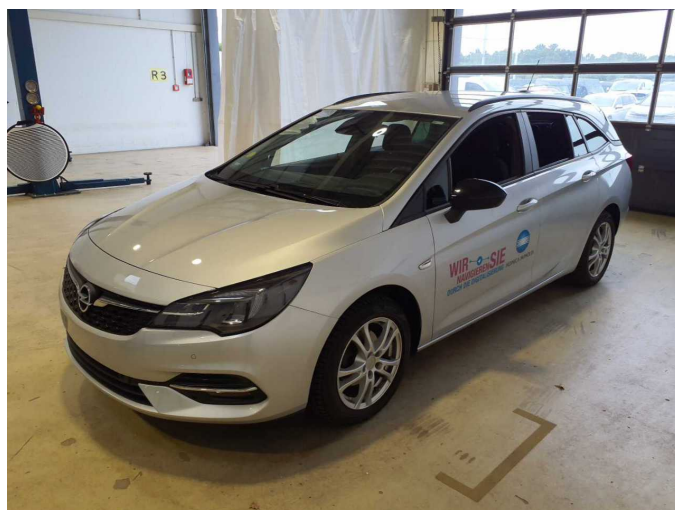
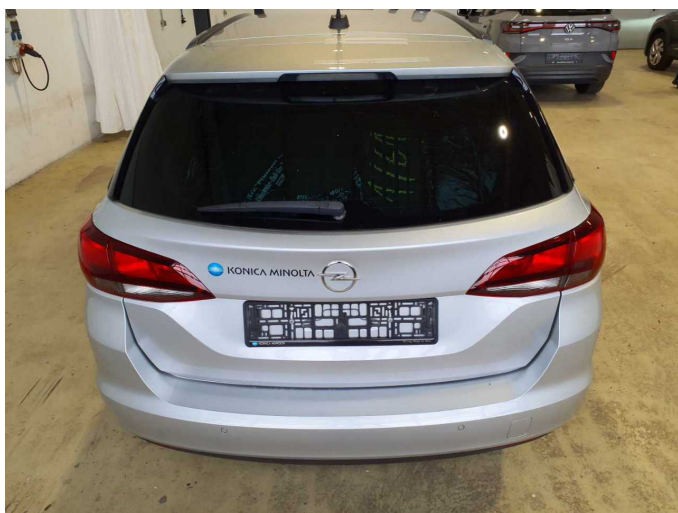
**Damage 3:** Body: Body - Glued / labelled - De-glue / neutralise

| No. | Component group | Description |
|---|---|---|
| 3 | Body | Body - Glued / labelled - De-glue / neutralise |
