Expertise

Protocol number: 45791133
Order No. / Reference: 26406159
Inspection date: 5 Jun 2026

Model: GLC-Coupe 300 e 4Matic 9G-TRONIC AMG Line

VIN: W1N2533531F885517

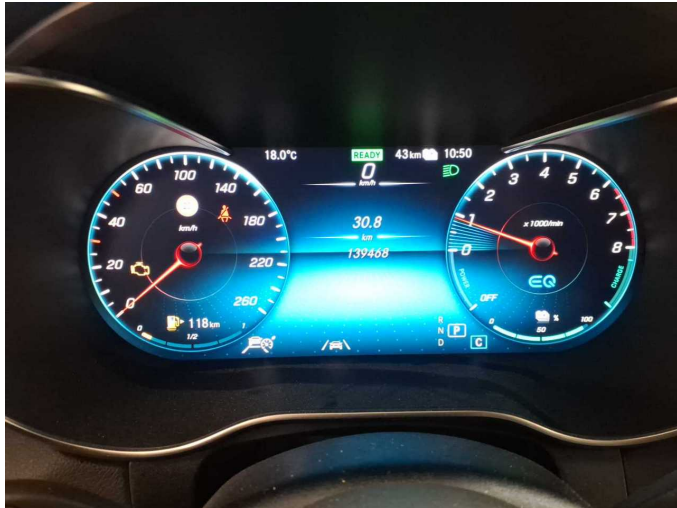
Figure 7: Instrument cluster

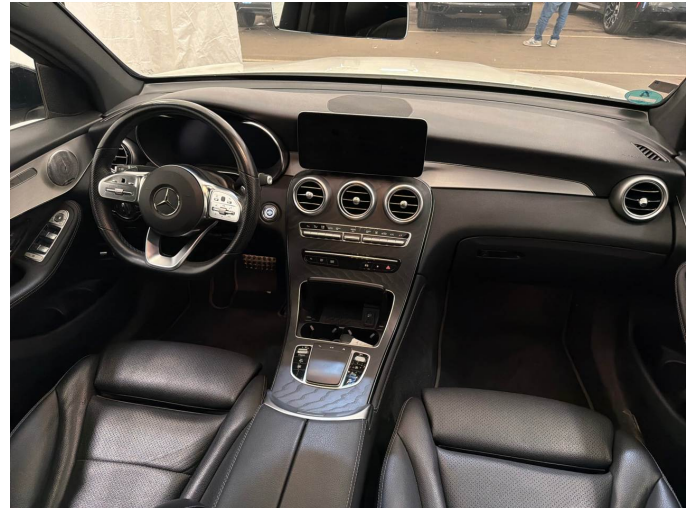
Figure 8: Instrument panel

No.	Component group	Description
1	Rear bumper	Rear bumper - Scratched - Smart repair
2	Instrument panel	Indicator light (Motorkontrolle) - on - Perform diagnosis

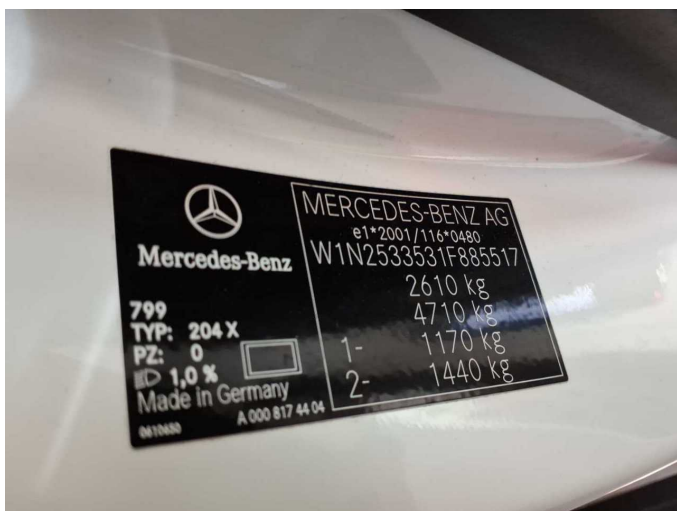
Figure 11: VIN

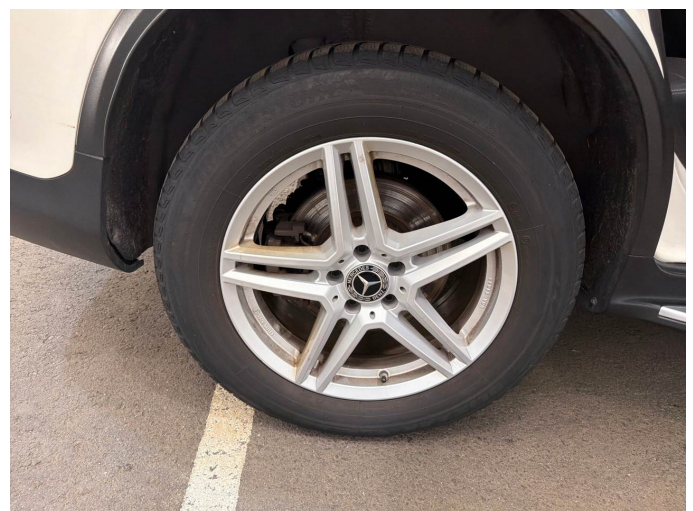
Figure 12: Mounted tyres

#	Tyre size	Type of tyre	Manufacturer	Tread depth
1)	235/60 R18 103H	Winter tyres on Light alloy	Bridgestone	6mm / 6mm
2)	235/60 R18 103H	Winter tyres on Light alloy	Bridgestone	6mm / 6mm

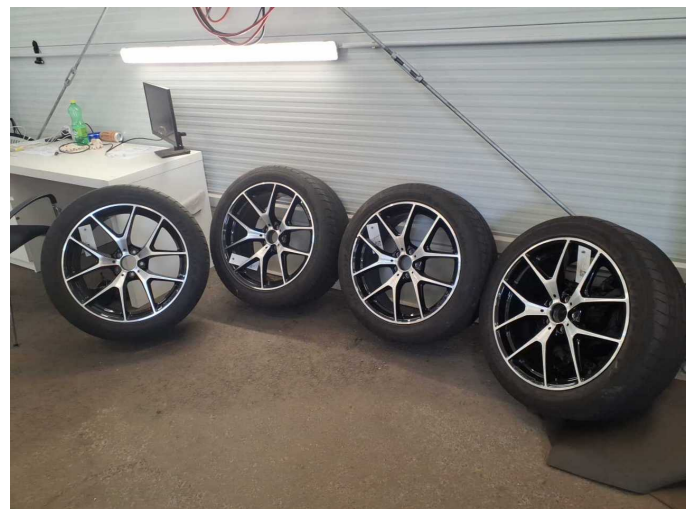
Figure 18: Additional tyres

#	Tyre size	Type of tyre	Manufacturer	Tread depth
1)	255/45 R20 105Y	Summer tyres on Light alloy	Dunlop	5mm / 5mm
2)	285/40 R20 108Y	Summer tyres on Light alloy	Dunlop	5mm / 5mm

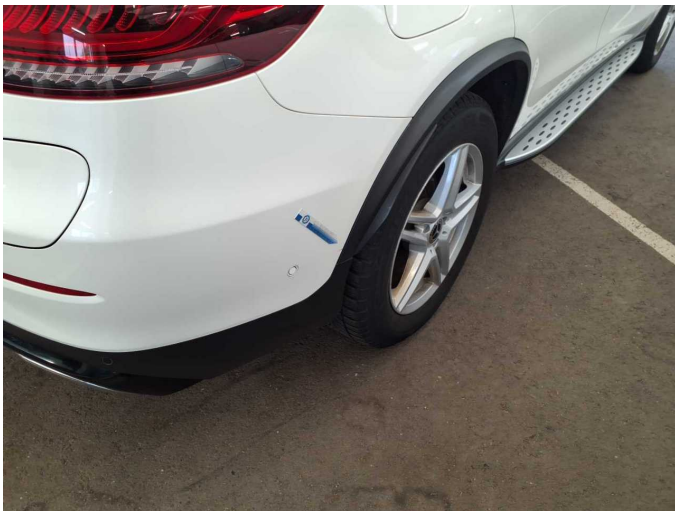
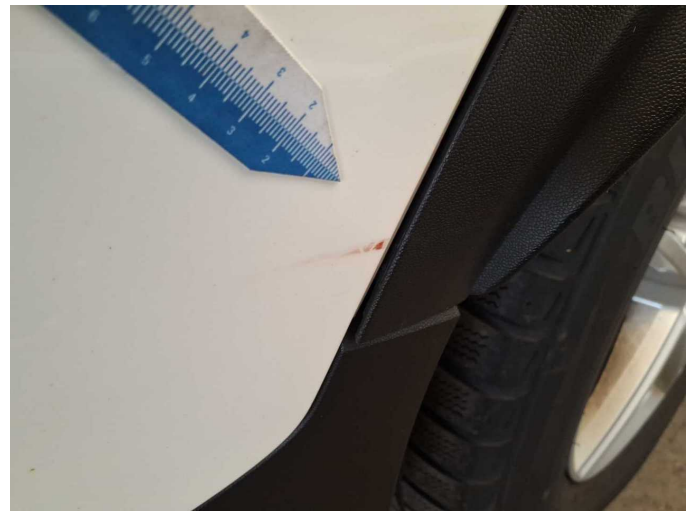
Damage 1: Rear bumper: Rear bumper - Scratched - Smart repair

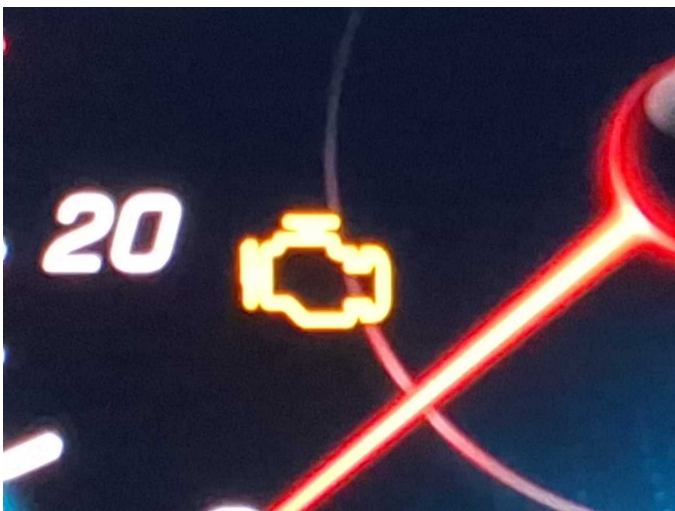
Damage 2: Instrument panel: Indicator light (Motorkontrolle) - on - Perform diagnosis

Documents submitted	At the time of the inspection, the vehicle registration certificate Part 2 (title) was available, but the vehicle registration certificate Part 1 (document) was not. (Copy)
VIN comparison	The vehicle identification number (VIN) was read from the vehicle and its conformity with the submitted documents was confirmed by the undersigned during the inspection.
Inspection	The inspection conditions were sufficient for the assessment of the vehicle. No lifting equipment or pit was available for inspecting the vehicle. Therefore, inspection of the vehicle's underside was only possible to a limited extent.
Test drive	No test drive/shunting maneuver was carried out during the inspection of the vehicle.
Engine function test	An engine test run was performed, problem has been detected This is due to the following reason.: Motorkontrolleuchte aktiv, Fehlerursache nicht genauer identifizierbar

readiness to drive	The vehicle was not capable of driving under its own power at the time of inspection, but can be moved on its own axle with the aid of assistance.
