Expertise

Protocol number: 46532400  
Order No. / Reference: 26687646  
Inspection date: 13 Jul 2026

| Manufacturer: Opel | Model: Astra 1.5 D Start/Stop Sports Tourer Automatik Edition |

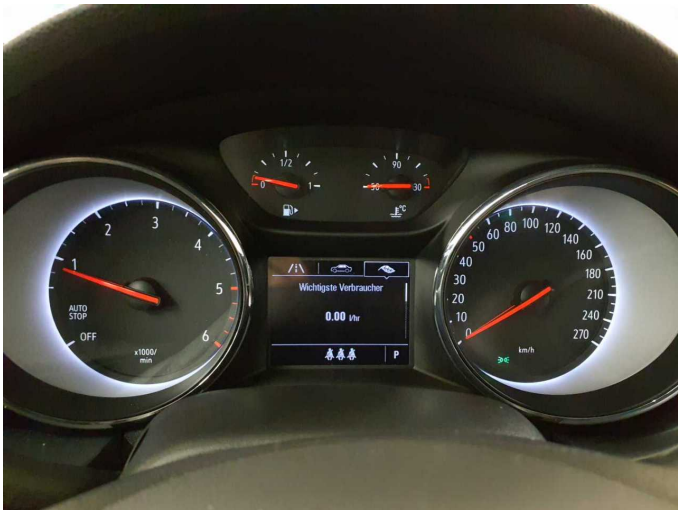
| Vehicle details | |
|---|---|
| Mileage (Read) | 161,034 km |

Figure 7: Instrument cluster

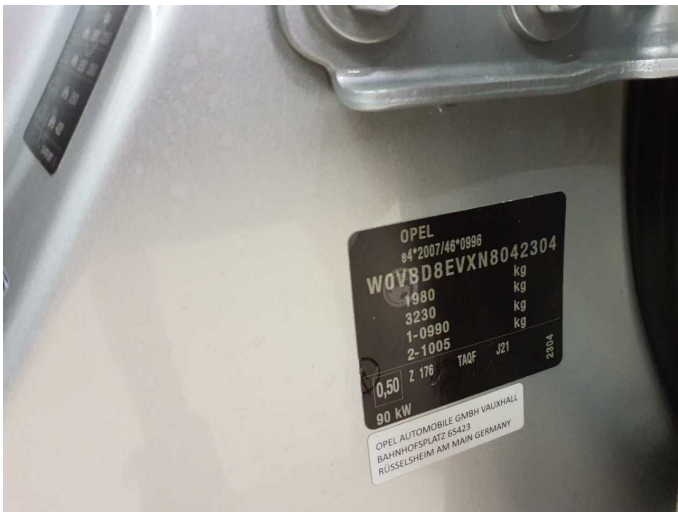
| VIN comparison | The vehicle identification number (VIN) was read from the vehicle and its conformity with the submitted documents was confirmed by the undersigned during the inspection. |

Figure 11: VIN

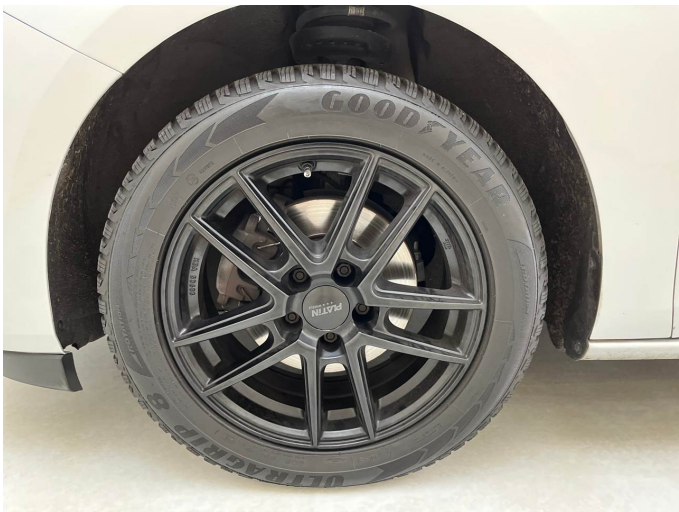
| # | Tyre size | Type of tyre | Manufacturer | Tread depth |
|---|---|---|---|---|
| 1) | 205/55 R16 91H | Winter tyres on Light alloy | Goodyear | 5mm / 5mm |
| 2) | 205/55 R16 91H | Winter tyres on Light alloy | Continental | 8mm / 8mm |

Figure 12: Mounted tyres

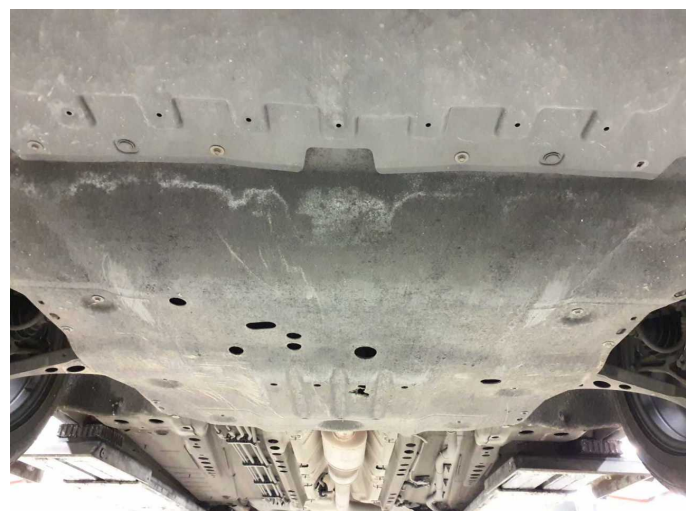
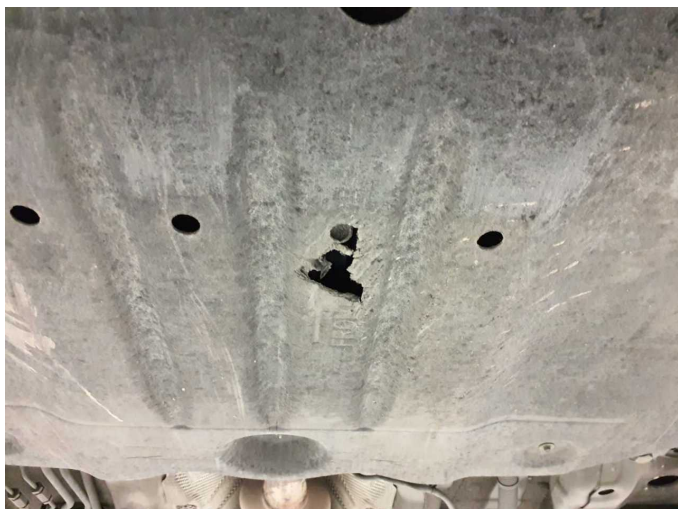
| No. | Component group | Description |
|---|---|---|
| 1 | Body | Underbody panelling (VM) - Broken / torn - Replace |

Damage 1: Body: Underbody panelling (VM) - Broken / torn - Replace

**Damage 1:** Body: Underbody panelling (VM) - Broken / torn - Replace

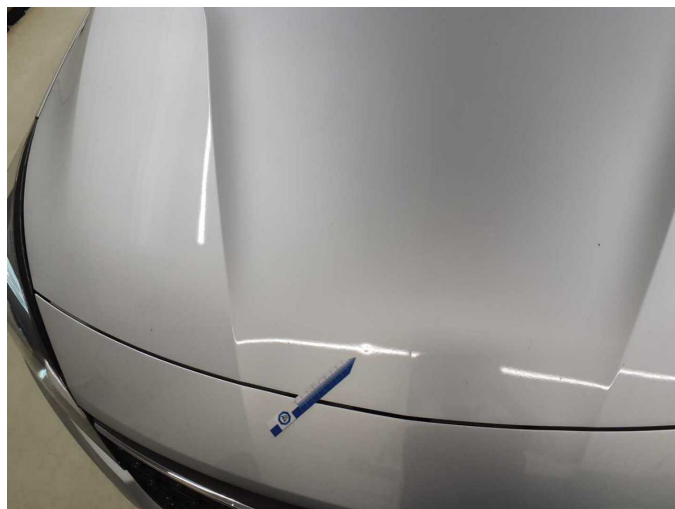
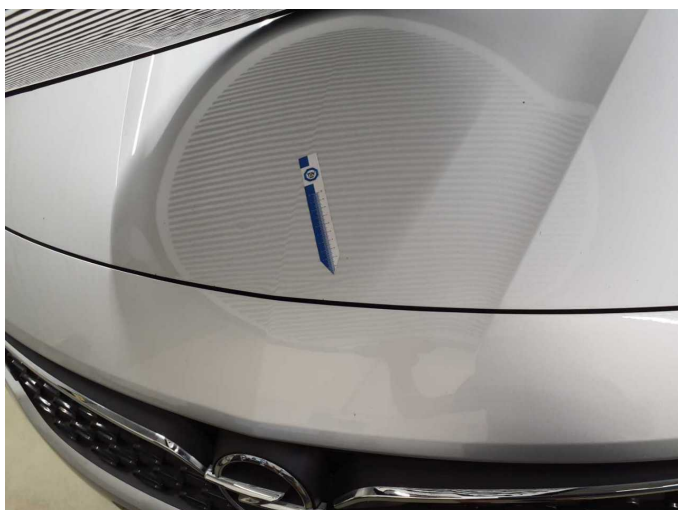
| No. | Component group | Description |
|---|---|---|
| 2 | Bonnet | Bonnet - dent(s) - Smart repair |

**Damage 2:** Bonnet: Bonnet - dent(s) - Smart repair

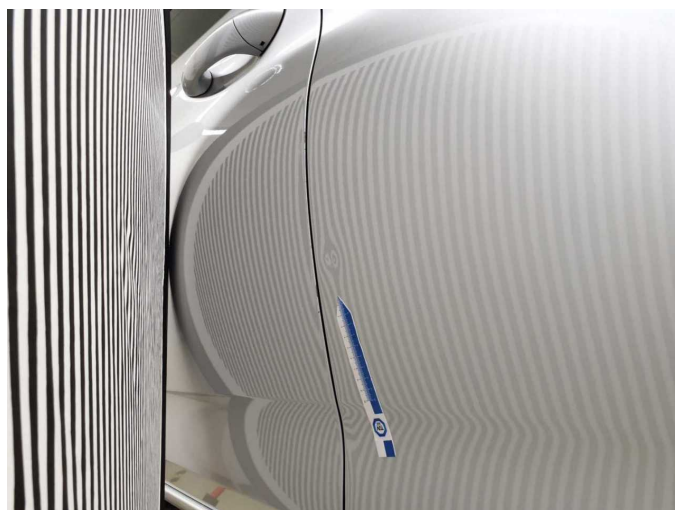
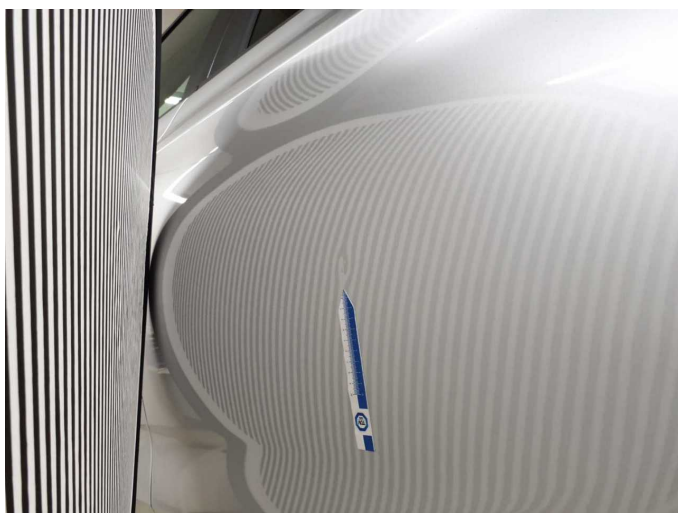
| No. | Component group | Description |
|---|---|---|
| 3 | Door - rear left side | Door - dent(s) - Smart repair |

**Damage 3:** Door - rear left side: Door - dent(s) - Smart repair

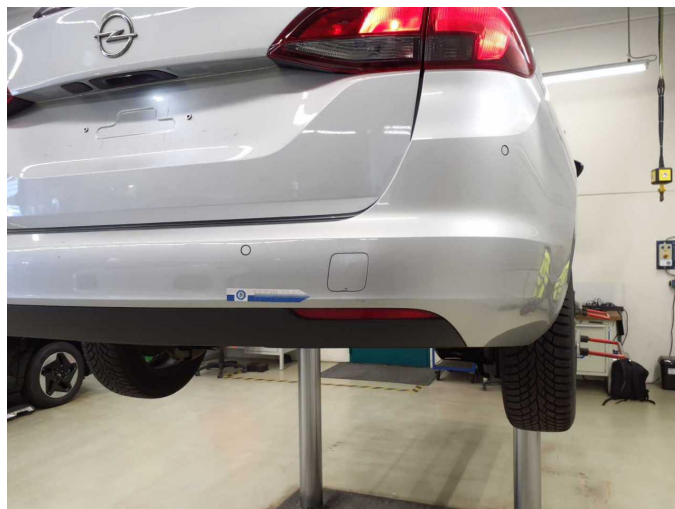
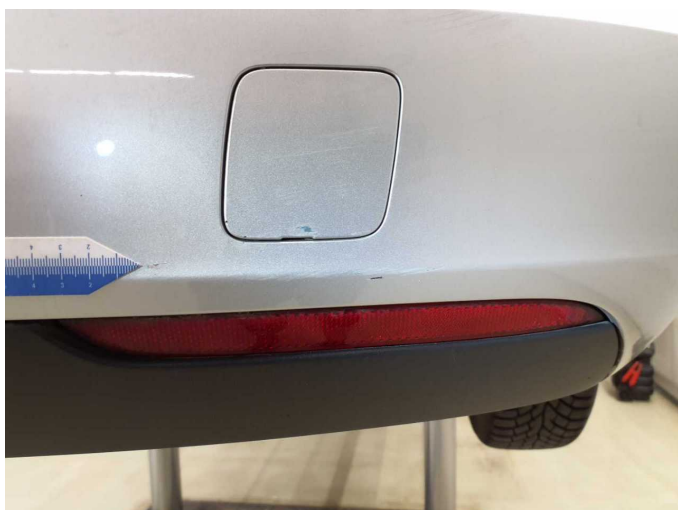
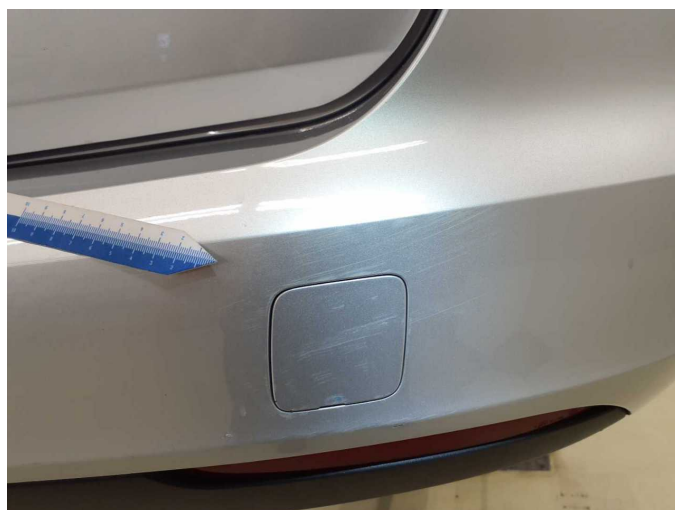
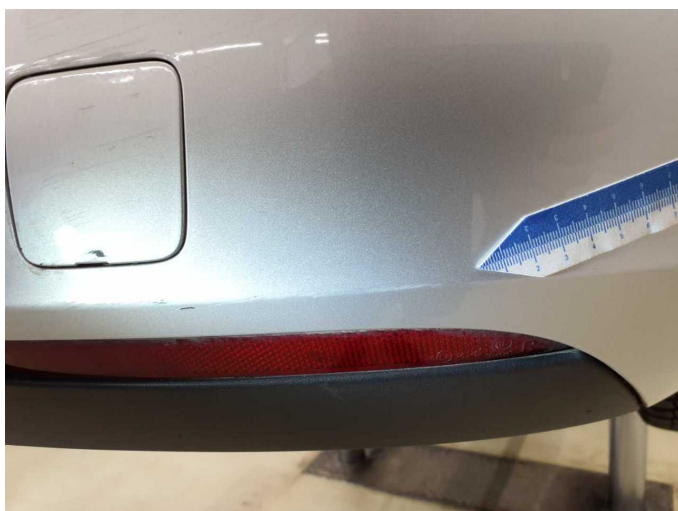
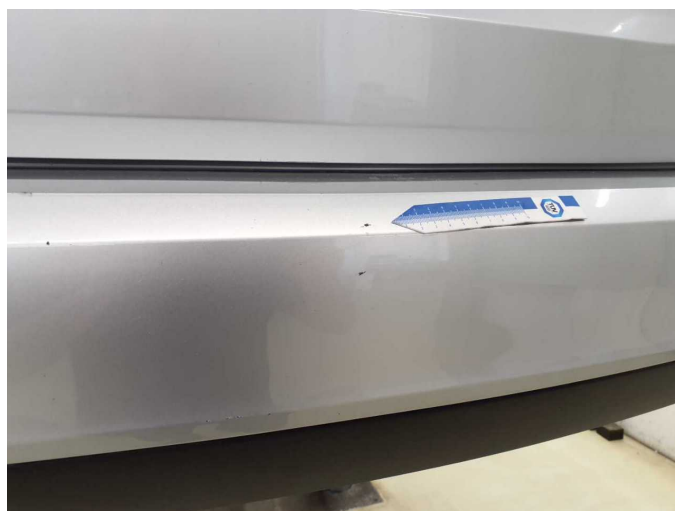
| No. | Component group | Description |
|---|---|---|
| 5 | Rear bumper | Bumper with Parktronic - Scratched - Paint |

**Damage 5:** Rear bumper: Bumper with Parktronic - Scratched - Paint

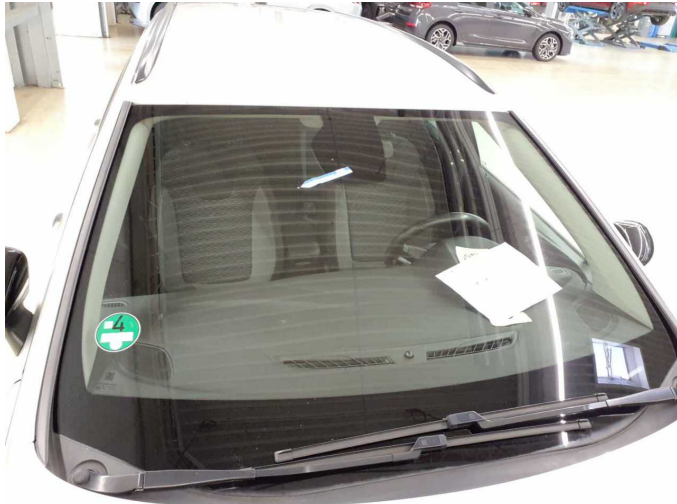
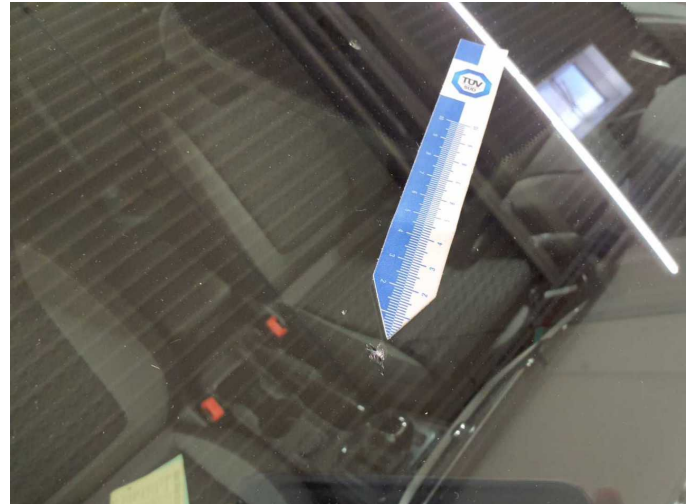
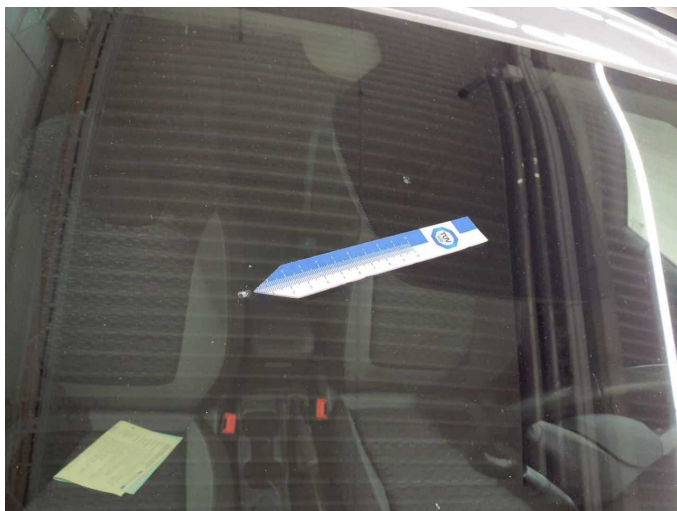
| No. | Component group | Description |
|---|---|---|
| 6 | Vehicle glazing | Windscreen - Stone chips - Replace |

**Damage 6:** Vehicle glazing: Windscreen - Stone chips - Replace

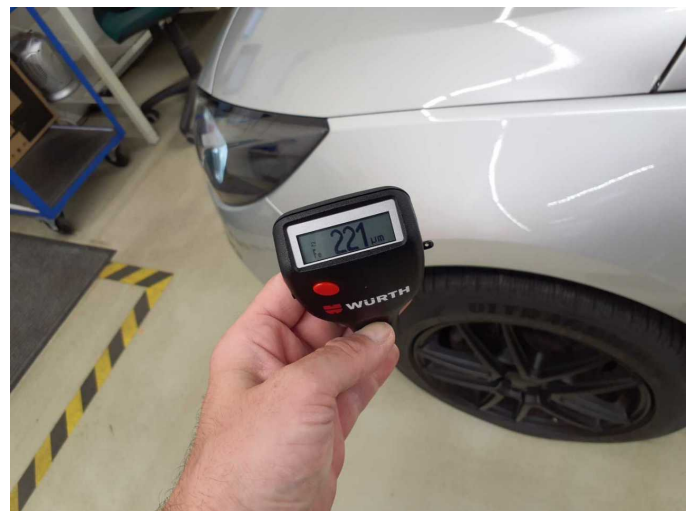
| No. | Repainting |
|---|---|
| 1 | Mudguard - left side, Professionally carried out |

| Mudguard - left side | 221 µm |

**Mudguard - left side:** 221 µm
