Expertise

Protocol number: 46463660  
Order No. / Reference: 26494589  
Inspection date: 10 Jul 2026

Manufacturer: Volvo

Model: XC90 B5 D AWD Geartronic RDesign

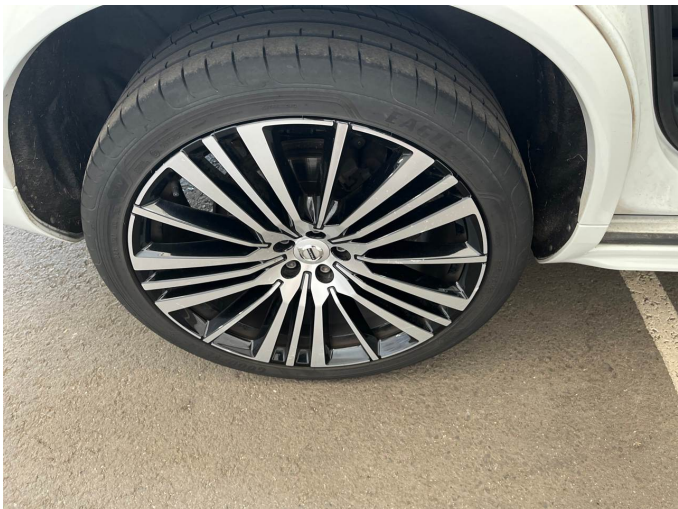
Figure 12: Mounted tyres

| # | Tyre size | Type of tyre | Manufacturer | Tread depth |
|---|---|---|---|---|
| 1) | 275/35 R22 104Y | Summer tyres on Light alloy | Goodyear | 5mm / 5mm |
| 2) | 275/35 R22 104Y | Summer tyres on Light alloy | Goodyear | 5mm / 5mm |

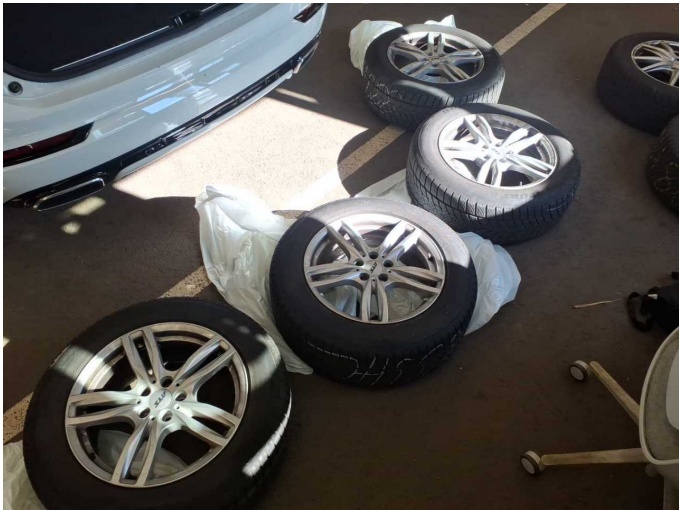
Figure 18: Additional tyres

| # | Tyre size | Type of tyre | Manufacturer | Tread depth |
|---|---|---|---|---|
| 1) | 235/60 R18 103H | Winter tyres on Light alloy | Pirelli | 5mm / 5mm |
| 2) | 235/60 R18 103H | Winter tyres on Light alloy | Pirelli | 6mm / 6mm |

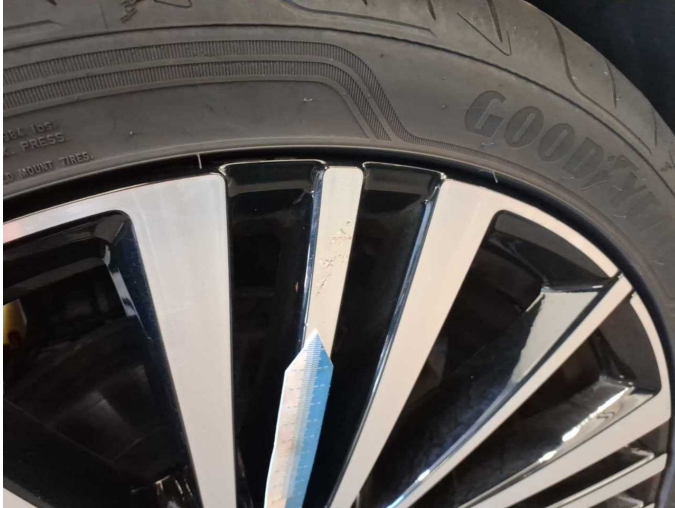
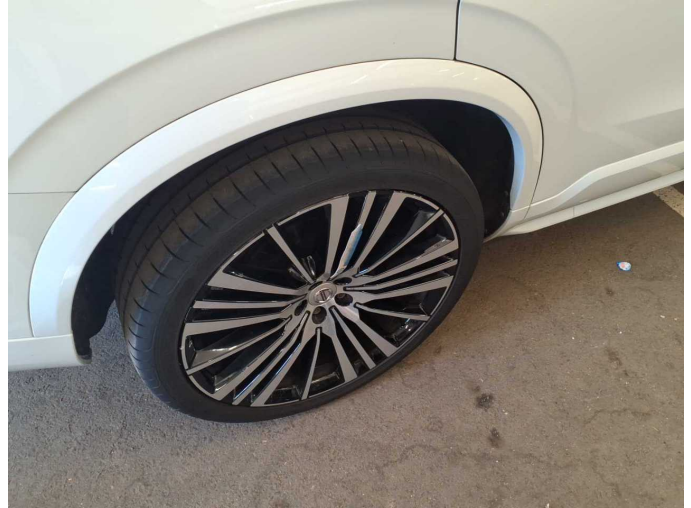
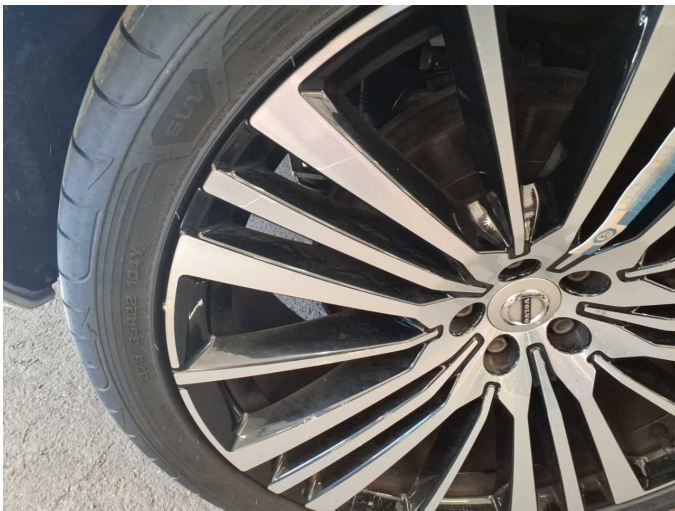
| No. | Component group | Description |
|---|---|---|
| 1 | Wheel / tyres | Alloy rim - rear right side - Scratch(es) - Loss in value |

**Damage 1:** Wheel / tyres: Alloy rim - rear right side - Scratch(es) - Loss in value

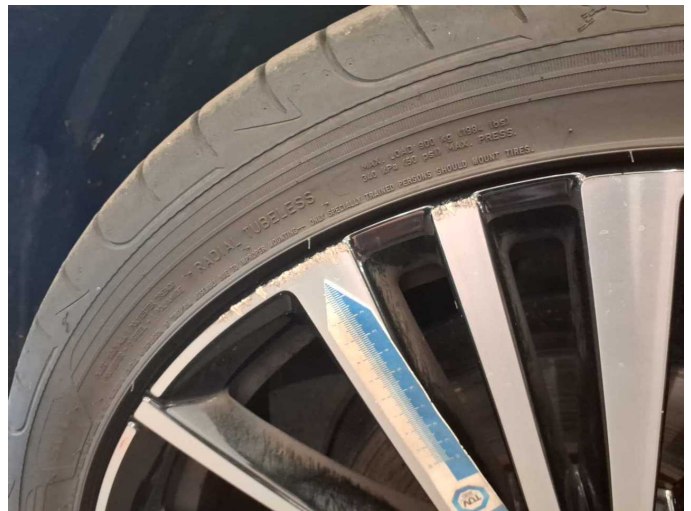
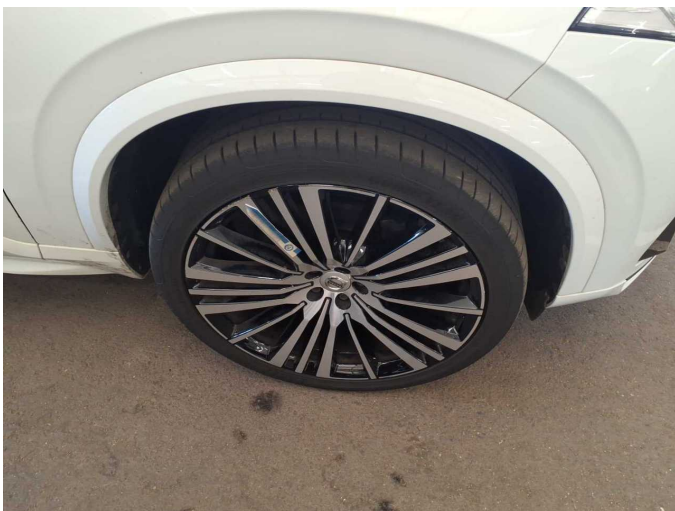
| No. | Component group | Description |
|---|---|---|
| 2 | Wheel / tyres | Alloy rim - front right side - Scratched - Loss in value |

**Damage 2:** Wheel / tyres: Alloy rim - front right side - Scratched - Loss in value

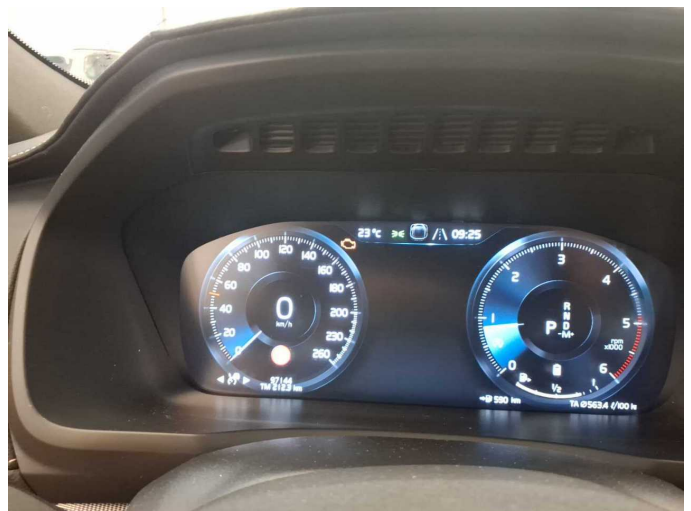
| Engine function test | An engine test run was performed, problem has been detected<br>This is due to the following reason.:<br>Motorkontrolle |

| No. | Component group | Description |
|---|---|---|
| 3 | Instrument panel | Indicator light (Motorkontrollleuchte) - on - Perform diagnosis |

**Damage 3:** Instrument panel: Indicator light (Motorkontrollleuchte) - on - Perform diagnosis

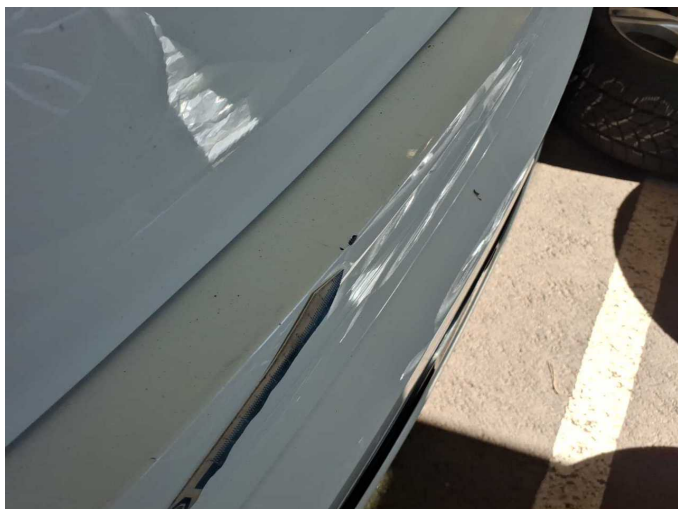
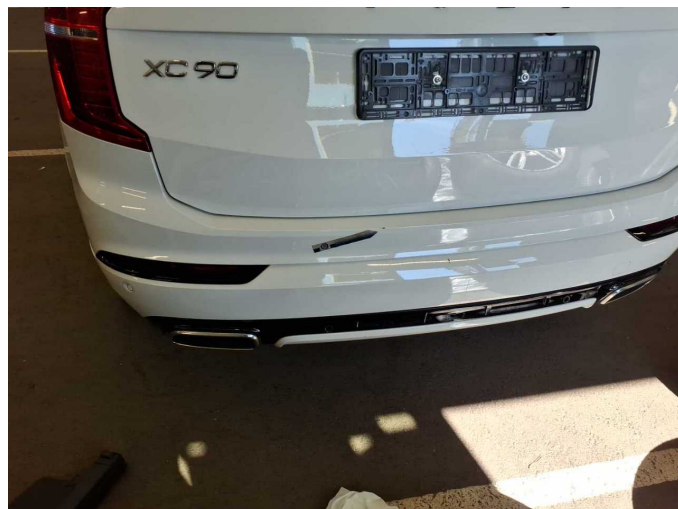
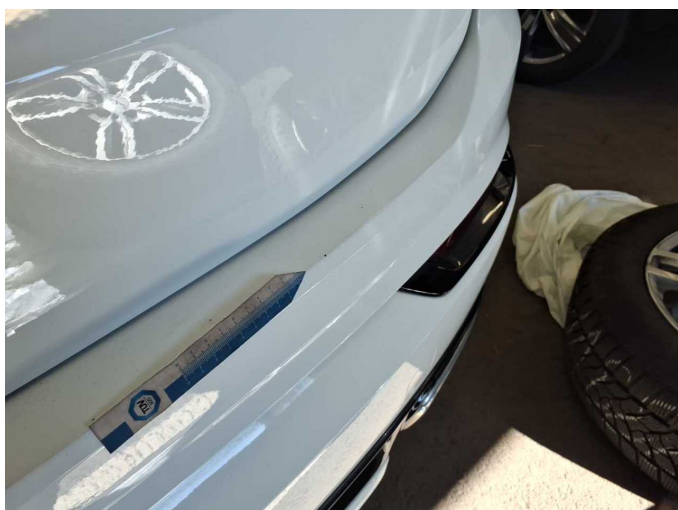
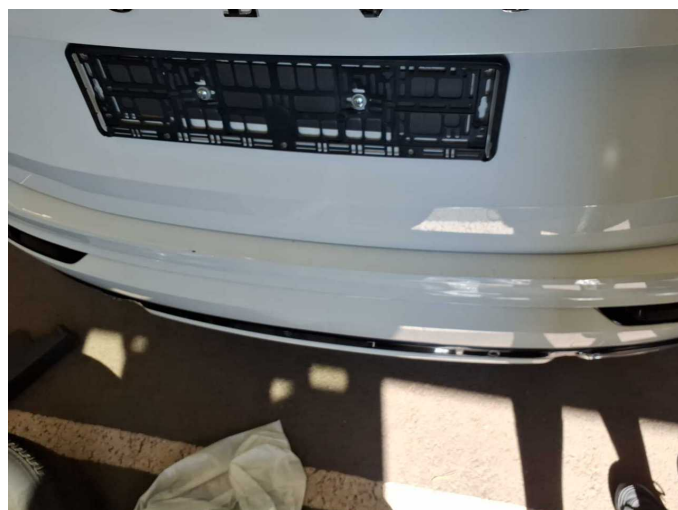
| No. | Component group | Description |
|---|---|---|
| 4 | Rear bumper | Rear bumper - Scratch(es) - Paint |

**Damage 4:** Rear bumper: Rear bumper - Scratch(es) - Paint

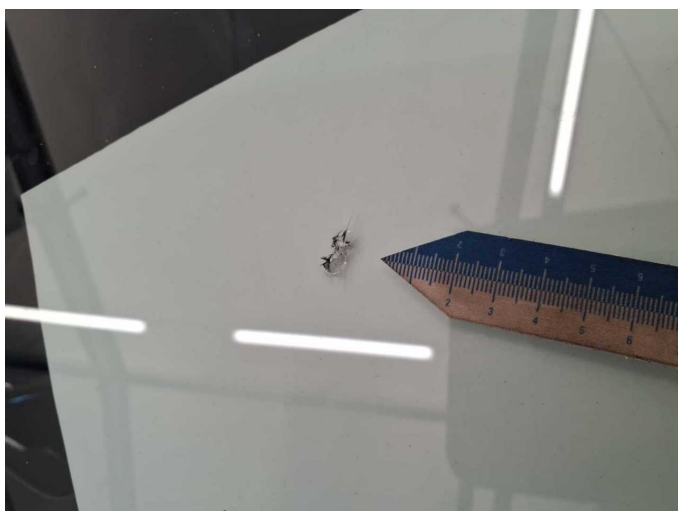
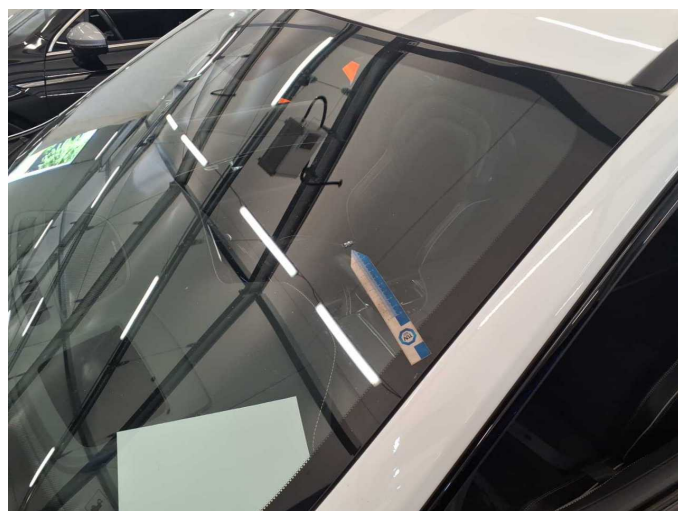
| No. | Component group | Description |
|---|---|---|
| 5 | Vehicle glazing | Windscreen - Broken / torn - Replace |

**Damage 5:** Vehicle glazing: Windscreen - Broken / torn - Replace

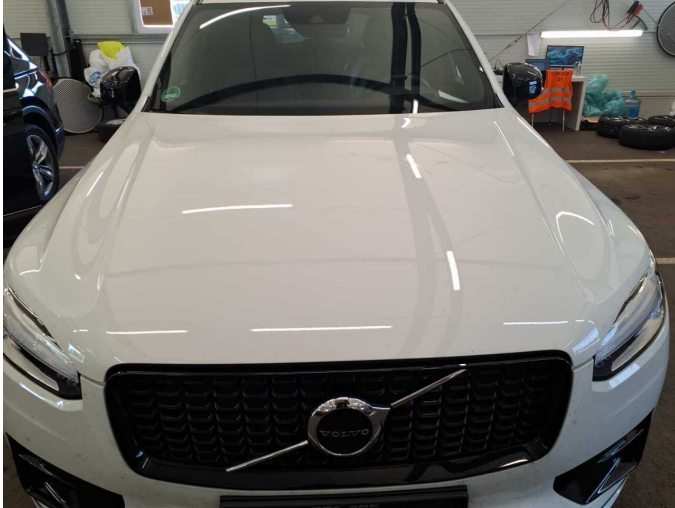
| No. | Component group | Description |
|---|---|---|
| 2 | Bonnet | Bonnet - Stone chips - No deduction |

**Wear and tear 2:** Bonnet: Bonnet - Stone chips - No deduction

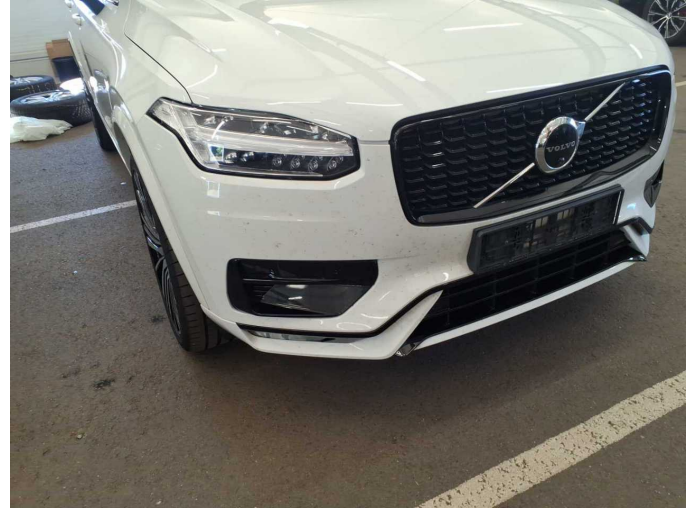
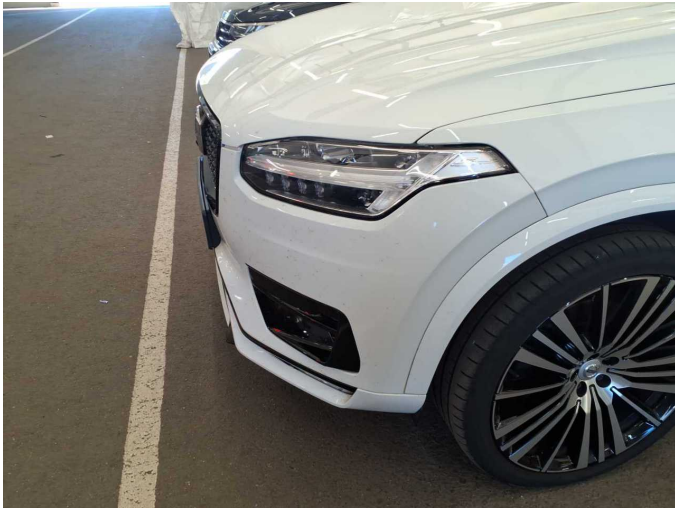
| No. | Component group | Description |
|---|---|---|
| 3 | Front bumper | Front bumper - Stone chips - No deduction |

**Wear and tear 3:** Front bumper: Front bumper - Stone chips - No deduction
