Expertise

Protocol number: 46601503  
Order No. / Reference: 26726126  
Inspection date: 14 Jul 2026

Manufacturer: Volkswagen

Model: Passat Variant 2.0 TDI SCR DSG Business

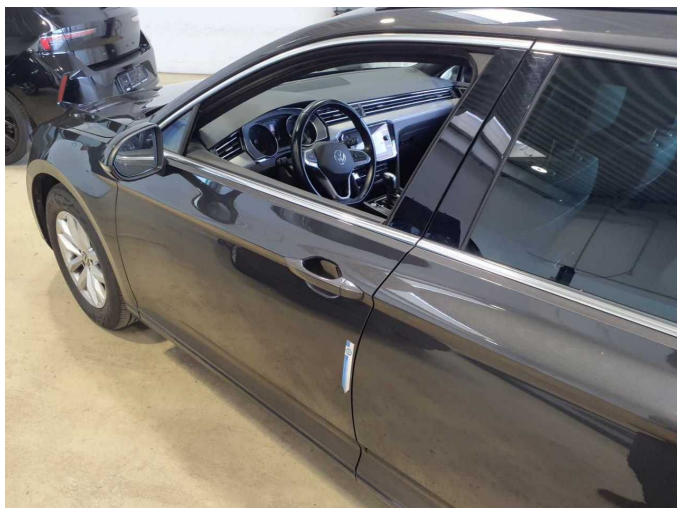
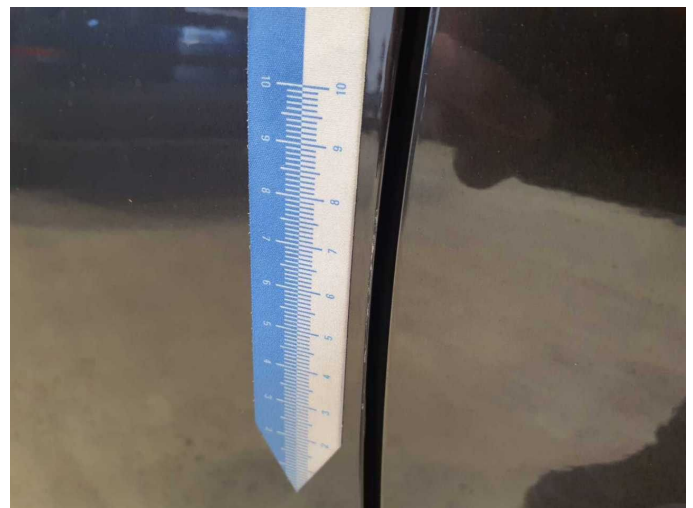
| No. | Component group | Description |
|---|---|---|
| 2 | Door - front left side | Door edge - Scratch(es) - Smart repair |

**Damage 2:** Door - front left side: Door edge - Scratch(es) - Smart repair

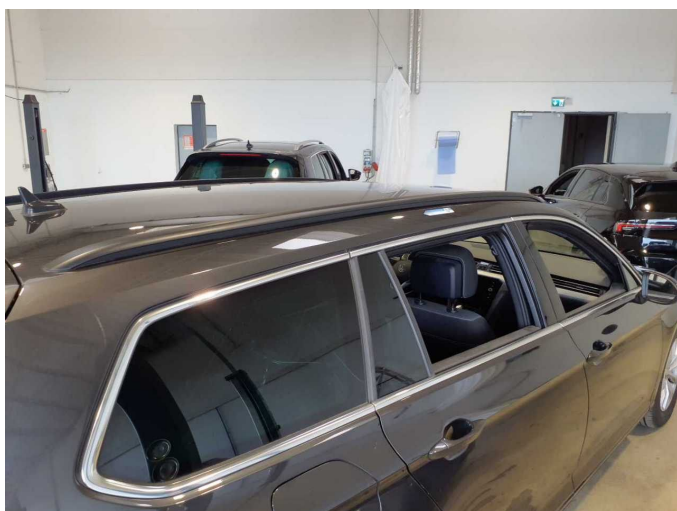
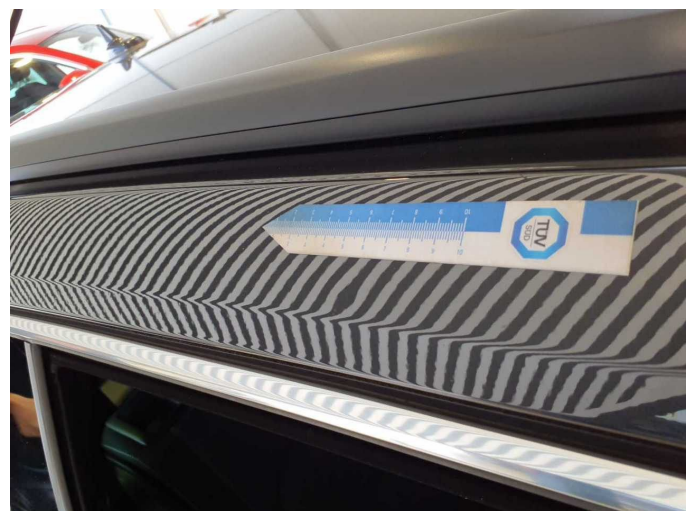
| No. | Component group | Description |
|---|---|---|
| 3 | Roof | Roof rail - right side - dent(s) - Smooth repair work |

**Damage 3:** Roof: Roof rail - right side - dent(s) - Smooth repair work

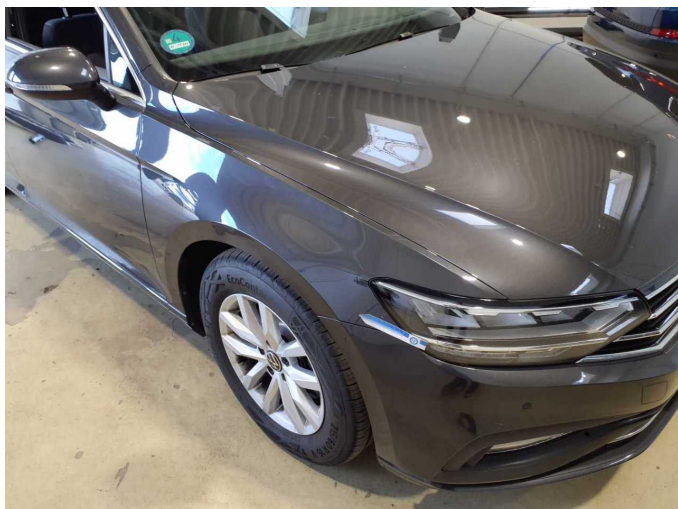
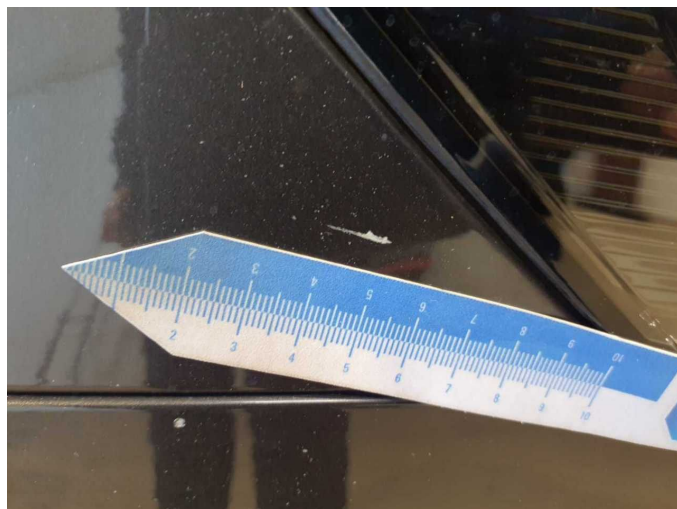
| No. | Component group | Description |
|---|---|---|
| 4 | Mudguard - right side | Mudguard - right side - Scratch(es) - Smart repair |

**Damage 4:** Mudguard - right side: Mudguard - right side - Scratch(es) - Smart repair

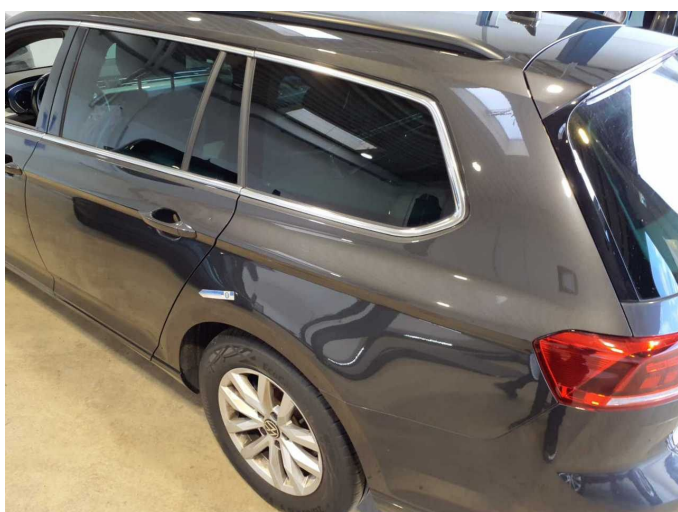
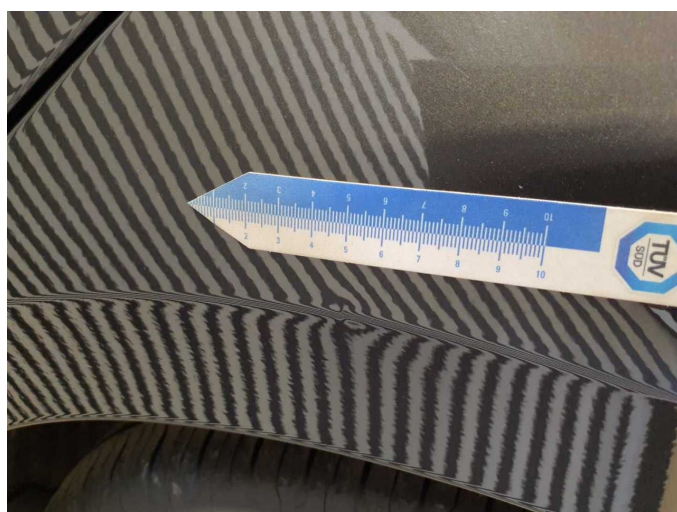
| No. | Component group | Description |
|---|---|---|
| 5 | Side panel - rear left side | Side panel - dent(s) - Smart repair |

**Damage 5:** Side panel - rear left side: Side panel - dent(s) - Smart repair

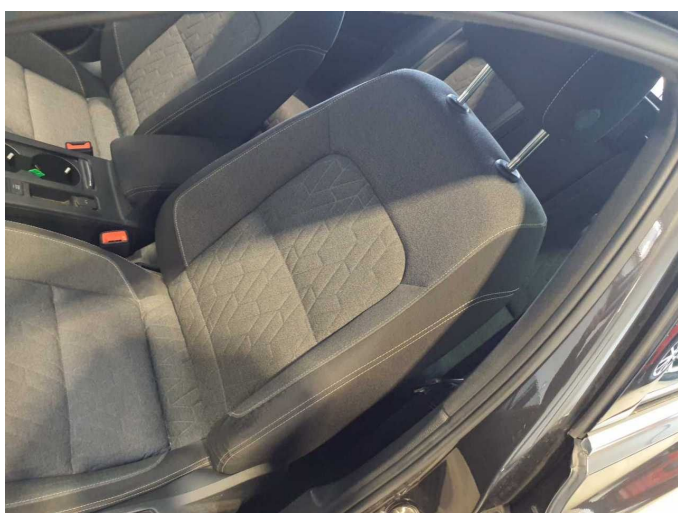
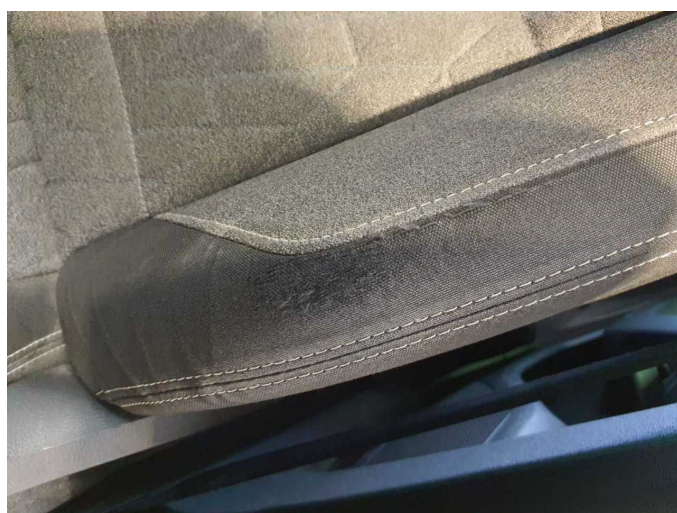
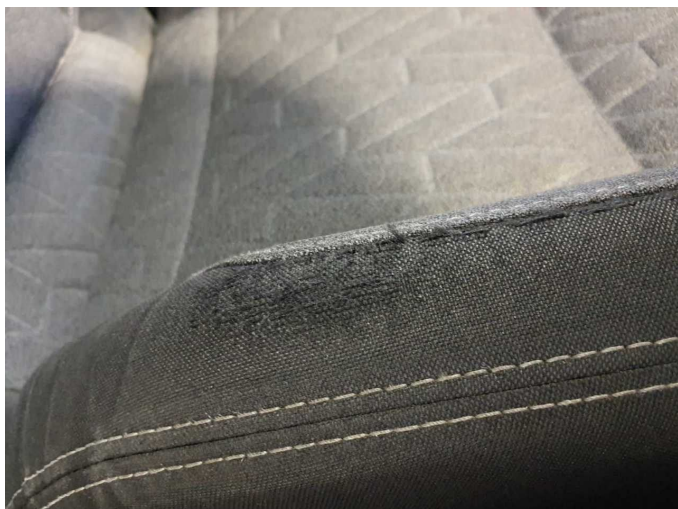
| No. | Component group | Description |
|---|---|---|
| 6 | Seat - front | Backrest cover - left side - Scratch(es) - Loss in value |

**Damage 6:** Seat - front: Backrest cover - left side - Scratch(es) - Loss in value

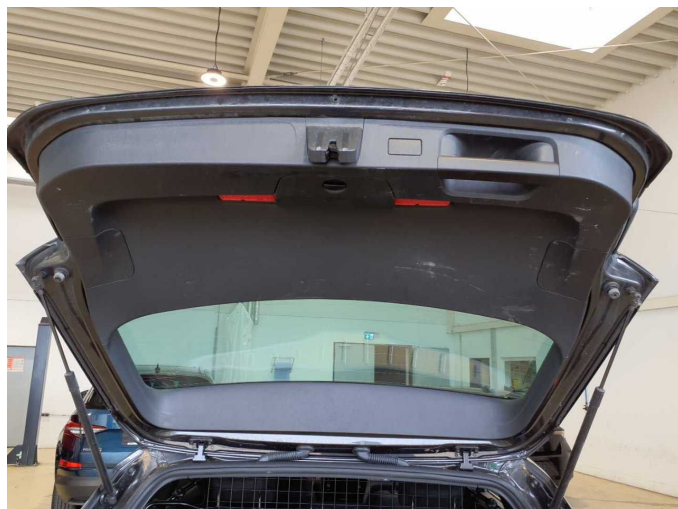
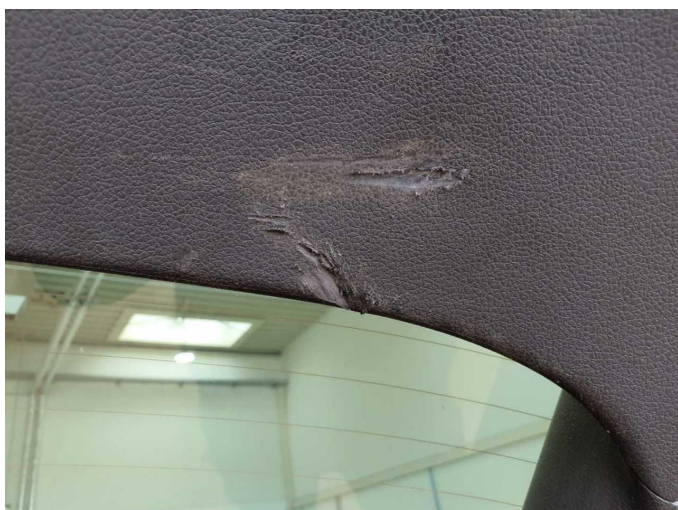
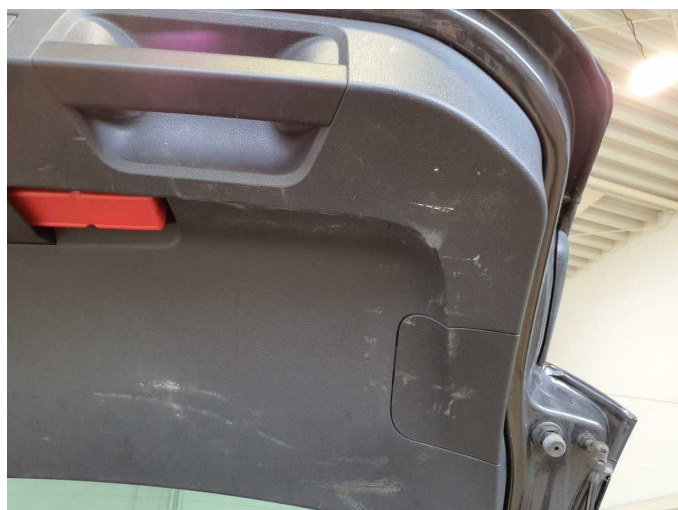
| No. | Component group | Description |
|---|---|---|
| 7 | Trim / covers | Boot lid - interior trim - Scratch(es) - Replace |

**Damage 7:** Trim / covers: Boot lid - interior trim - Scratch(es) - Replace

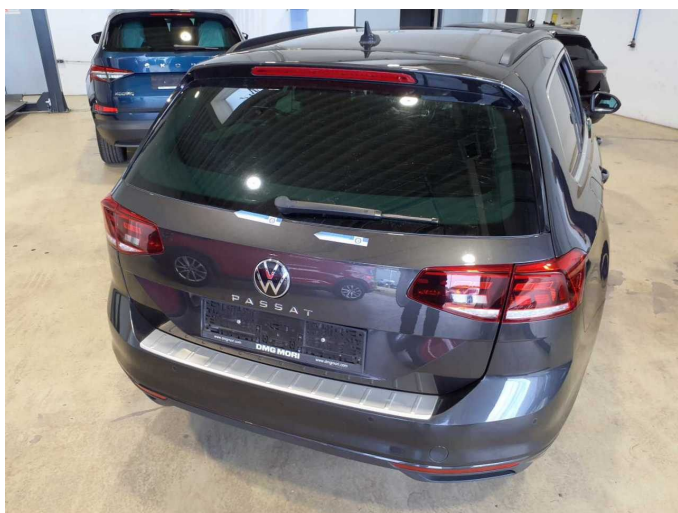
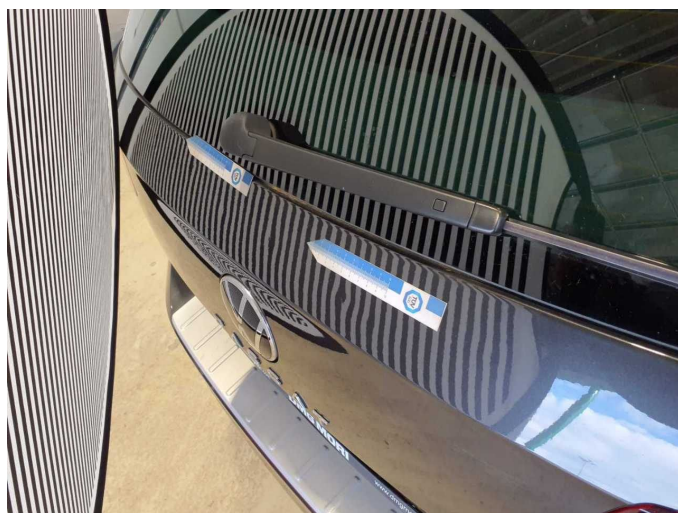
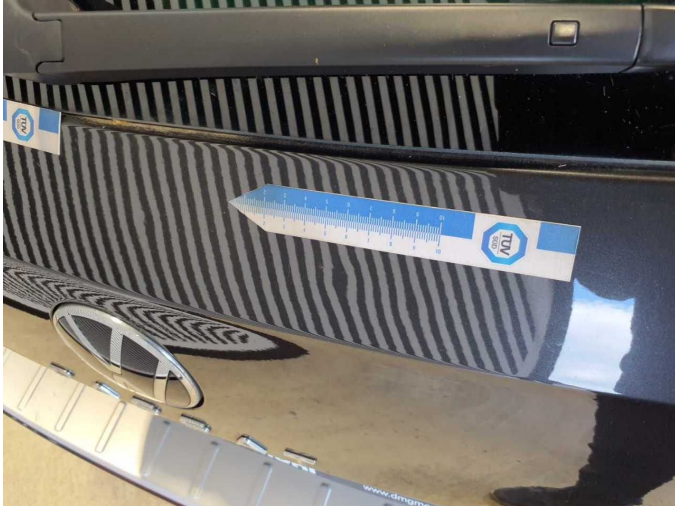
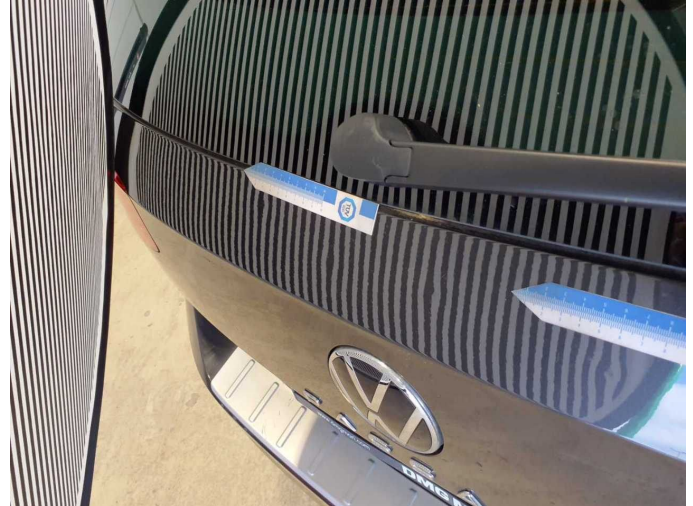
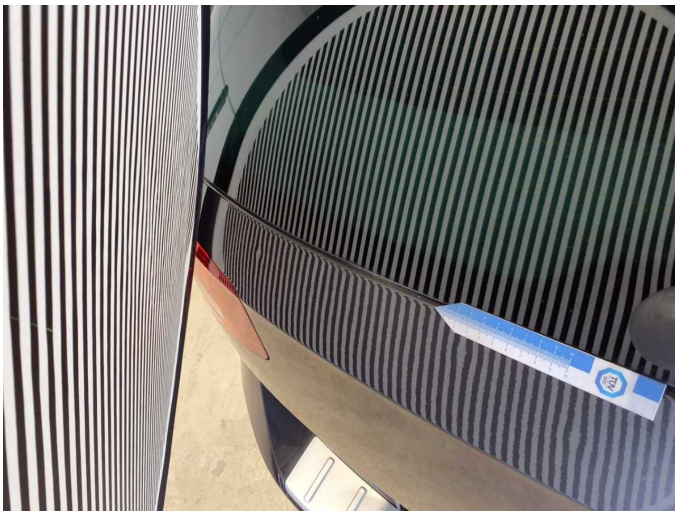
| No. | Component group | Description |
|---|---|---|
| 8 | Boot lid / rear door | Boot lid - dent(s) - Smooth repair work |

**Damage 8:** Boot lid / rear door: Boot lid - dent(s) - Smooth repair work

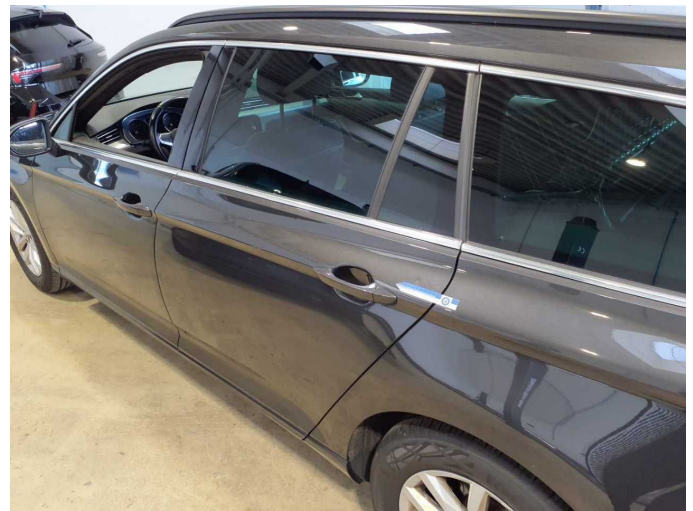
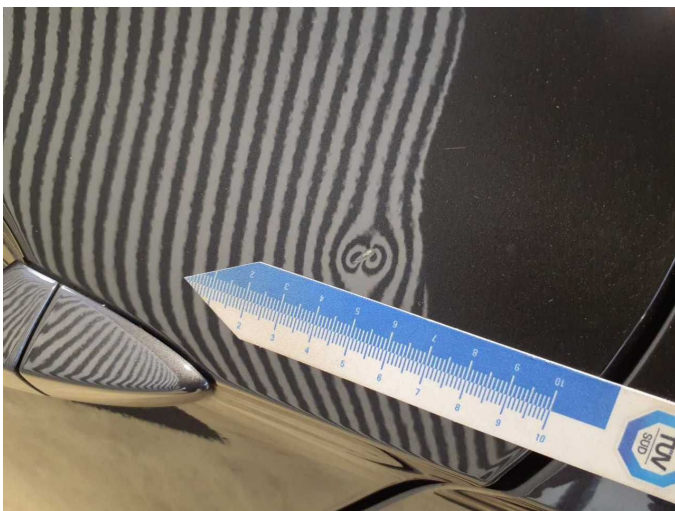
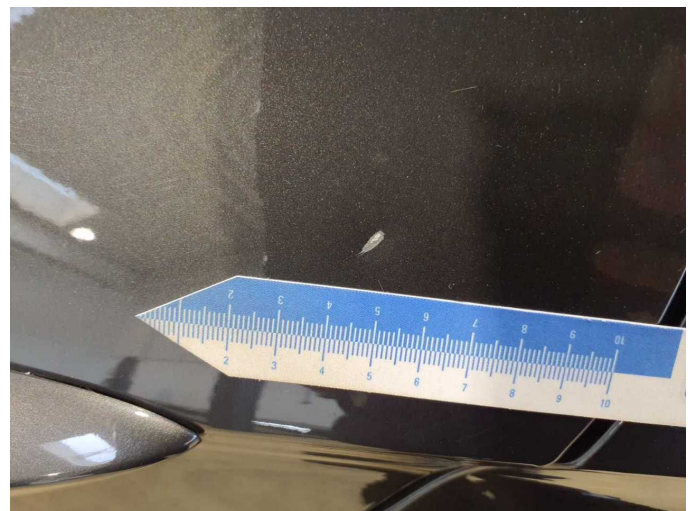
| No. | Component group | Description |
|---|---|---|
| 9 | Door - rear left side | Door - Dent / paintcoat damage - Paint |

**Damage 9:** Door - rear left side: Door - Dent / paintcoat damage - Paint

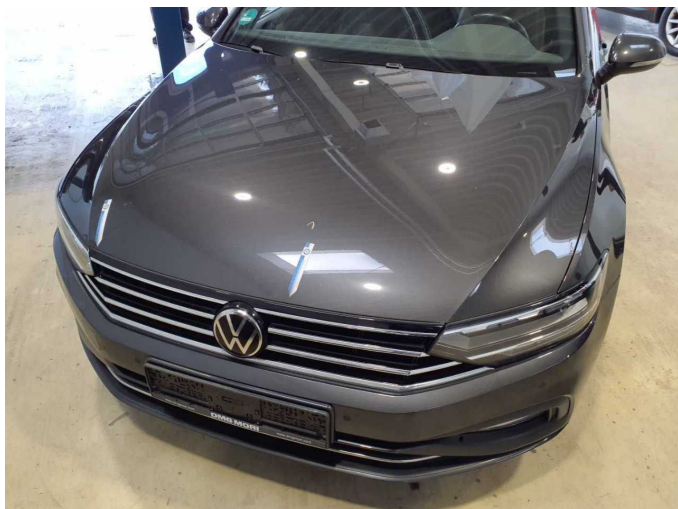
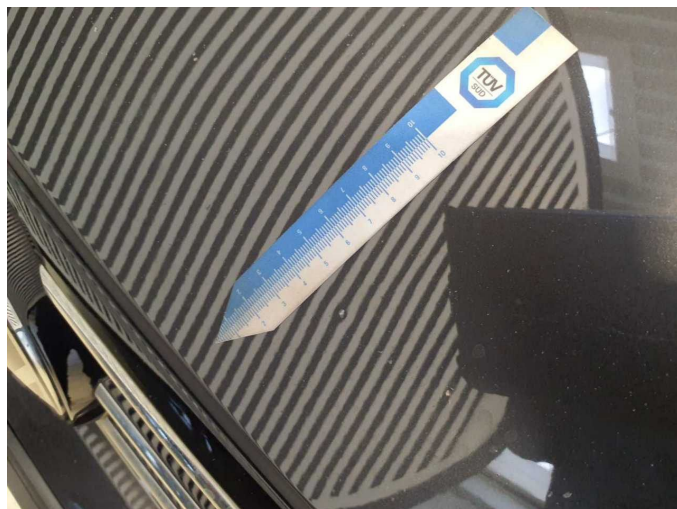
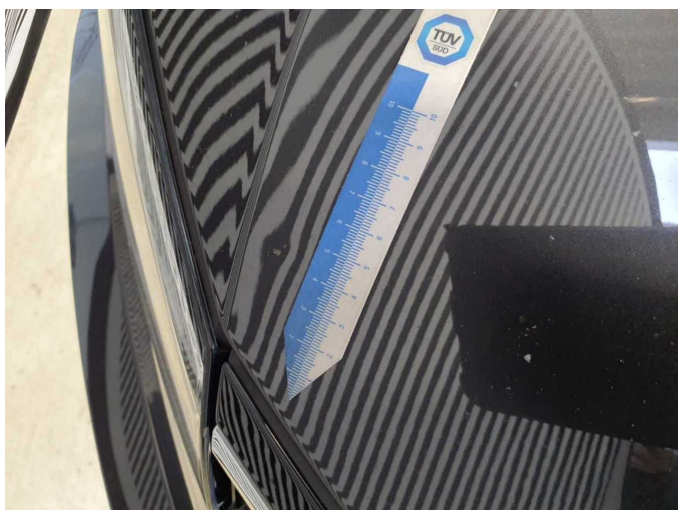
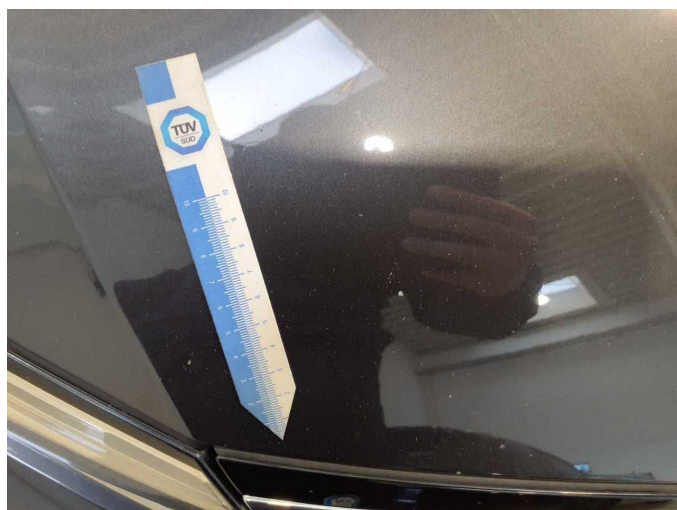
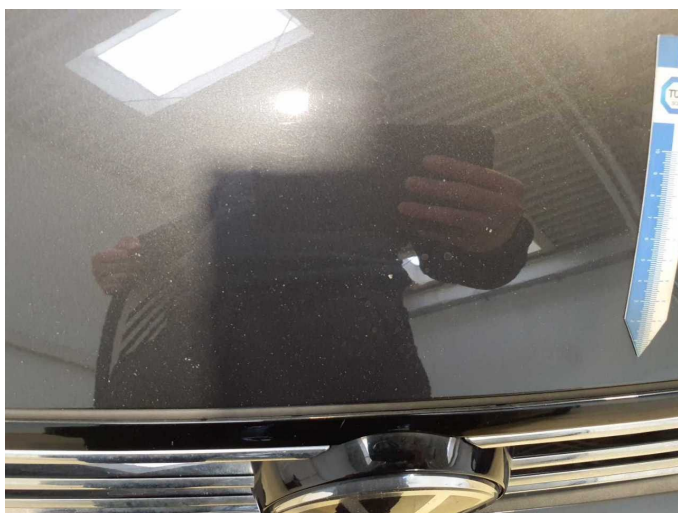
| No. | Component group | Description |
|---|---|---|
| 10 | Bonnet | Bonnet - Dent / paintcoat damage - Repair and paint |

**Damage 10:** Bonnet: Bonnet - Dent / paintcoat damage - Repair and paint

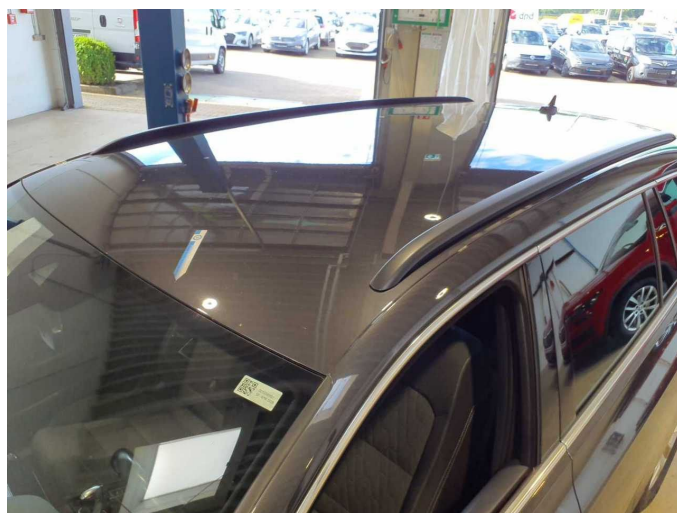
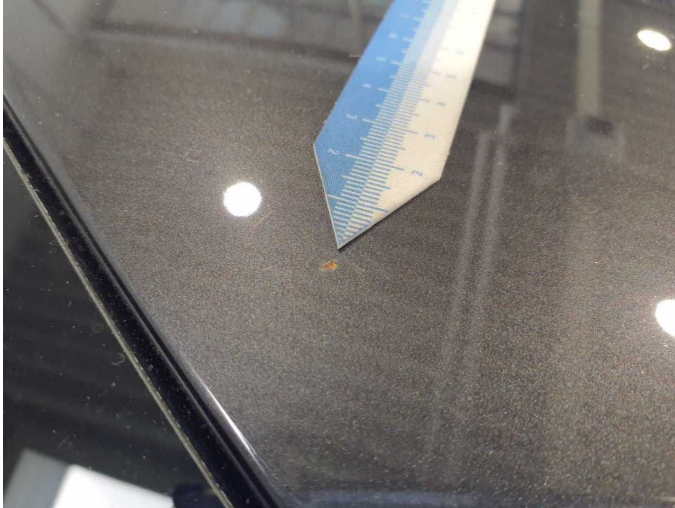
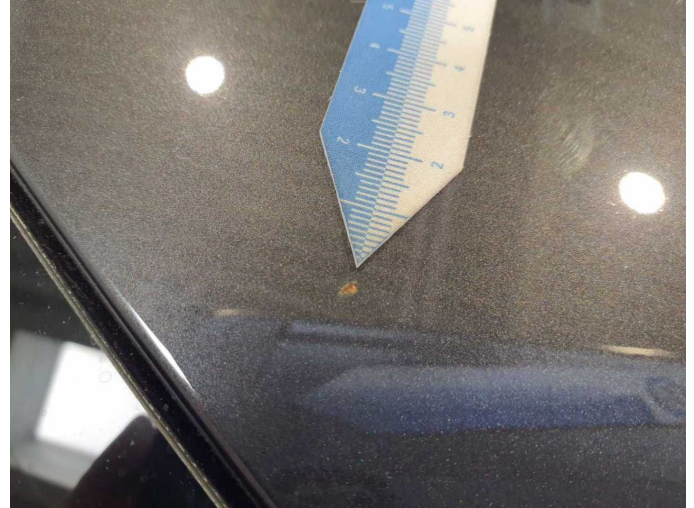
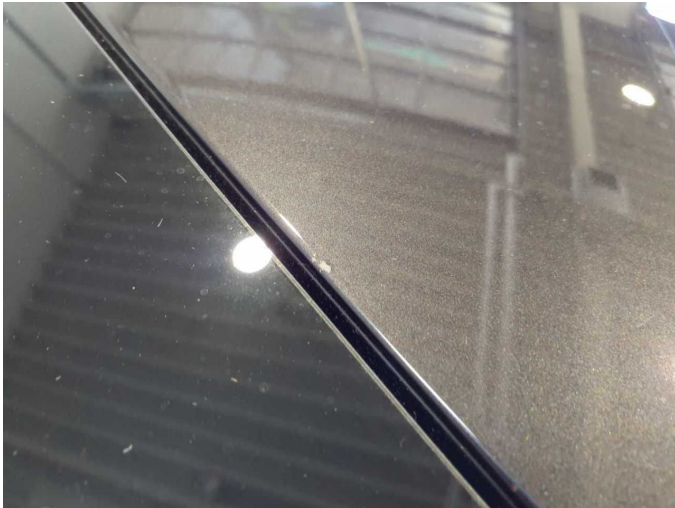
| No. | Component group | Description |
|---|---|---|
| 11 | Roof | Roof - Corrosion - Repair and paint |

**Damage 11:** Roof: Roof - Corrosion - Repair and paint
