Expertise

Protocol number: 46163653  
Order No. / Reference: 26345289  
Inspection date: 25 Jun 2026

Manufacturer: Skoda  
VIN: TMBJJ7NS7N8008061

Model: Kodiaq 2.0 TDI DSG Clever

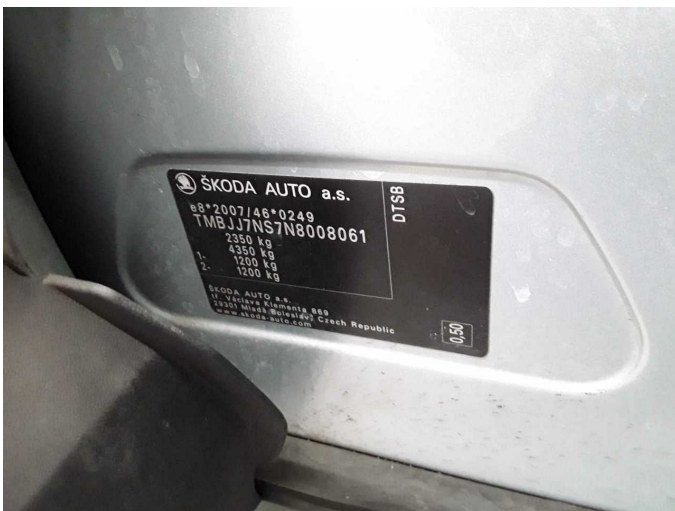
Figure 11: VIN

| VIN comparison | The vehicle identification number (VIN) was read from the vehicle and its conformity with the submitted documents was confirmed by the undersigned during the inspection. |

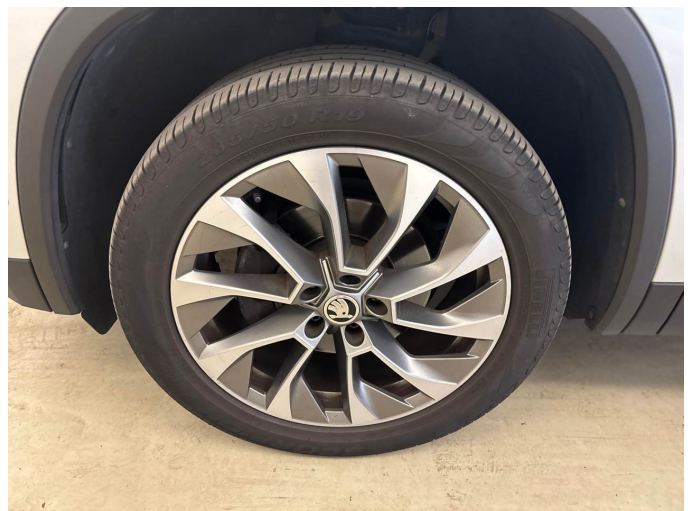
Figure 12: Mounted tyres

| # | Tyre size | Type of tyre | Manufacturer | Tread depth |
|---|---|---|---|---|
| 1) | 235/50 R19 99V | Summer tyres on Light alloy | Pirelli | 4mm / 4mm |
| 2) | 235/50 R19 99V | Summer tyres on Light alloy | Pirelli | 4mm / 4mm |

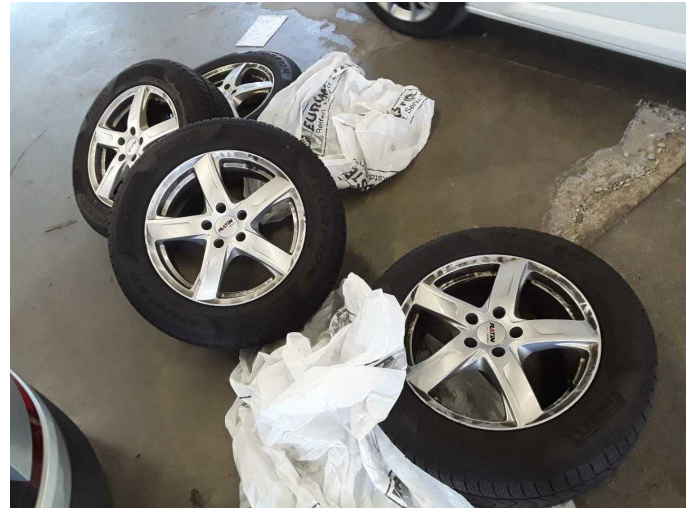
Figure 14: Additional tyres

| # | Tyre size | Type of tyre | Manufacturer | Tread depth |
|---|---|---|---|---|
| 1) | 215/65 R17 99H | Winter tyres on Light alloy | Pirelli | 5mm / 5mm |
| 2) | 215/65 R17 99H | Winter tyres on Light alloy | Pirelli | 5mm / 5mm |

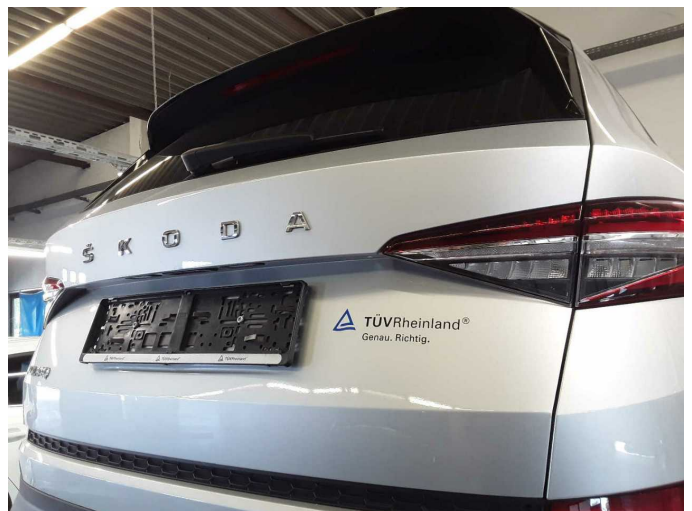
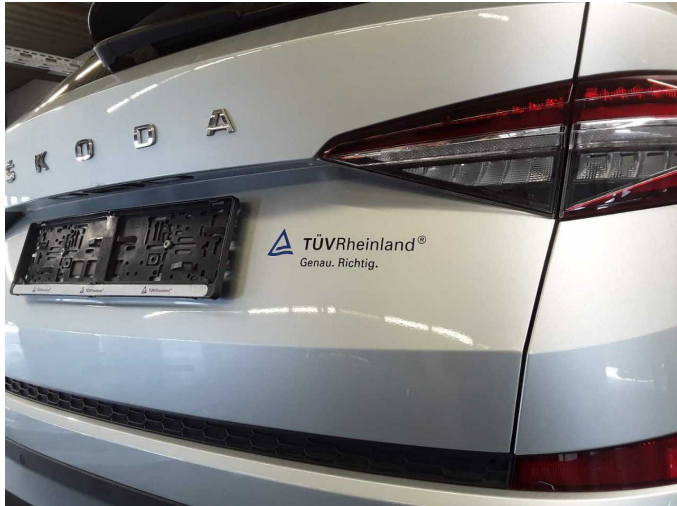
**Damage 1:** Boot lid / rear door: Boot lid - Glued / labelled - De-glue / neutralise

| No. | Component group | Description |
|---|---|---|
| 1 | Boot lid / rear door | Boot lid - Glued / labelled - De-glue / neutralise |

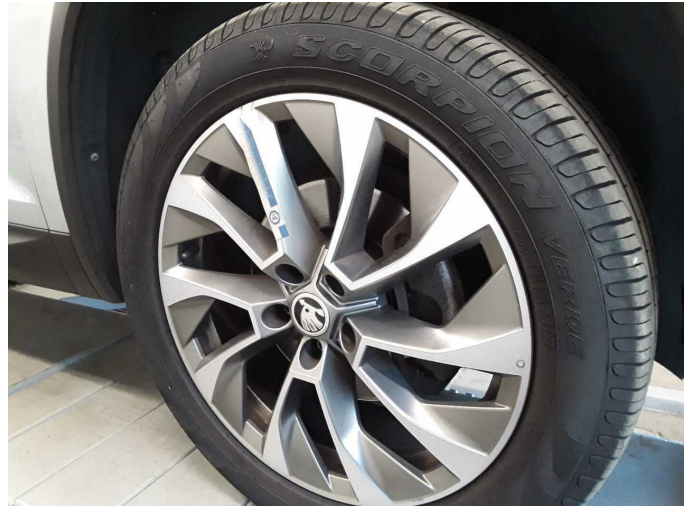
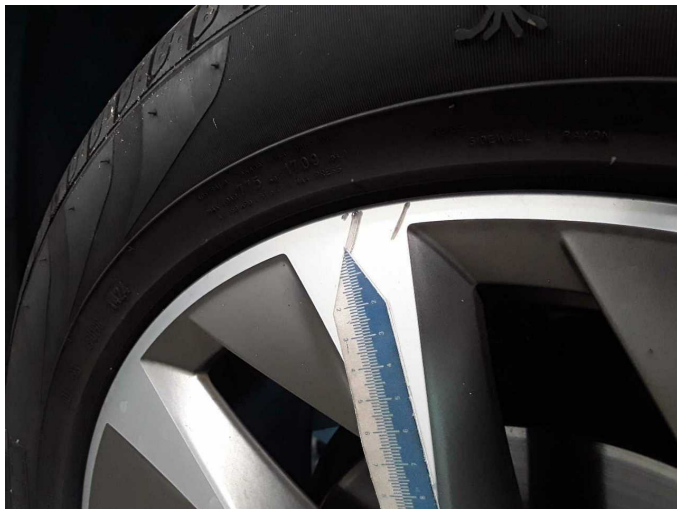
**Damage 2:** Wheel / tyres: Alloy rim - front right side - Scratch(es) - Loss in value

| No. | Component group | Description |
|---|---|---|
| 2 | Wheel / tyres | Alloy rim - front right side - Scratch(es) - Loss in value |

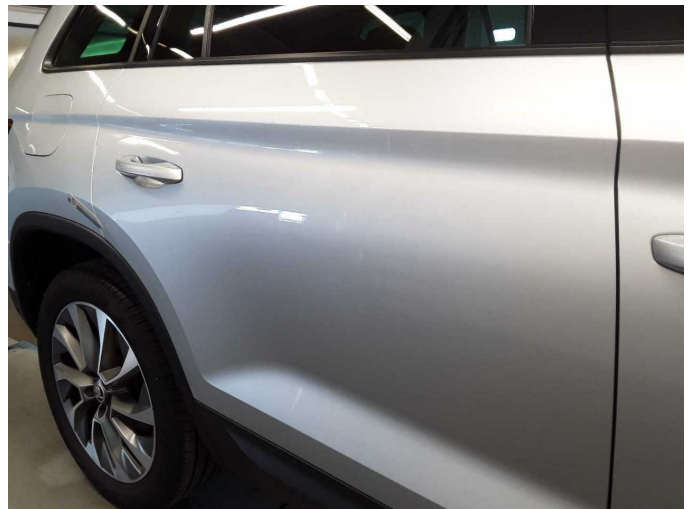
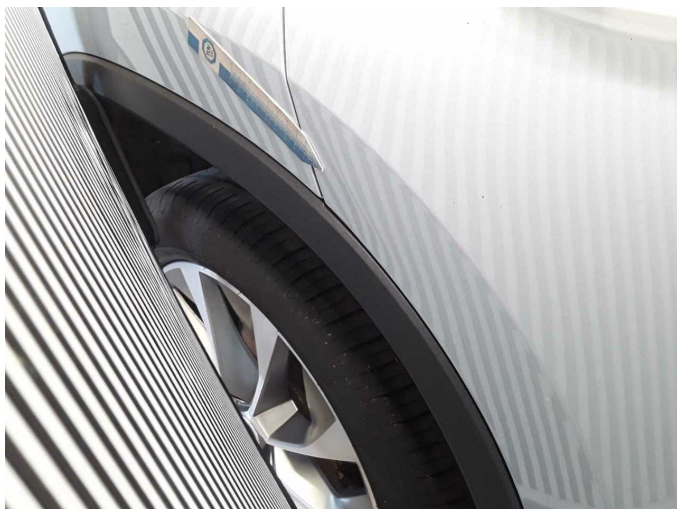
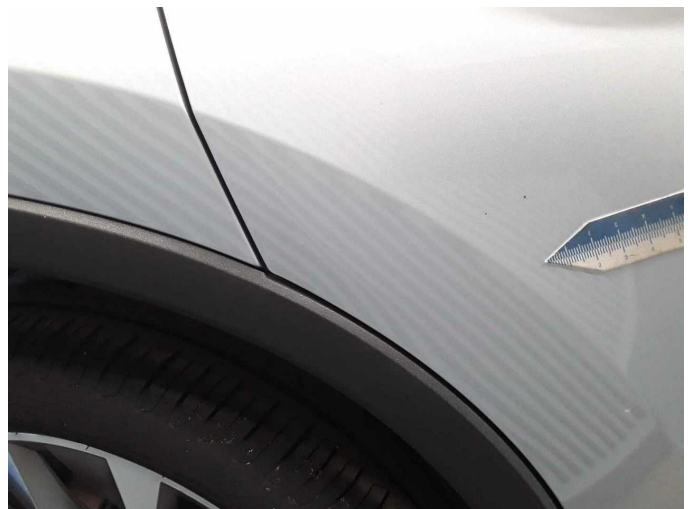
**Damage 3:** Door - rear right side: Door - Deformed - Repair and paint

| No. | Component group | Description |
|---|---|---|
| 3 | Door - rear right side | Door - Deformed - Repair and paint |

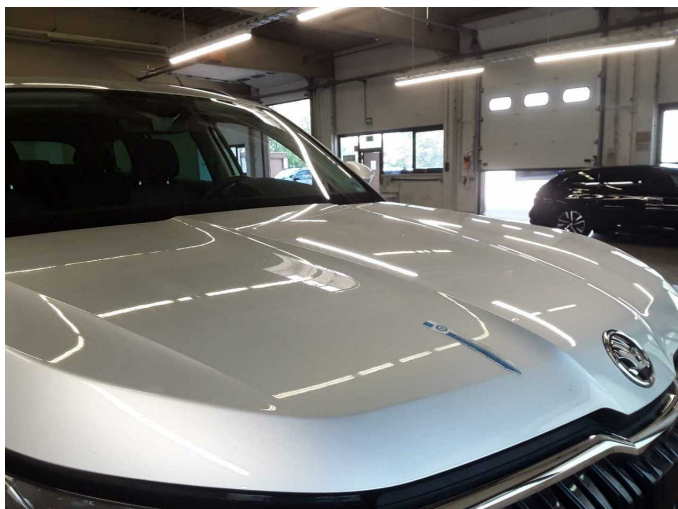
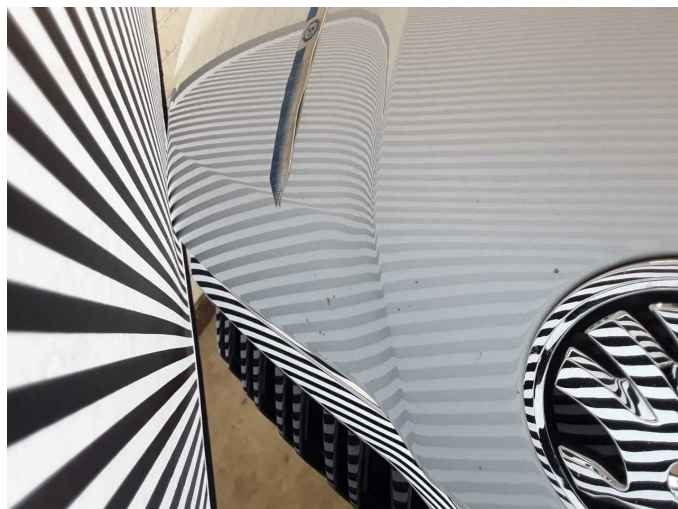
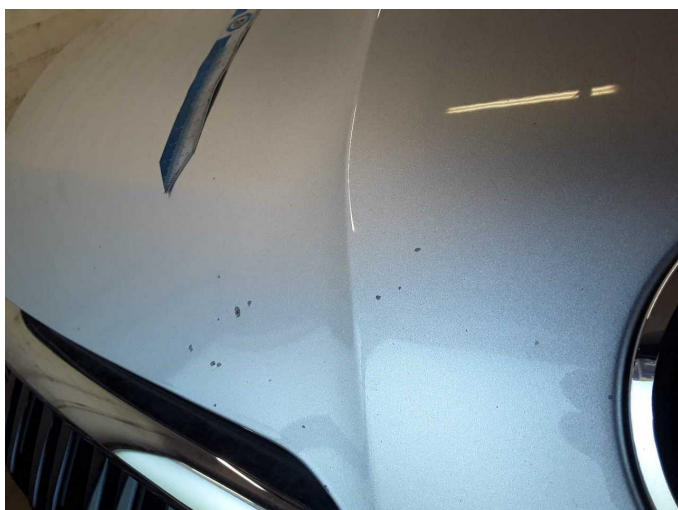
**Damage 4:** Bonnet: Bonnet - Dent / paintcoat damage - Repair and paint

| No. | Component group | Description |
|---|---|---|
| 4 | Bonnet | Bonnet - Dent / paintcoat damage - Repair and paint |

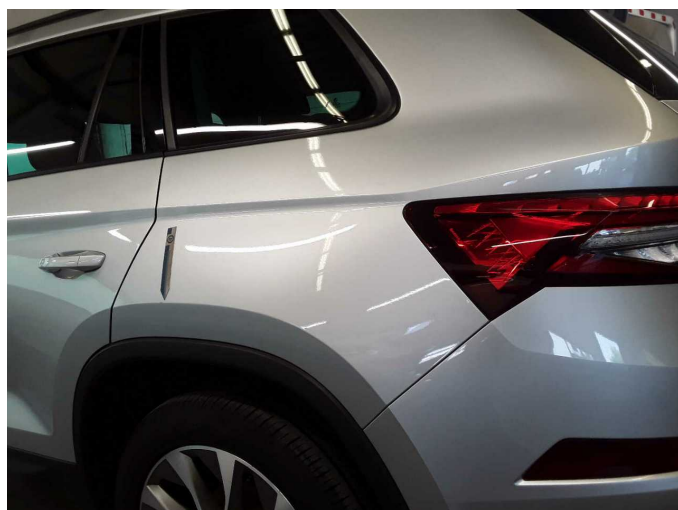
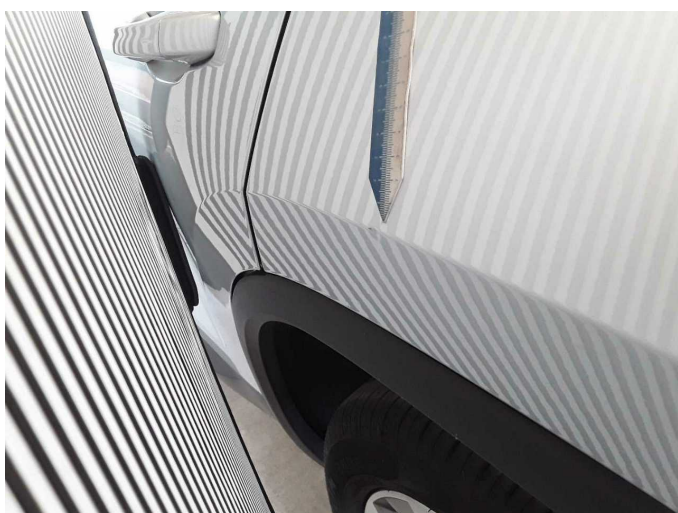
**Damage 5:** Side panel - rear left side: Side panel - Dent / paintcoat damage - Repair and paint

| No. | Component group | Description |
|---|---|---|
| 5 | Side panel - rear left side | Side panel - Dent / paintcoat damage - Repair and paint |

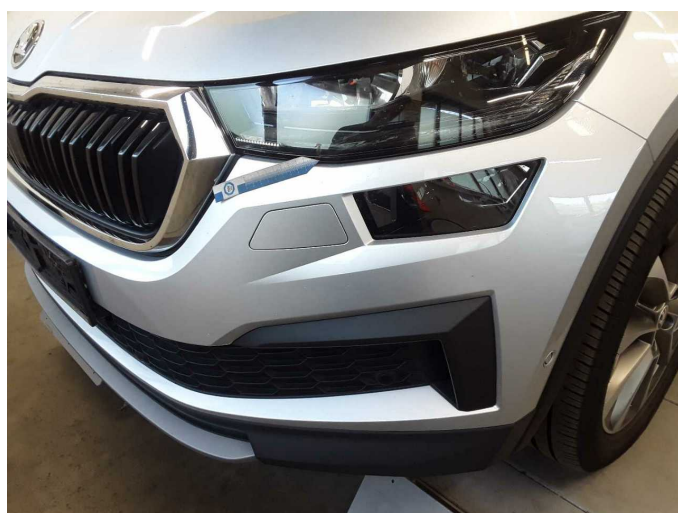
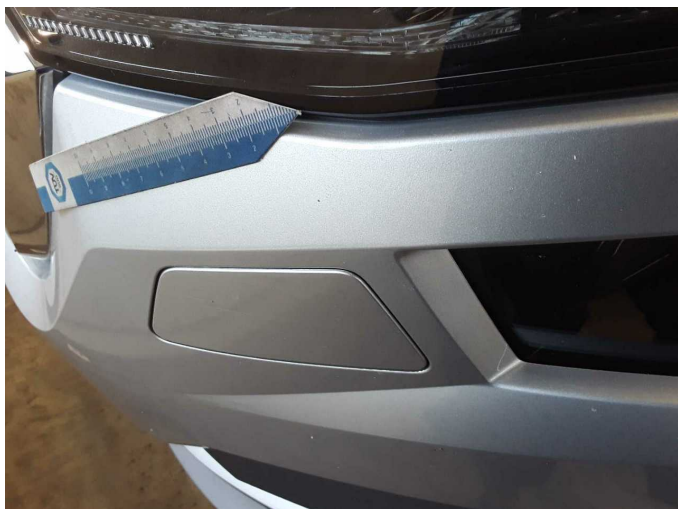
| No. | Component group | Description |
|---|---|---|
| 1 | Front bumper | Front bumper - Stone chips - No deduction |

**Wear and tear 1:** Front bumper: Front bumper - Stone chips - No deduction

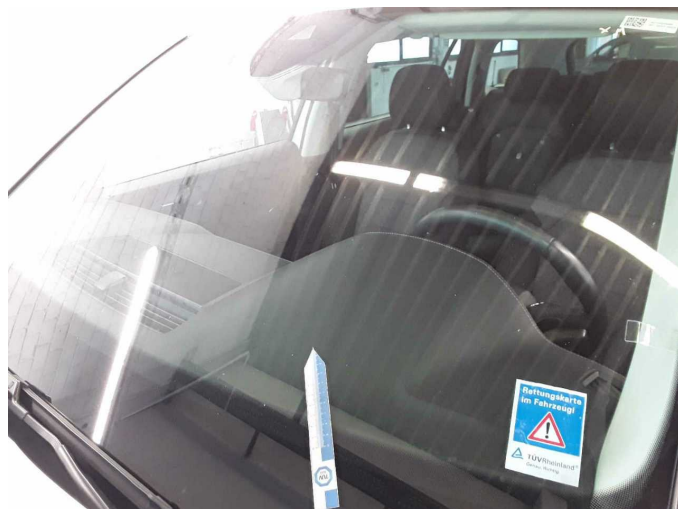
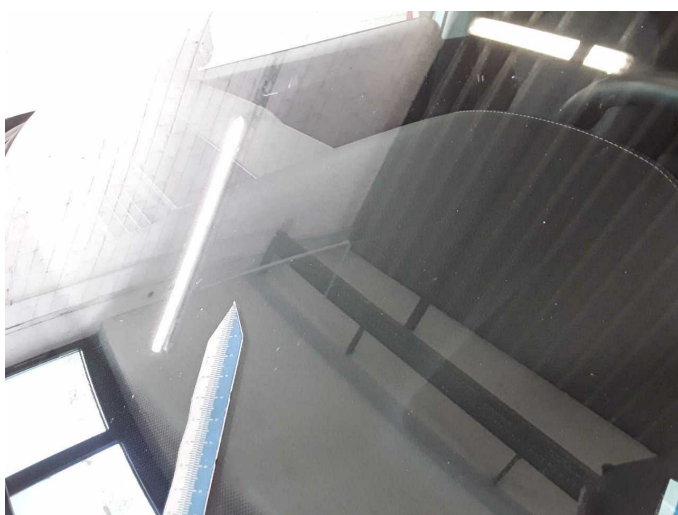
| No. | Component group | Description |
|---|---|---|
| 2 | Vehicle glazing | Windscreen - Stone chips - No deduction |

**Wear and tear 2:** Vehicle glazing: Windscreen - Stone chips - No deduction

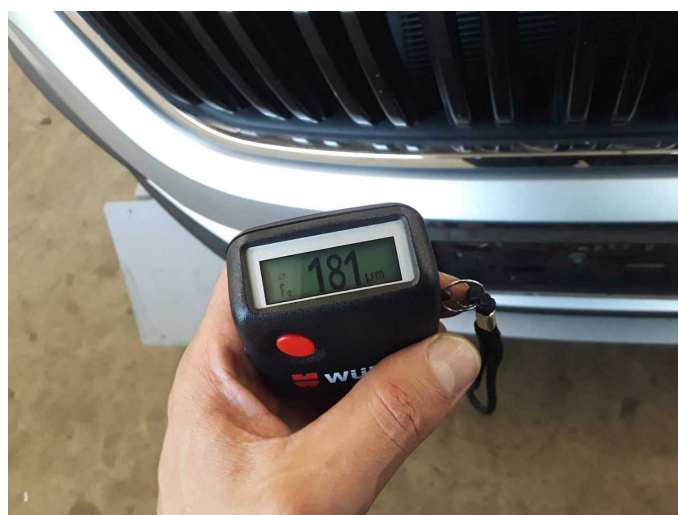
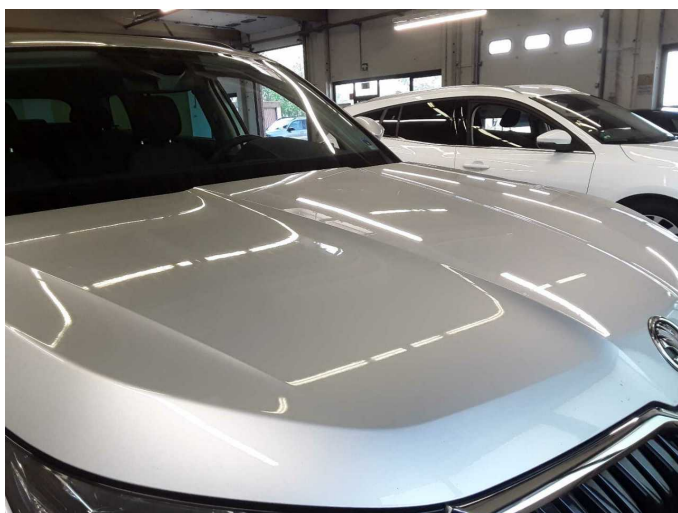
| No. | Repainting |
|---|---|
| 1 | Bonnet, Professionally carried out, Invoice of repair done Non-existent |

**Repainting 1:** Bonnet
