Expertise

Protocol number: 46646687  
Order No. / Reference: 26725851  
Inspection date: 21 Jul 2026

| Manufacturer: Ford | Model: Focus Turnier 1.5 EcoBlue Start-Stopp-System Aut. TITANIUM |

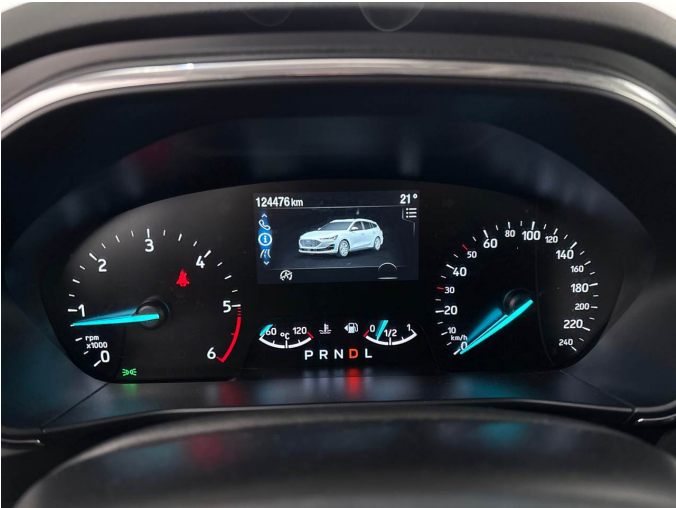
Figure 7: Instrument cluster

| Vehicle details | |
|---|---|
| Mileage (Read) | 124,476 km |

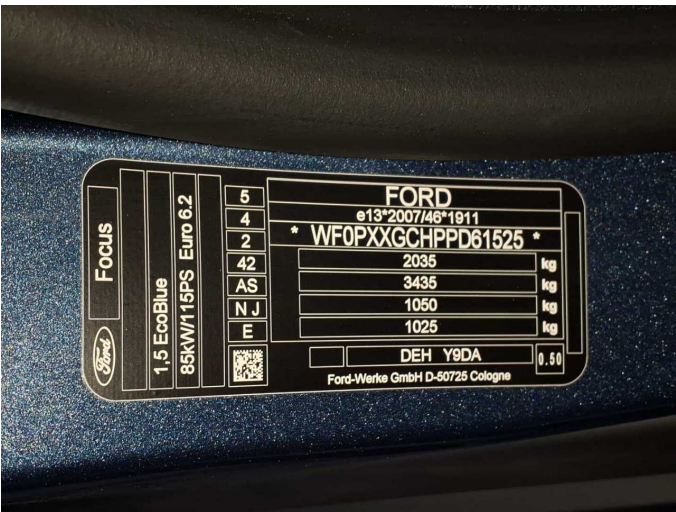
Figure 11: VIN

| VIN comparison | The vehicle identification number (VIN) was read from the vehicle and its conformity with the submitted documents was confirmed by the undersigned during the inspection. |

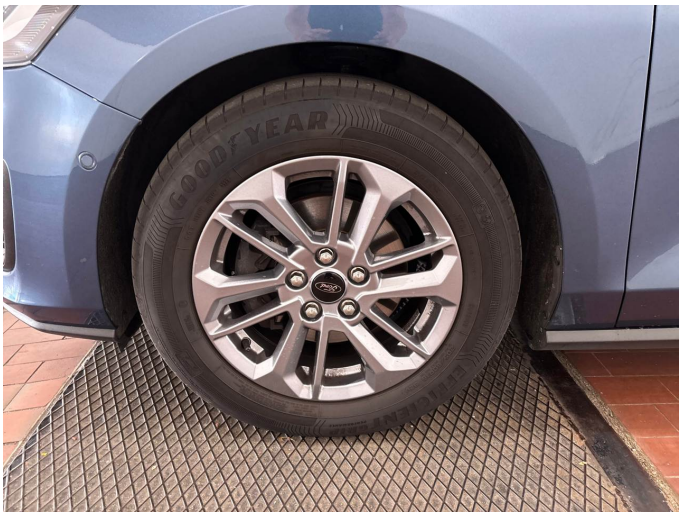
Figure 12: Mounted tyres

| # | Tyre size | Type of tyre | Manufacturer | Tread depth |
|---|---|---|---|---|
| 1) | 205/60 R16 92V | Summer tyres on Light alloy | Goodyear | 4mm / 4mm |
| 2) | 205/60 R16 92V | Summer tyres on Light alloy | Goodyear | 6mm / 6mm |

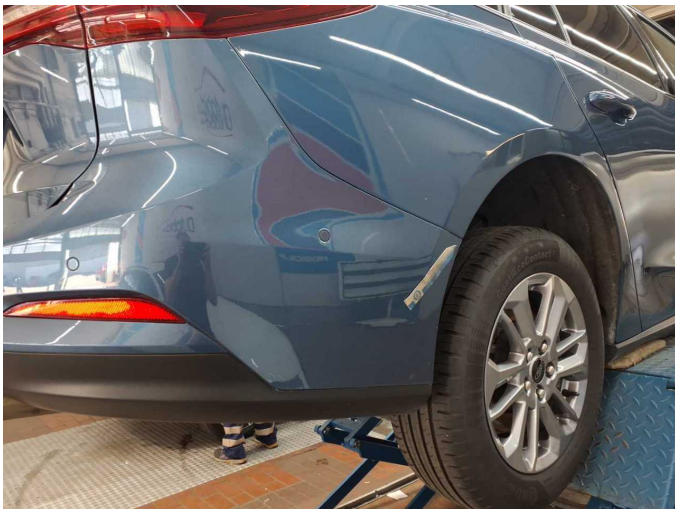
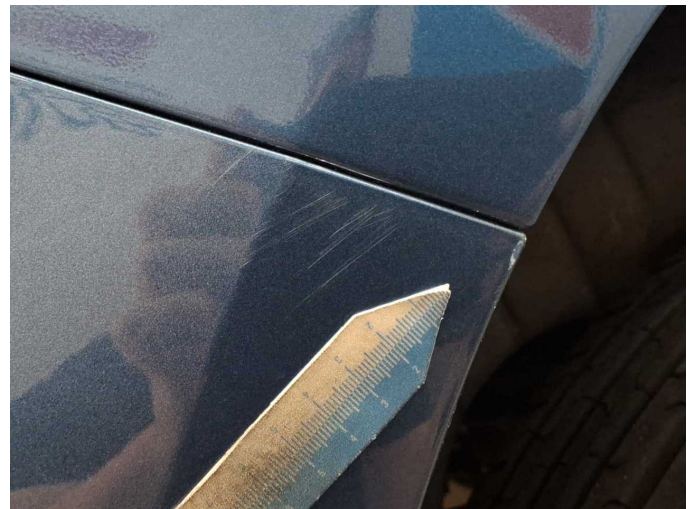
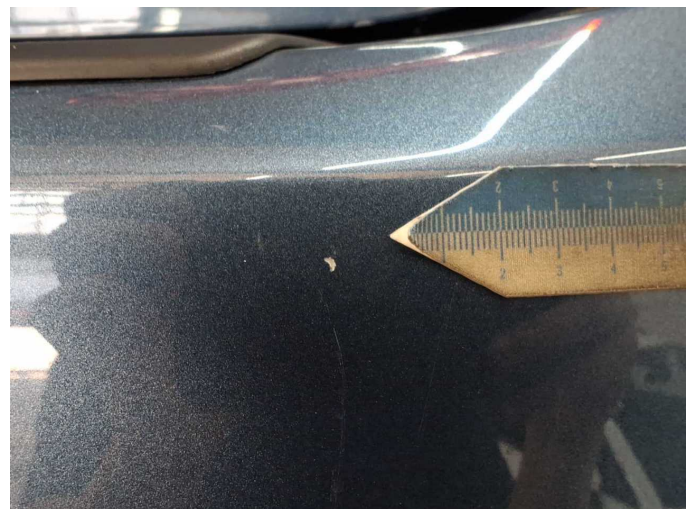
| No. | Component group | Description |
|---|---|---|
| 5 | Rear bumper | Rear bumper (polierbar) - Scratch(es) - No deduction |

**Wear and tear 5:** Rear bumper: Rear bumper (polierbar) - Scratch(es) - No deduction

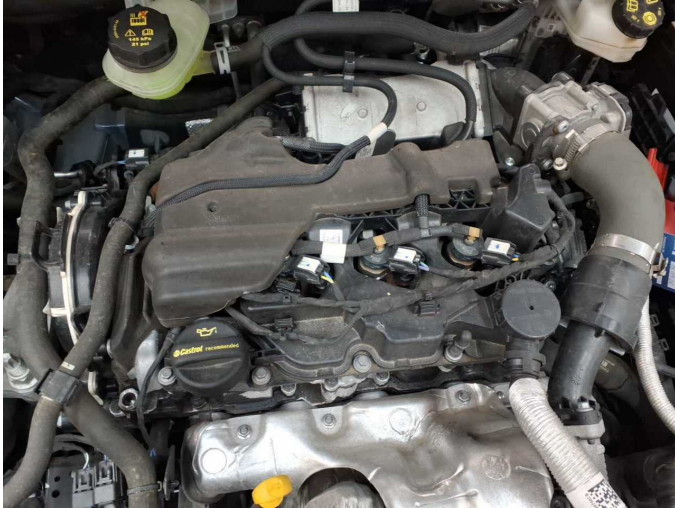
Engine - Engine cover

**Missing part 1:** Engine: Engine cover - Missing - Replace

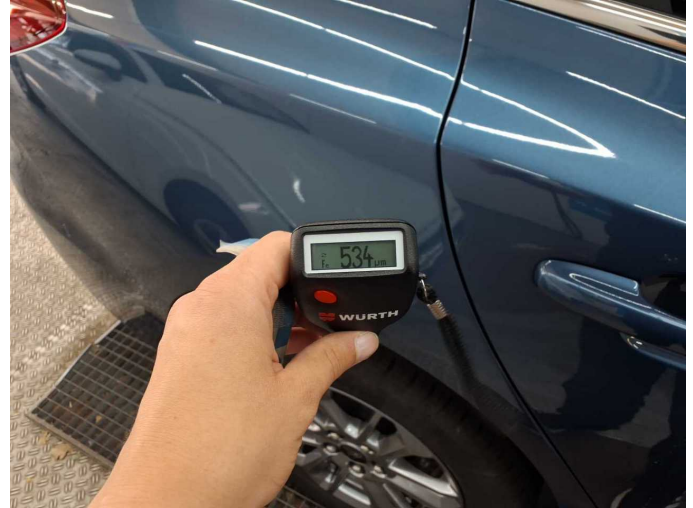
- Side panel - rear right side, Professionally carried out, Invoice of repair done Non-existent
- Door - rear right side, Professionally carried out, Invoice of repair done Non-existent

| Side panel - rear right side | 534 µm | Door - rear right side | 177 µm |

**Repainting 1:** Side panel - rear right side

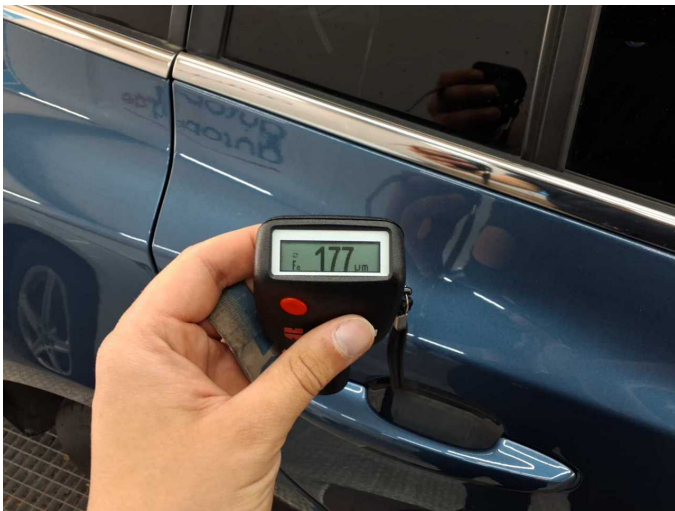
**Repainting 2:** Door - rear right side
