Expertise

Protocol number: 46541884  
Order No. / Reference: 26472265  
Inspection date: 15 Jul 2026

Manufacturer: Volvo

Model: XC60 T6 AWD Recharge Plus Bright

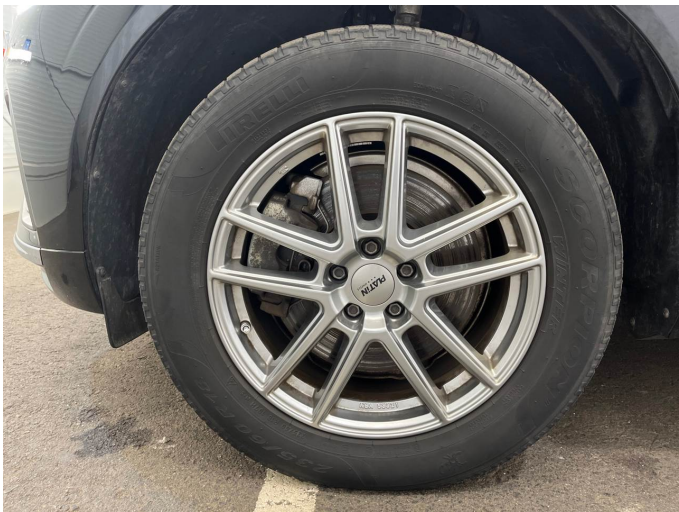
| # | Tyre size | Type of tyre | Manufacturer | Tread depth |
|---|---|---|---|---|
| 1) | 235/60 R18 107H | Winter tyres on Light alloy | Pirelli | 2mm / 2mm |

Figure 12: Mounted tyres

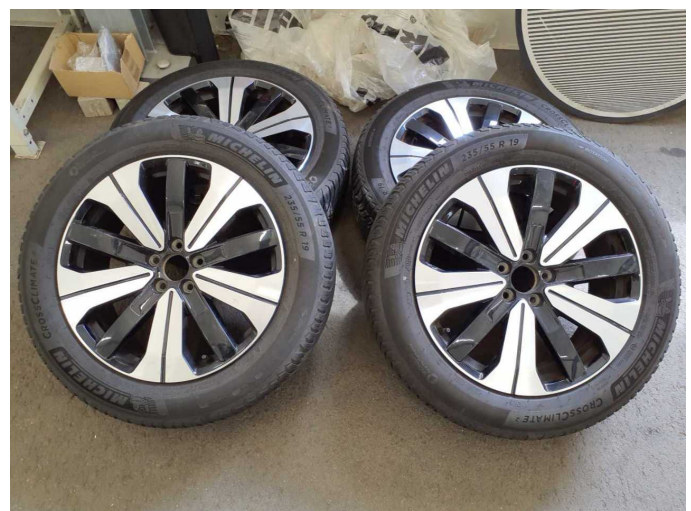
| # | Tyre size | Type of tyre | Manufacturer | Tread depth |
|---|---|---|---|---|
| 1) | 235/55 R19 105H | All-season tyres on Light alloy | Michelin | 4mm / 4mm |

Figure 18: Additional tyres

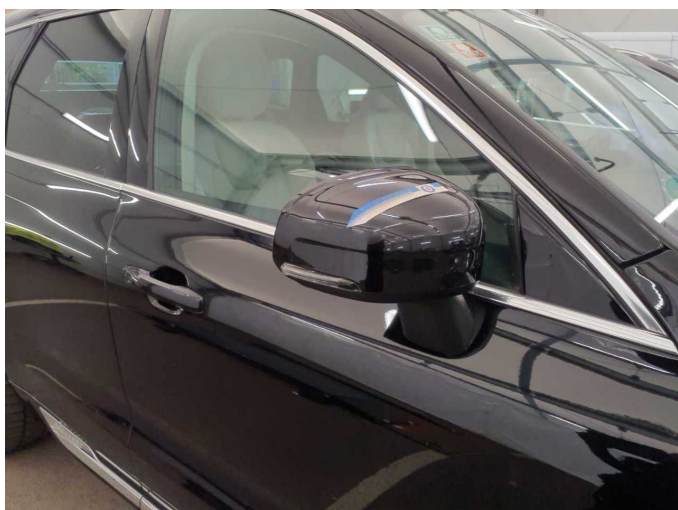
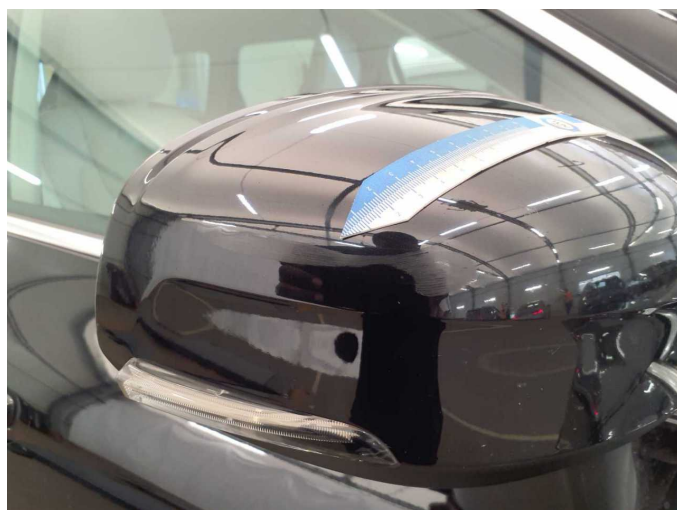
| No. | Component group | Description |
|---|---|---|
| 1 | Wing mirror - right side | Cap - Scratch(es) - Smart repair |

**Damage 1:** Wing mirror - right side: Cap - Scratch(es) - Smart repair

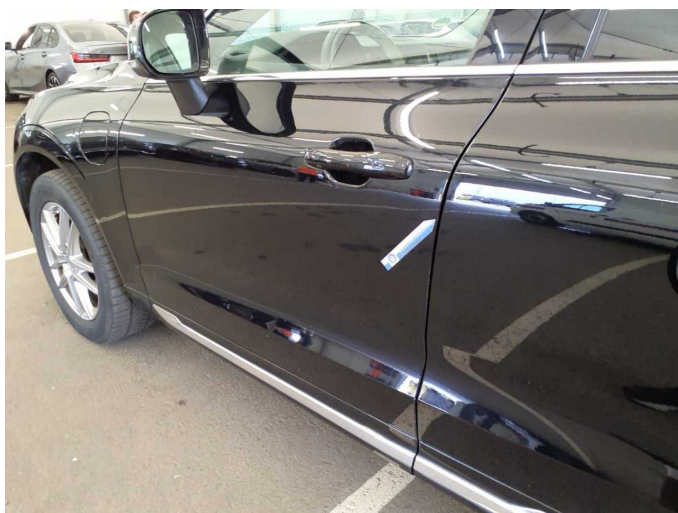
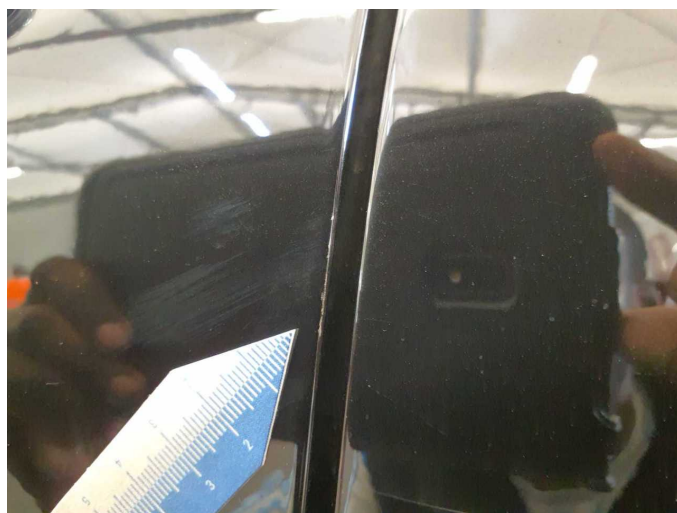
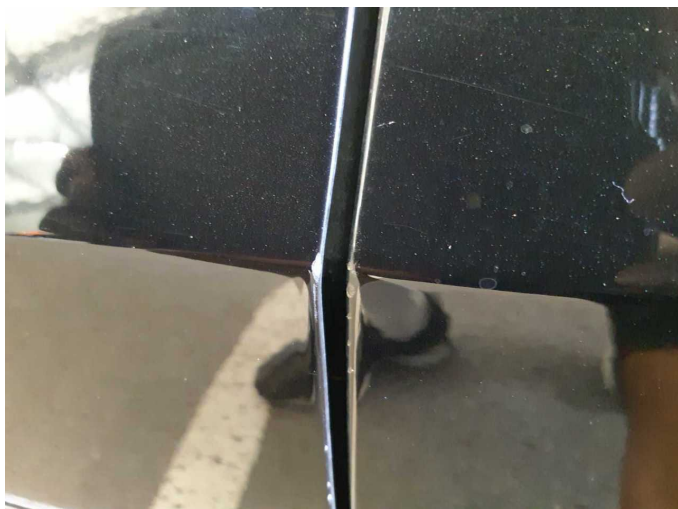
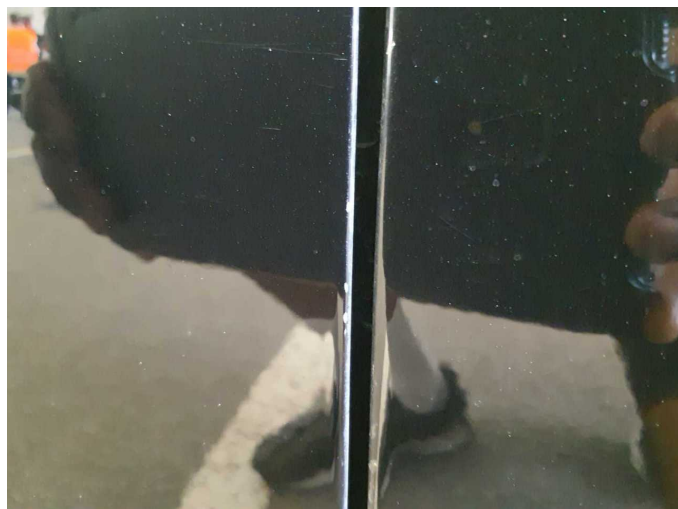
| No. | Component group | Description |
|---|---|---|
| 2 | Door - front left side | Door edge - Scratch(es) - Smart repair |

**Damage 2:** Door - front left side: Door edge - Scratch(es) - Smart repair

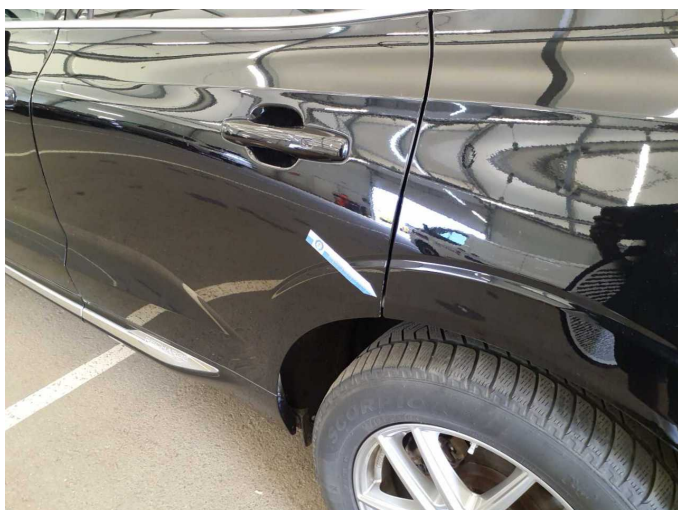
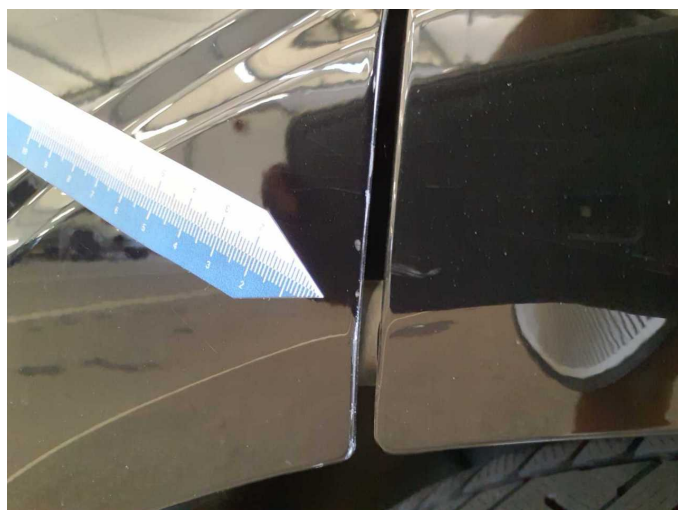
| No. | Component group | Description |
|---|---|---|
| 3 | Door - rear left side | Door edge - Scratch(es) - Smart repair |

**Damage 3:** Door - rear left side: Door edge - Scratch(es) - Smart repair

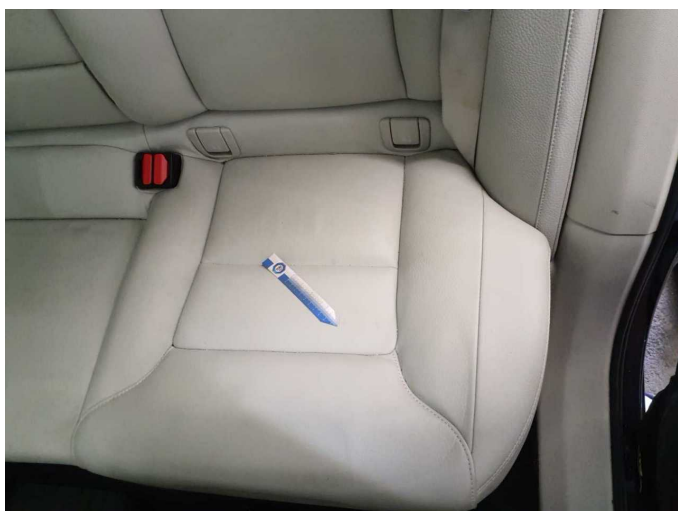
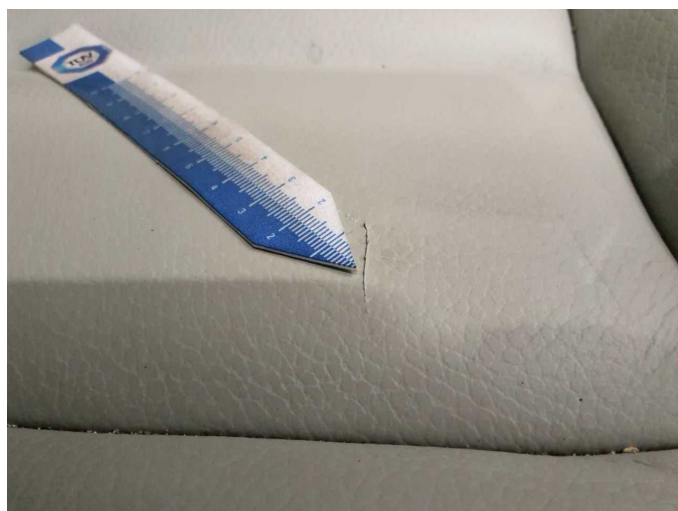
| No. | Component group | Description |
|---|---|---|
| 4 | Seat - rear | Back seat - Holes - Smart repair |

**Damage 4:** Seat - rear: Back seat - Holes - Smart repair

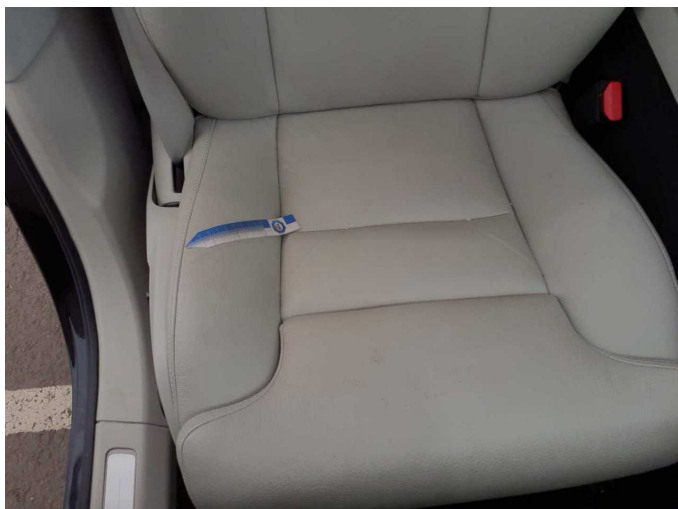
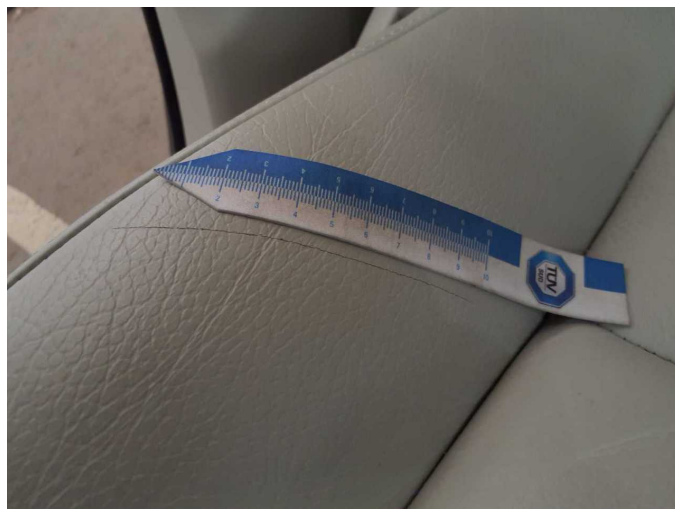
| No. | Component group | Description |
|---|---|---|
| 5 | Seat - front | Seat cover - right side - Scratch(es) - Smart repair |

**Damage 5:** Seat - front: Seat cover - right side - Scratch(es) - Smart repair

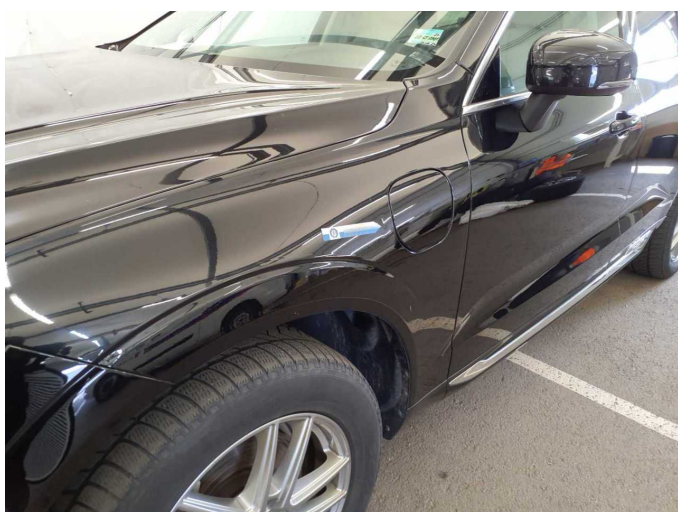
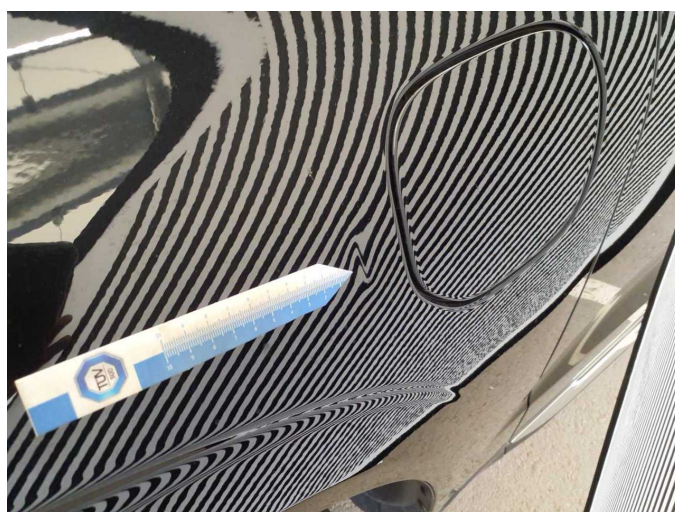
| No. | Component group | Description |
|---|---|---|
| 6 | Mudguard - left side | Mudguard - left side - dent(s) - Smart repair |

**Damage 6:** Mudguard - left side: Mudguard - left side - dent(s) - Smart repair

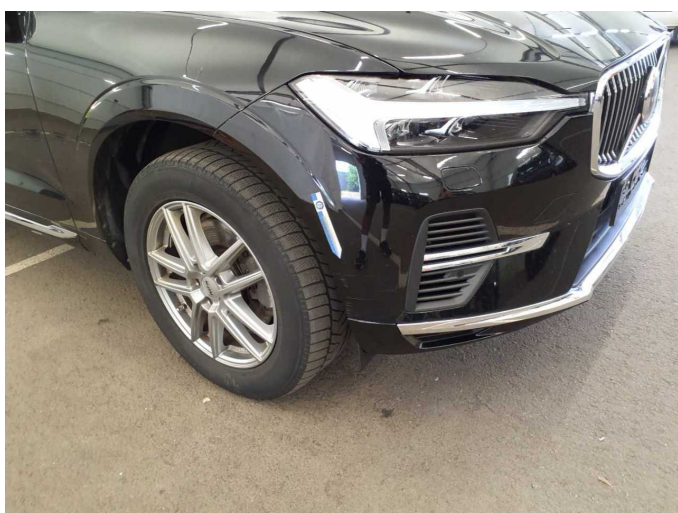
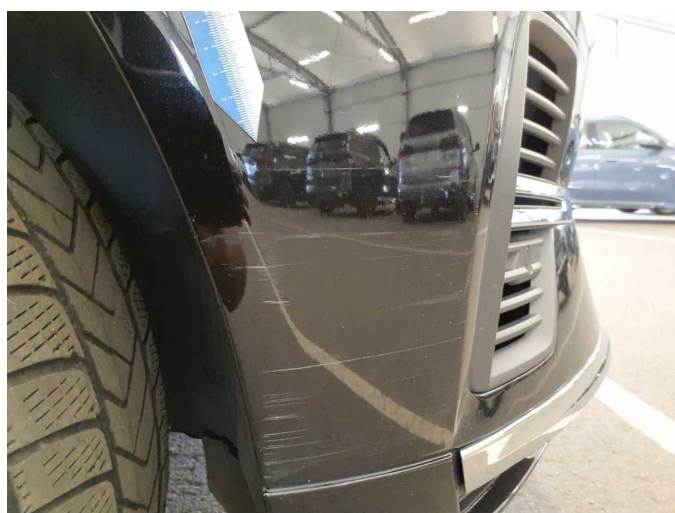
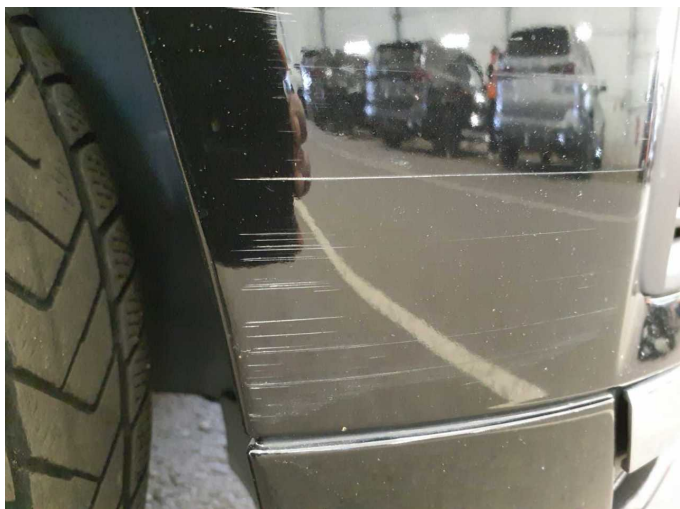
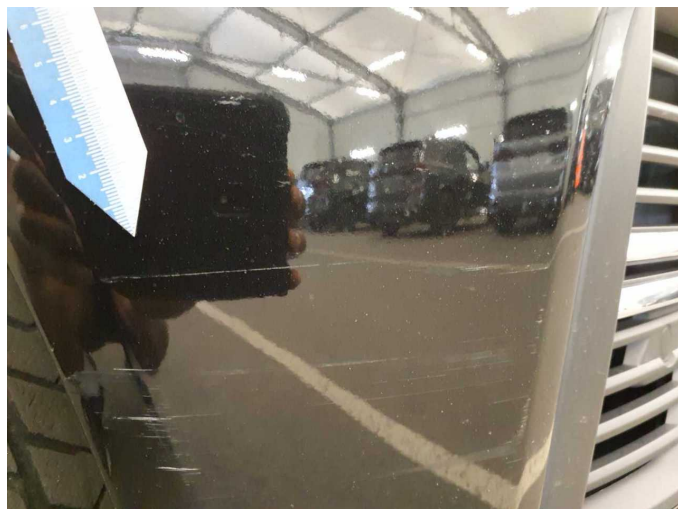
| No. | Component group | Description |
|---|---|---|
| 7 | Front bumper | Front bumper - Scratch(es) - Paint |

**Damage 7:** Front bumper: Front bumper - Scratch(es) - Paint

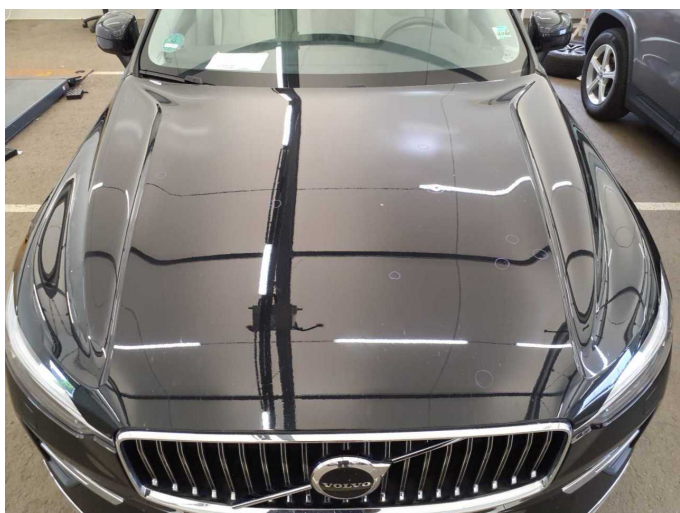
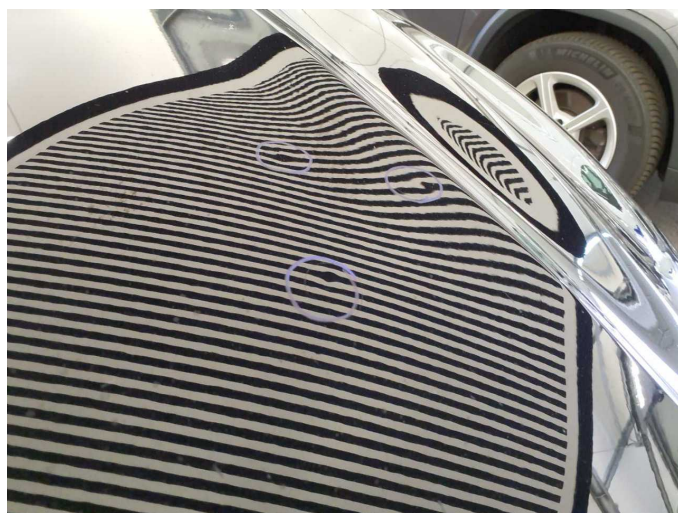
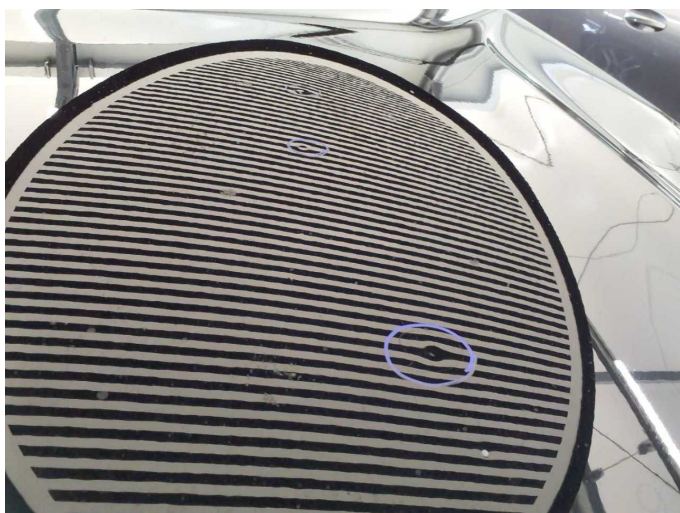
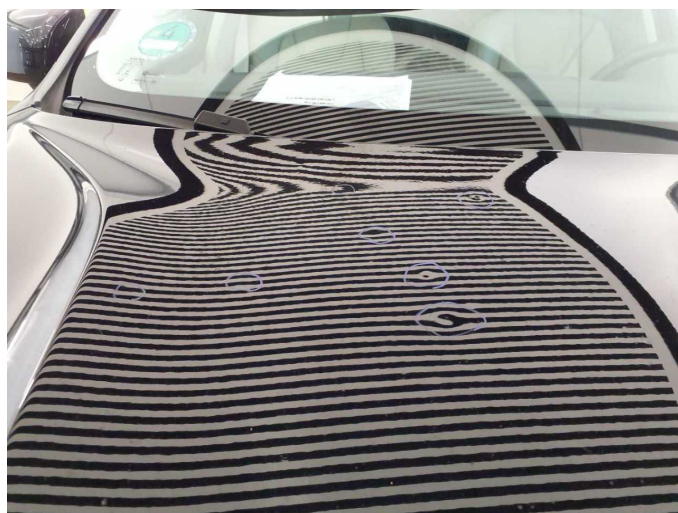
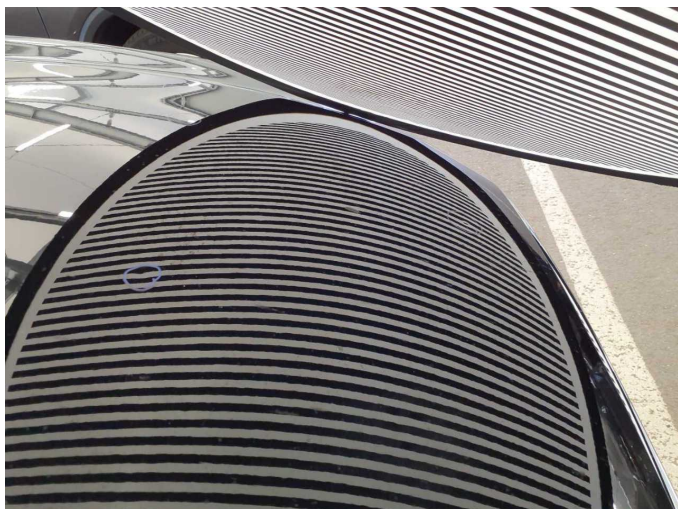
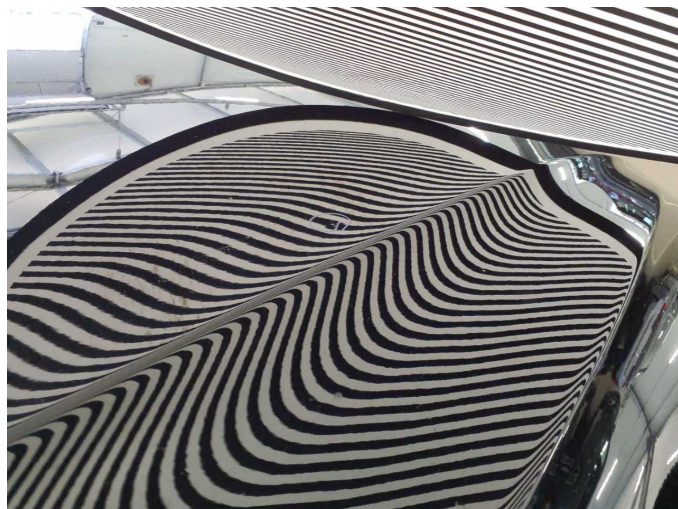
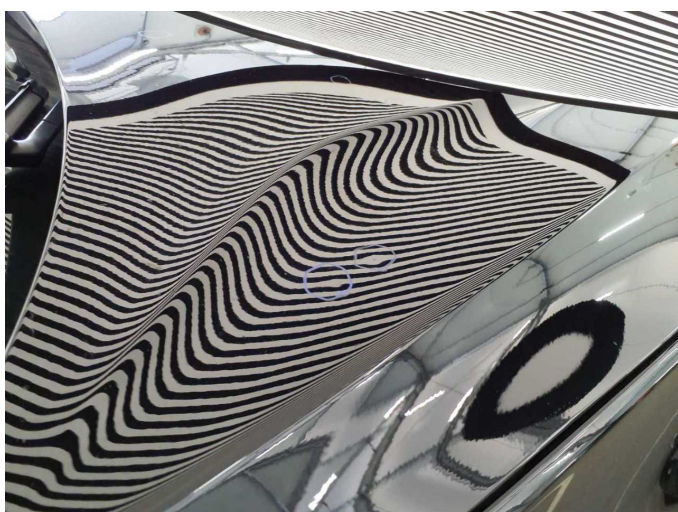
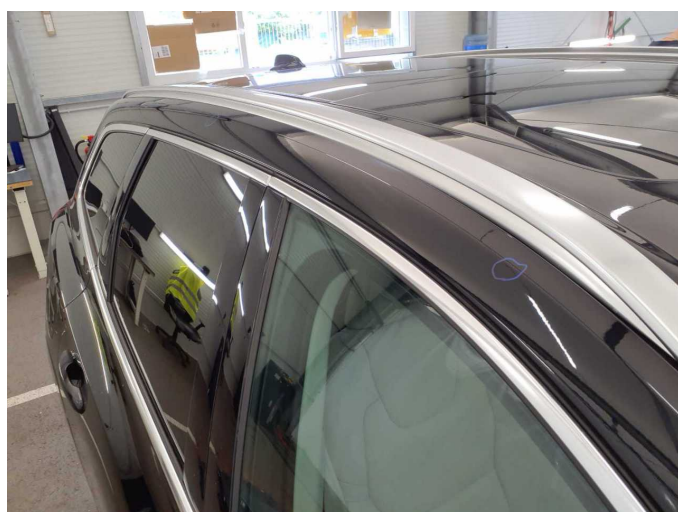
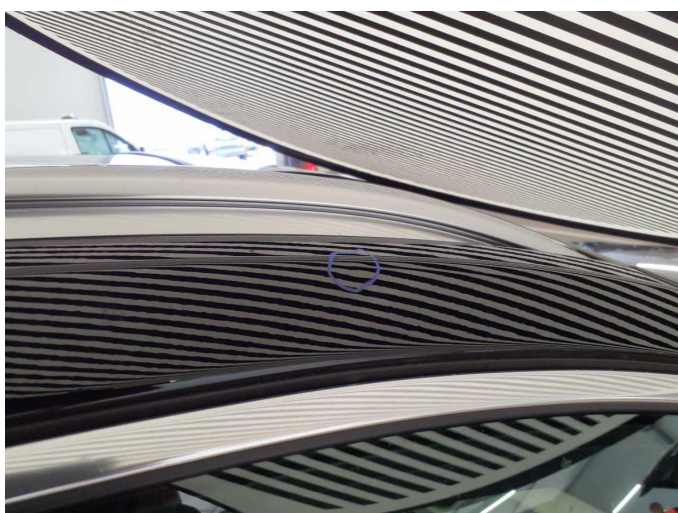
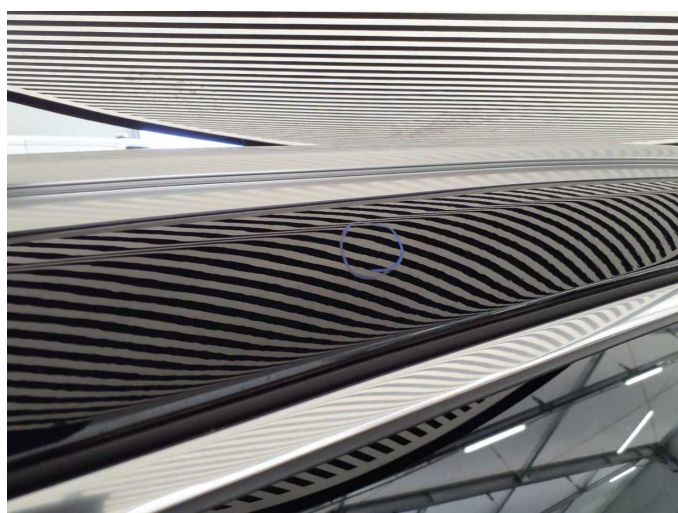
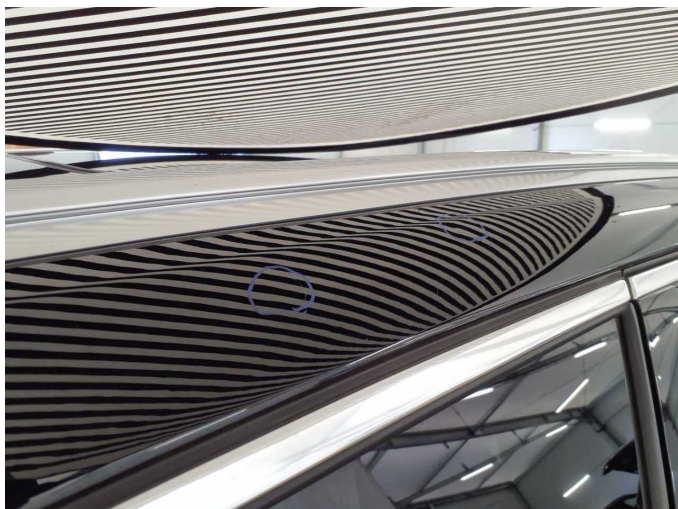
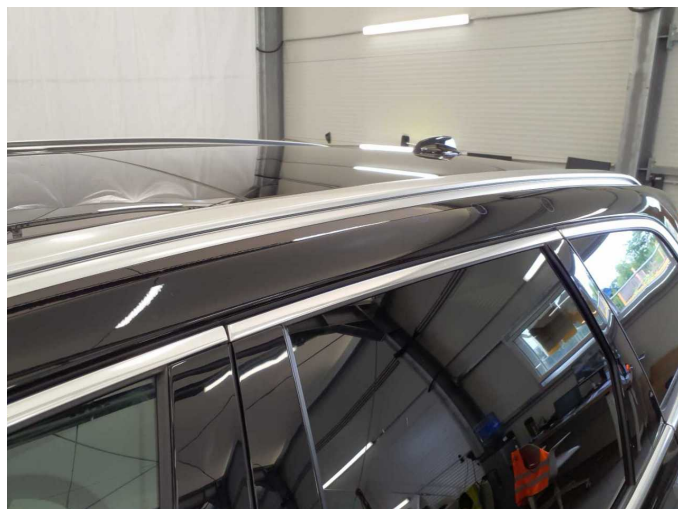
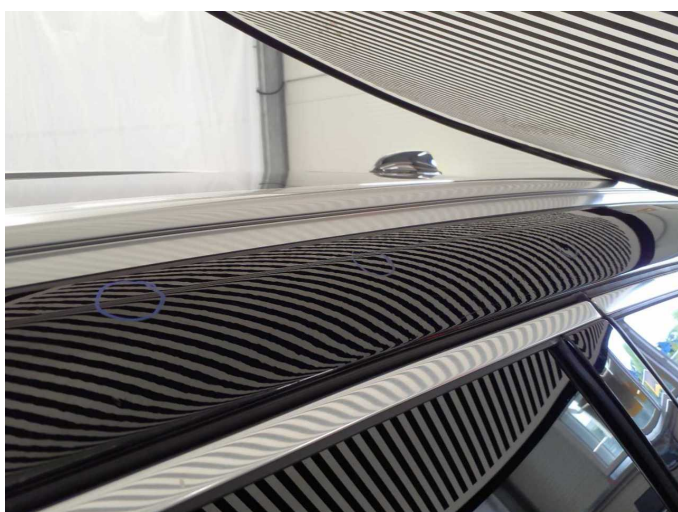
| No. | Component group | Description |
|---|---|---|
| 8 | Body | Body - Damage by hail - Smart repair |

**Damage 8:** Body: Body - Damage by hail - Smart repair

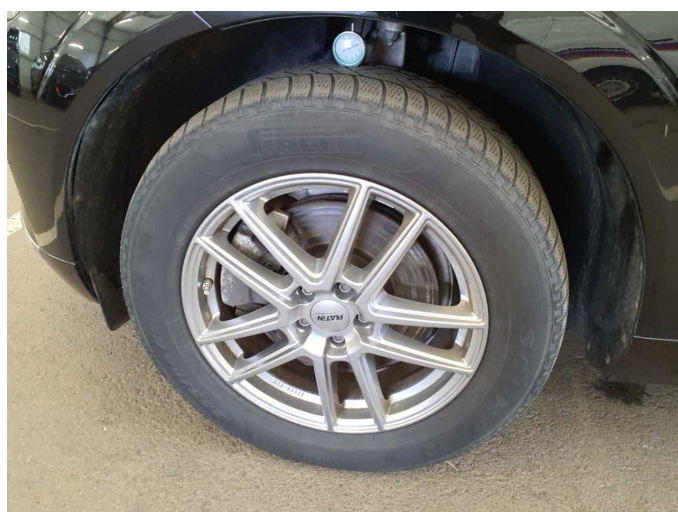
| No. | Component group | Description |
|---|---|---|
| 1 | Wheel / tyres | Tyres - complete set (WR) - Worn - No deduction |

**Wear and tear 1:** Wheel / tyres: Tyres - complete set (WR) - Worn - No deduction

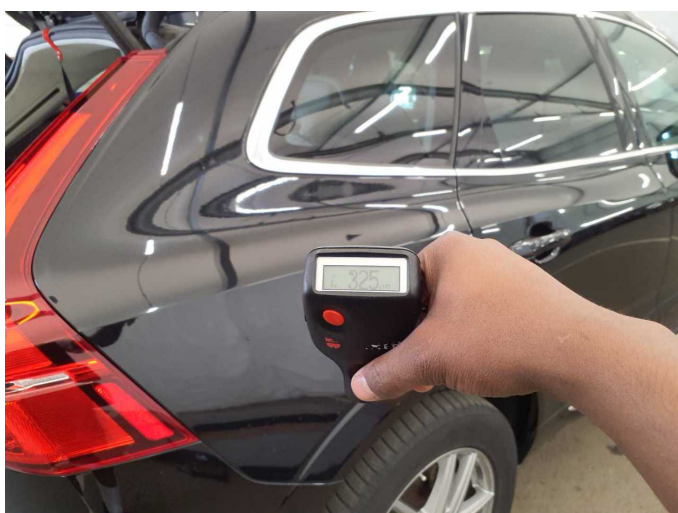
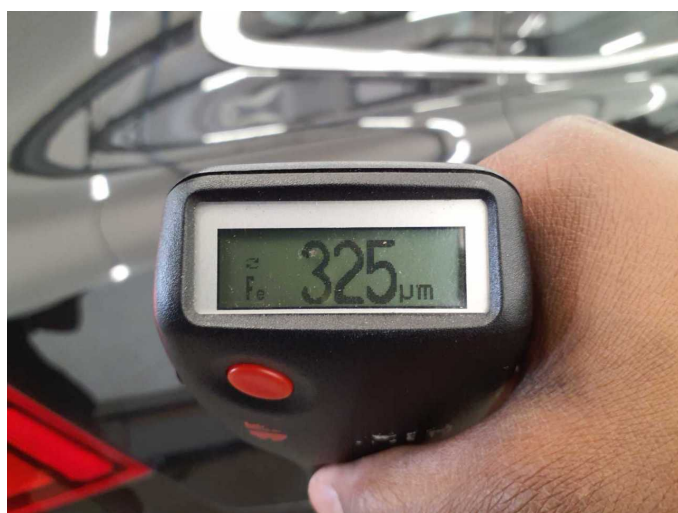
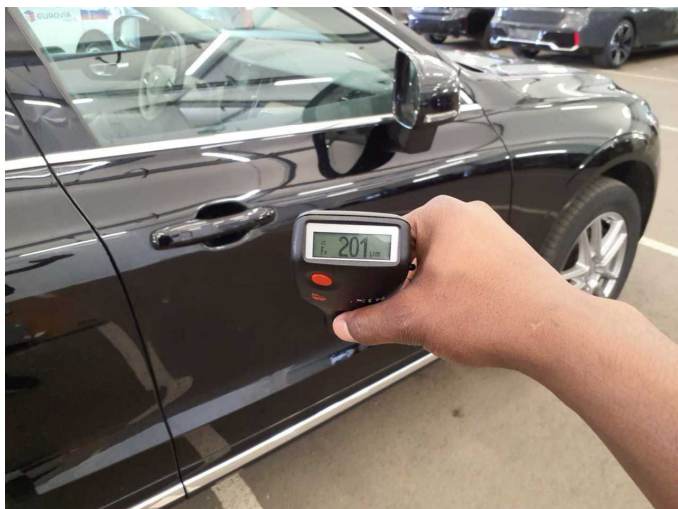
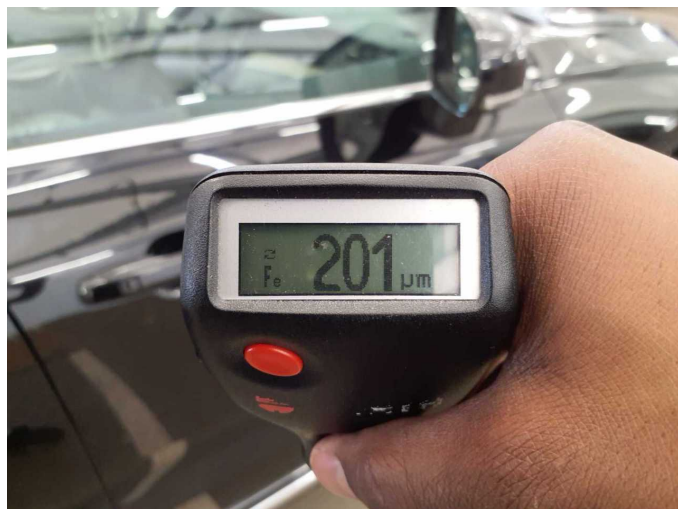
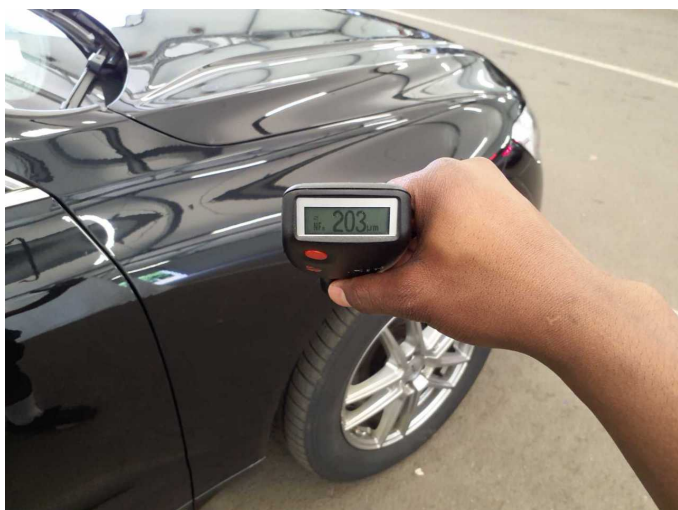
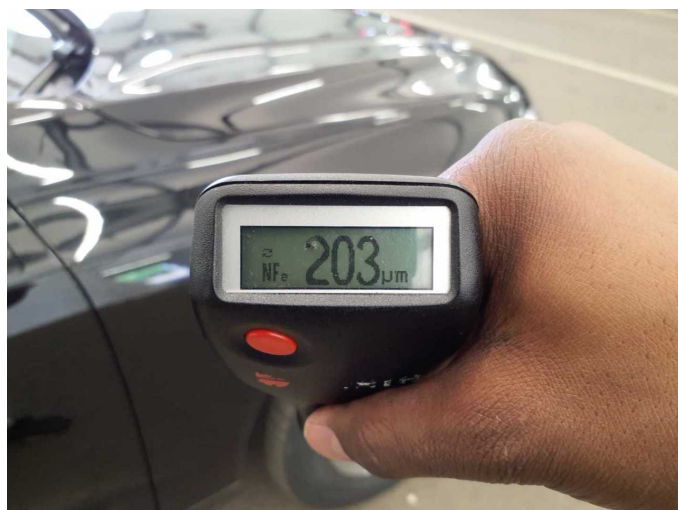
| No. | Repainting |
|---|---|
| 1 | Mudguard - right side, Side panel - rear right side, Door - front right side, Professionally carried out, Invoice of repair done Non-existent |

| Mudguard - right side | 203 µm | Side panel - rear right side | 325 µm |
| Door - front right side | 201 µm | | |

**Repainting 1:** Mudguard - right side, Side panel - rear right side, Door - front right side
