Expertise

Protocol number: 46170534  
Order No. / Reference: 26562076  
Inspection date: 23 Jun 2026

Manufacturer: Volkswagen

Model: Passat Variant 2.0 TDI SCR DSG Business

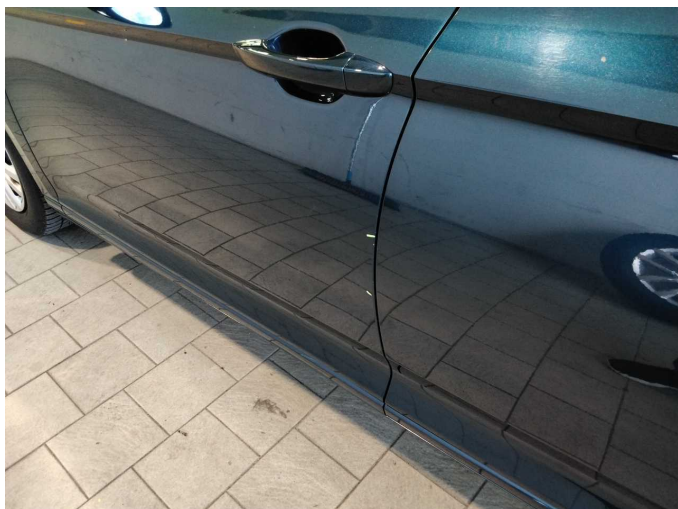
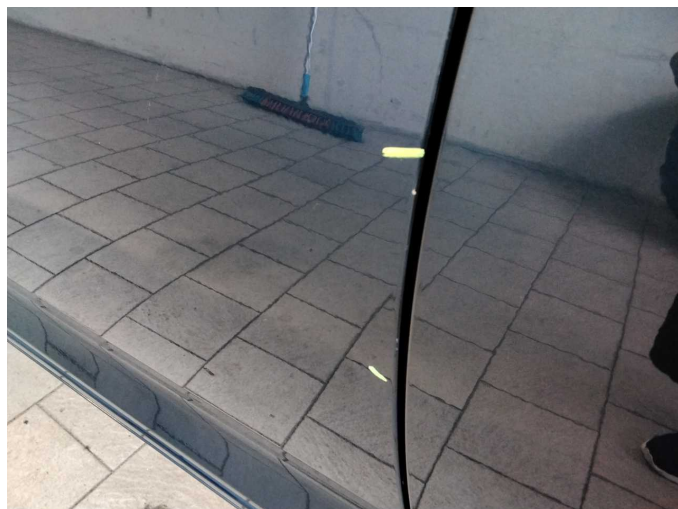
| No. | Component group | Description |
|---|---|---|
| 1 | Door - front left side | Door edge - Scratch(es) - Smart repair |

**Damage 1:** Door - front left side: Door edge - Scratch(es) - Smart repair

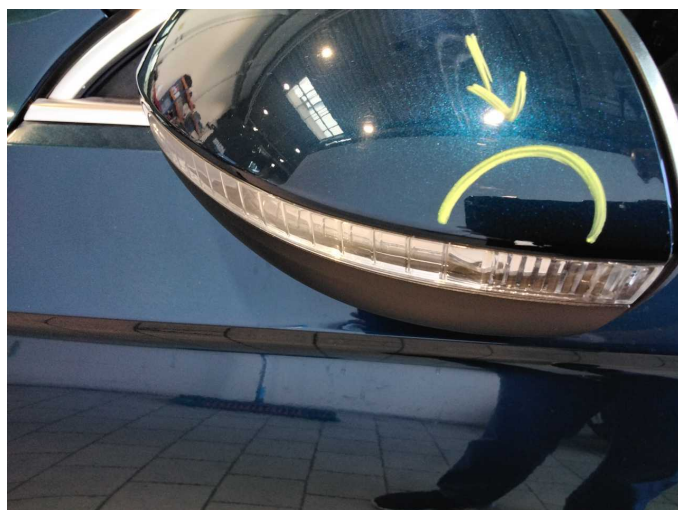
| No. | Component group | Description |
|---|---|---|
| 2 | Wing mirror - left side | Cap - Scratch(es) - Smart repair |

**Damage 2:** Wing mirror - left side: Cap - Scratch(es) - Smart repair

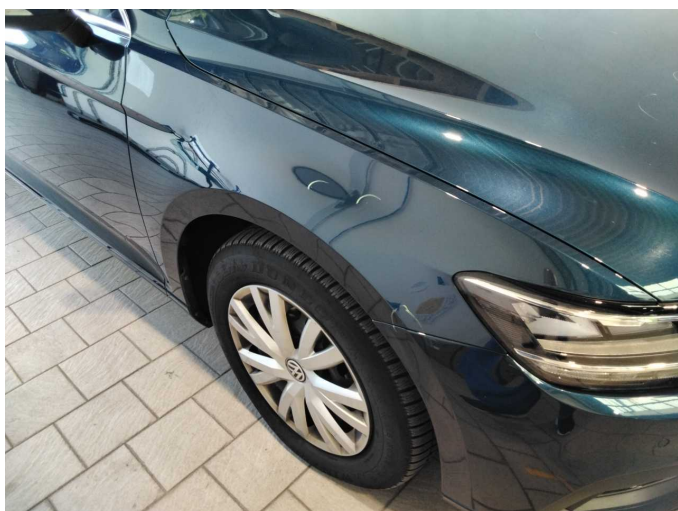
| No. | Component group | Description |
|---|---|---|
| 3 | Mudguard - right side | Mudguard - right side - Scratch(es) - Smart repair |

**Damage 3:** Mudguard - right side: Mudguard - right side - Scratch(es) - Smart repair

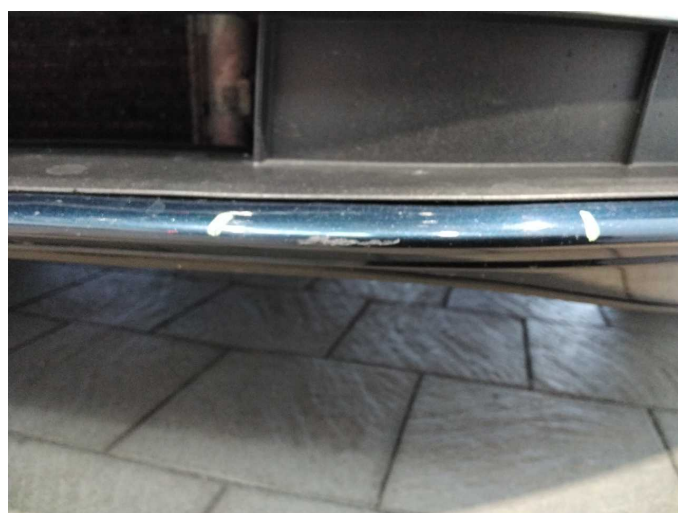
| No. | Component group | Description |
|---|---|---|
| 5 | Front bumper | Front bumper - Scratch(es) - Smart repair |

**Damage 5:** Front bumper: Front bumper - Scratch(es) - Smart repair

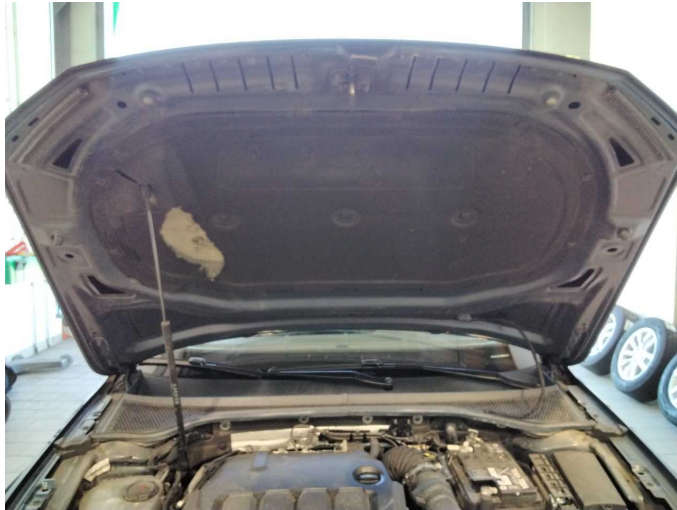
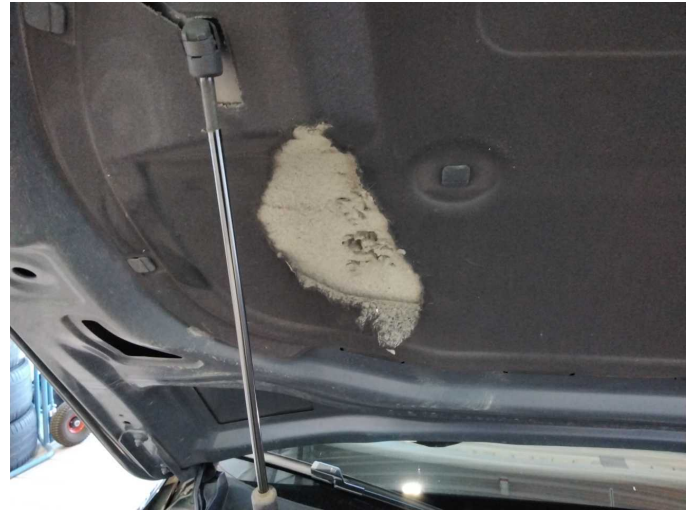
| No. | Component group | Description |
|---|---|---|
| 6 | Bonnet | Insulation lining - Damage caused by marten / rodent - Replace |

**Damage 6:** Bonnet: Insulation lining - Damage caused by marten / rodent  
- Replace

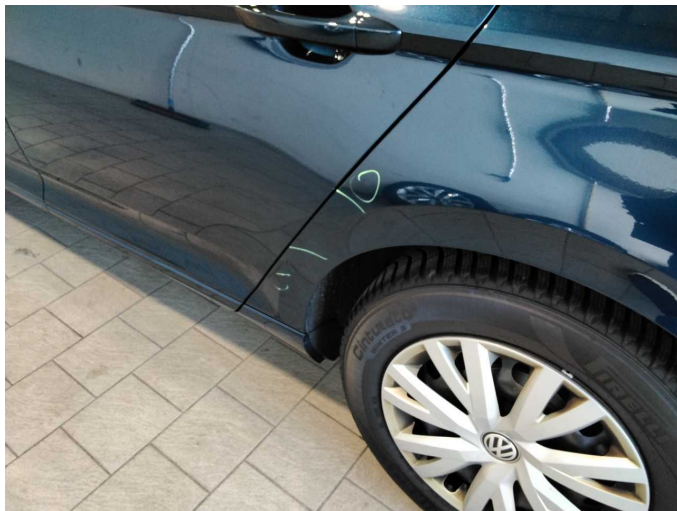
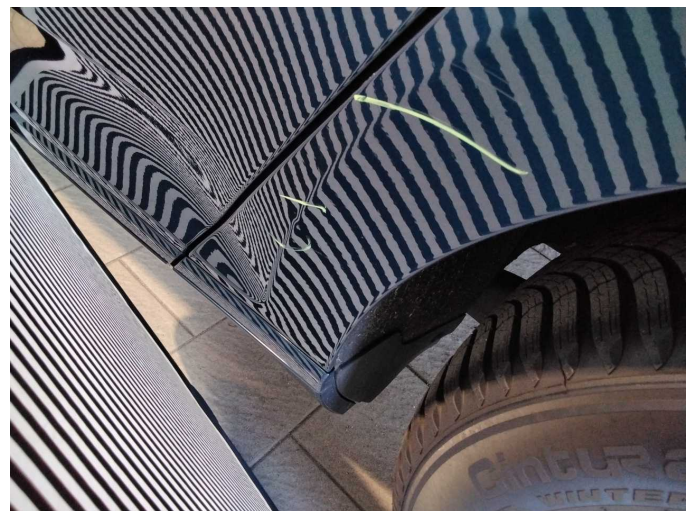
| No. | Component group | Description |
|---|---|---|
| 7 | Side panel - rear left side | Side panel - Dent / paintcoat damage - Repair and paint |

**Damage 7:** Side panel - rear left side: Side panel - Dent / paintcoat  
damage - Repair and paint

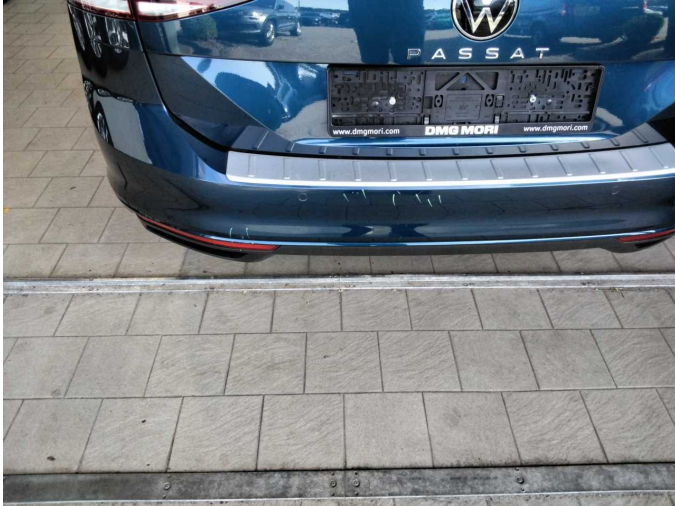
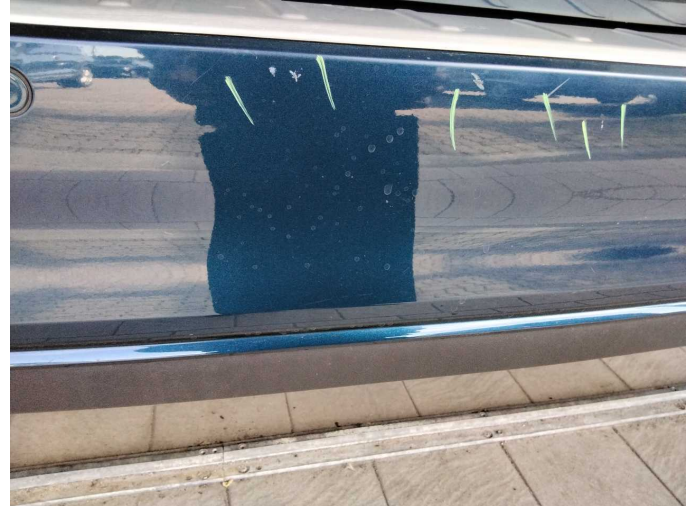
| No. | Component group | Description |
|---|---|---|
| 8 | Rear bumper | Rear bumper - Scratch(es) - Paint |

**Damage 8:** Rear bumper: Rear bumper - Scratch(es) - Paint

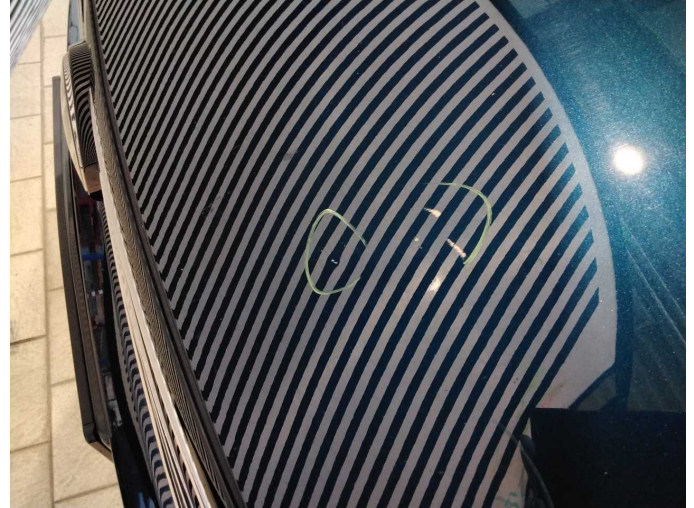
| No. | Component group | Description |
|---|---|---|
| 9 | Bonnet | Bonnet - Dent / paintcoat damage - Repair and paint |

**Damage 9:** Bonnet: Bonnet - Dent / paintcoat damage - Repair and paint
