Expertise

Protocol number: 46908407  
Order No. / Reference: 26685897  
Inspection date: 28 Jul 2026

| Manufacturer: Ford | Model: Focus Turnier 1.5 EcoBlue Start-Stopp-System Aut. TITANIUM |

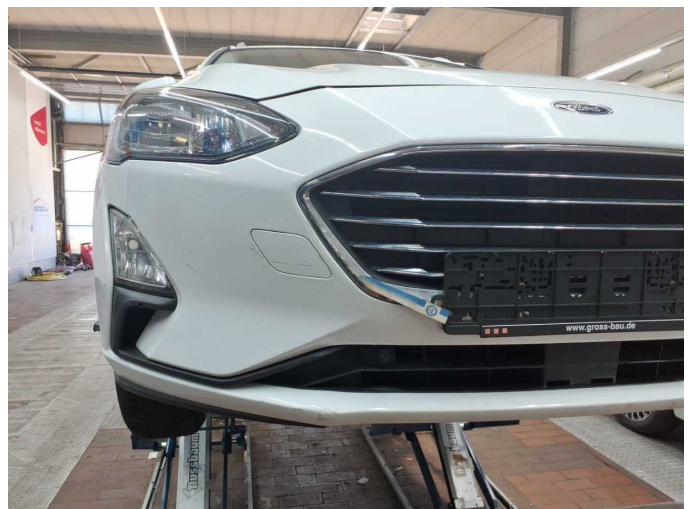
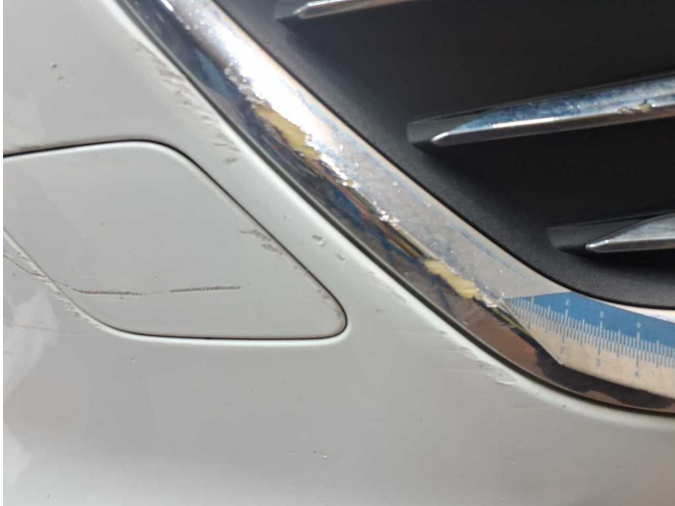
| No. | Component group | Description |
|---|---|---|
| 1 | Bonnet | Radiator grille - Scratched - Loss in value |

Damage 1: Bonnet: Radiator grille - Scratched - Loss in value

**Damage 1:** Bonnet: Radiator grille - Scratched - Loss in value

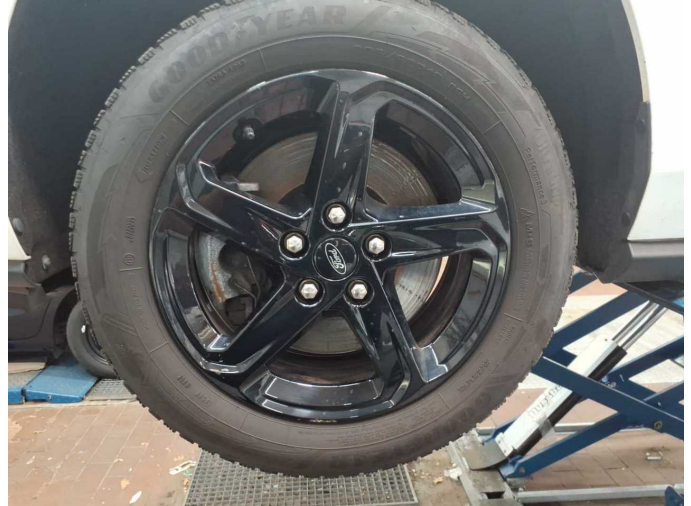
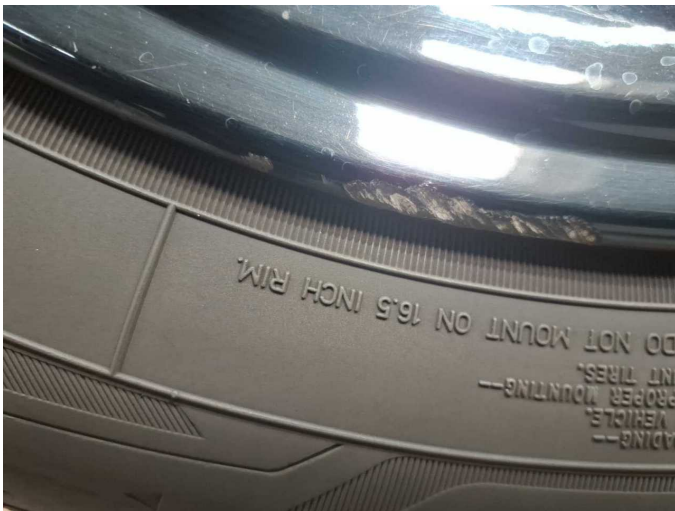
| No. | Component group | Description |
|---|---|---|
| 2 | Wheel / tyres | Alloy rim - front left side - Scratched - Loss in value |

**Damage 2:** Wheel / tyres: Alloy rim - front left side - Scratched - Loss in value

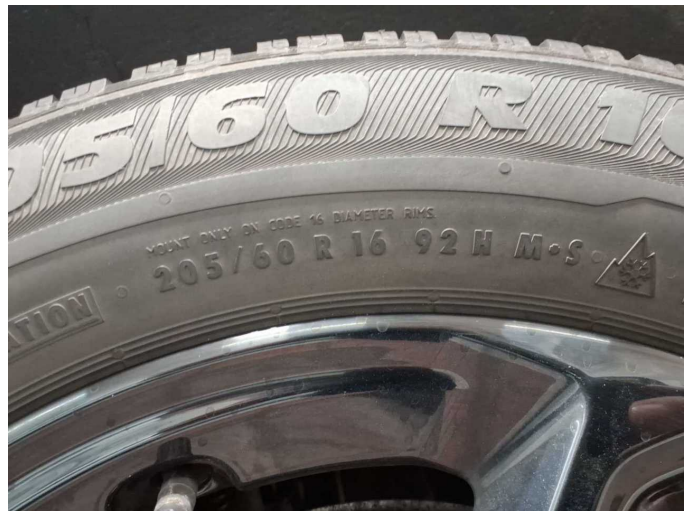
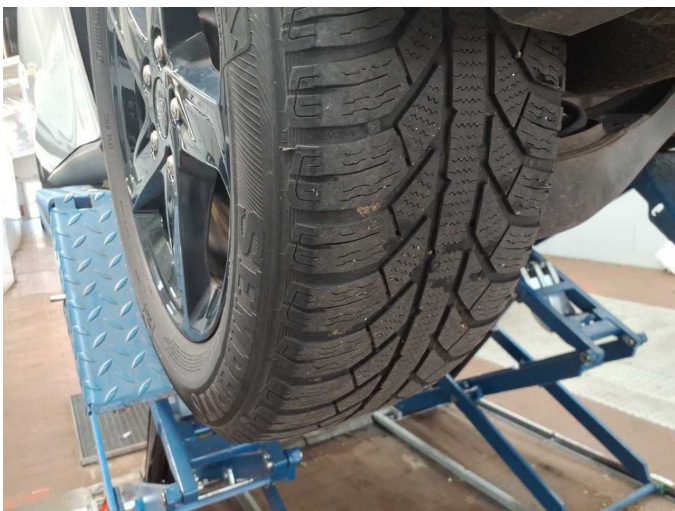
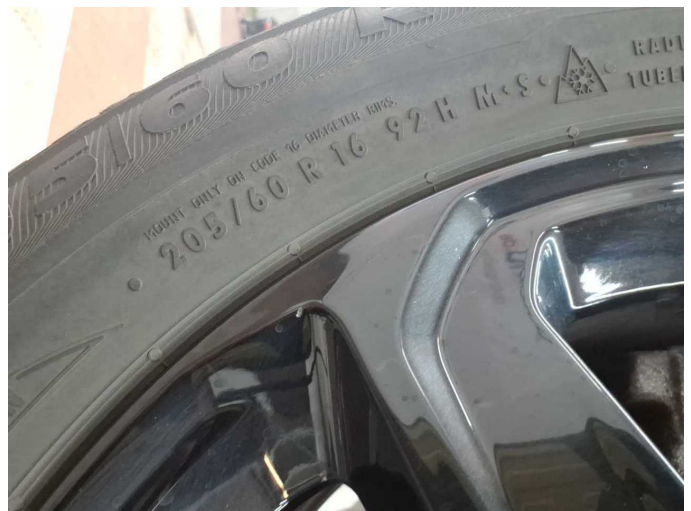
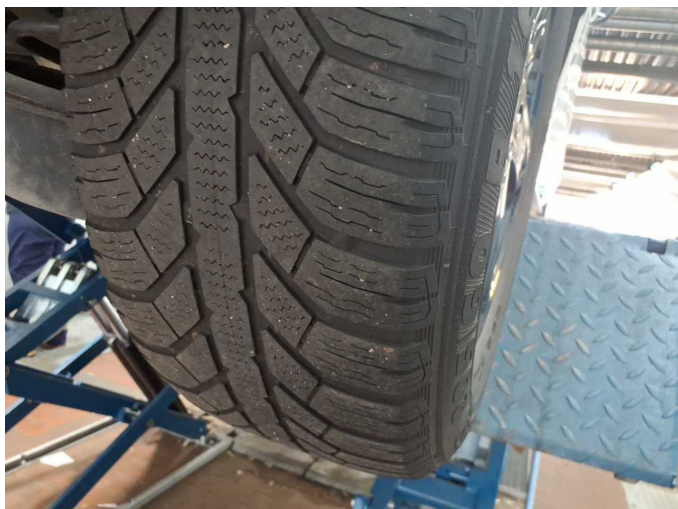
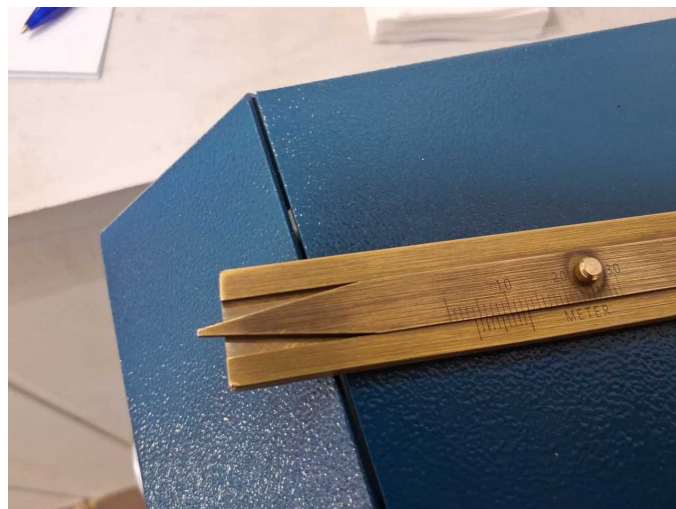
| No. | Component group | Description |
|---|---|---|
| 3 | Wheel / tyres | Tyre - right - Does not meet the leasing specifications - Replace |

**Damage 3:** Wheel / tyres: Tyre - right - Does not meet the leasing specifications - Replace

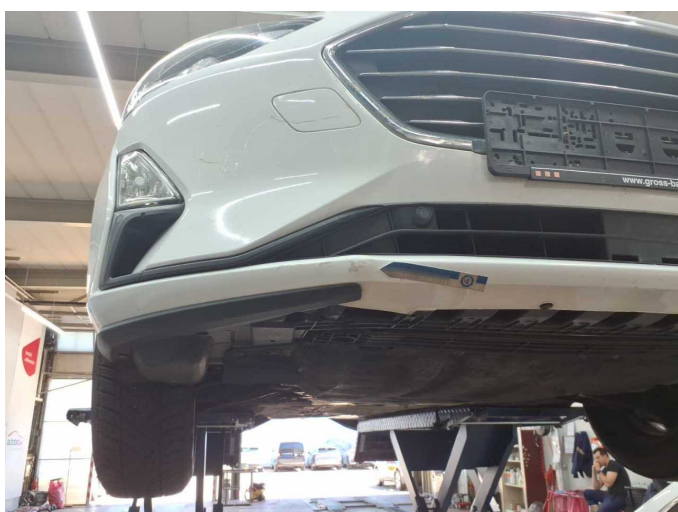
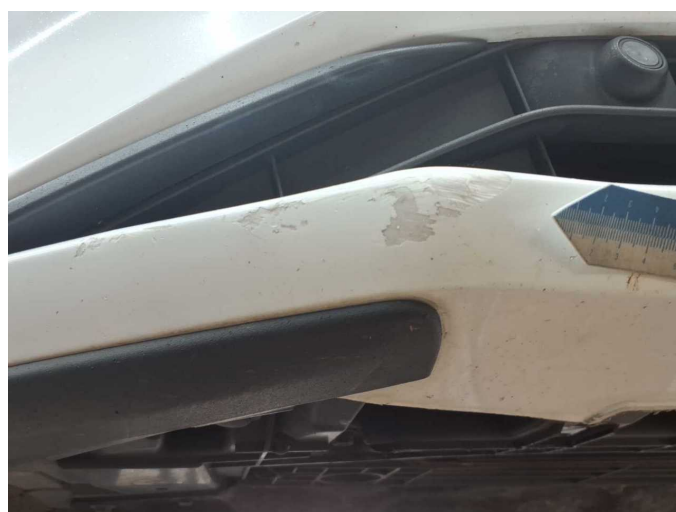
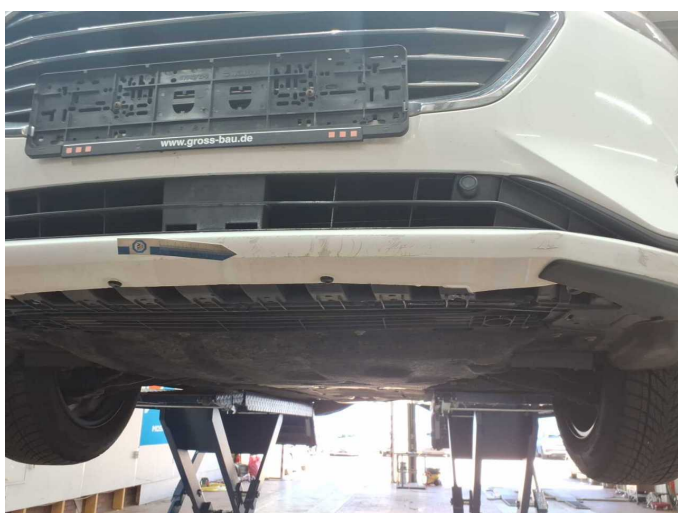
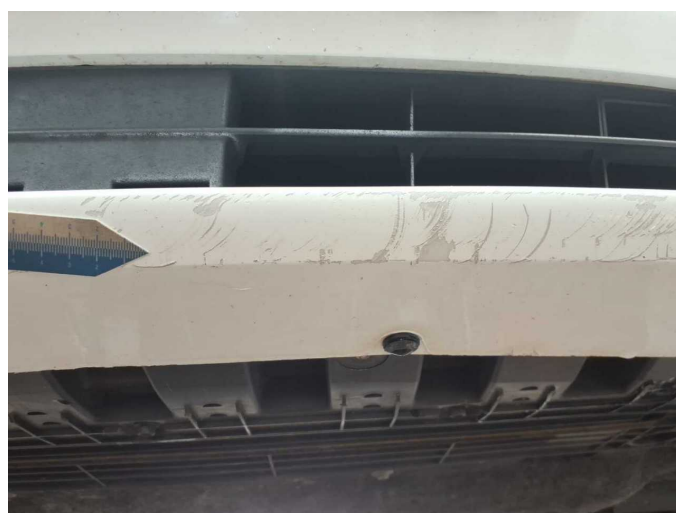
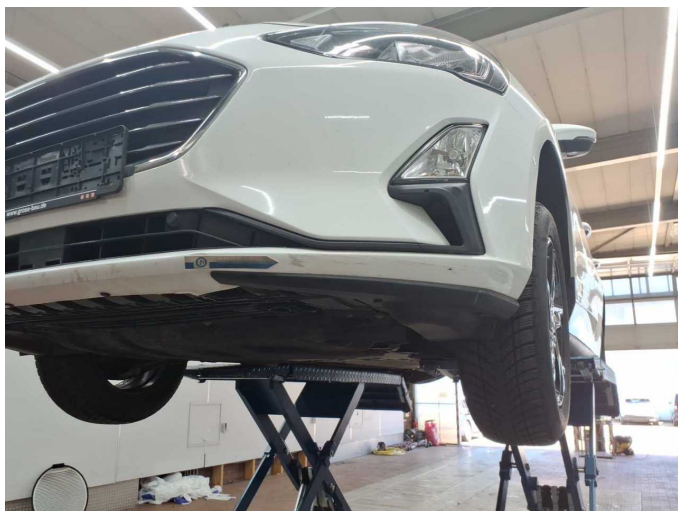
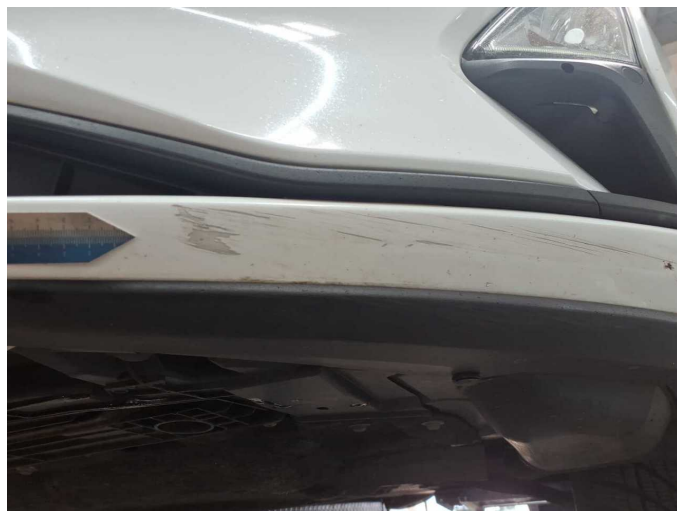
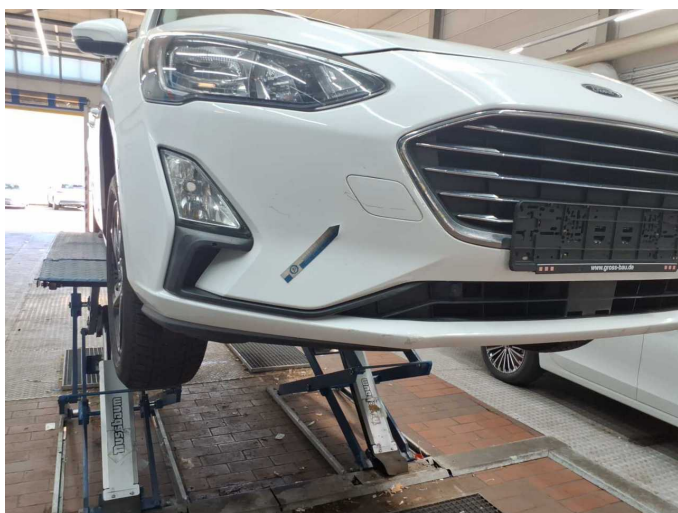
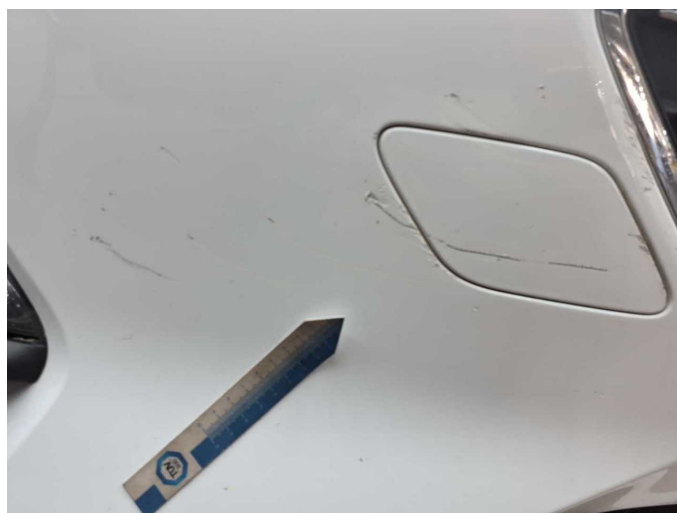
| No. | Component group | Description |
|---|---|---|
| 4 | Front bumper | Front bumper - Scratched - Paint |

**Damage 4:** Front bumper: Front bumper - Scratched - Paint

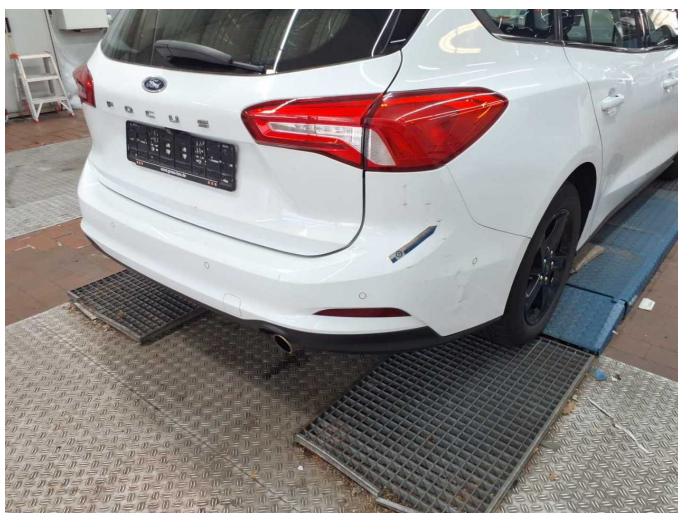
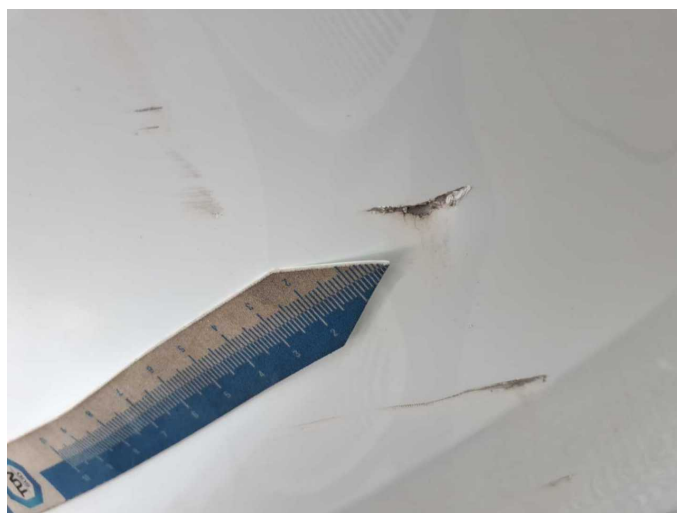
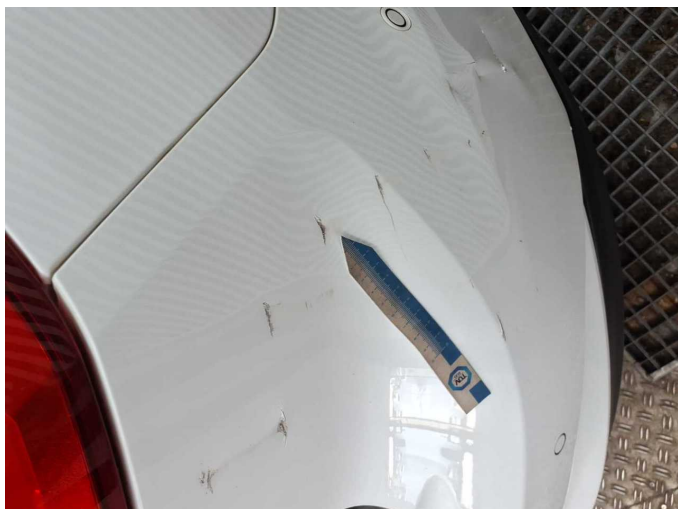
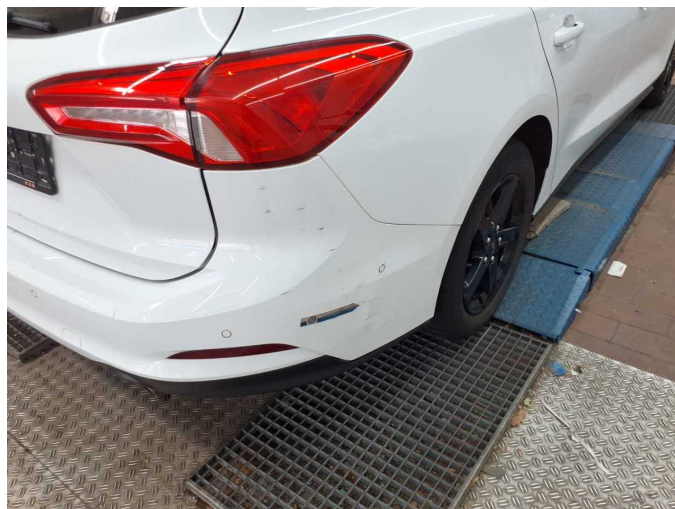
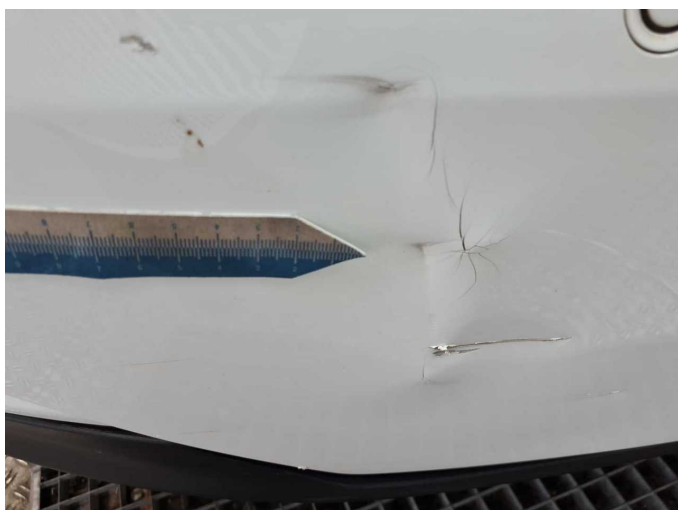
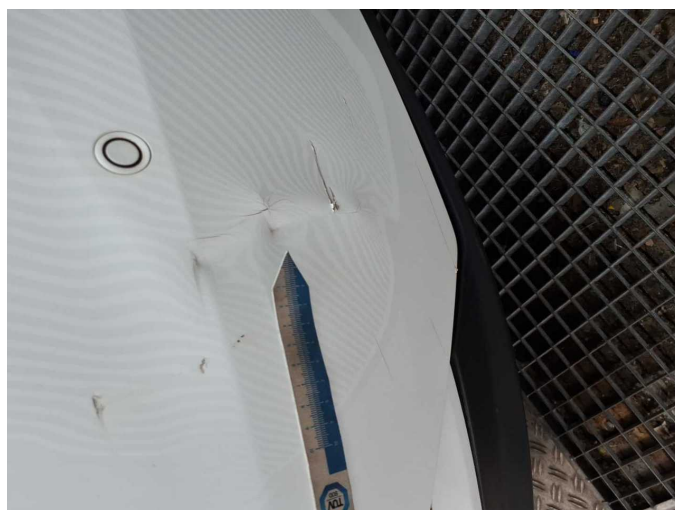
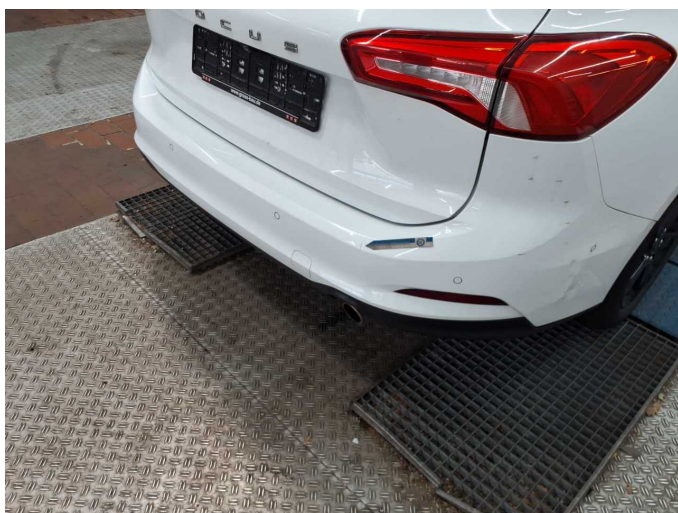
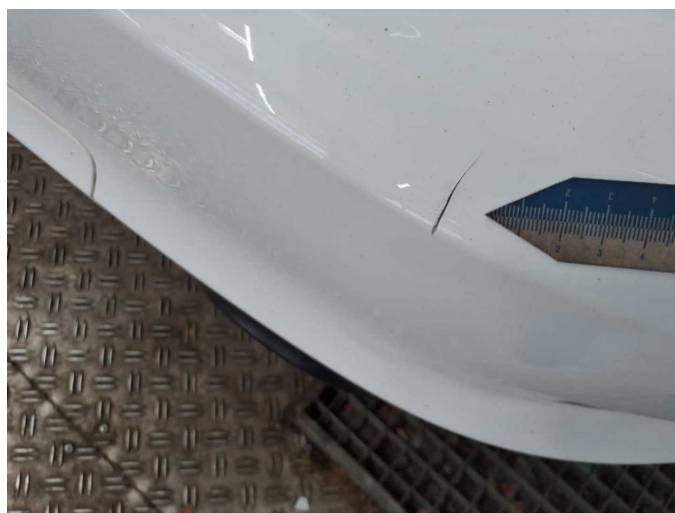
| No. | Component group | Description |
|---|---|---|
| 5 | Rear bumper | Rear bumper - Broken / torn - Replace |

**Damage 5:** Rear bumper: Rear bumper - Broken / torn - Replace

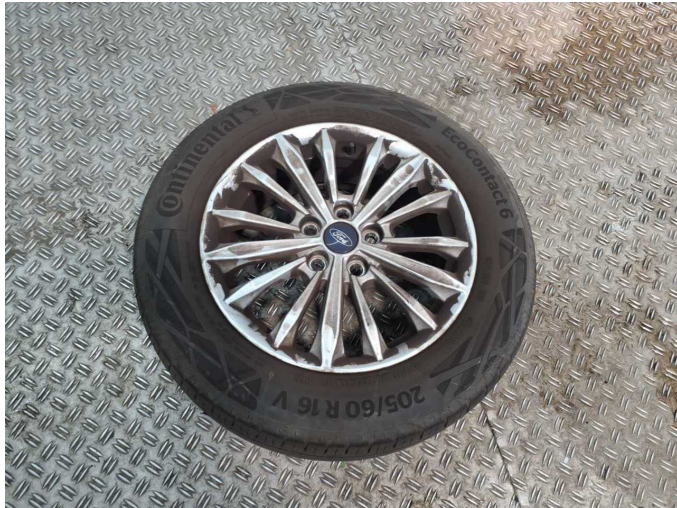
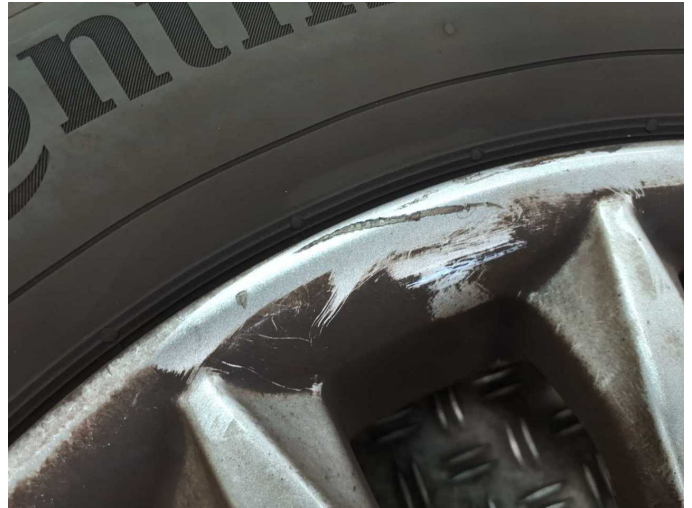
| No. | Component group | Description |
|---|---|---|
| 2 | 2nd wheel set | 1 alloy rim - Scratched - No deduction |

**Wear and tear 2:** 2nd wheel set: 1 alloy rim - Scratched - No deduction

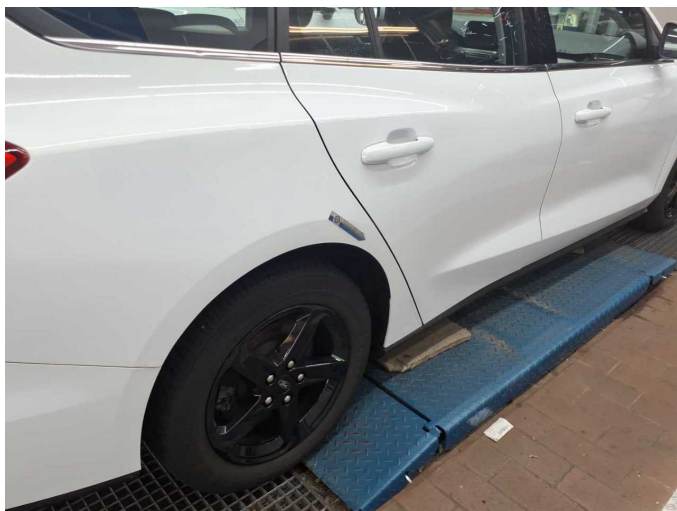
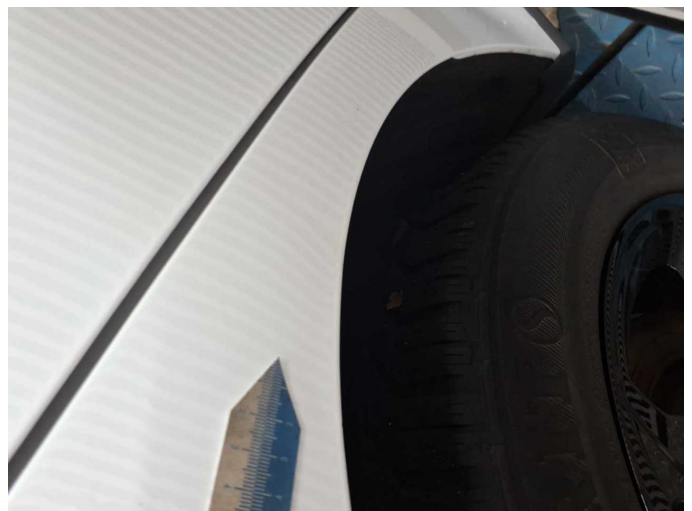
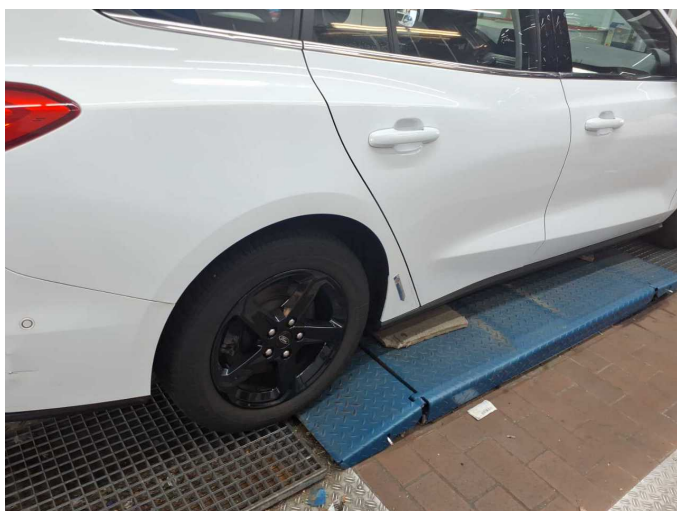
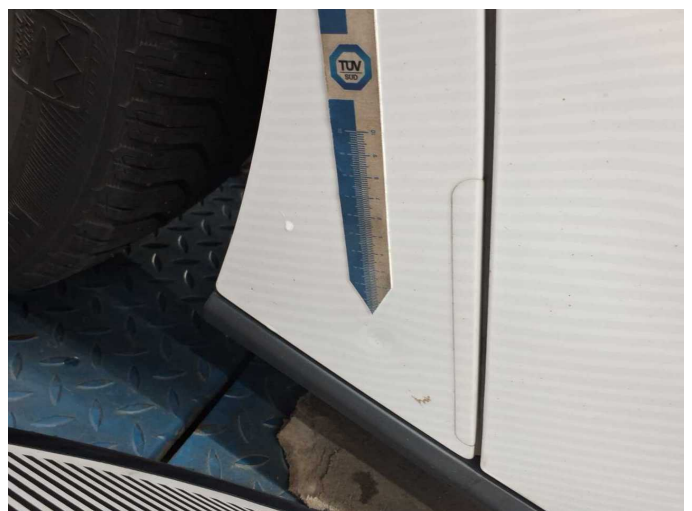
| No. | Component group | Description |
|---|---|---|
| 4 | Side panel - rear right side | Elbow - dent(s) - No deduction |

**Wear and tear 4:** Side panel - rear right side: Elbow - dent(s) - No deduction

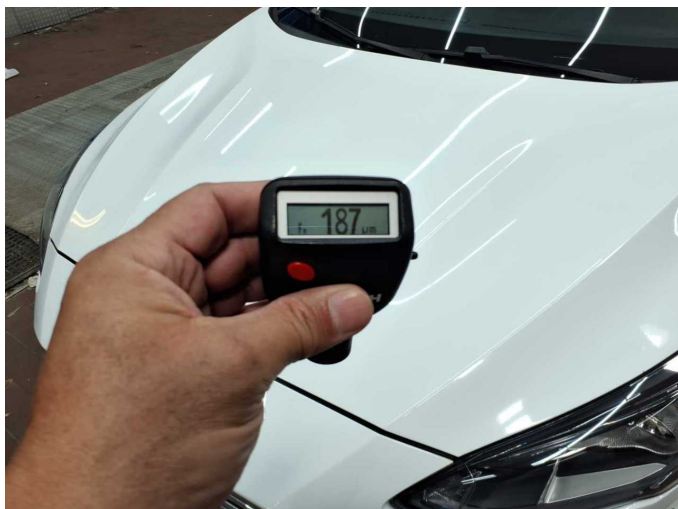
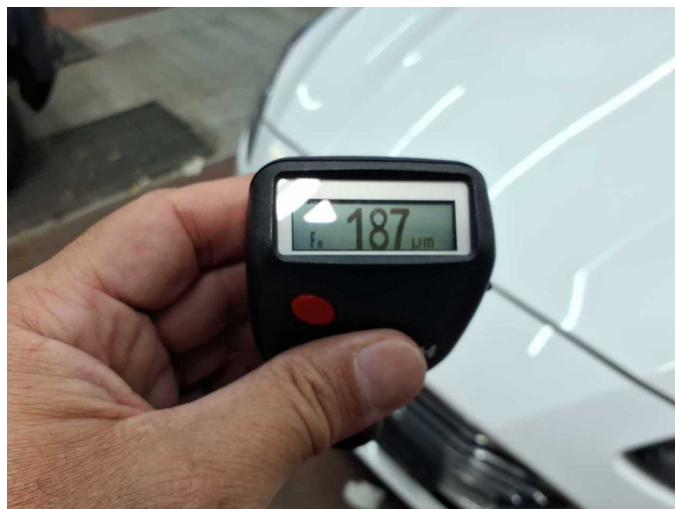
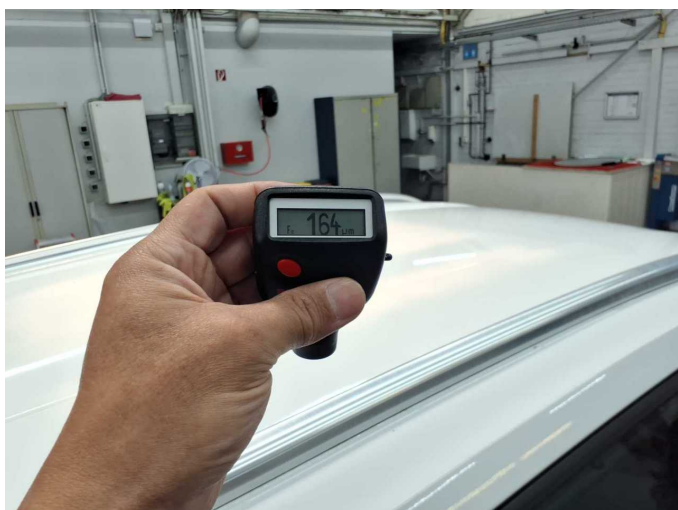
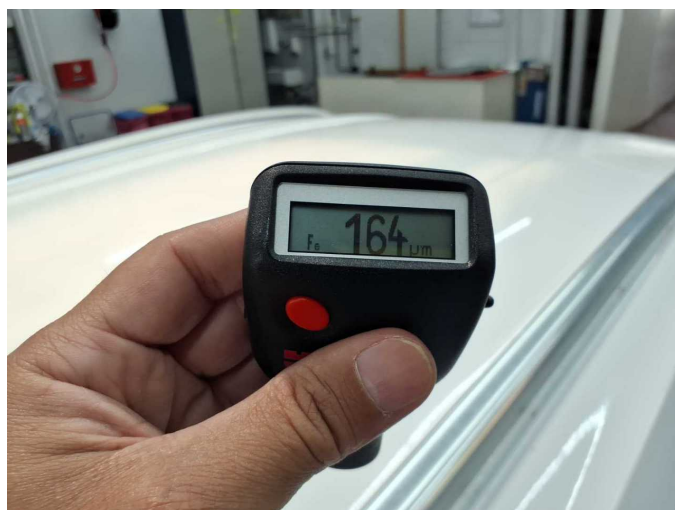
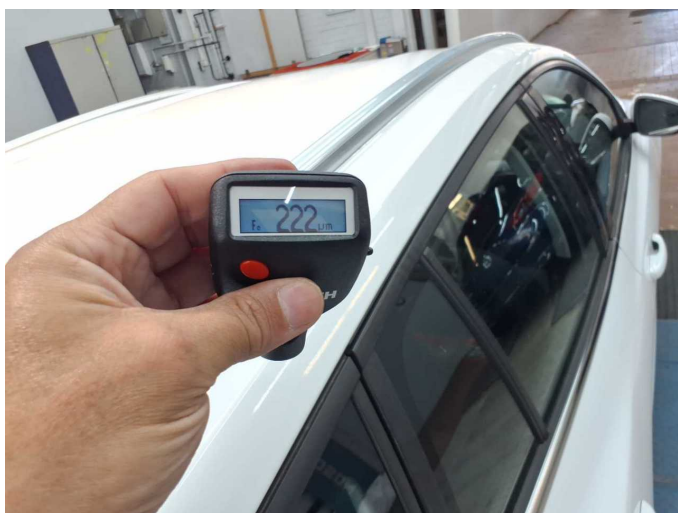
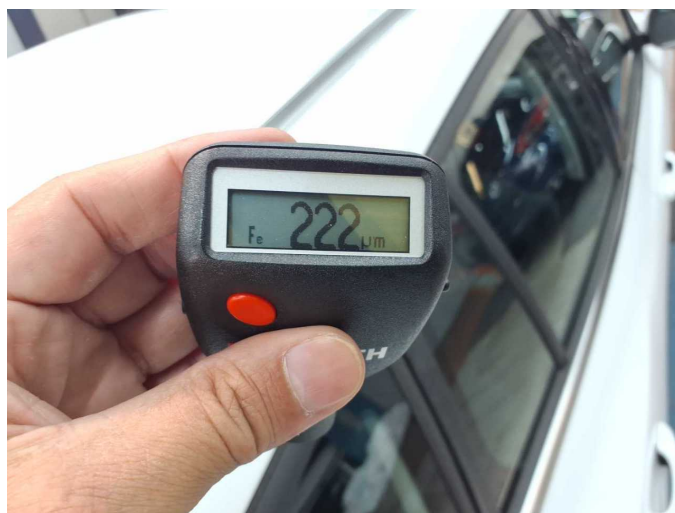
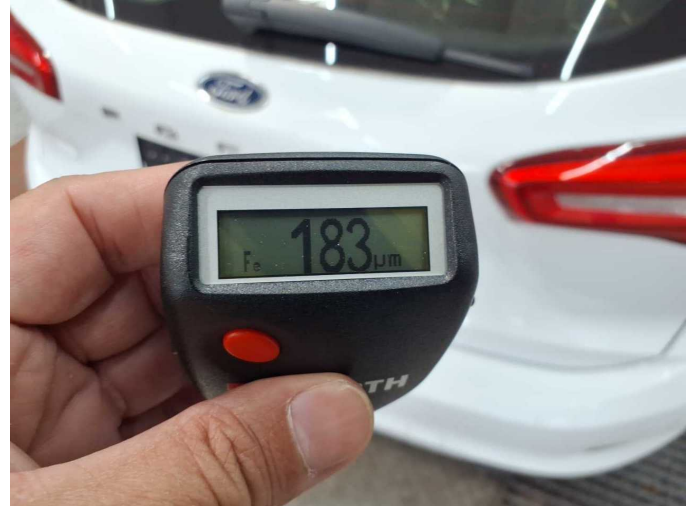
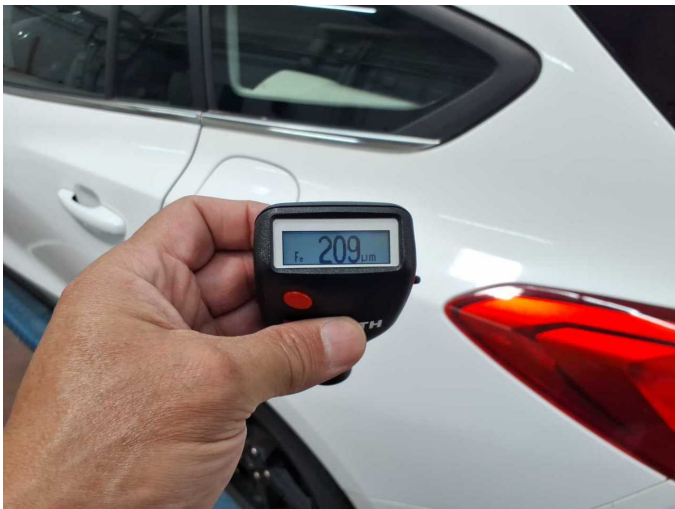
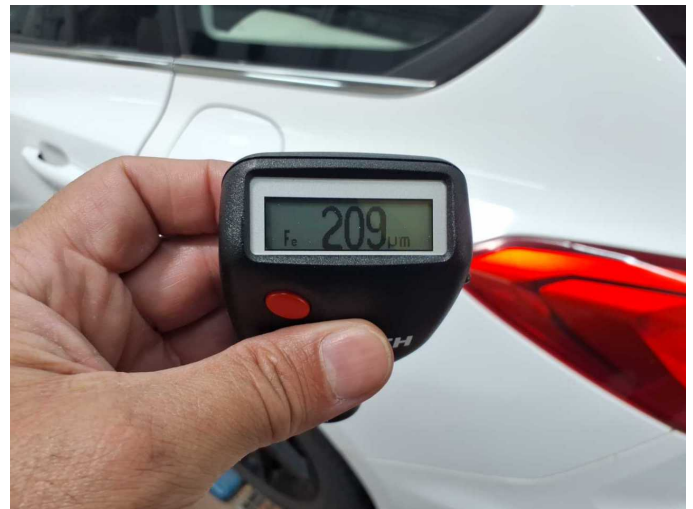
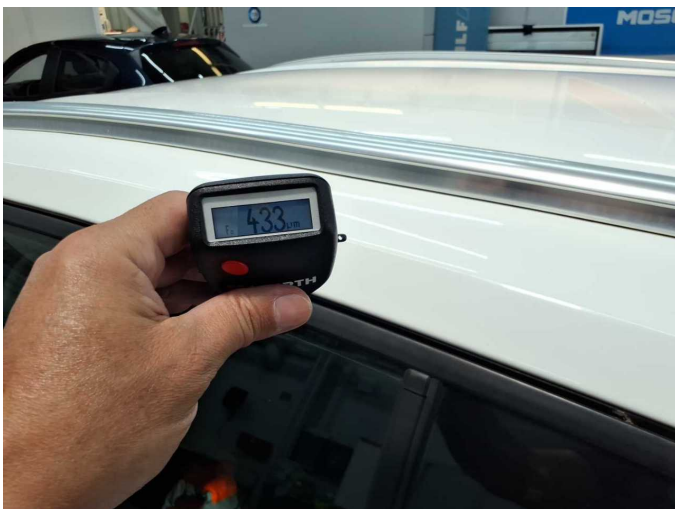
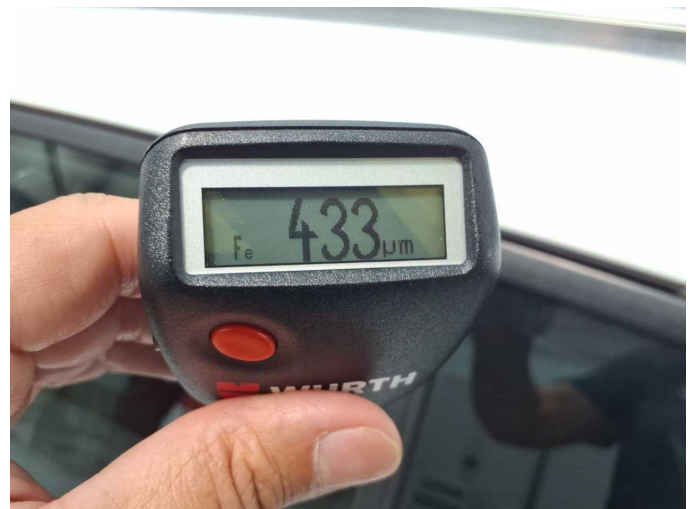
1 Roof, Roof rail - left side, Roof rail - right side, Boot lid / rear door, Bonnet, Side panel - rear left side, Professionally carried out

| Roof | 164 µm | Roof rail - left side | 433 µm |
| Roof rail - right side | 222 µm | Boot lid / rear door | 183 µm |
| Bonnet | 187 µm | Side panel - rear left side | 209 µm |

**Repainting 1:** Roof, Roof rail - left side, Roof rail - right side, Boot lid / rear door, Bonnet, Side panel - rear left side

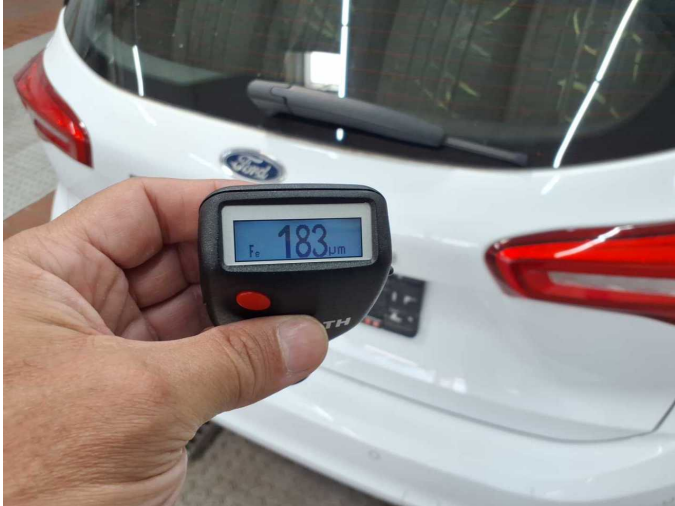
**Repainting 1:** Roof, Roof rail - left side, Roof rail - right side, Boot lid / rear door, Bonnet, Side panel - rear left side
