Expertise

Protocol number: 46290437  
Order No. / Reference: 26354490  
Inspection date: 2 Jul 2026

Manufacturer: Volkswagen

Model: Passat Variant 2.0 TDI SCR DSG Business

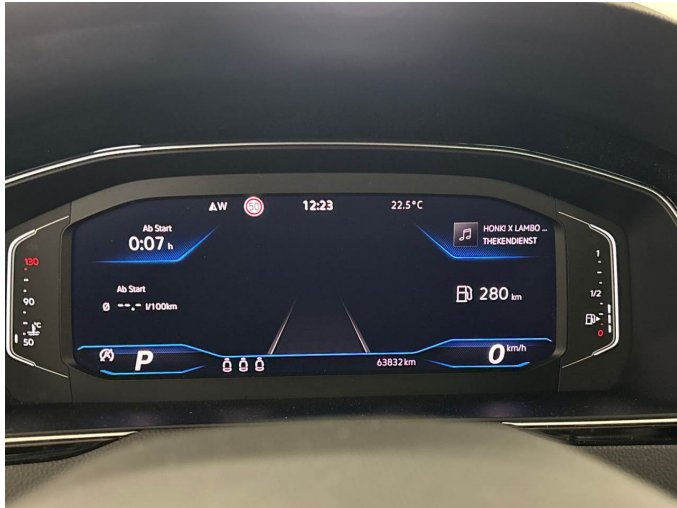
Figure 7: Instrument cluster

| Vehicle details | |
|---|---|
| Mileage (Read) | 63,832 km |

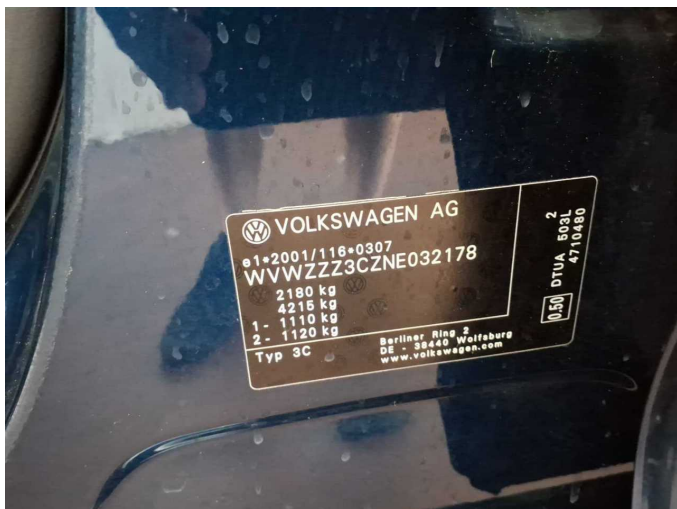
Figure 11: VIN

| VIN comparison | The vehicle identification number (VIN) was read from the vehicle and its conformity with the submitted documents was confirmed by the undersigned during the inspection. |

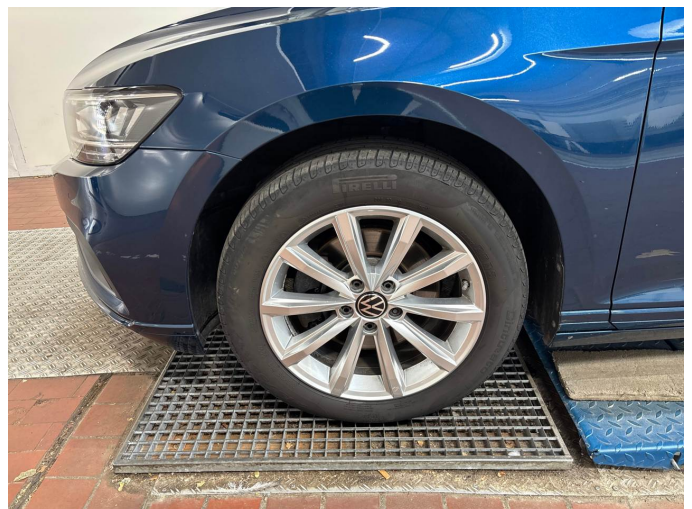
Figure 12: Mounted tyres

| # | Tyre size | Type of tyre | Manufacturer | Tread depth |
|---|---|---|---|---|
| 1) | 215/55 R17 94W | Summer tires (with run-flat tires) on Light alloy | Pirelli | 6mm / 6mm |
| 2) | 215/55 R17 94W | Summer tyres on Light alloy | Continental | 8mm / 8mm |

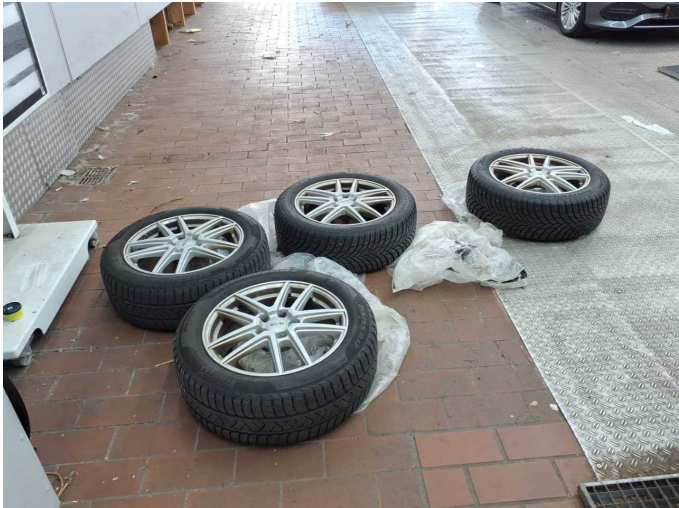
Figure 16: Additional tyres

| # | Tyre size | Type of tyre | Manufacturer | Tread depth |
|---|---|---|---|---|
| 1) | 215/55 R17 98V | Winter tyres on Light alloy | Firestone | 8mm / 8mm |
| 2) | 215/55 R17 94H | Winter tires (with run-flat tires) on Light alloy | Pirelli | 3mm / 3mm |

Winter Radsatz ist kein Bestandteil des Lieferumfangs.

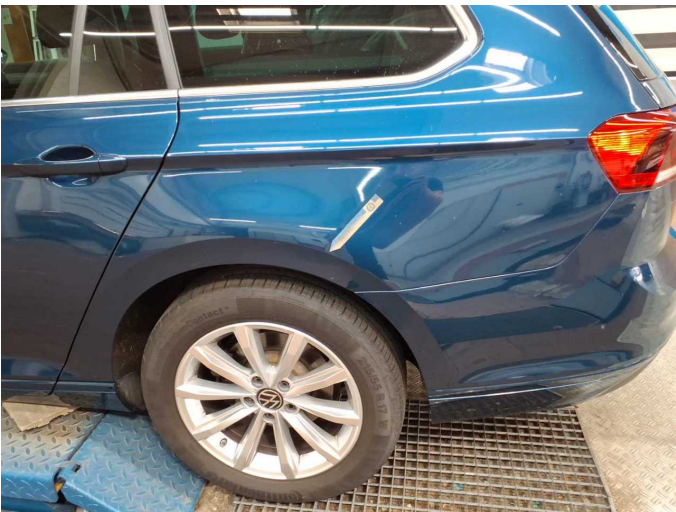
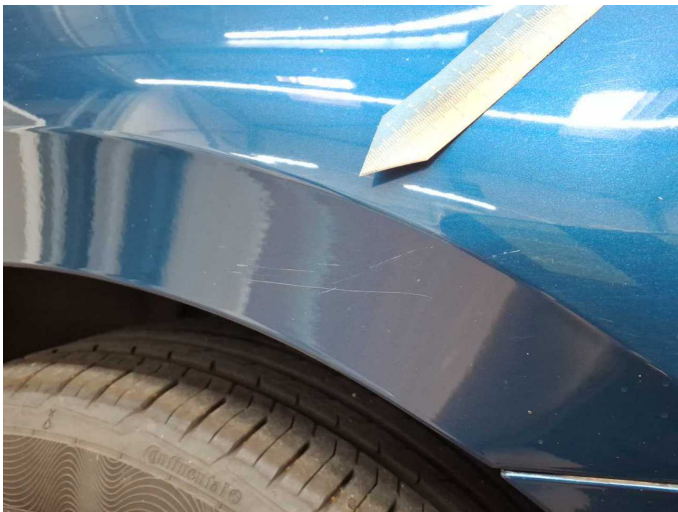
| No. | Component group | Description |
|---|---|---|
| 1 | Side panel - rear left side | Side panel - Scratch(es) - Smart repair |

Damage 1: Side panel - rear left side: Side panel - Scratch(es) - Smart repair

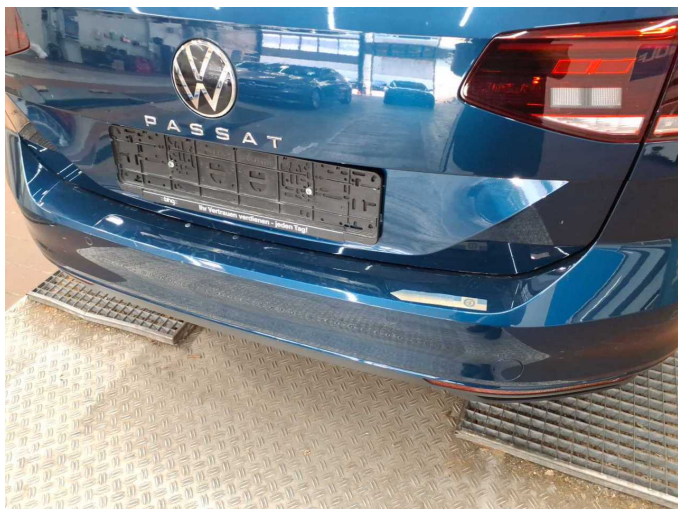
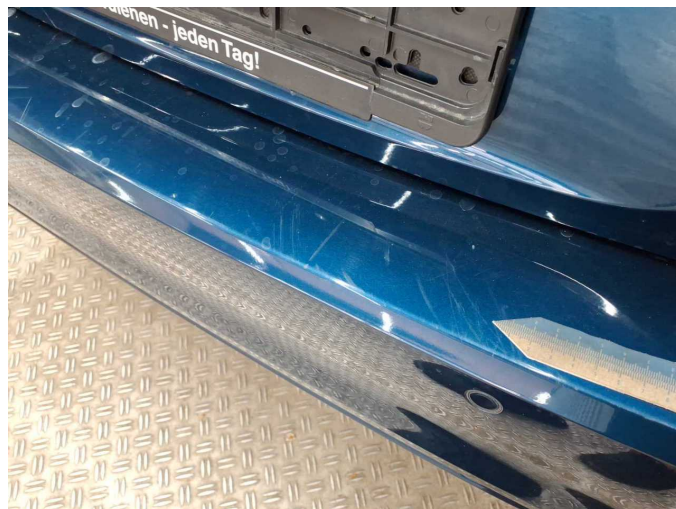
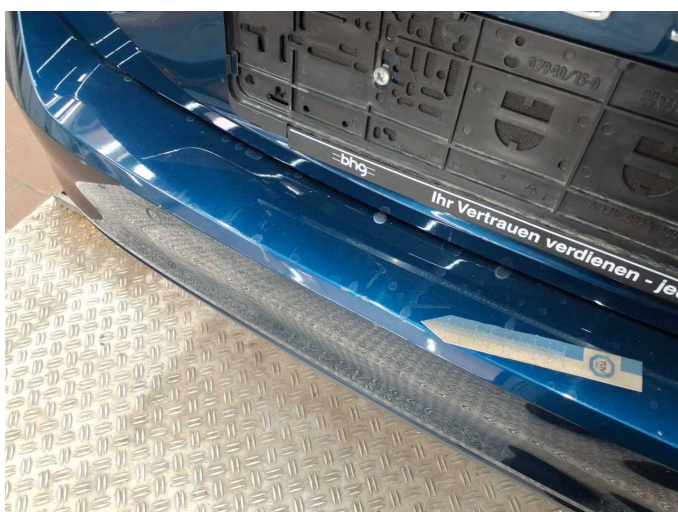
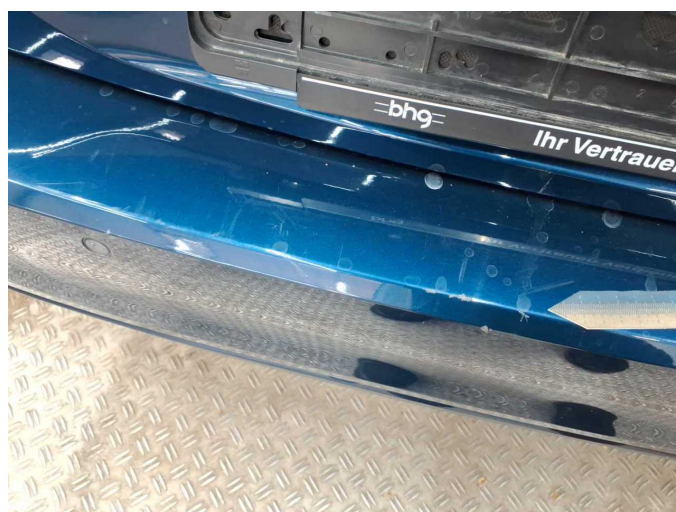
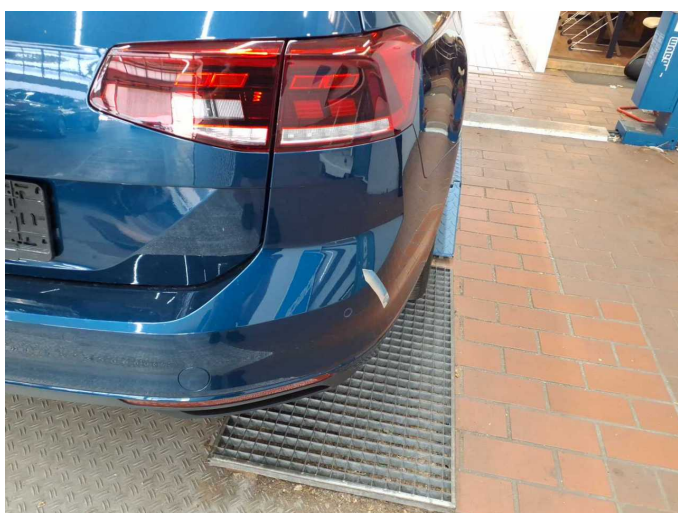
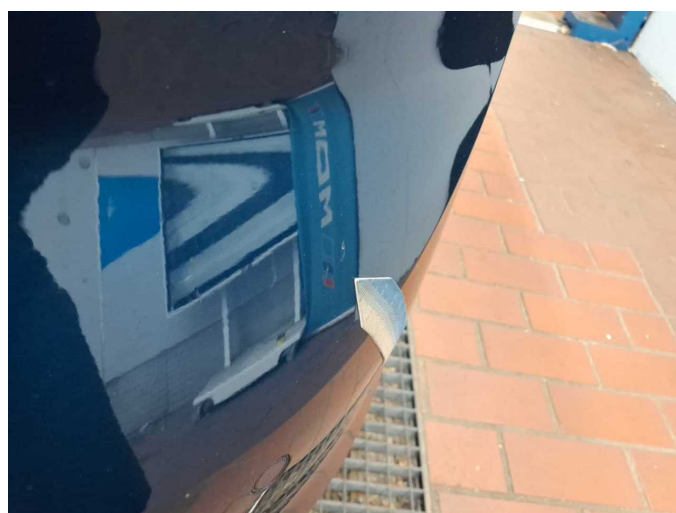
| No. | Component group | Description |
|---|---|---|
| 2 | Rear bumper | Rear bumper - Scratch(es) - Paint |

**Damage 2:** Rear bumper: Rear bumper - Scratch(es) - Paint

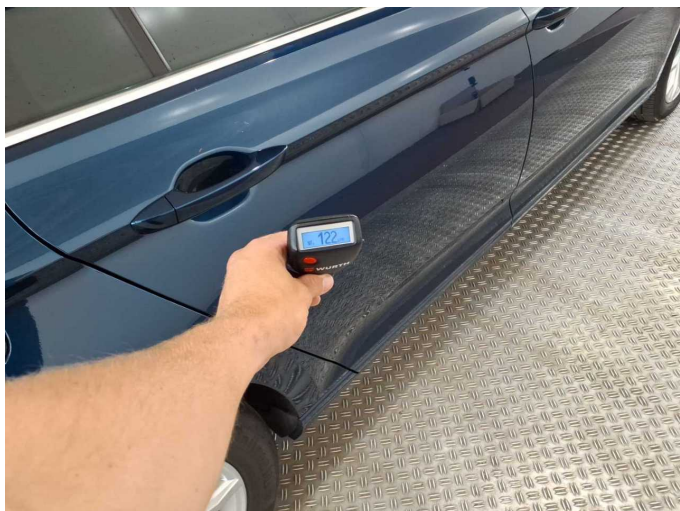
| No. | Previous damage | Extent of damage (Net) |
|---|---|---|
| 2 | Side right, Provided by user / customer, from 31 Oct 2022 | 3.236,72 € |

According to available information previous damages were repaired at the vehicle. Traces of repairs, which allow conclusions about the area of repair, were not recognizable during the inspection.

**Previous damage 2:** Side right
