Expertise

Protocol number: 46285834  
Order No. / Reference: 26381529  
Inspection date: 30 Jun 2026

Model: 5008 BlueHDi 180 EAT8 GT Pack

VIN: VF3MJEHZUNS183710

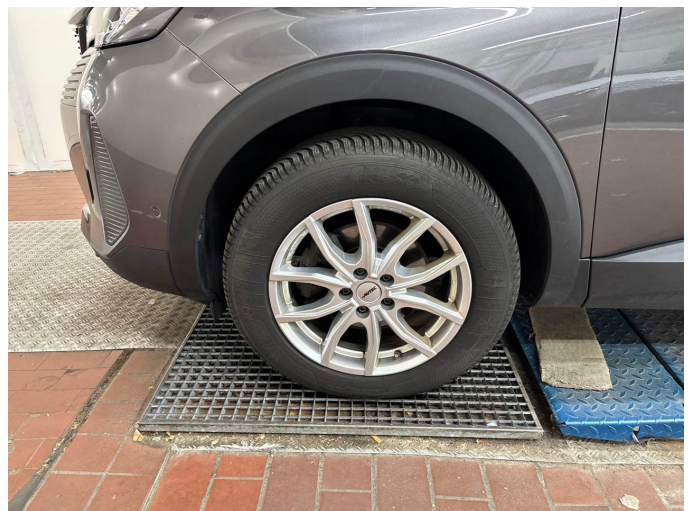
Figure 12: Mounted tyres

| # | Tyre size | Type of tyre | Manufacturer | Tread depth |
|---|---|---|---|---|
| 1) | 215/65 R17 99V | Winter tyres on Light alloy | Kleber | 5mm / 5mm |
| 2) | 215/65 R17 99H | Winter tyres on Light alloy | Continental | 5mm / 5mm |

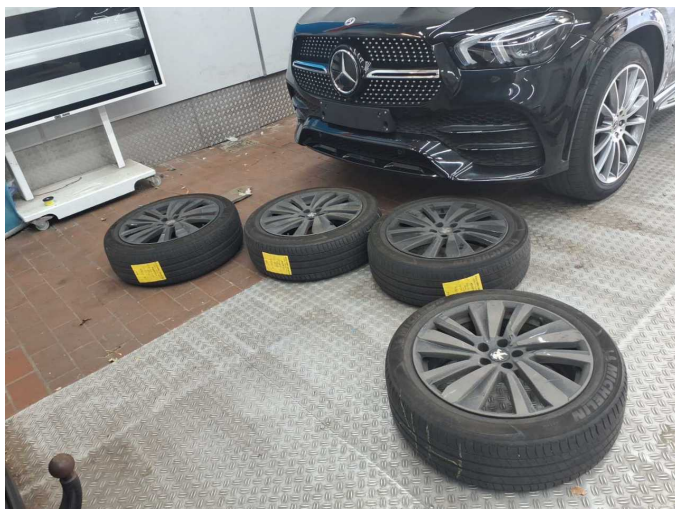
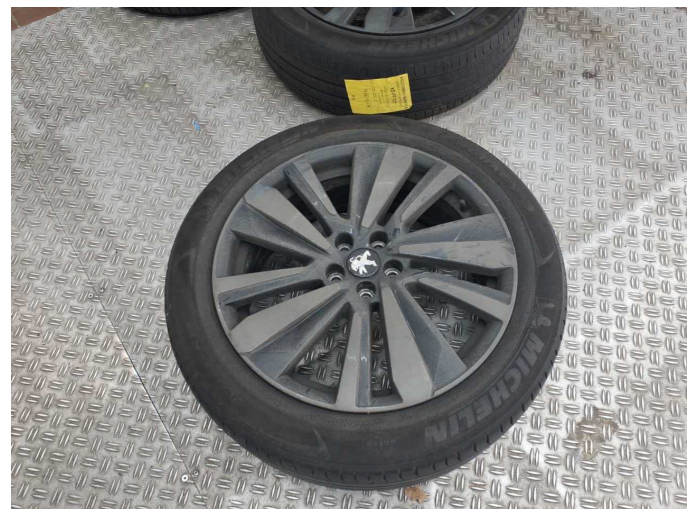
Figure 17: Additional tyres

| # | Tyre size | Type of tyre | Manufacturer | Tread depth |
|---|---|---|---|---|
| 1) | 205/55 R19 97V | Summer tyres on Light alloy | Michelin | 4mm / 4mm |
| 2) | 205/55 R19 97V | Summer tyres on Light alloy | Michelin | 6mm / 6mm |

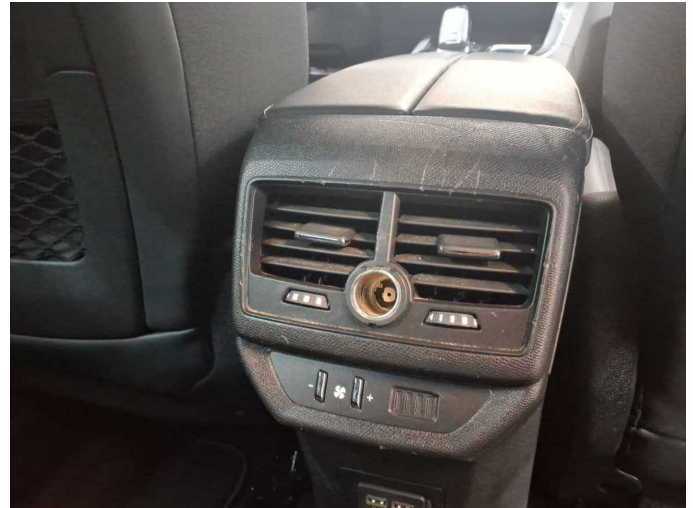
| No. | Component group | Description |
|---|---|---|
| 1 | Electrical system | Power socket (hinten) - Incomplete - Replace |

**Damage 1:** Electrical system: Power socket (hinten) - Incomplete - Replace

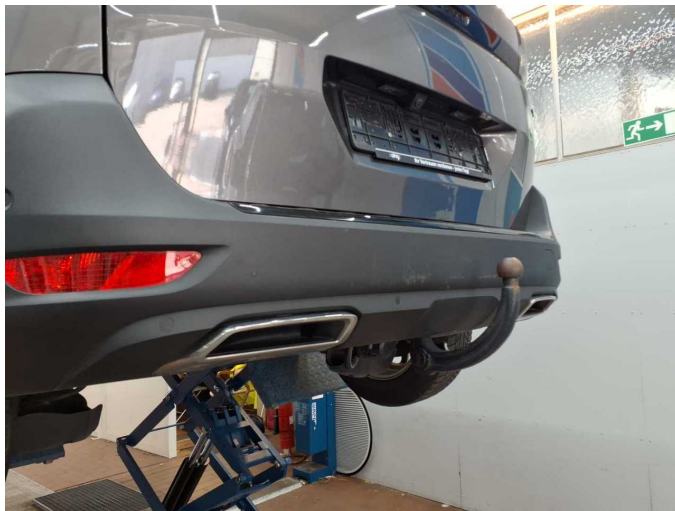
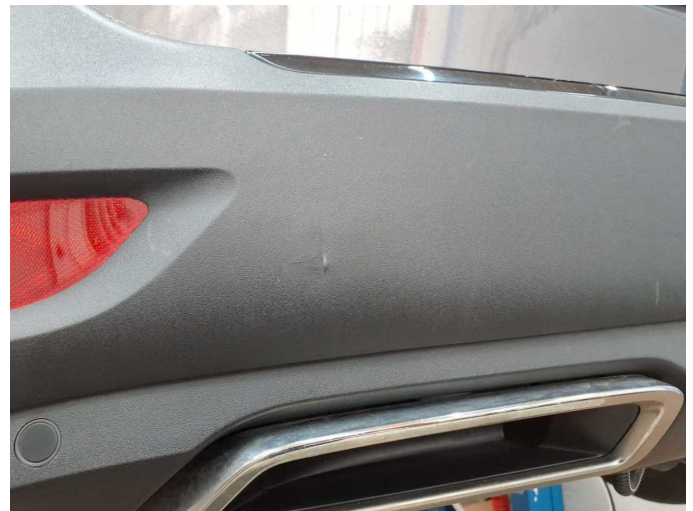
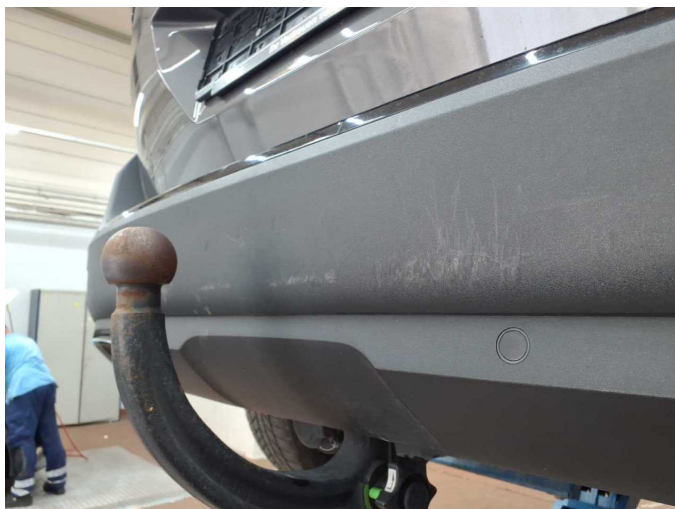
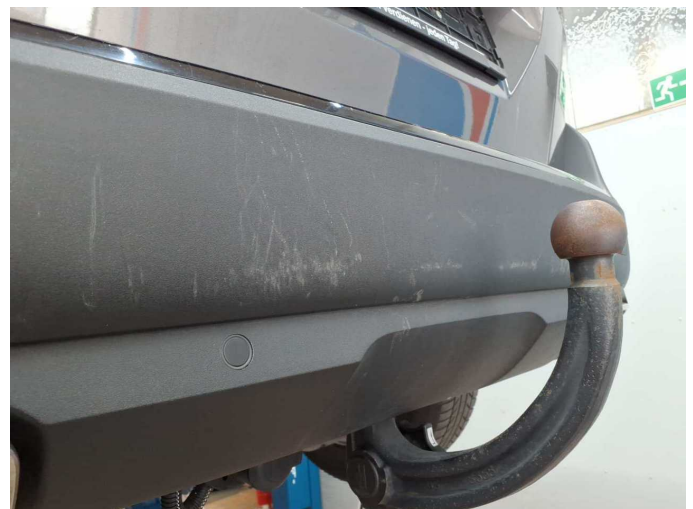
| No. | Component group | Description |
|---|---|---|
| 2 | Rear bumper | Rear bumper (unpainted) - Scratched - Loss in value |

**Damage 2:** Rear bumper: Rear bumper (unpainted) - Scratched - Loss in value

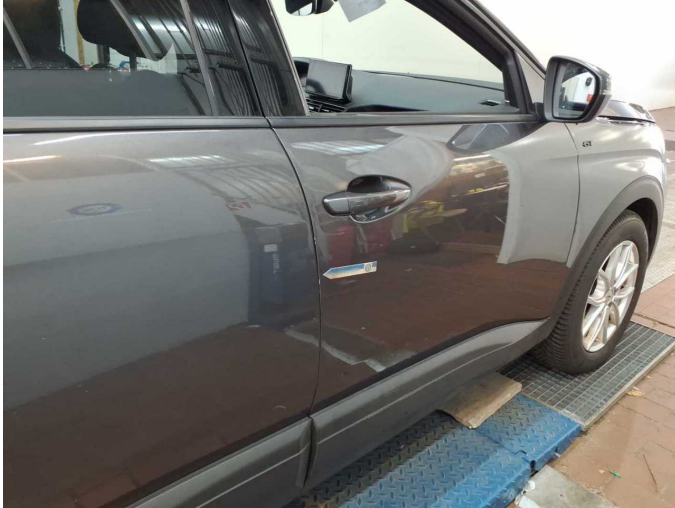
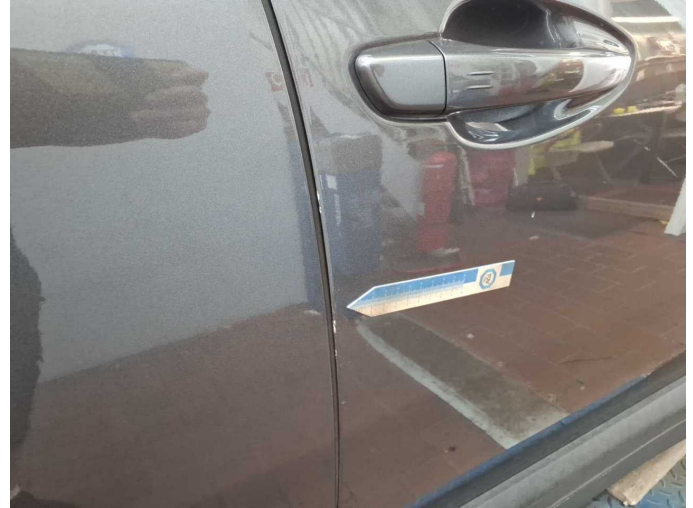
| No. | Component group | Description |
|---|---|---|
| 3 | Door - front right side | Door edge - Scratch(es) - Smart repair |

**Damage 3:** Door - front right side: Door edge - Scratch(es) - Smart repair

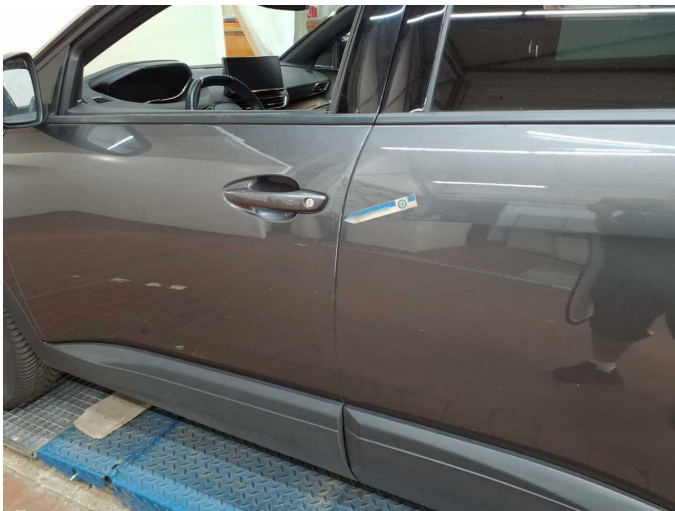
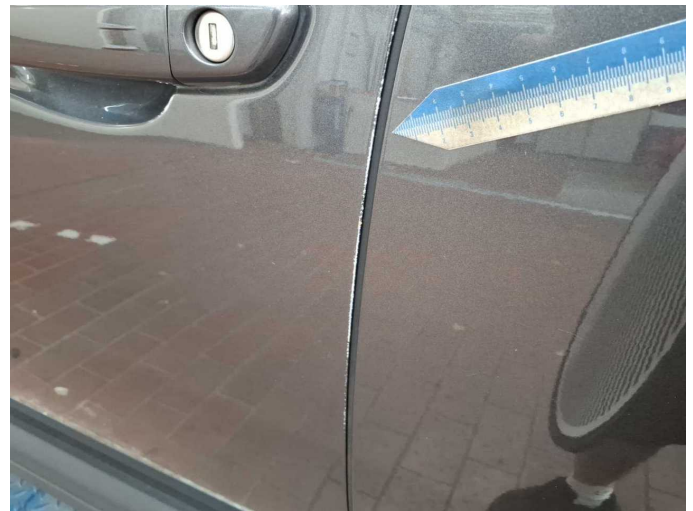
| No. | Component group | Description |
|---|---|---|
| 4 | Door - front left side | Door edge - Scratch(es) - Smart repair |

**Damage 4:** Door - front left side: Door edge - Scratch(es) - Smart repair

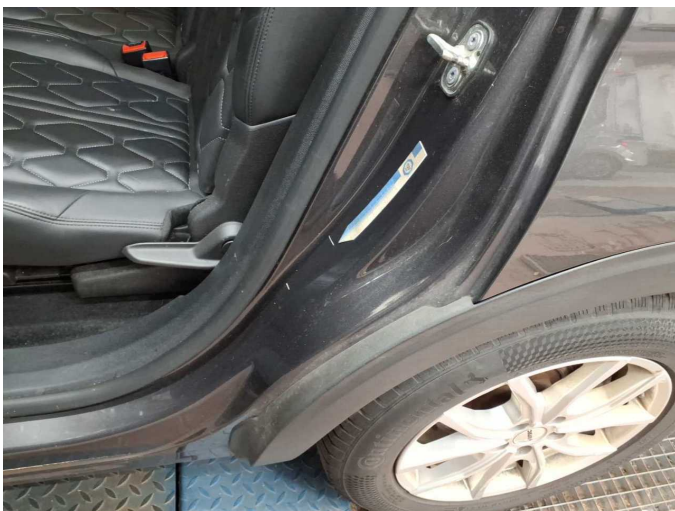
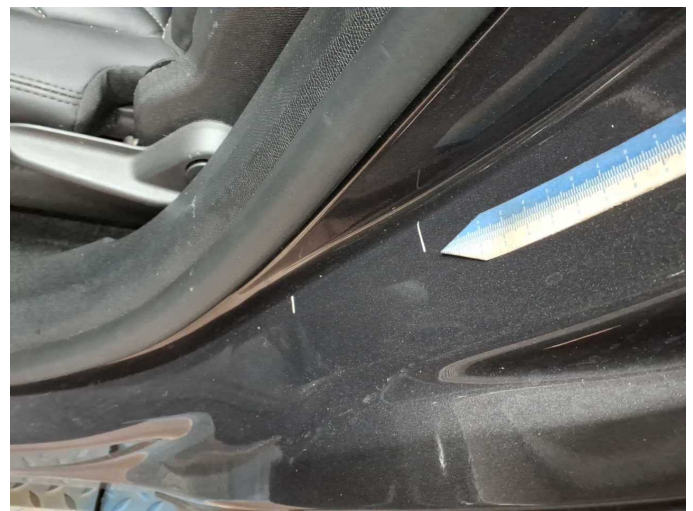
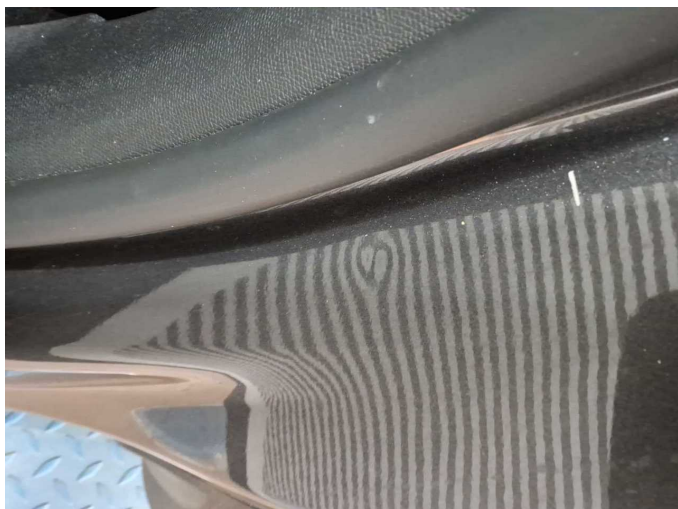
| No. | Component group | Description |
|---|---|---|
| 5 | Side panel - rear left side | Sill - Dent / paintcoat damage - Smart repair |

**Damage 5:** Side panel - rear left side: Sill - Dent / paintcoat damage - Smart repair

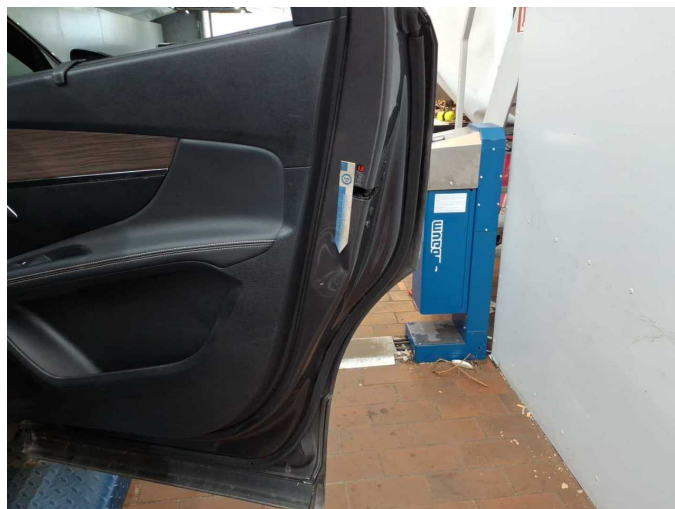
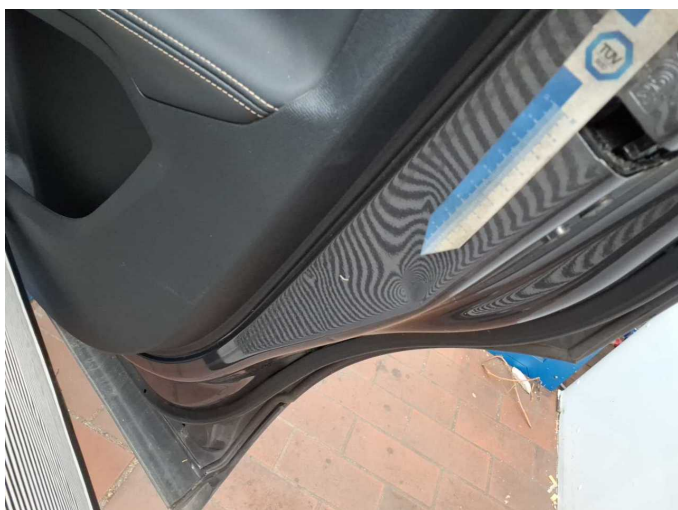
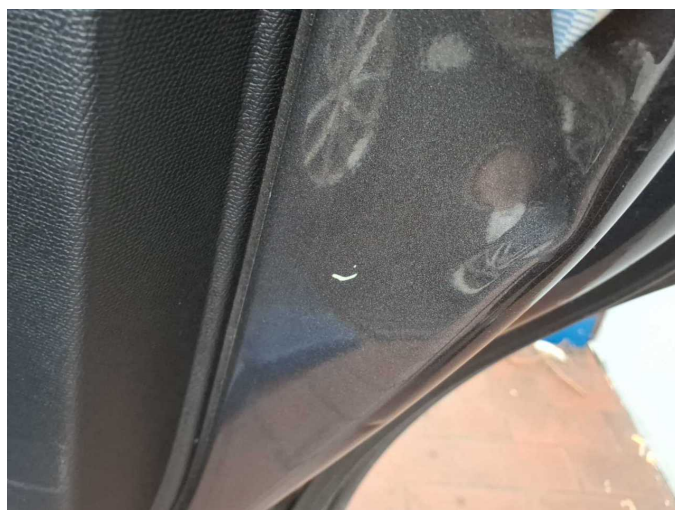
| No. | Component group | Description |
|---|---|---|
| 6 | Door - rear left side | Door - Dent / paintcoat damage - Smart repair |

| Door - rear left side | 116 µm |

**Damage 6:** Door - rear left side: Door - Dent / paintcoat damage - Smart repair

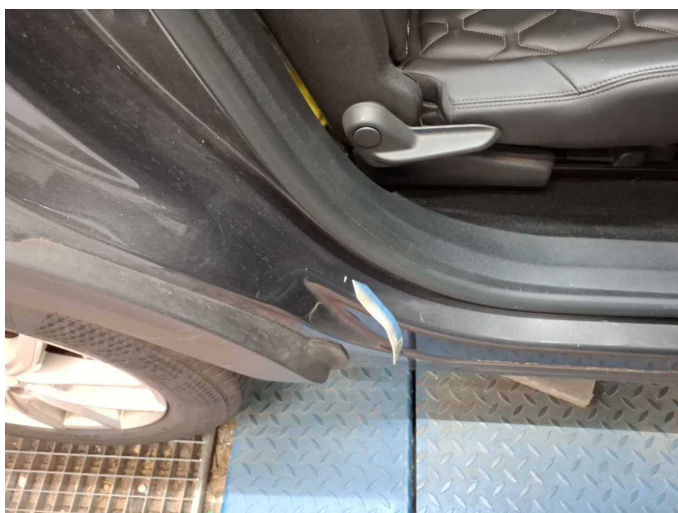
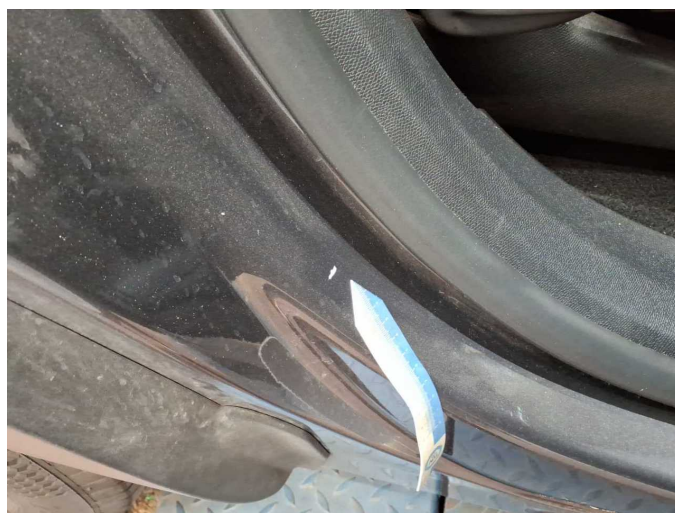
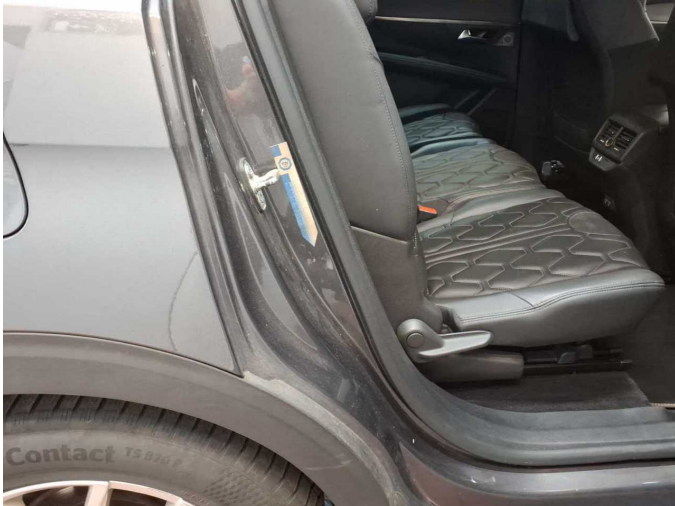
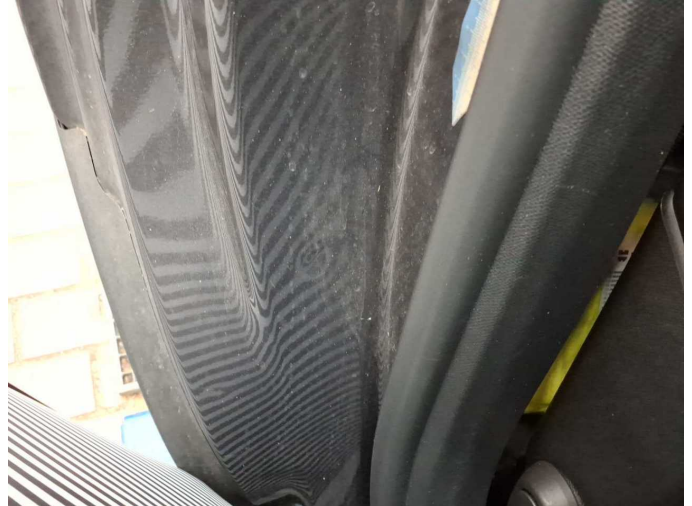
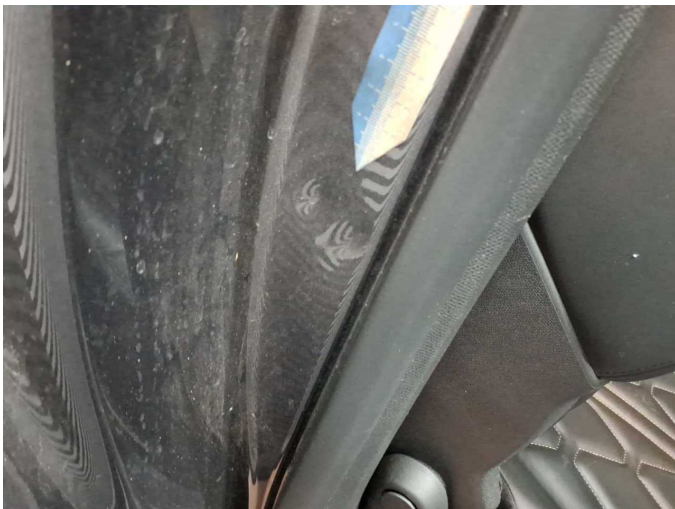
| No. | Component group | Description |
|---|---|---|
| 7 | Side panel - rear right side | Sill - Dent / paintcoat damage - Smart repair |

**Damage 7:** Side panel - rear right side: Sill - Dent / paintcoat damage - Smart repair

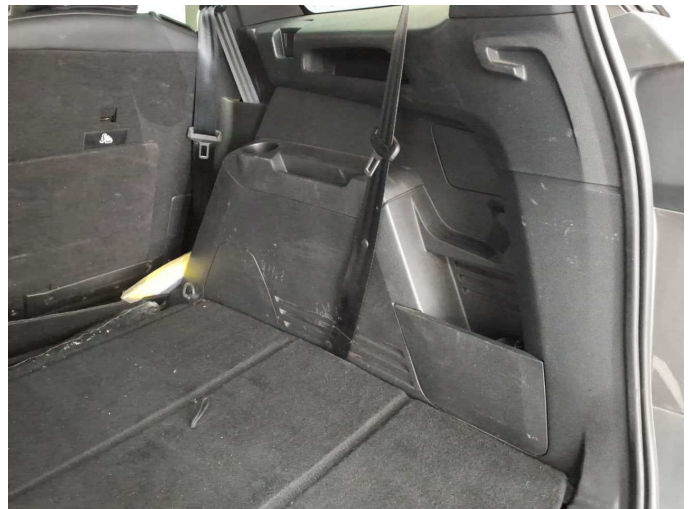
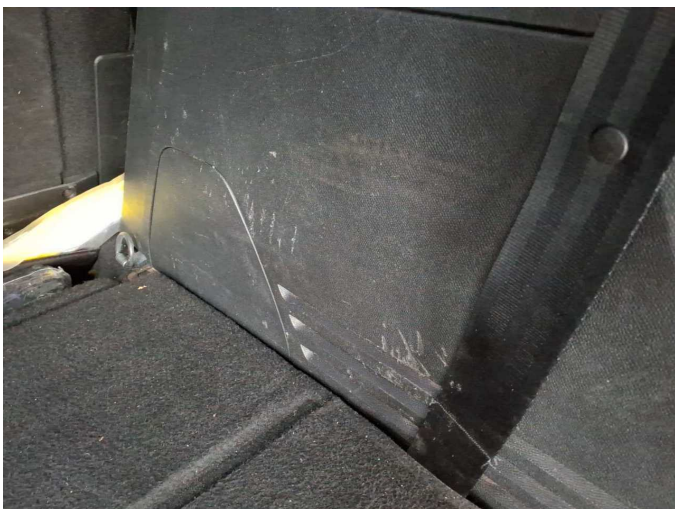
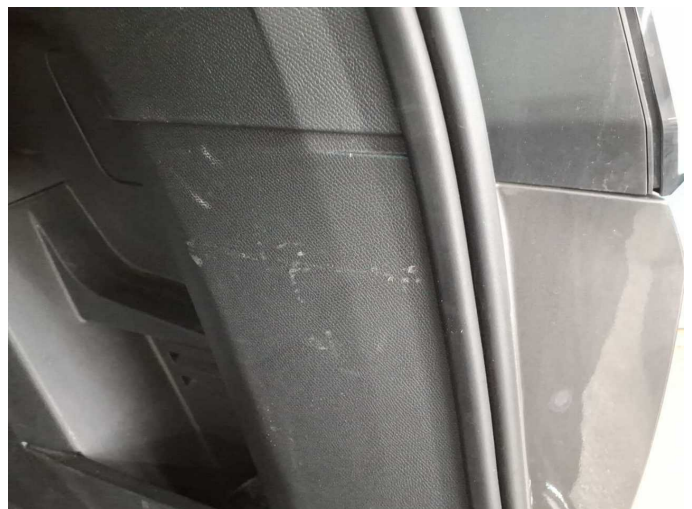
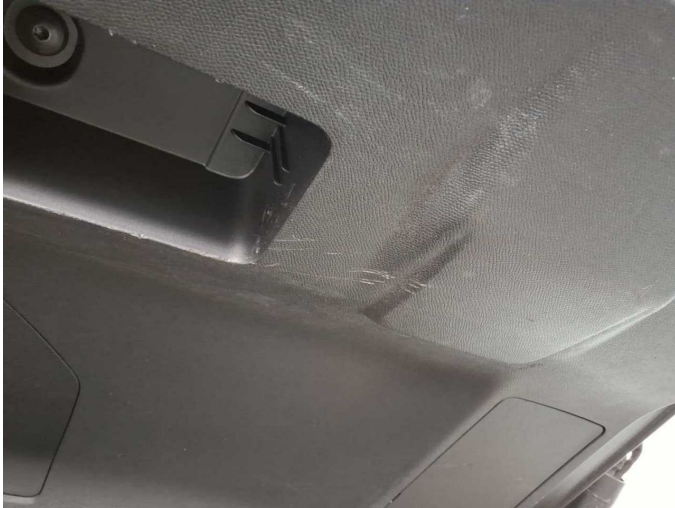
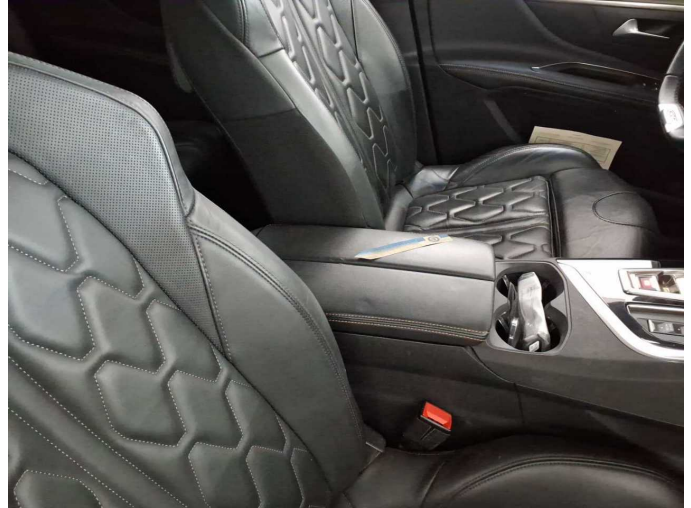
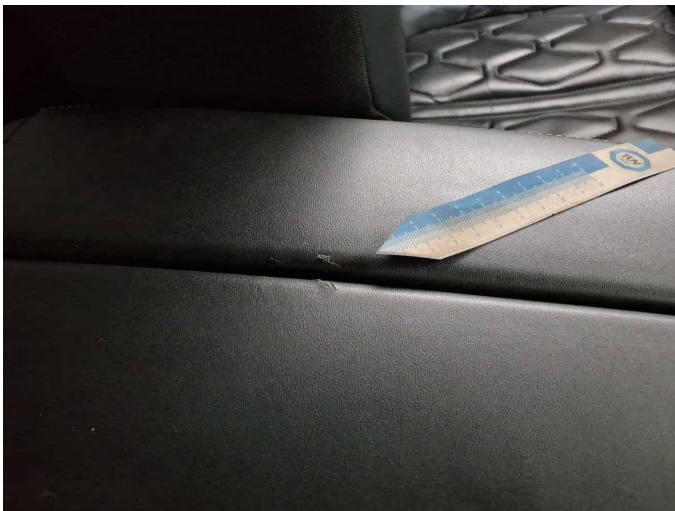
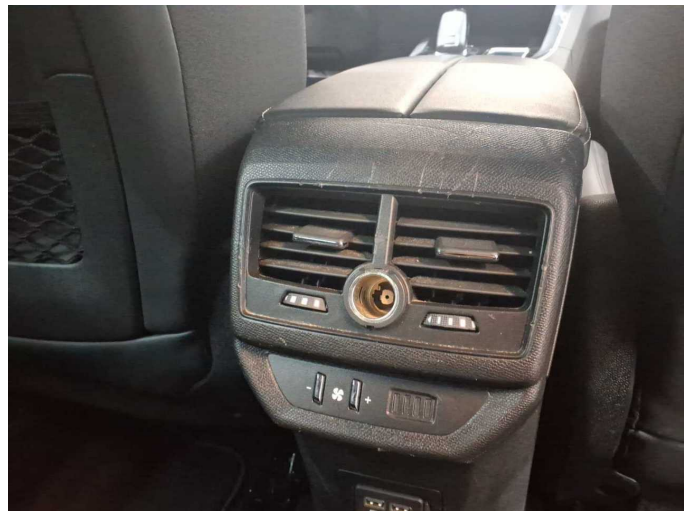
| No. | Component group | Description |
|---|---|---|
| 8 | Interior | Interior - Scratched - Loss in value |

**Damage 8:** Interior: Interior - Scratched - Loss in value

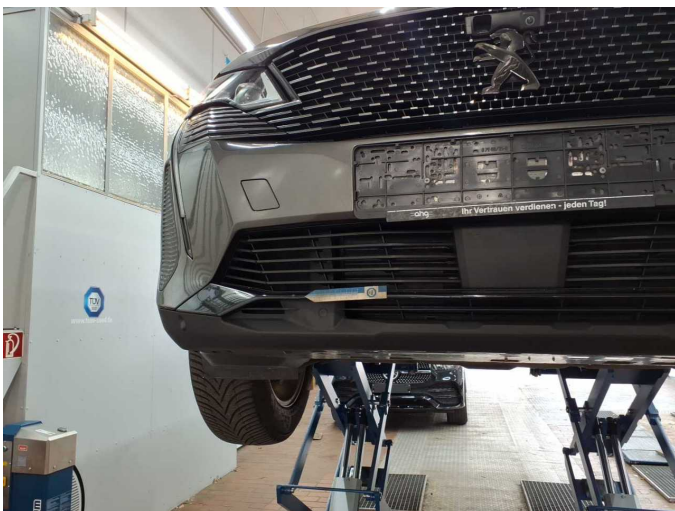
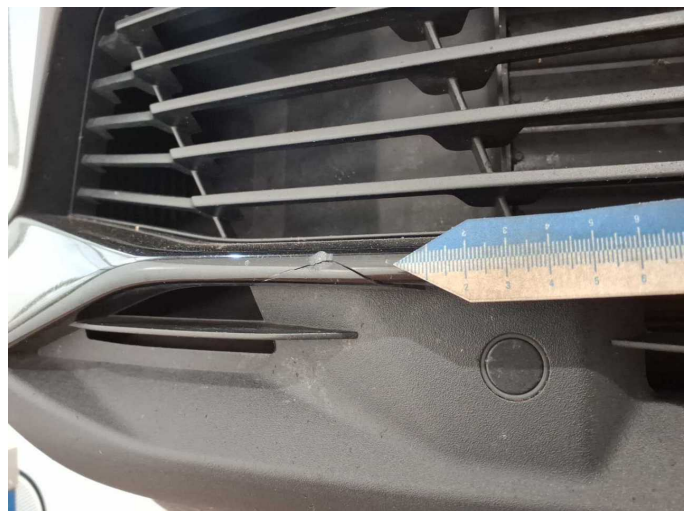
| No. | Component group | Description |
|---|---|---|
| 9 | Front bumper | Front strip - Broken / torn - Replace |

**Damage 9:** Front bumper: Front strip - Broken / torn - Replace
