VOLKSWAGEN ARTEON

Vehicle information

Summary of damages

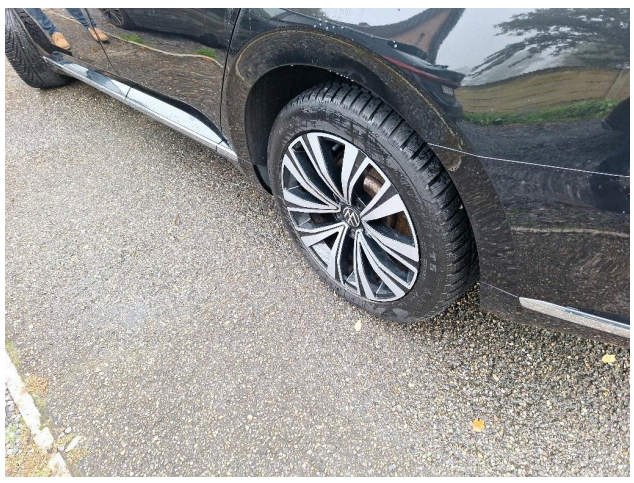
Bodywork

Damaged -

Acceptable.

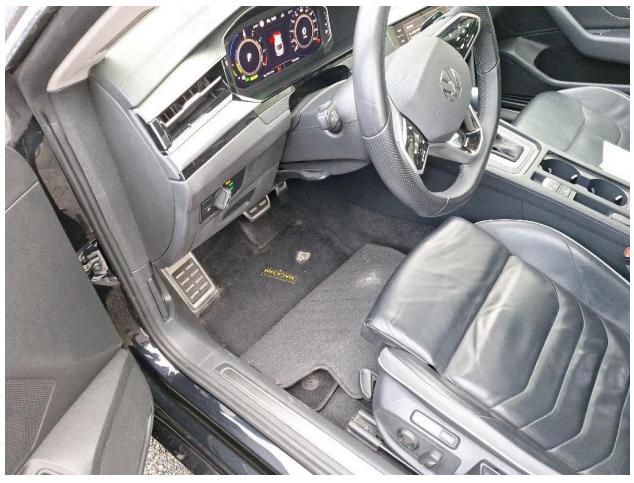
AVG Smart Repair
Hole **Floor Mats** Interior
