Expertise

Protocol number: 48052403
Order No. / Reference: 27075408
Inspection date: 12 Oct 2026

Manufacturer: Mercedes-Benz	Model: C 200 d T 9G-TRONIC Avantgarde
VIN: W1KAH0DB7PF104541

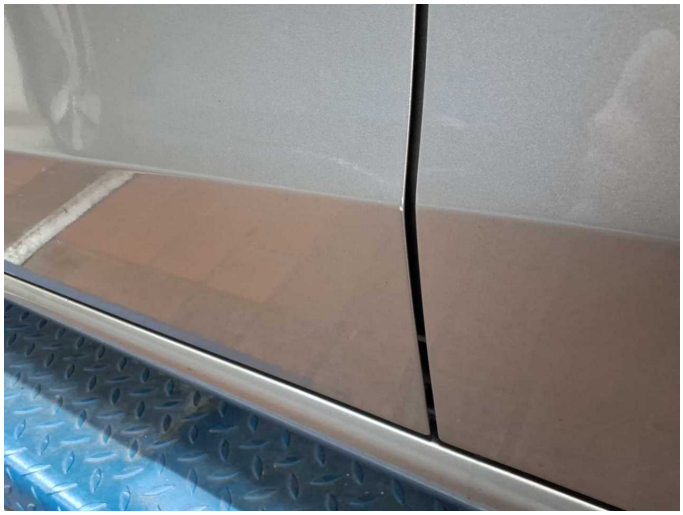
Damage 2: Door - front left side: Door - Scratch(es) - Smart repair
