Audi

VIN: WAUZZZF36P1042449

Estimated repair cost

Statement details

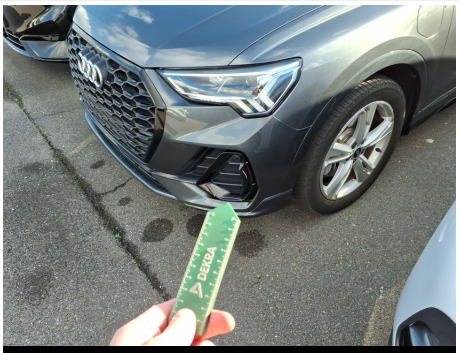
006	Bumper grille / Front Right Painted : No / Chromed : No	Broken	Replace	57.77 EUR

Bumper grille / Front Right / Broken

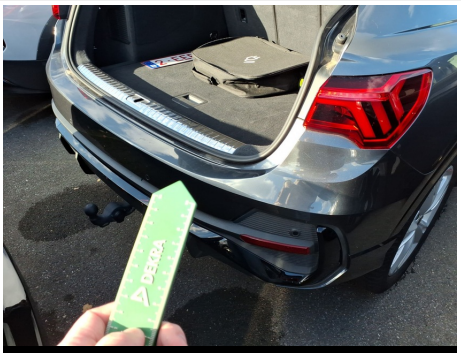
014	Bumper moulding / Back Painted : Yes / Chromed : No	Improper Repair	Painting	161.00 EUR

Bumper moulding / Back / Improper Repair
