Expertise

Protocol number: 48551295
Order No. / Reference: 27248946
Inspection date: 4 Nov 2026

Manufacturer: Audi	Model: A4 Avant 40 TDI S tronic
VIN: WAUZZZF44PA068170

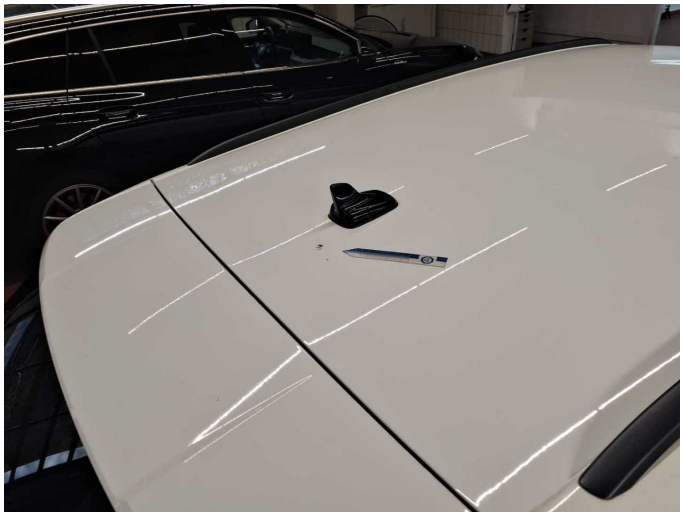
Damage 1: Roof: Roof (- Mehrkosten können entstehen) - Soiled - Conditioning

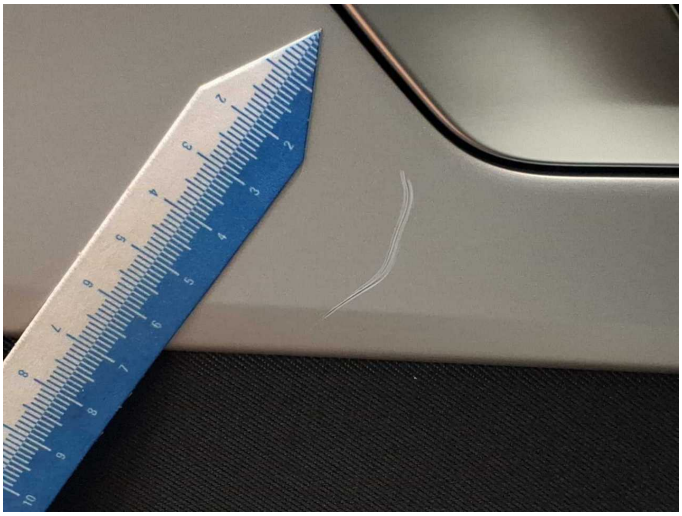
No.	Component group	Description
1	Roof	Roof (- Mehrkosten können entstehen) - Soiled - Conditioning
2	Trim / covers	Door trim - rear left side (Blende) - Scratch(es) - Replace
3	Rear bumper	Spoiler - Scratch(es) - Smart repair
4	Side panel - rear right side	Elbow - Scratch(es) - Smart repair
5	Side panel - rear left side	Sill - Scratch(es) - Smart repair
6	Wheel / tyres	Alloy rim - rear left side - Scratched - Loss in value
7	Wheel / tyres	Alloy rim - front left side - Scratched - Loss in value
8	Door - rear right side	Door - Scratch(es) - Paint
9	Rear bumper	Rear bumper - Scratched - Paint
10	Front bumper	Front bumper - Scratch(es) - Paint

Damage 2: Trim / covers: Door trim - rear left side (Blende) - Scratch(es) - Replace

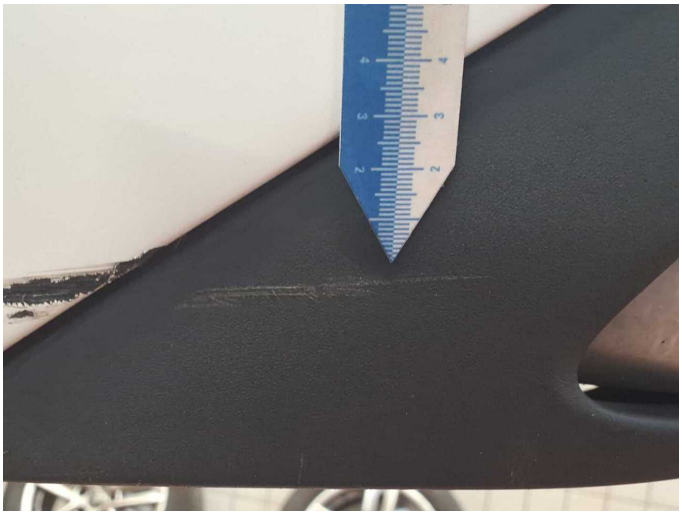
Damage 3: Rear bumper: Spoiler - Scratch(es) - Smart repair

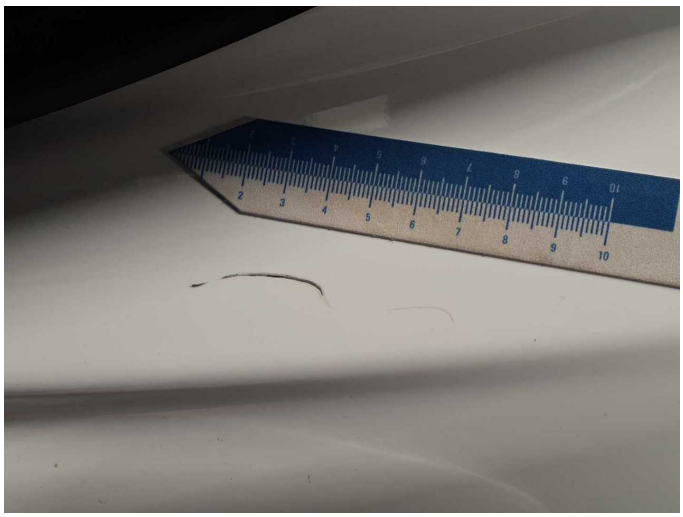
Damage 5: Side panel - rear left side: Sill - Scratch(es) - Smart repair

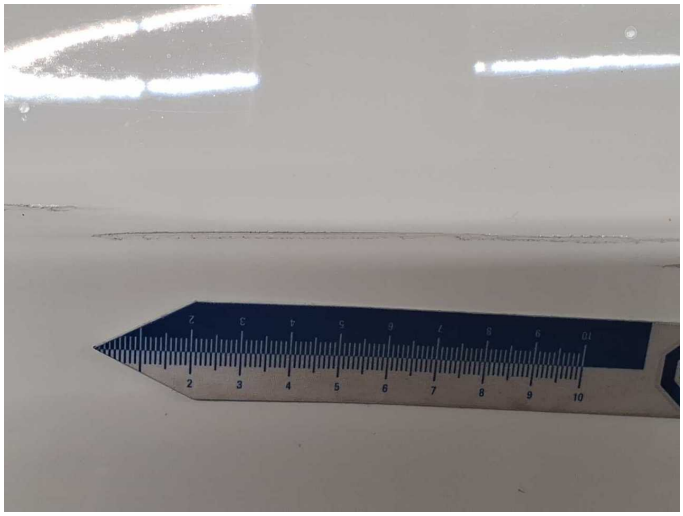
Damage 8: Door - rear right side: Door - Scratch(es) - Paint

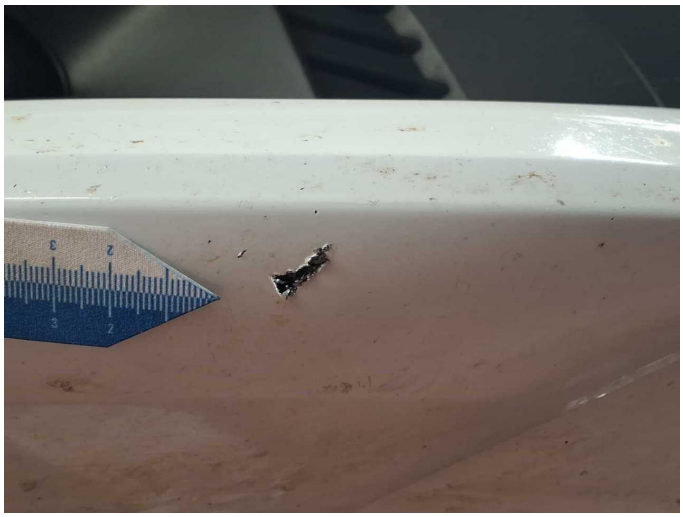
Damage 10: Front bumper: Front bumper - Scratch(es) - Paint

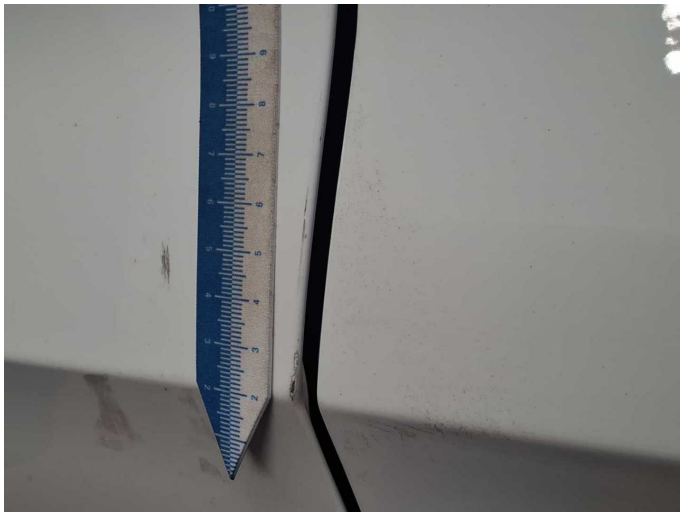
Wear and tear 1: Door - front left side: Door edge - Scratch(es) - No deduction
