Expertise

Protocol number: 48574904
Order No. / Reference: 27296759
Inspection date: 9 Nov 2026

Manufacturer: Ford	Model: Transit Custom 300 L2H1 LKW VA Trend
VIN: WF0YXXTTGYKJ65323

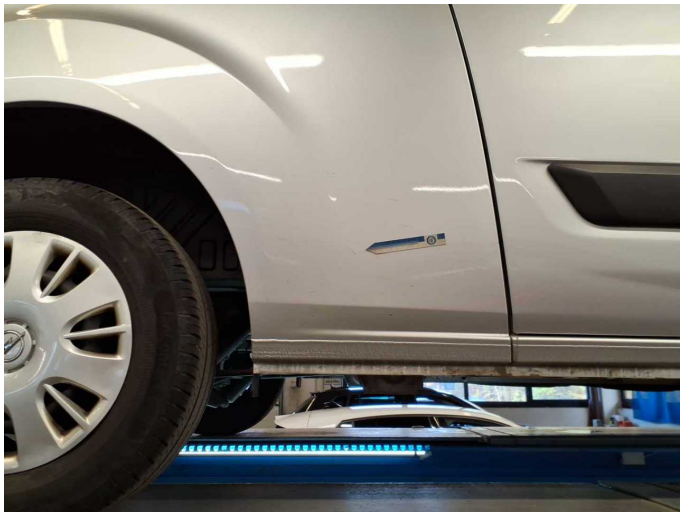
Damage 4: Mudguard - right side: Mudguard - right side - Scratch(es) - Smart repair
